**ANNUAL POWER POLE INTEGRITY PROGRAM
MAY 2005
SUMMARY**

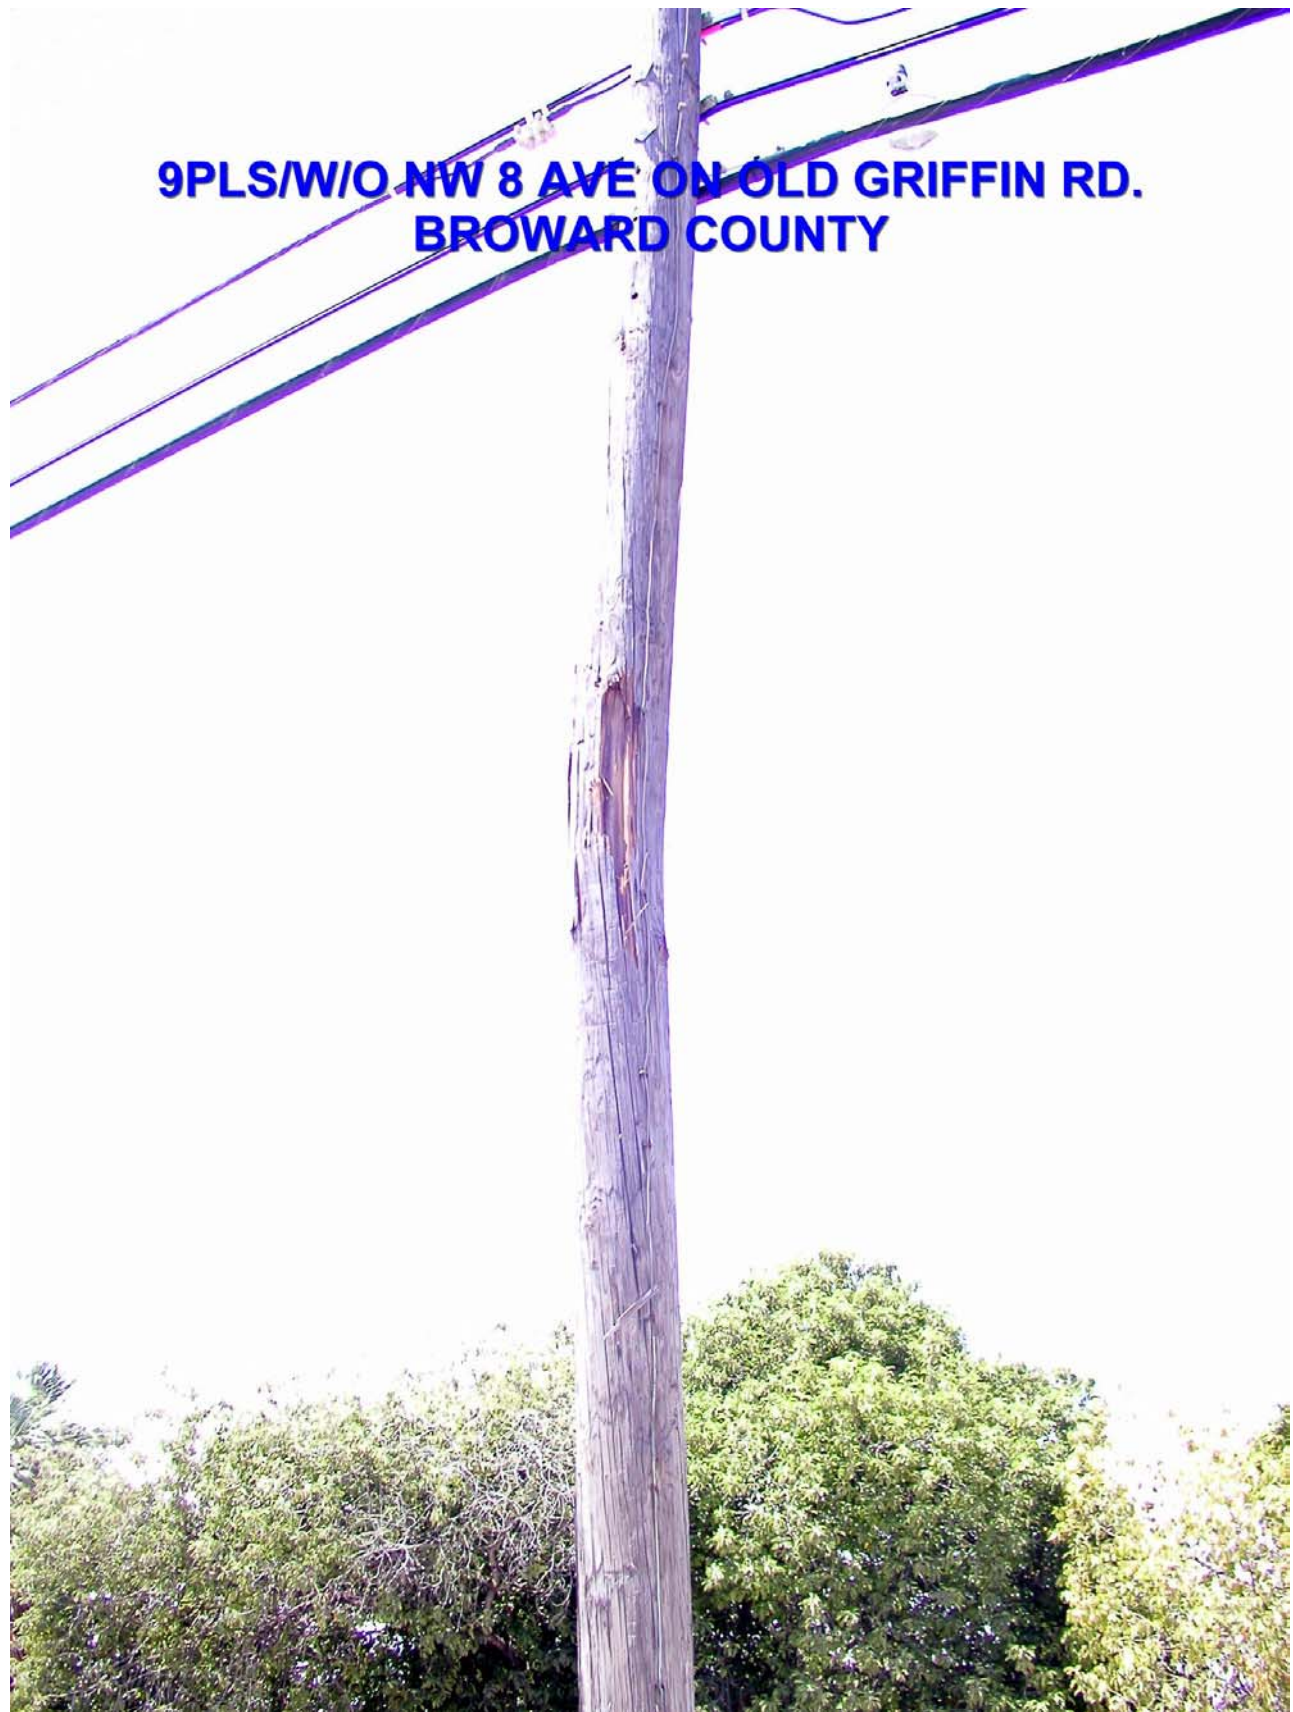
**9PLS/W/O NW 8 AVE ON OLD GRIFFIN RD.
BROWARD COUNTY**

9PLS/W/O NW 8 AVE ON OLD GRIFFIN RD. - A significant fracture approximately half way up the pole has compromised it's structural integrity. It is possible that the upper half may topple over during a storm with high winds. Although not visible in the photo, the pole supports primary conductors.

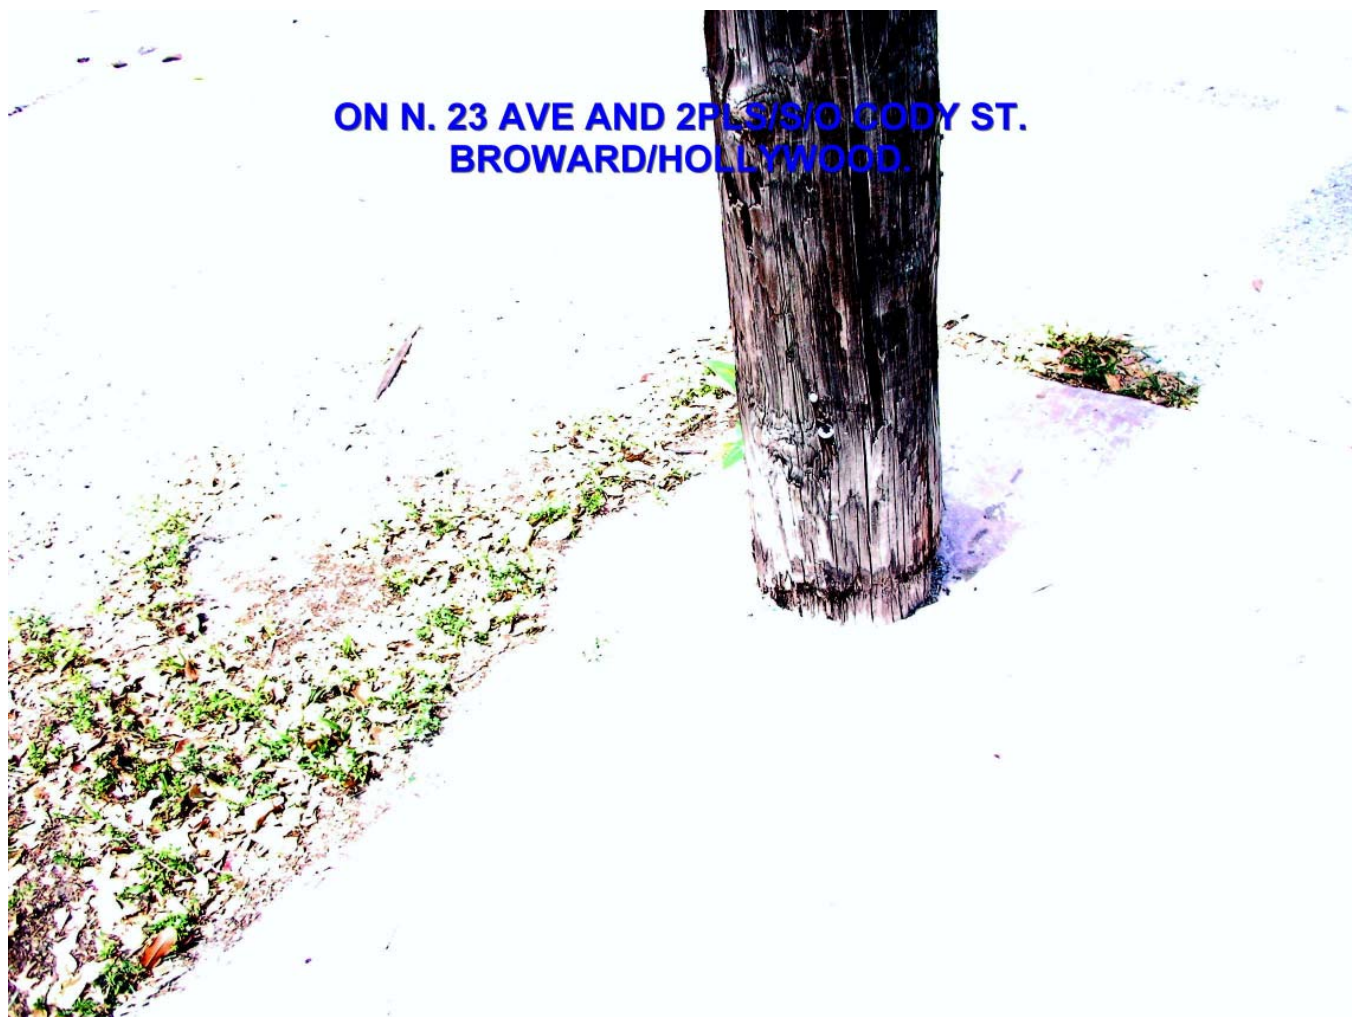
ON 23 AVE & 2PLS/S/O CODY ST. - A semi-circular pattern of damage can be seen at the base of this pole.

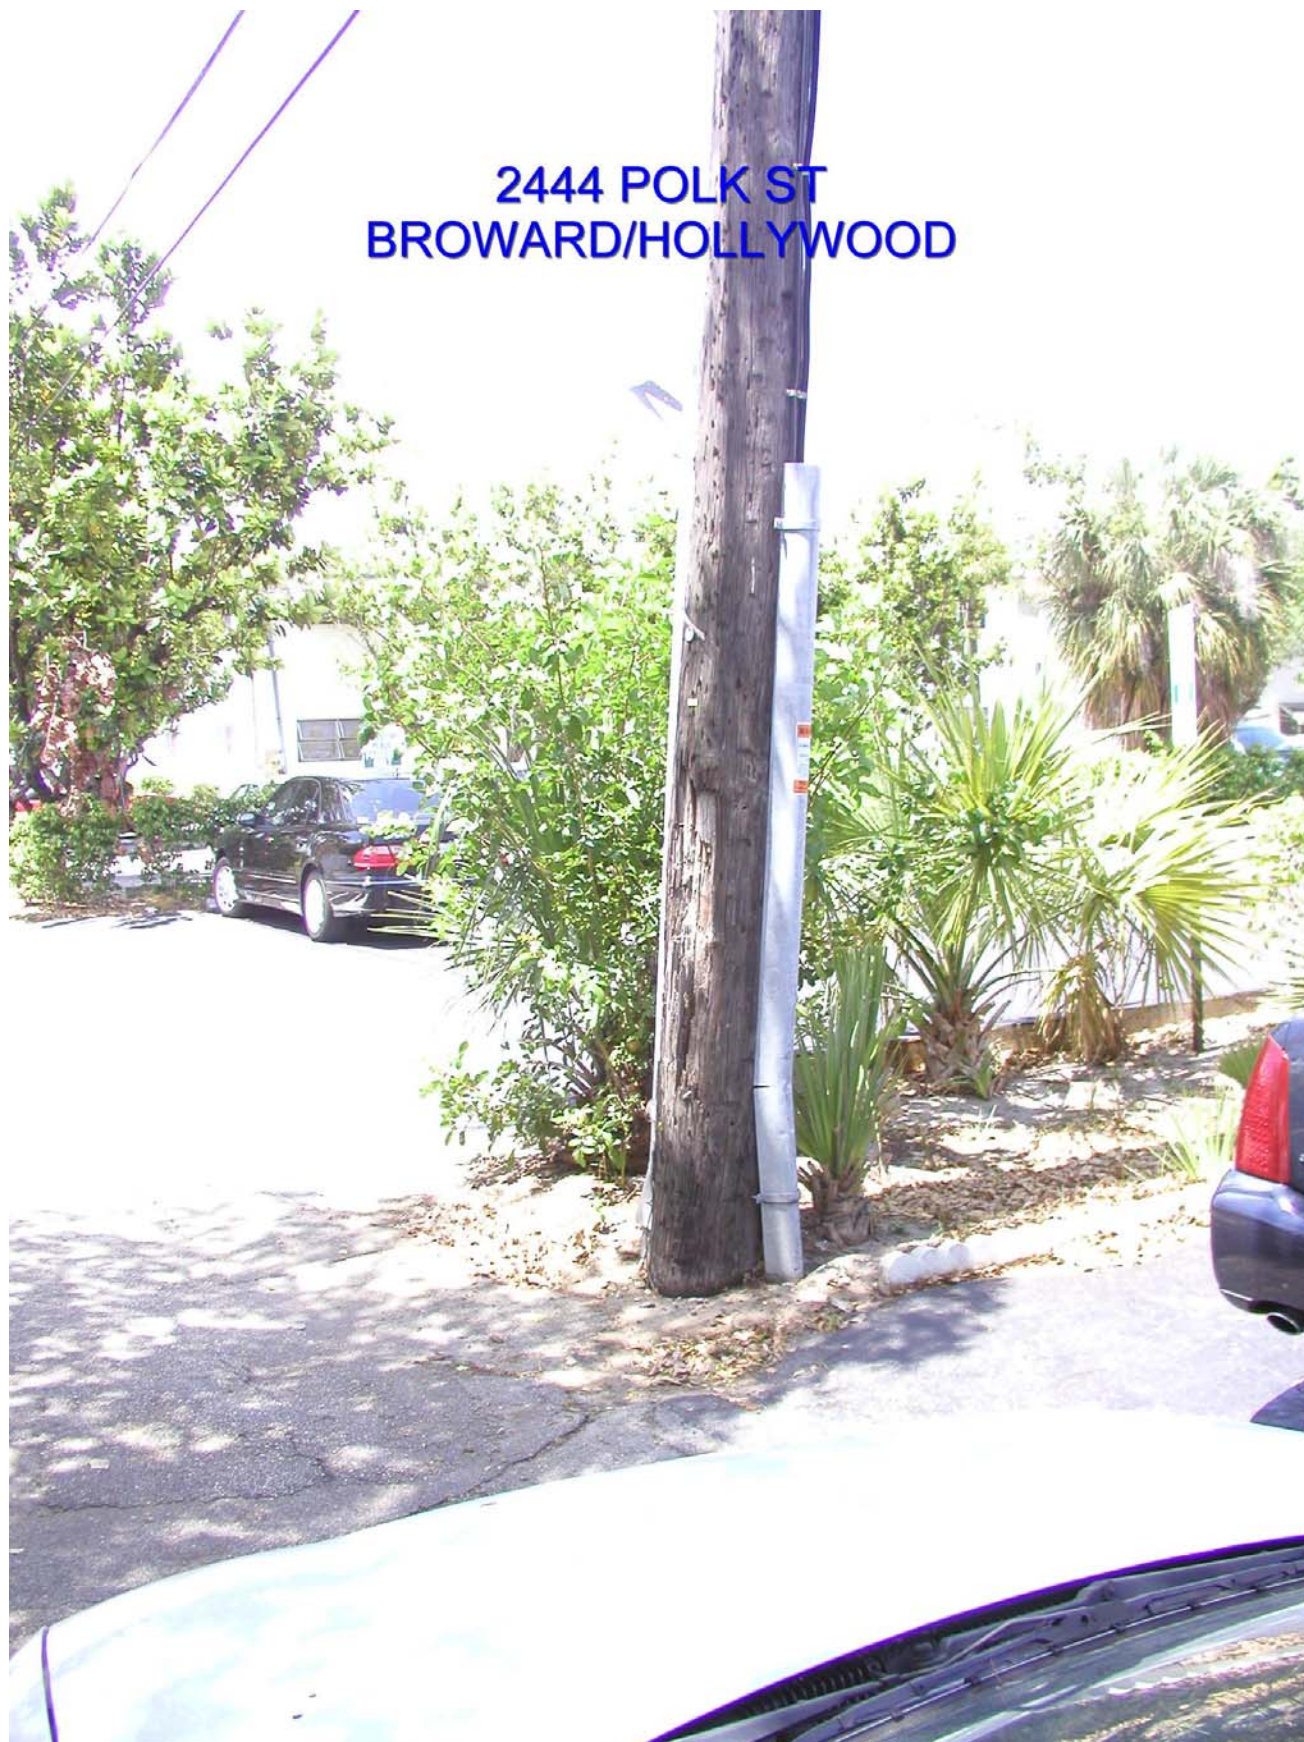
R/O 2444 POLK ST - A deep gash is visible between 1 and 3 feet above the ground.

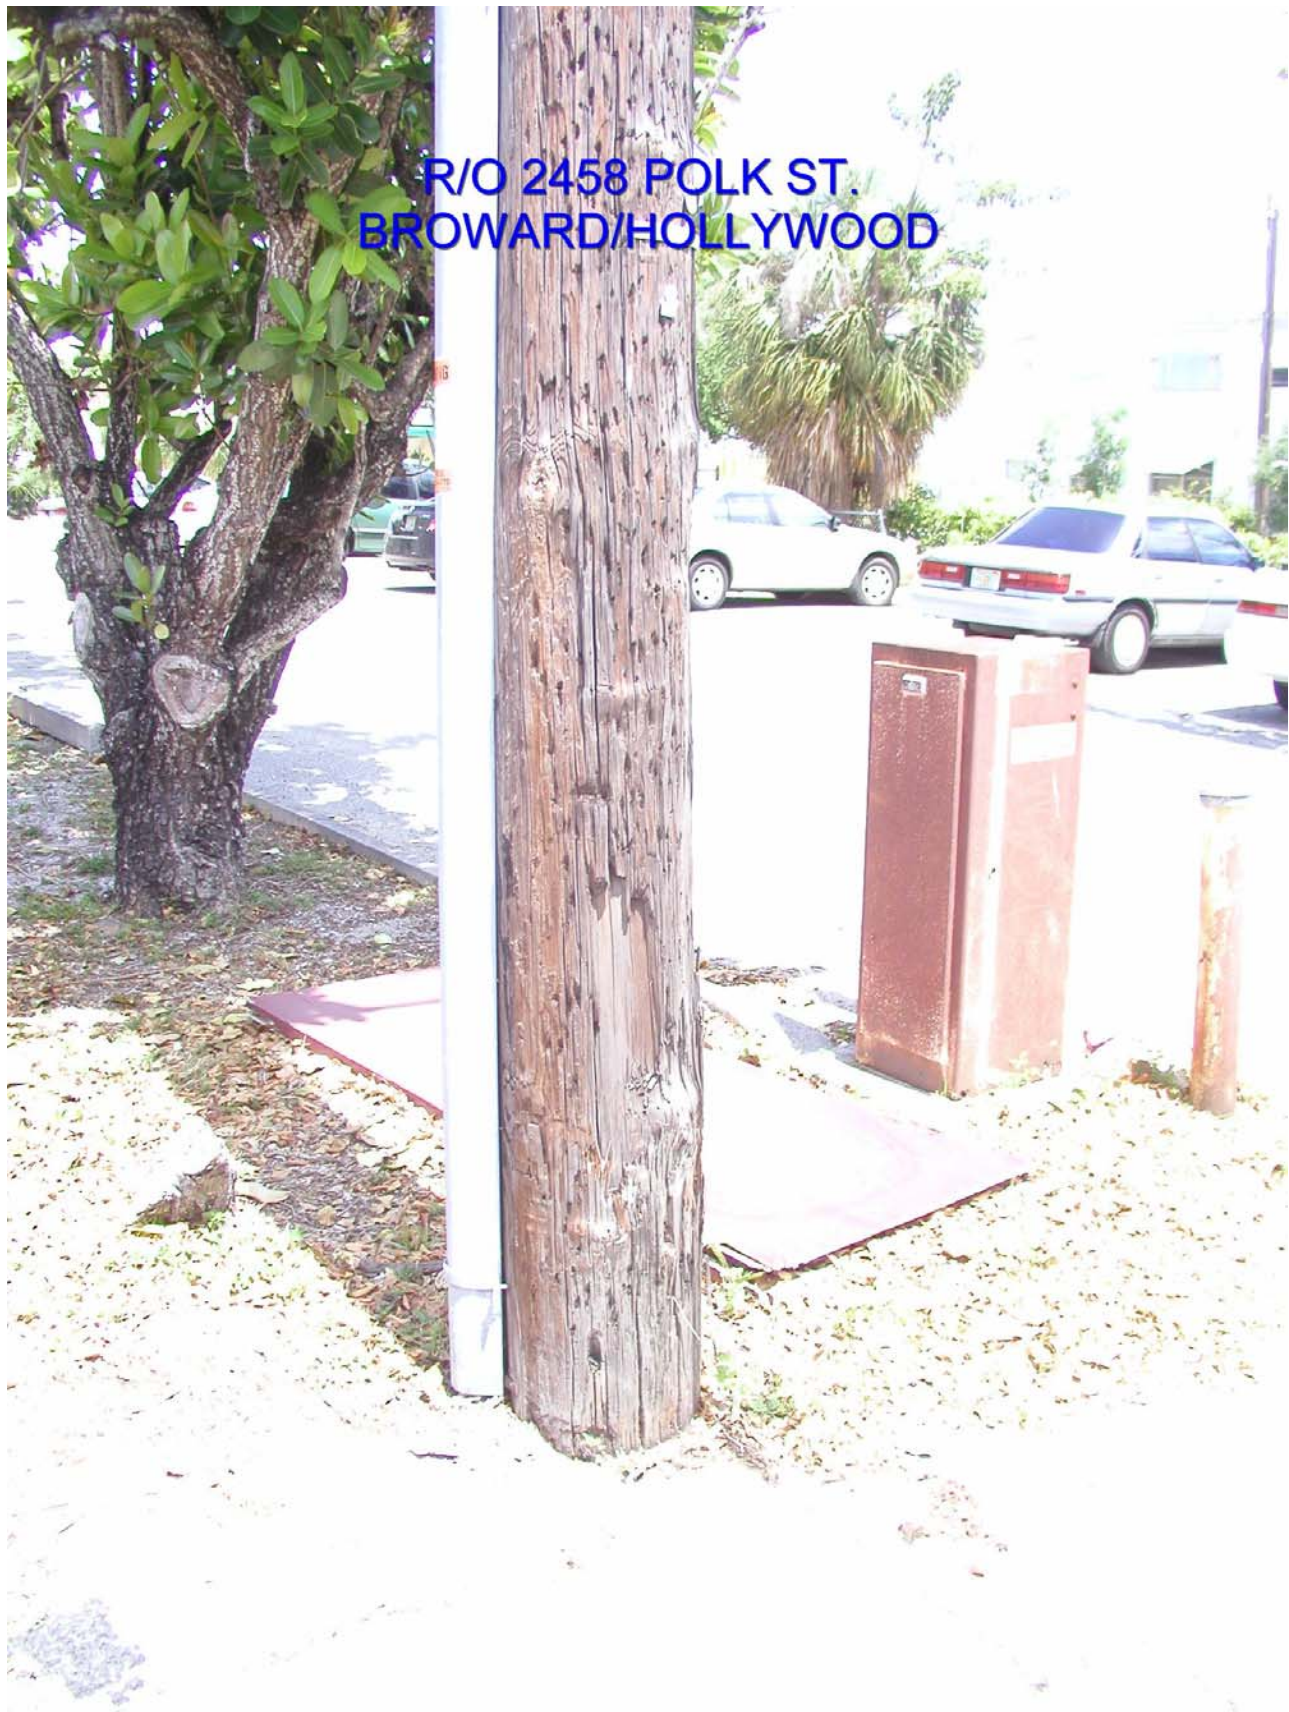
R/O 2458 POLK ST.
BROWARD/HOLLYWOOD

R/O 2458 POLK ST - A deep gash is visible between 1 and 3 feet above the ground.

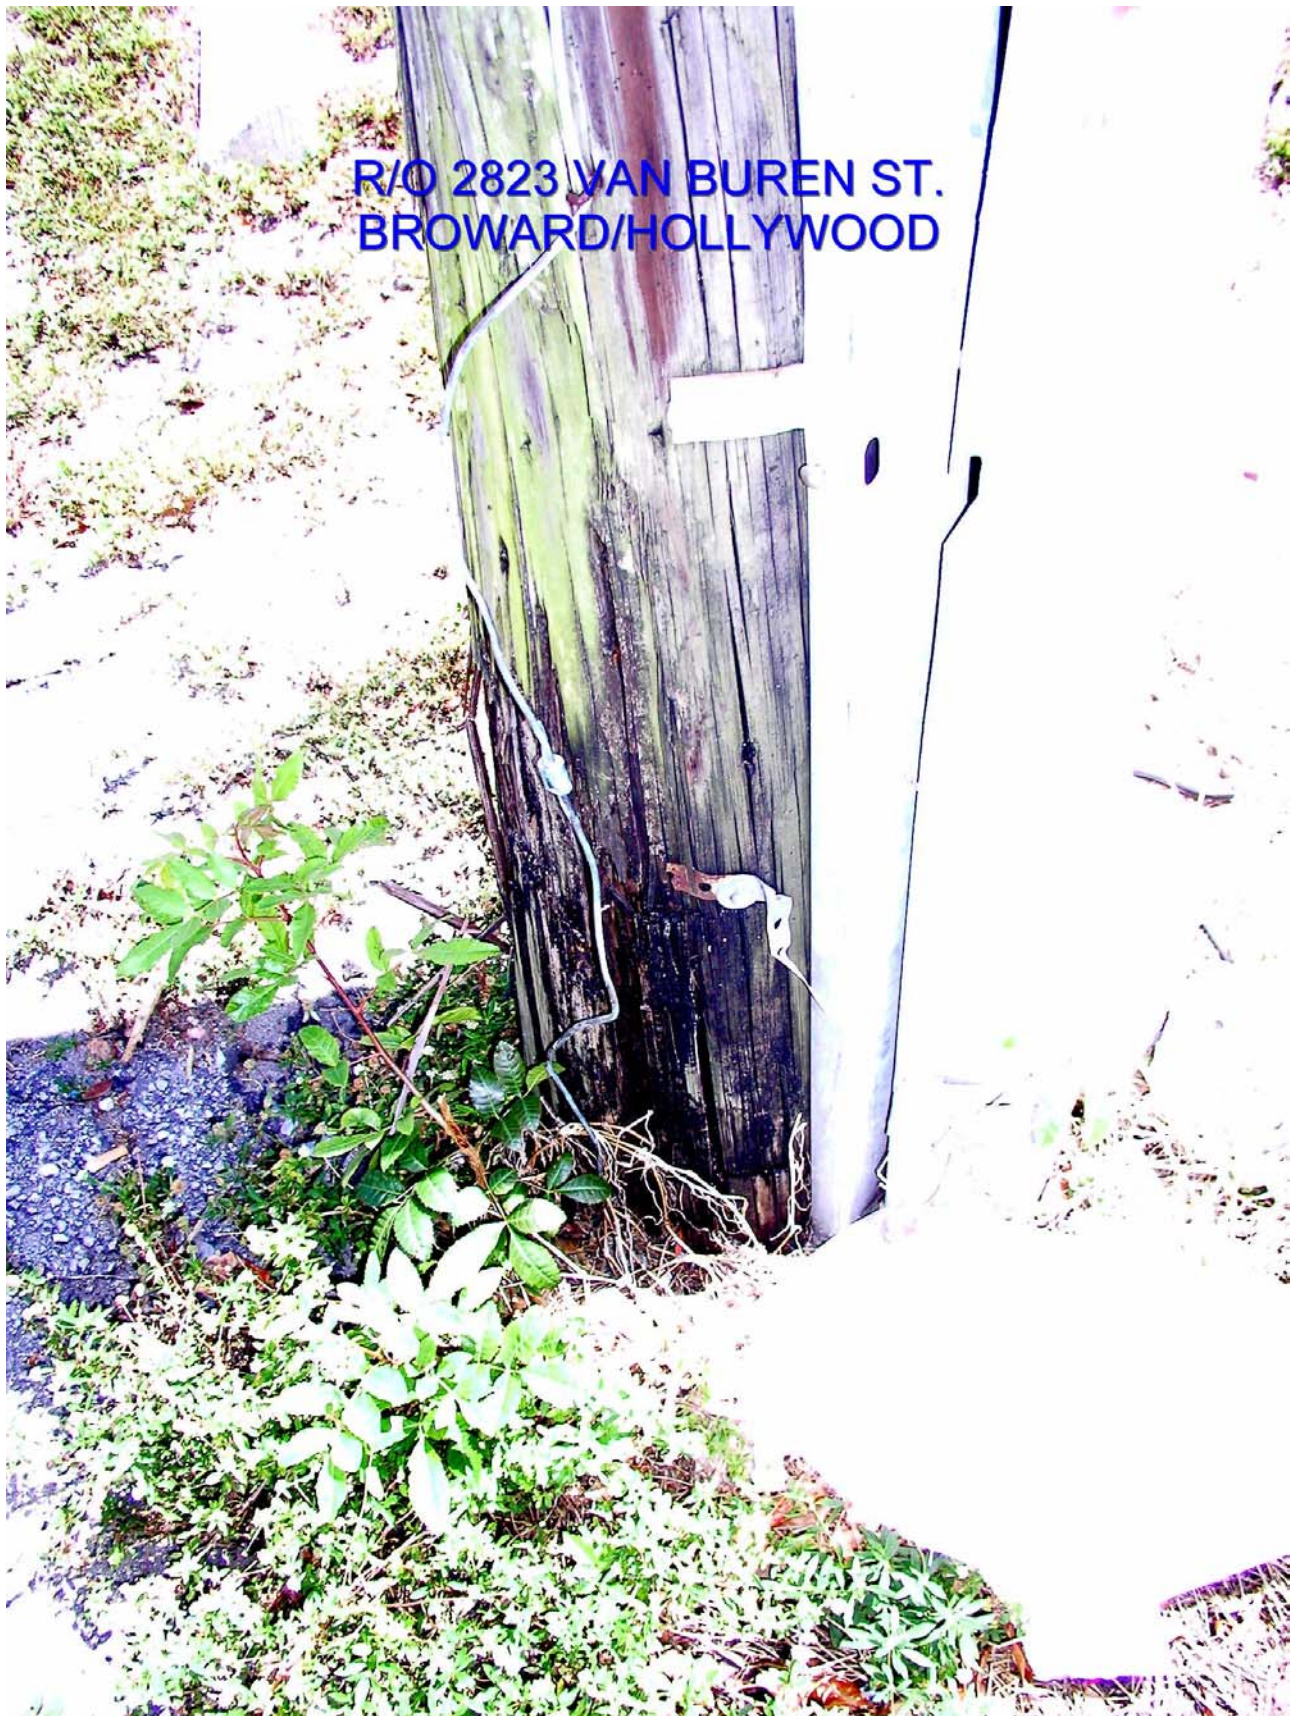
R/O 2823 VAN BUREN ST - Decay near base of pole.

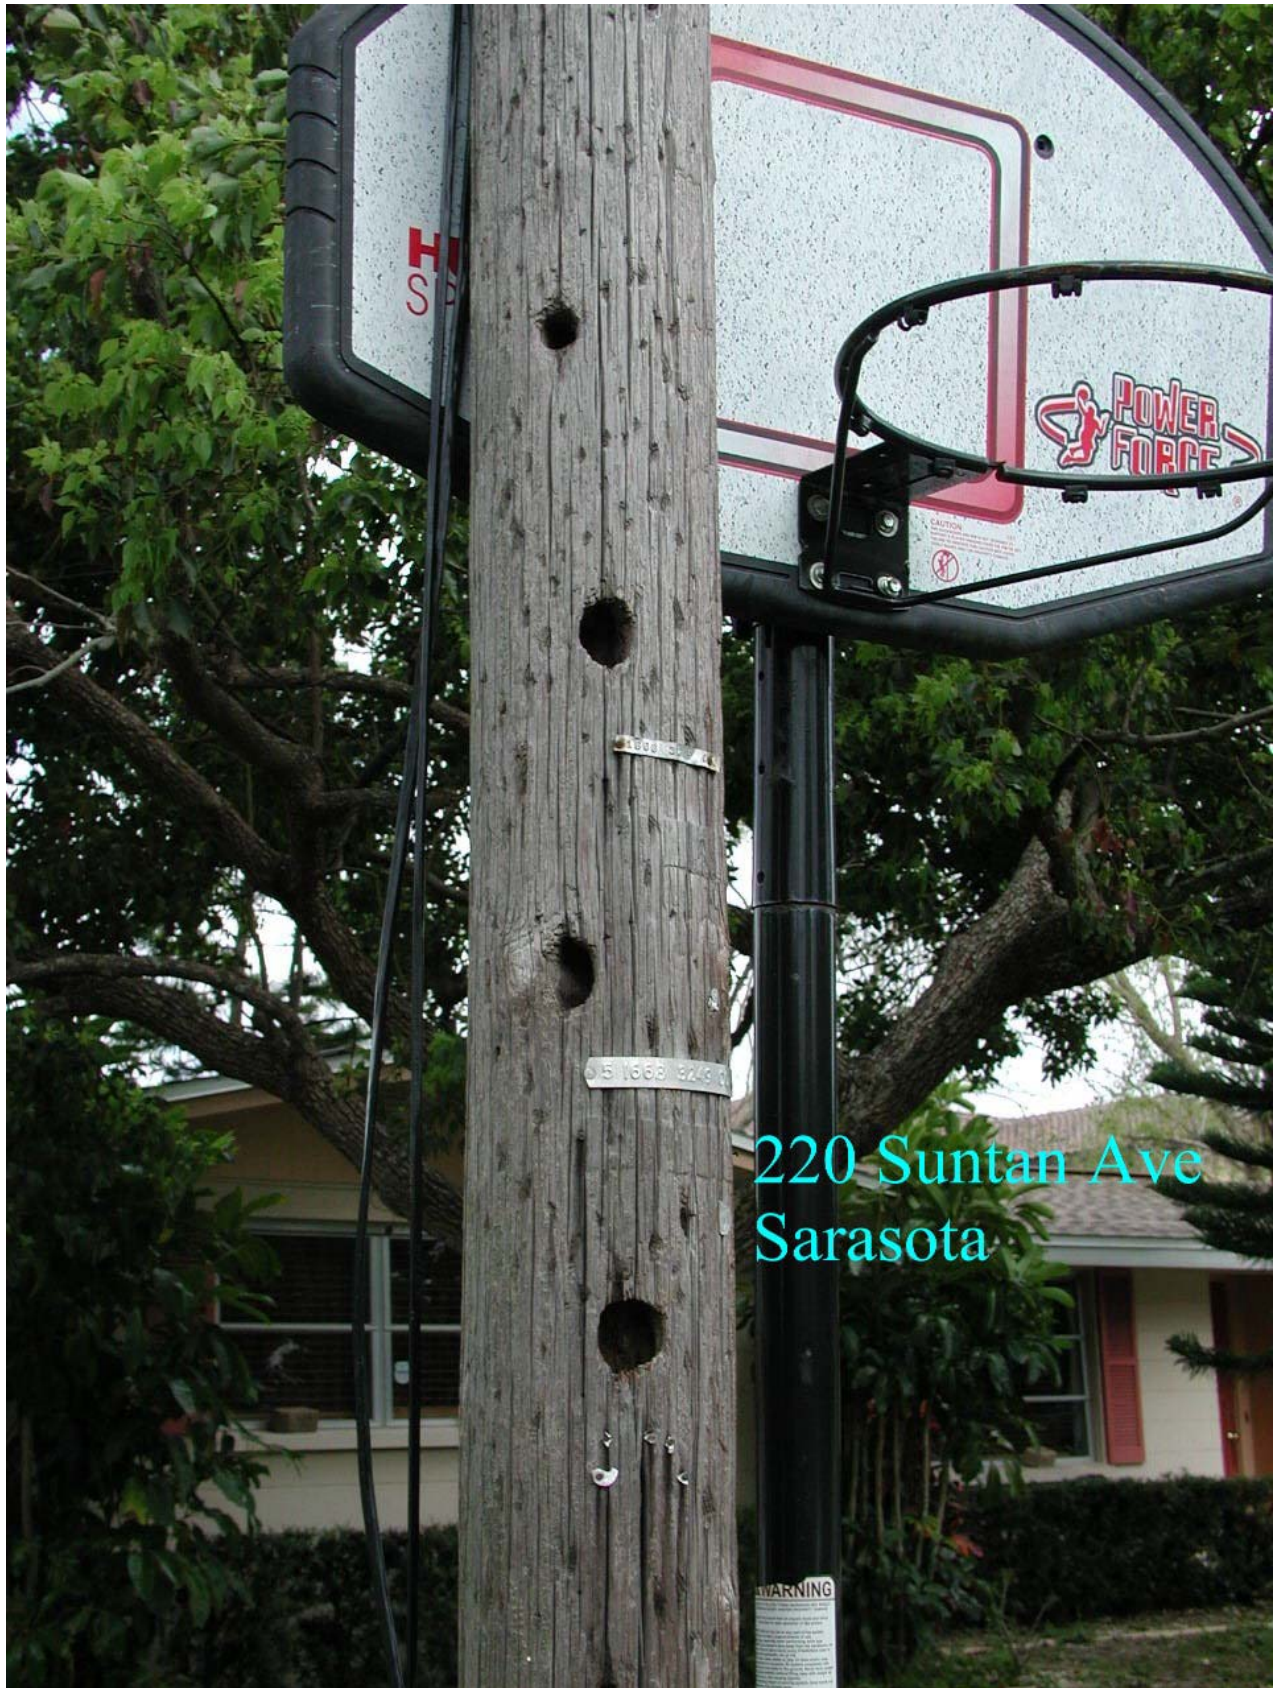
220 Suntan Ave
Sarasota

220 Suntan Ave in Sarasota, FL - Several deep woodpecker holes have exposed the pole's interior to the elements. Banging on the pole revealed a hollow, spongy sound indicating that internal rot may be present.
