Docket No. 110200-WU -- Application for increase in water rates in Franklin

County by Water Management Services, Inc.

Amended Bridge Contract and Inspection Reports

INSPECTION AND MAINTENANCE CONTRACT FOR THE WATER SUPPLY MAIN TO ST. GEORGE ISLAND

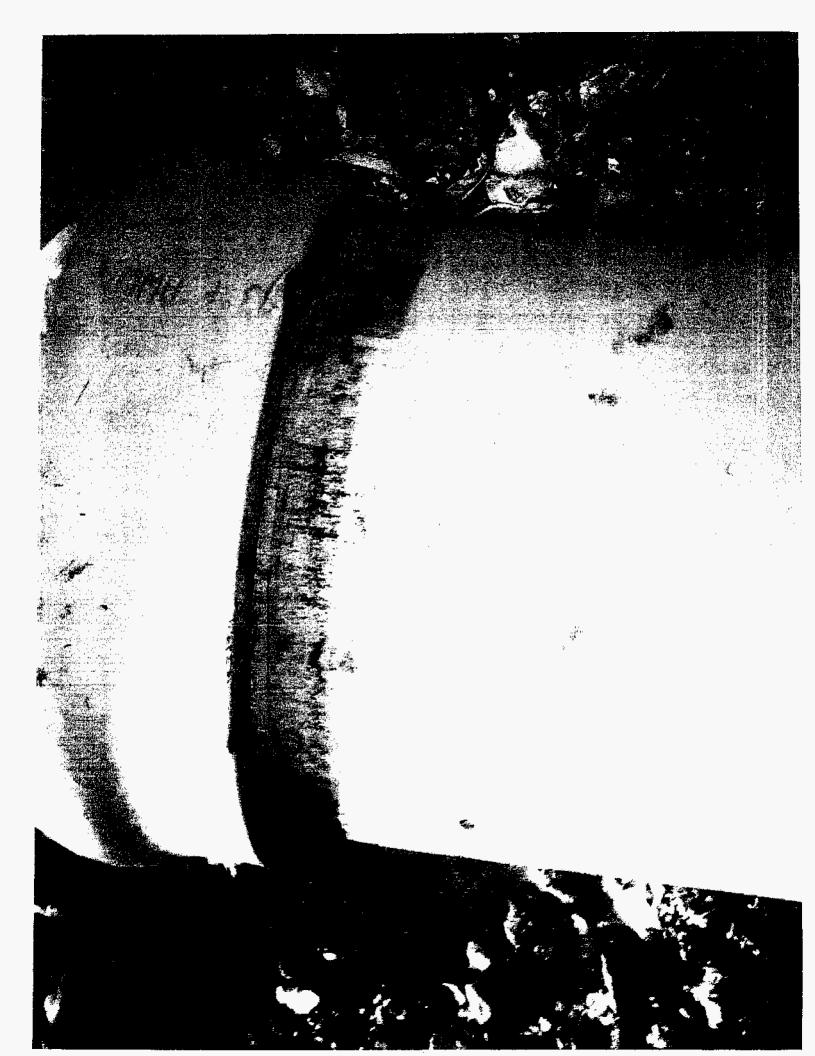
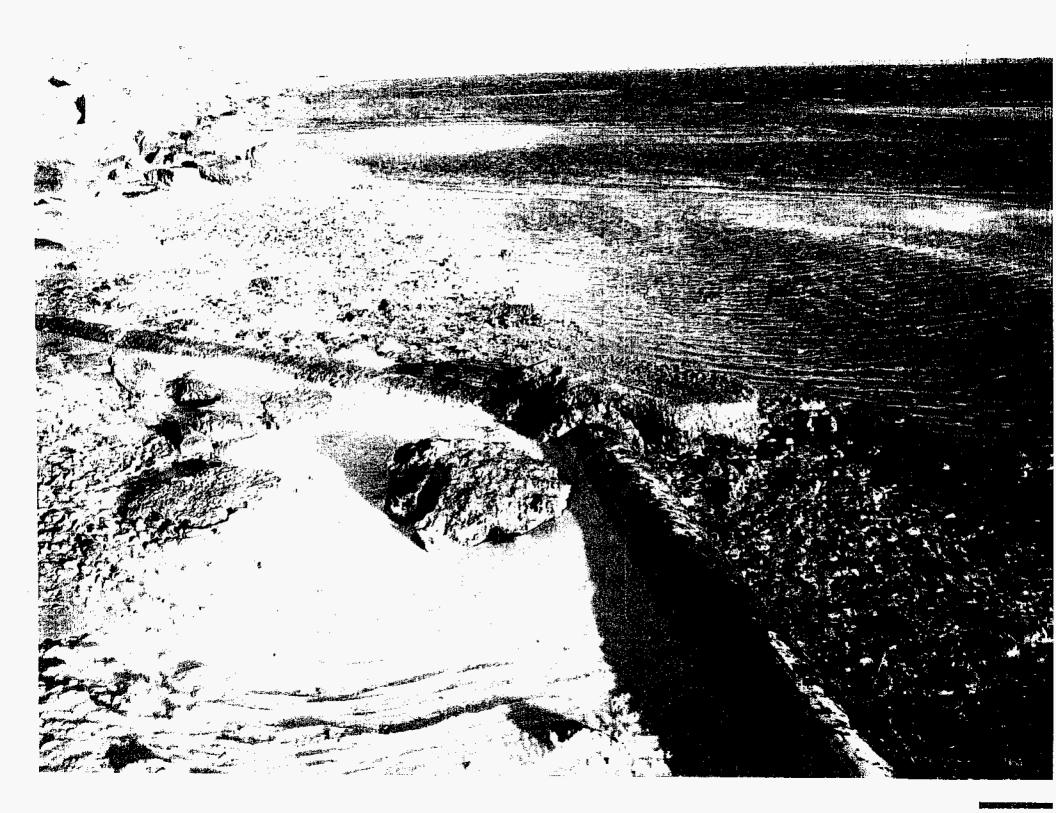
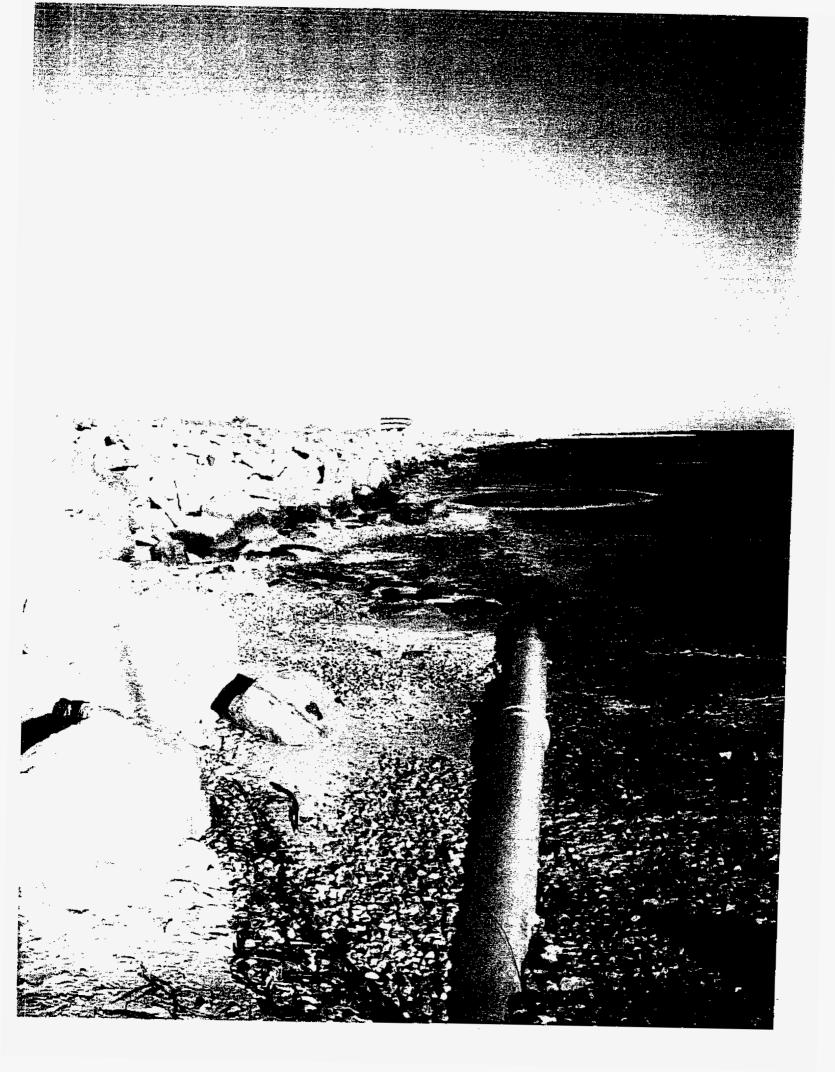
<u>Leaks</u>. We found a leak in the pipe on the island side of the bridge. (See below).

<u>Pipe.</u> The exposed pipe at the foot of the bridge on the island side was found to be in the process of separating. When this was discovered, the pipe was less than 2 inches away from a total blow-out, which would have caused a termination of water service to the island. The pipe was promptly repaired and there was no interruption of service. Please see 3 photos attached. The rest of the pipe appeared to be secure and in good condition, except for the coating on certain sections of the pipe which is being recoated pursuant to the contract between the parties.
