**REVIEW OF  
PEOPLES GAS  
DISTRIBUTION FACILITY  
INSPECTIONS**

**SEPTEMBER 2013**

# **Peoples Gas System Distribution Facility Inspections Follow-up Audit**

NOVEMBER 2015

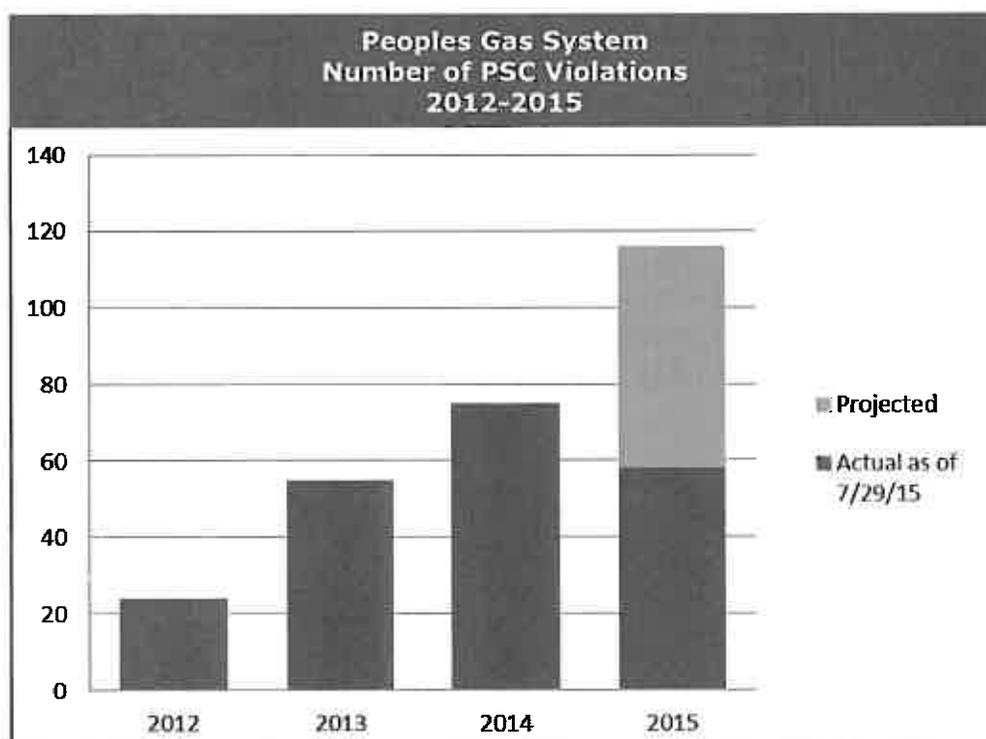
While the company tried to address repeat non-compliance, the company was not successful in completely correcting all the issues that it had previously identified. **Exhibit 1** depicts the total number of PSC violations the company incurred over the period 2012 through July 29, 2015. As shown, the number of violations has increased from 24 in 2012 to a projected 116 violations by year end 2015.

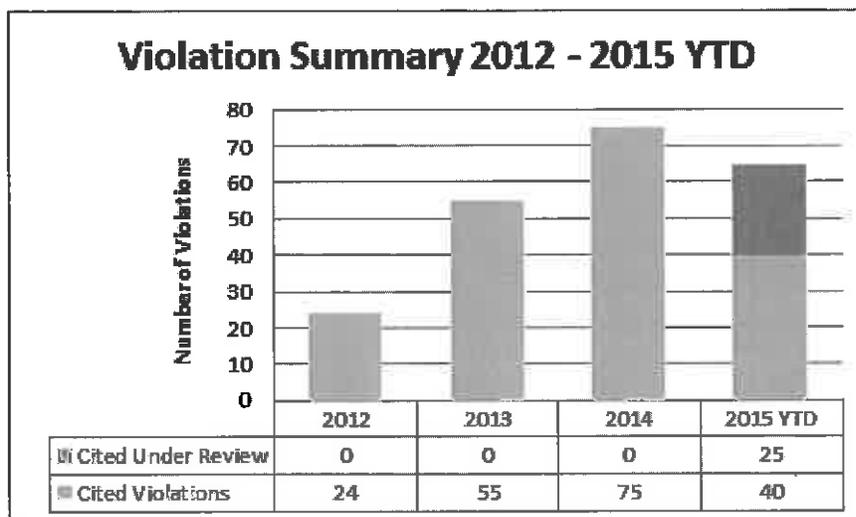
The report suggests that the company was not successful in addressing repeat noncompliance, stating that the number of violations increased from 2012 through a projected number of violations for 2015. See Exhibit 1 to this report. It should be noted that the corrective action plan was incapable of addressing 2013 issues because that year's compliance activities had already occurred (i.e., 2013 compliance records were inspected in 2014). Further, a number of the violations cited in 2015 (involving 2014 compliance) are currently under review with the Commission staff, and the company has provided additional information requested by staff. As shown by the chart below, the company believes the number of cited violations should actually decrease for 2015.

\* 2015 YTD, through October. 18 of 21 audits complete.
