Power Delivery Performance

Hurricane Irma

Storm Date: September 9, 2017

Report Date: April 19, 2018

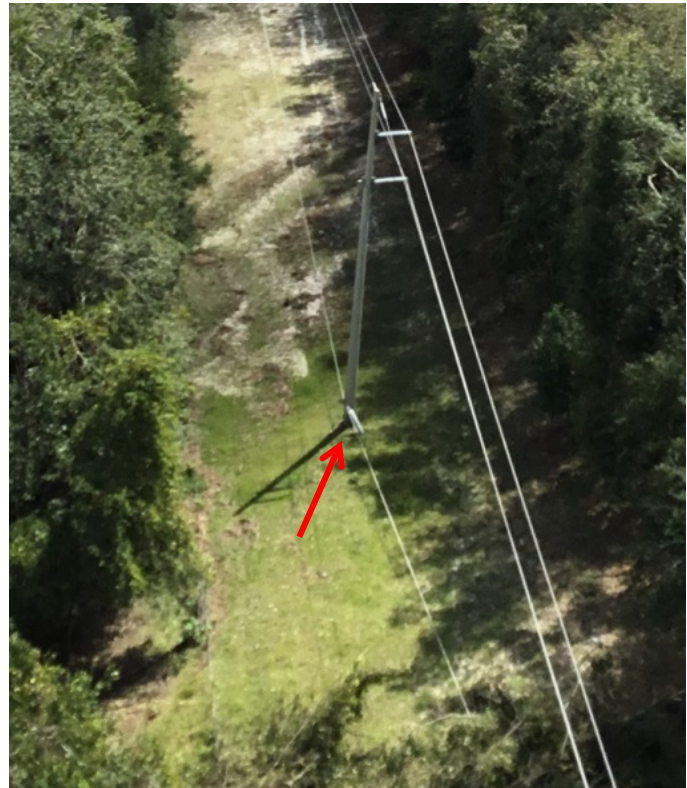
Structure 55R13A – Broken insulator

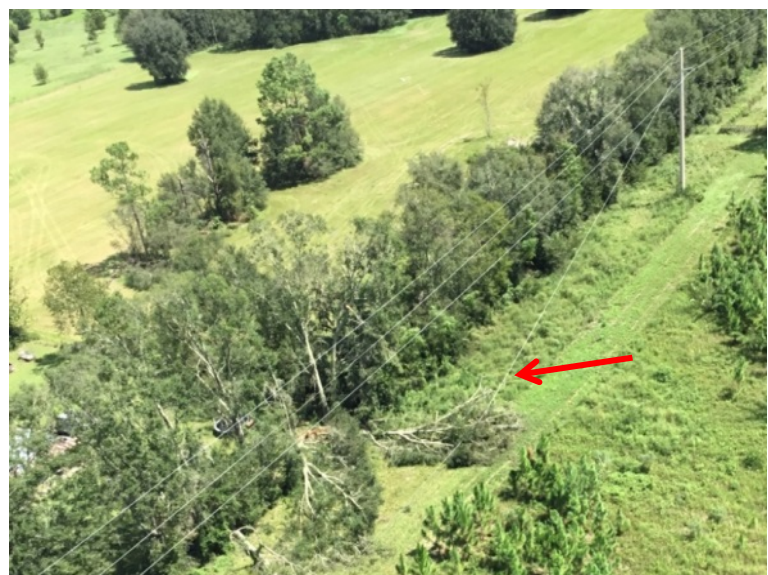
Structure 112R1 - Wire down due to vegetation

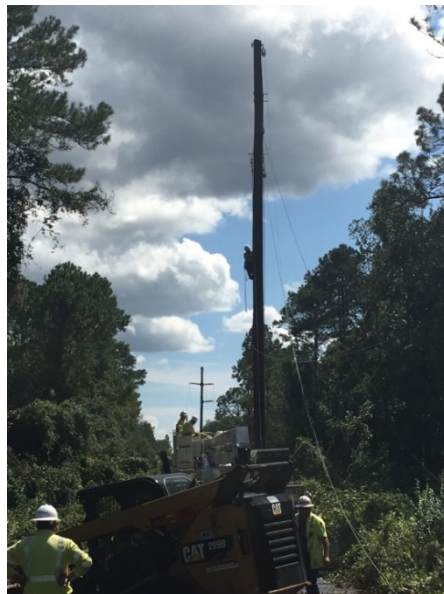
- One single pole wood structure (75G3) was replaced on the Deland-Putnam 115kV [0091] Line, Satsuma Tap-Putnam Tap Section.
 - The poles were inspected in 2017. The pole was reported as Level 4 condition (replacement not required).
- Winds in the area were reported to be 61-80 mph gusts or higher
- An approximately 80 foot tall slash pine tree was reported to have fallen on the transmission line; the impact caused this pole to fail.

Pole Replacement of Structure 75G3 (115KV line in North area)

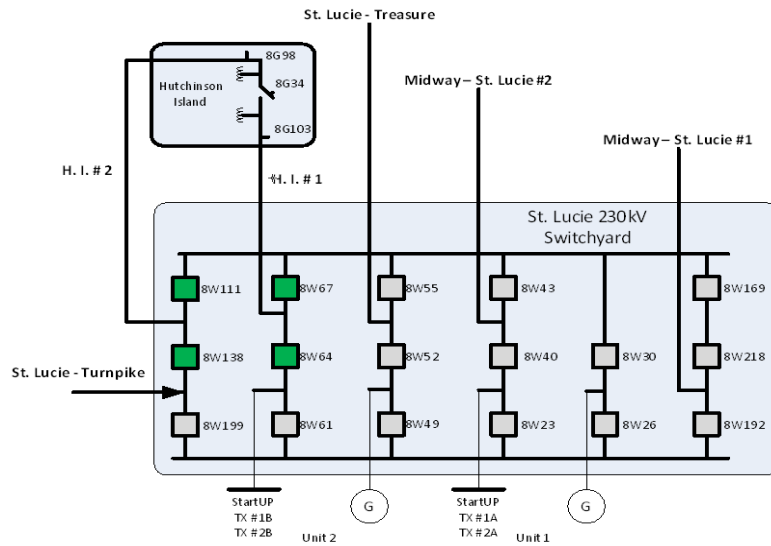
Hutchinson Island #2 line terminal trips for a B-Phase fault on the 8F10 switch in Hutchinson Island. The switch was found in the closed position with flash marks across the shunt trip insulator on the B-Phase. The protective relays and the transmission breakers in the St. Lucie station operated as designed and de-energized the high voltage line and the feed to the transformer from the St. Lucie switchyard.

One-line showing Hutchenson Island breaker open

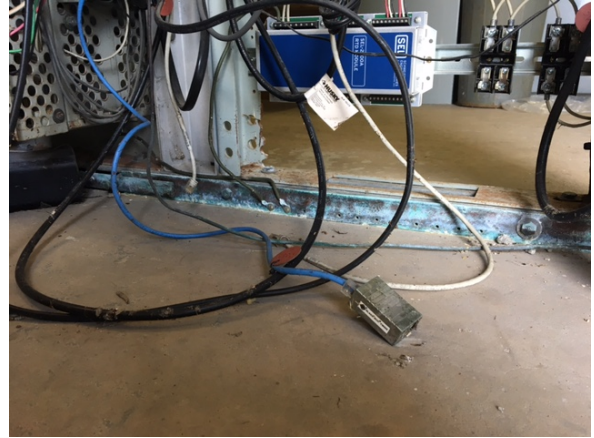
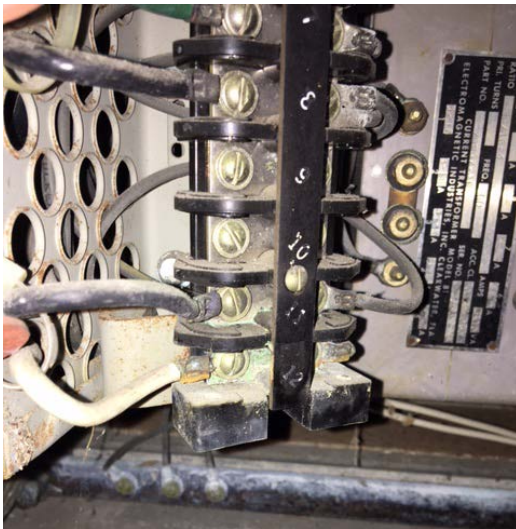
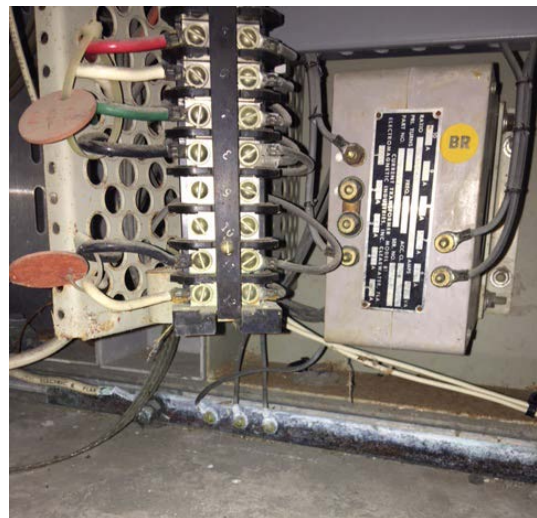
Examples of South Daytona Substation Damage inside the vault

Flood waters reached 5 1/2" on the inside of the relay vault and affected ground bus and some connections

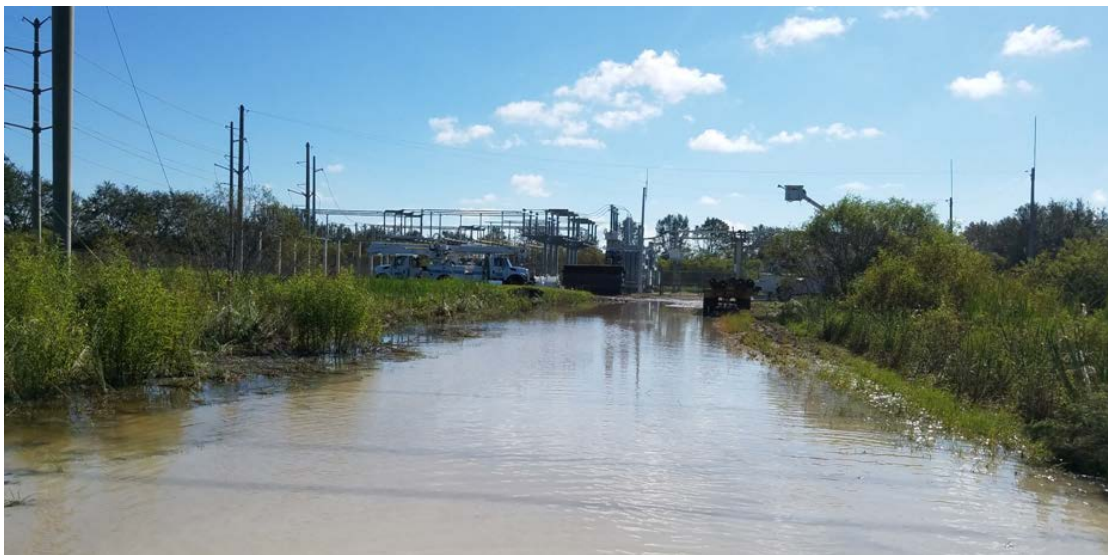
Corkscrew Substation Rain Event Flooding

Corkscrew Access Drive

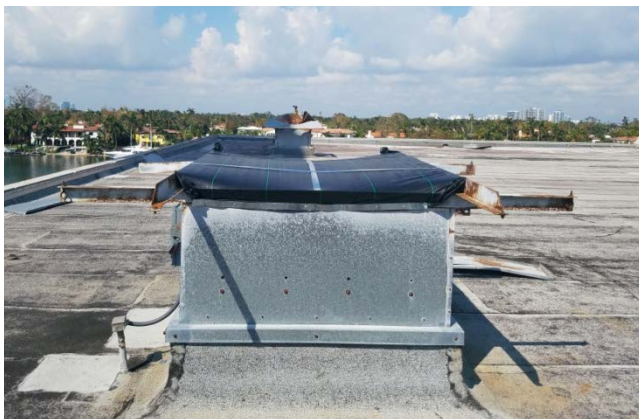
Indian Creek Substation – Roof Exhaust Fan

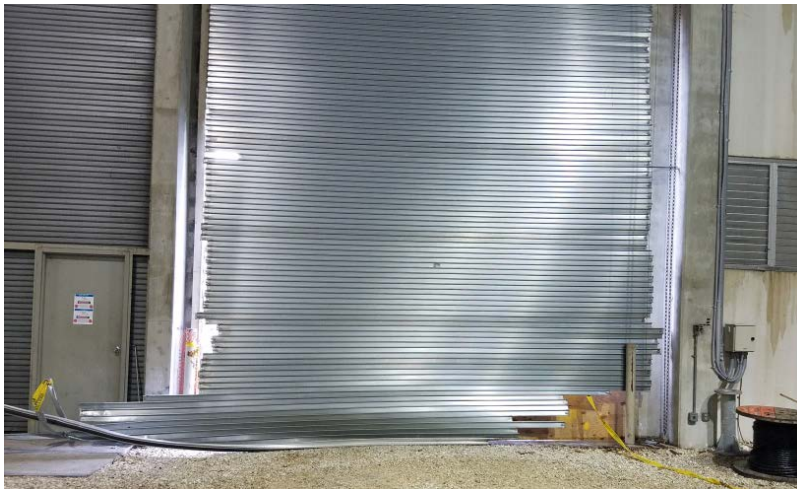
Watkins Substation – Overhead Door

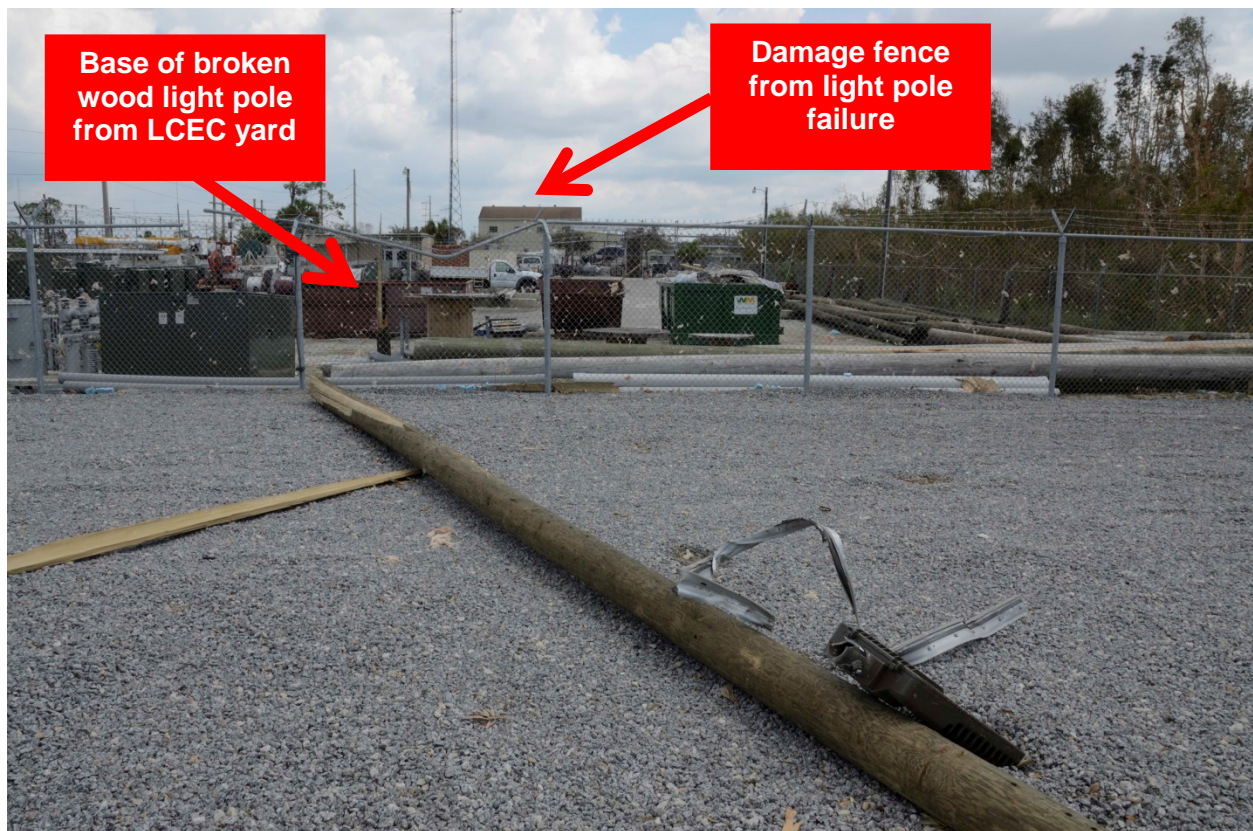
Switch jumper was damaged/disconnected due to debris from LCEC.

Station and fence performed well even with the large debris impact. Station and fence were designed to FPL current design criteria.

Belle Meade Substation (Looking East) adjacent to LCEC yard (Lee County Electric Coop)

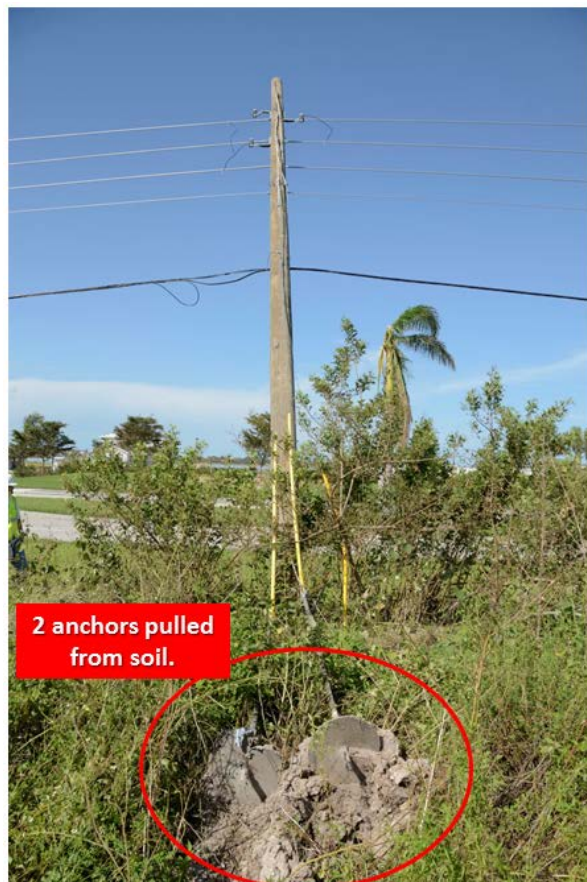
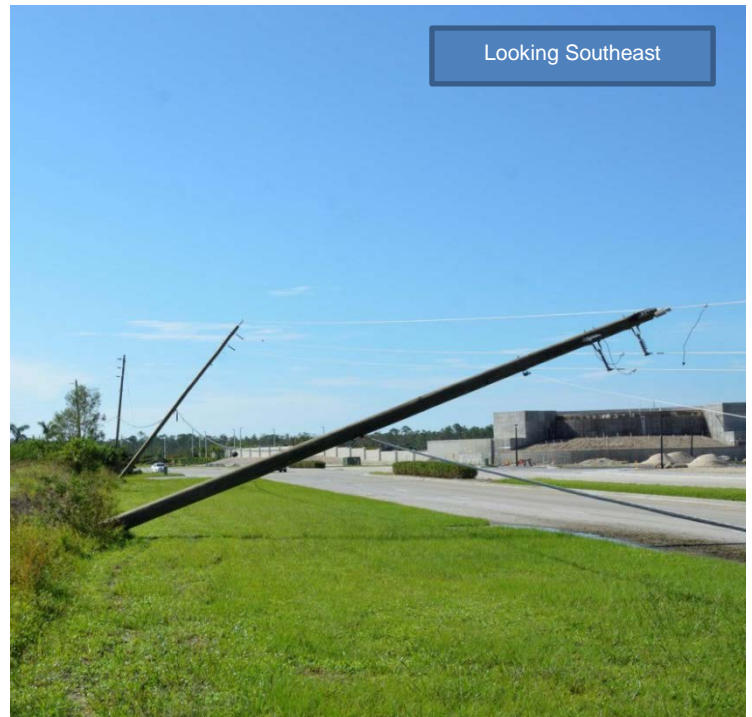
The anchors on the structure at the northern end of the failure pulled out of the soil. The anchors were set in a berm with a small pond behind. No extensions were utilized on the anchors. The shallow installation depth into a berm would significantly reduce the holding capacity of the anchor particularly in saturation soil.

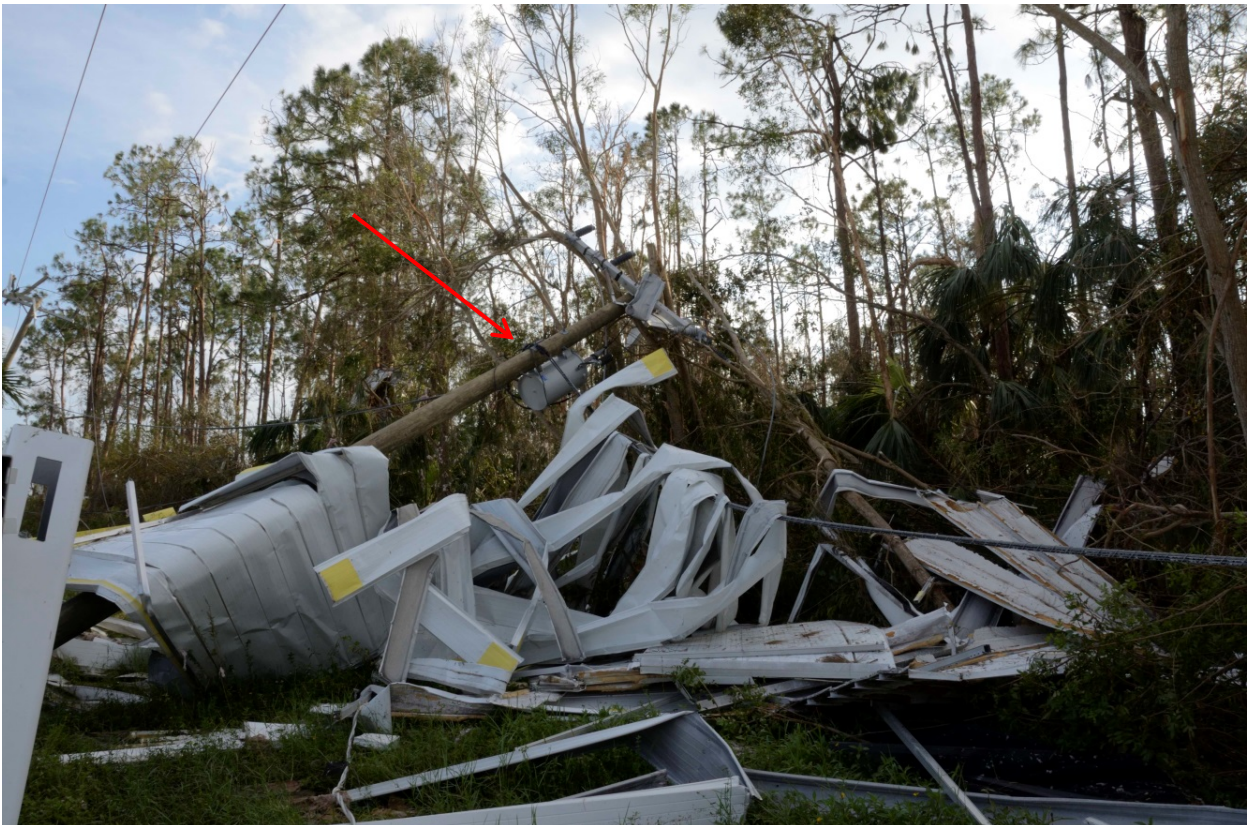
11 FPL Hardened Feeder poles (10 wood, 1 concrete) with foreign attachments were leaning and 1 pole (wood) was down on the Capri 504061 Feeder due to high winds and debris from the adjacent trailer park.

No poles broke and all were able to be straightened and reset. Cross-arms, wires, and equipment were damaged and would need to be replaced.

Pole down with transformer in West area due to trailer park debris

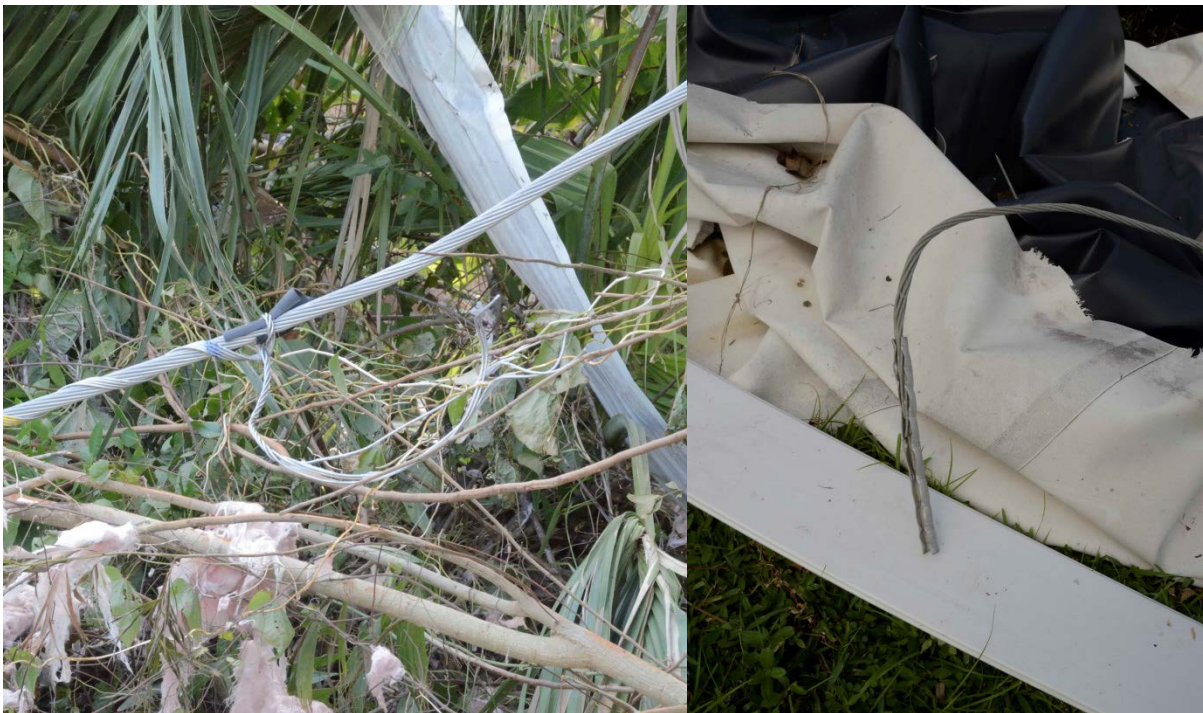
Insulator tie and failed splice. Below: ALS out of support and on ground

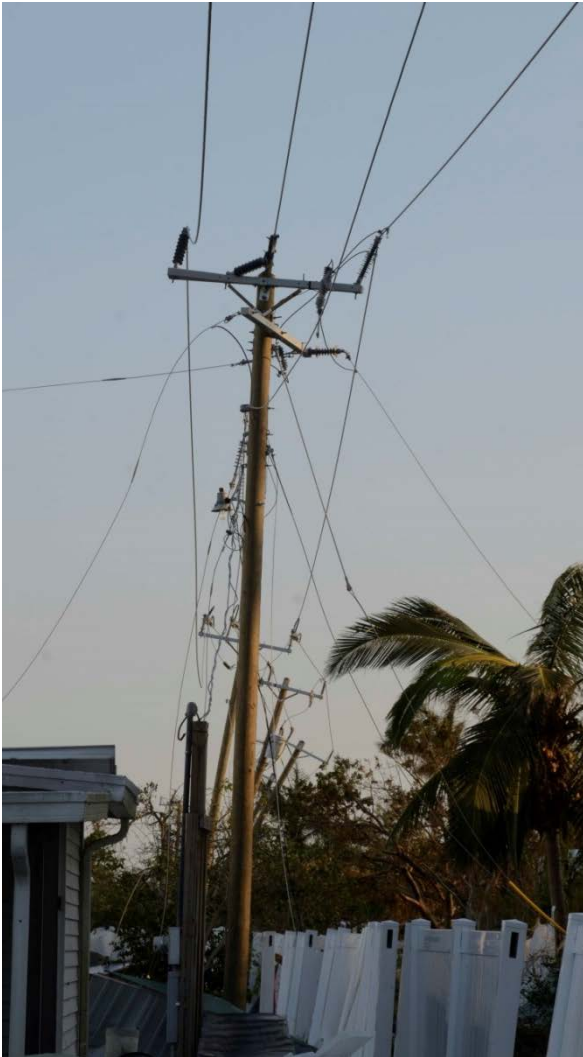
View of leaning poles

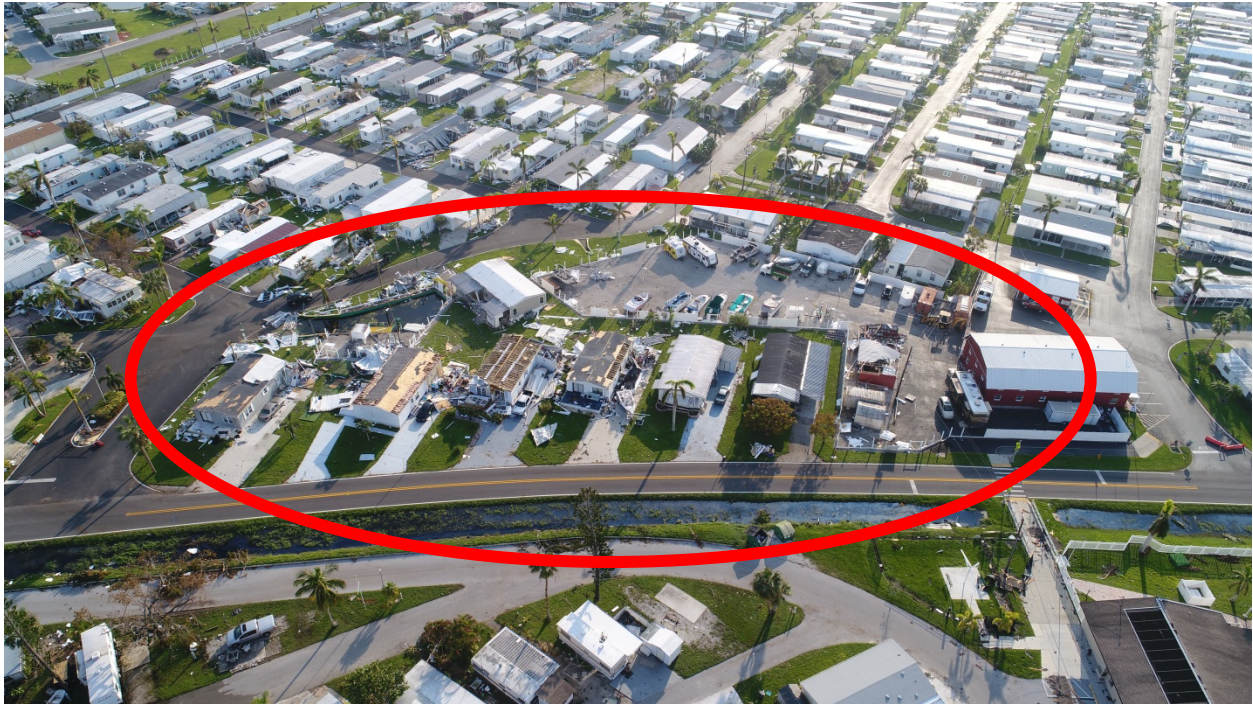
Area of concentrated damage, looking west.

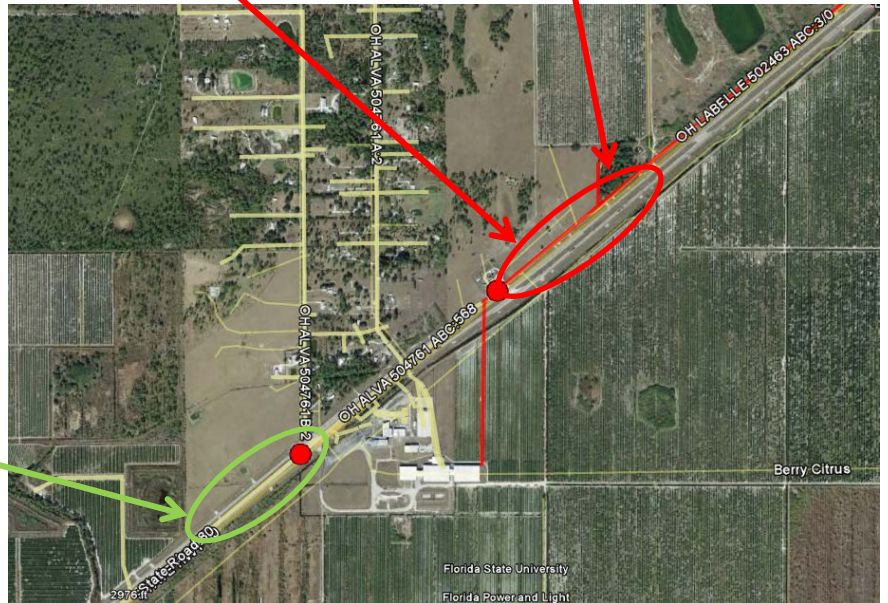
Hardened (Alva Feeder 504761 – West of switch number 20714)

- Section of wood hardened poles that were unaffected by the storm. These poles were not leaning and showed no signs of any damage.

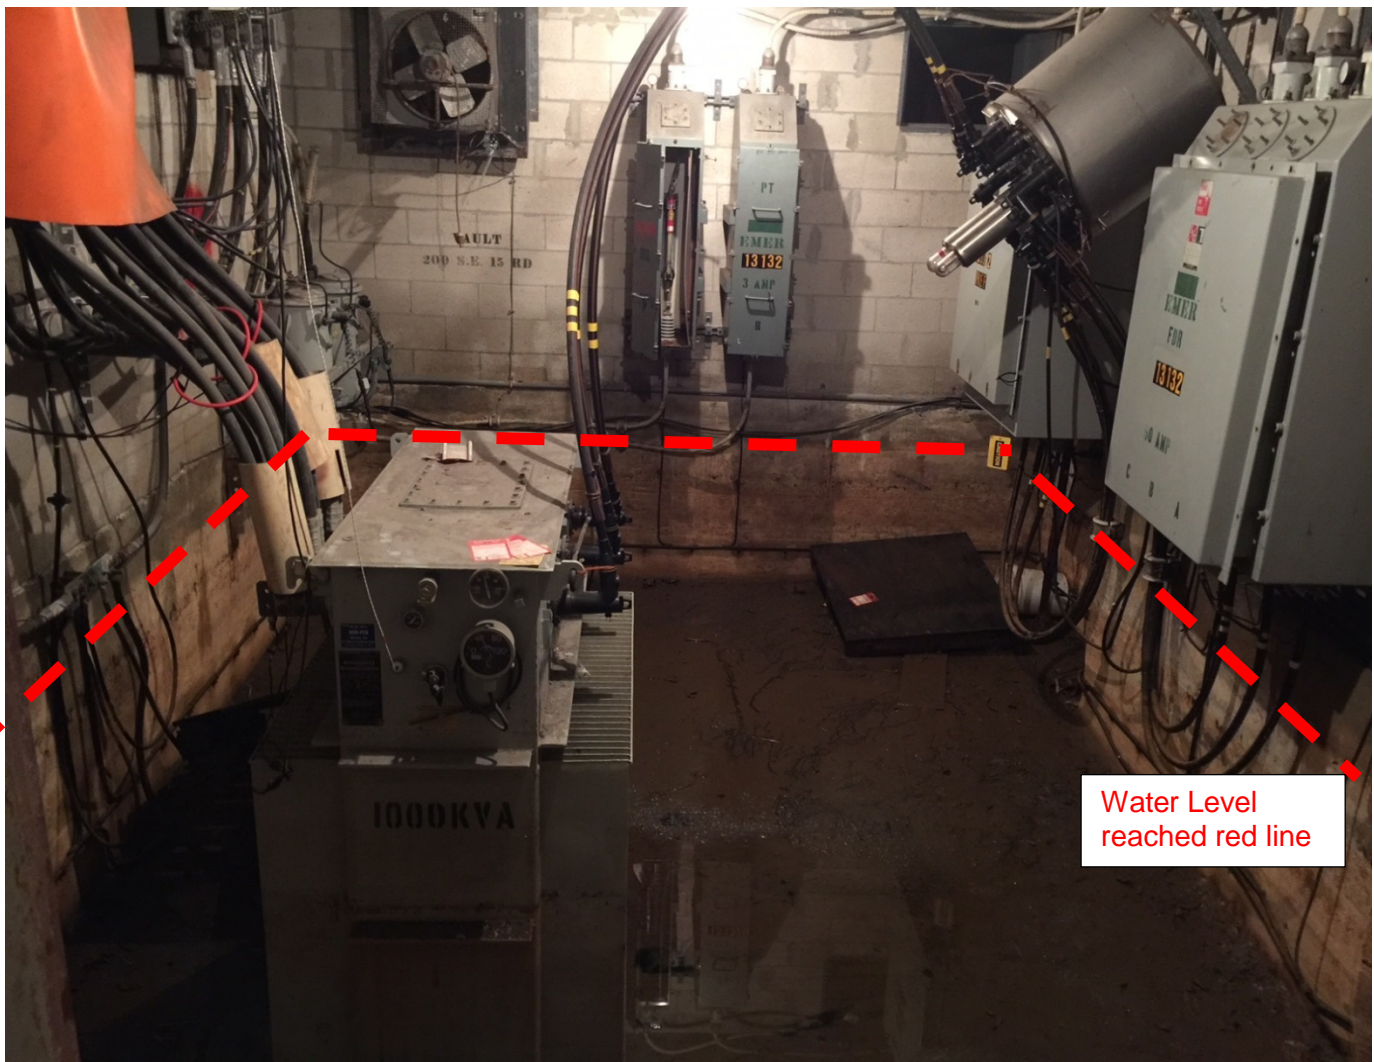
Below is one of the vaults after the water was pumped out (200 SE 15th Road, 8VC13102.) It is the vault for Brickell Harbour, which is a subgrade vault. The water level (noted by the red line) never reached the spades of the transformer nor the bottom of the fuse cabinets, so it remained in service. Actually, none of the flooded network vaults lost power because of Hurricane Irma.

Subgrade Vault for Brickell Harbour

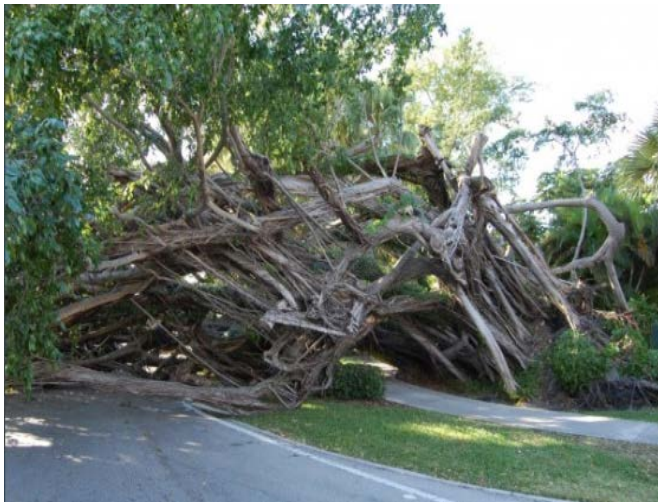
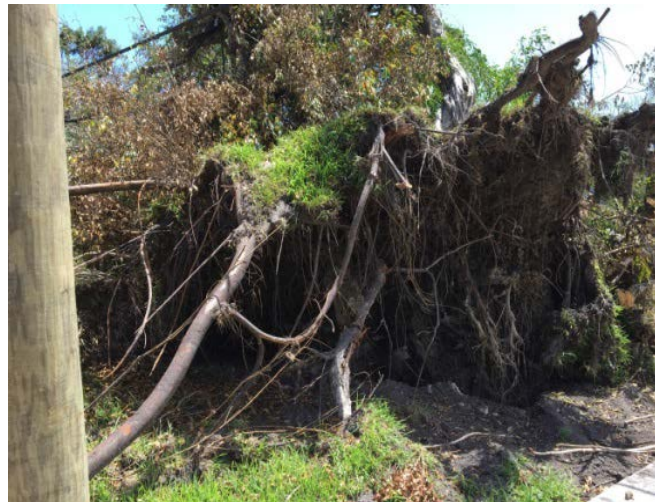
Pictures above:
Large, mature ficus trees topple over due to massive tree canopy with shallow root systems

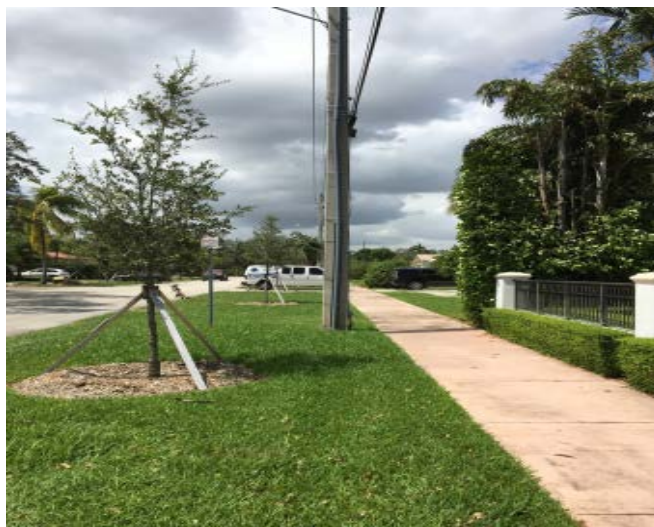
Pictures to the right:
Young canopy trees (i.e. oak) and palms planted in the wrong place and will impact facilities in the future

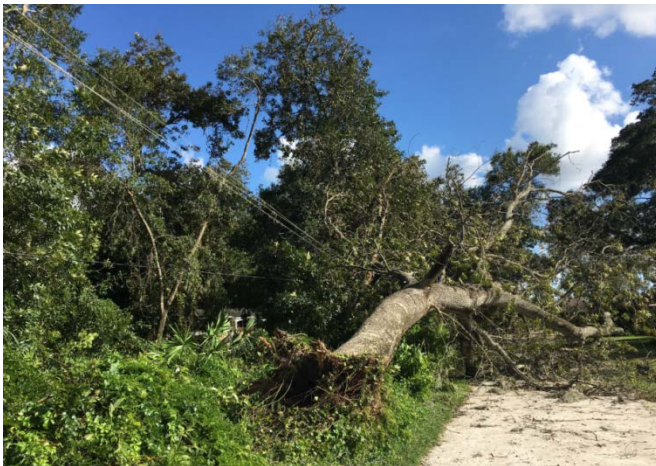
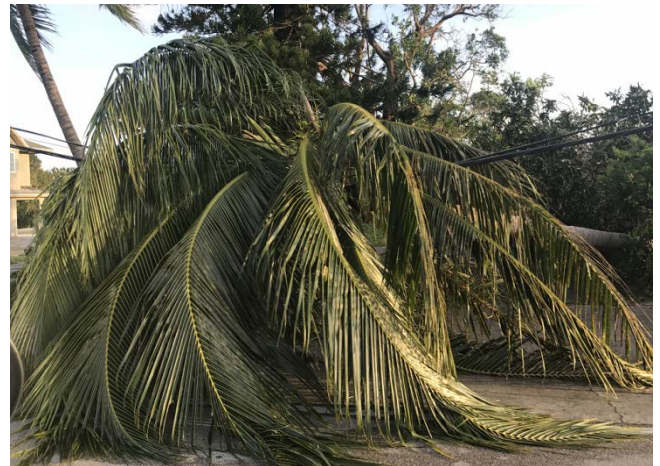
Large trees and palms topple over onto from outside the utility trim zone
