Re: Docket No. 20220001-EI

Please find enclosed for filing in the above referenced docket the Direct Testimony and Exhibits of Richard Polich, P.E. This filing is being made via the Florida Public Service Commission's Web Based Electronic Filing portal.

**Turkey Point
 Root Cause Evaluation
 Unit 3 Trip During Restoration from RPS Testing
 Event Date: March 1, 2021 CR 2385529
 Revision 1**

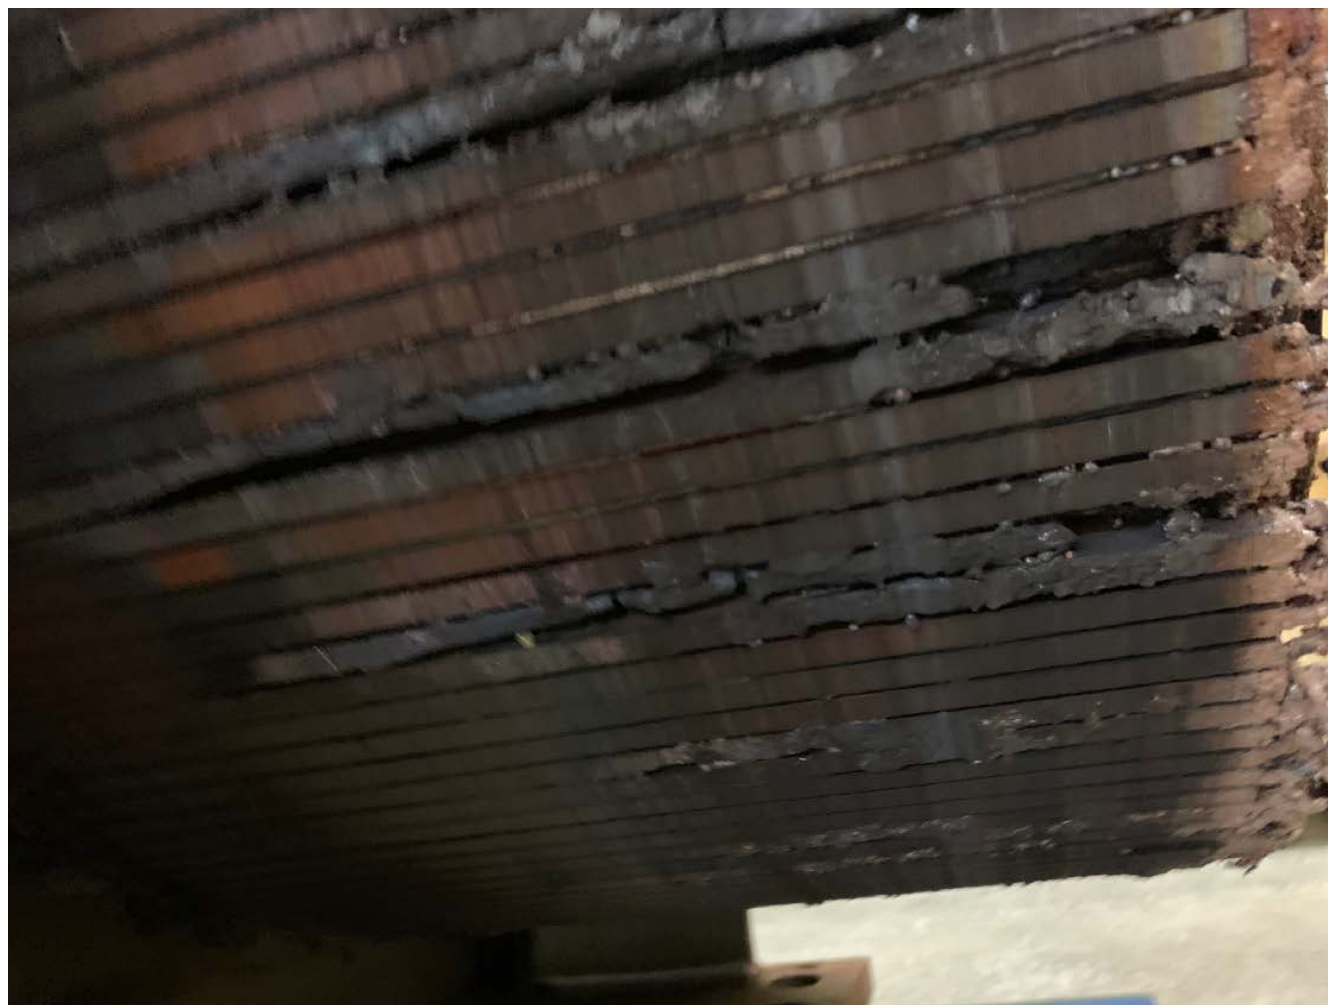
Fig. 6 PMG Stator Core – Coil Melt in Slots

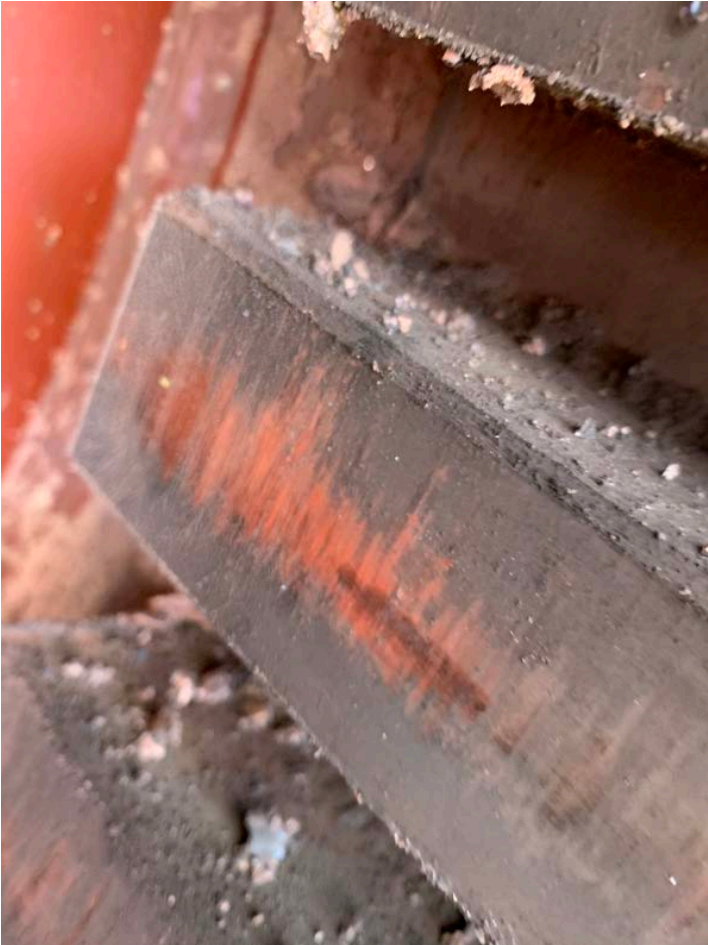
Fig. 9 PMG Magnet Rub

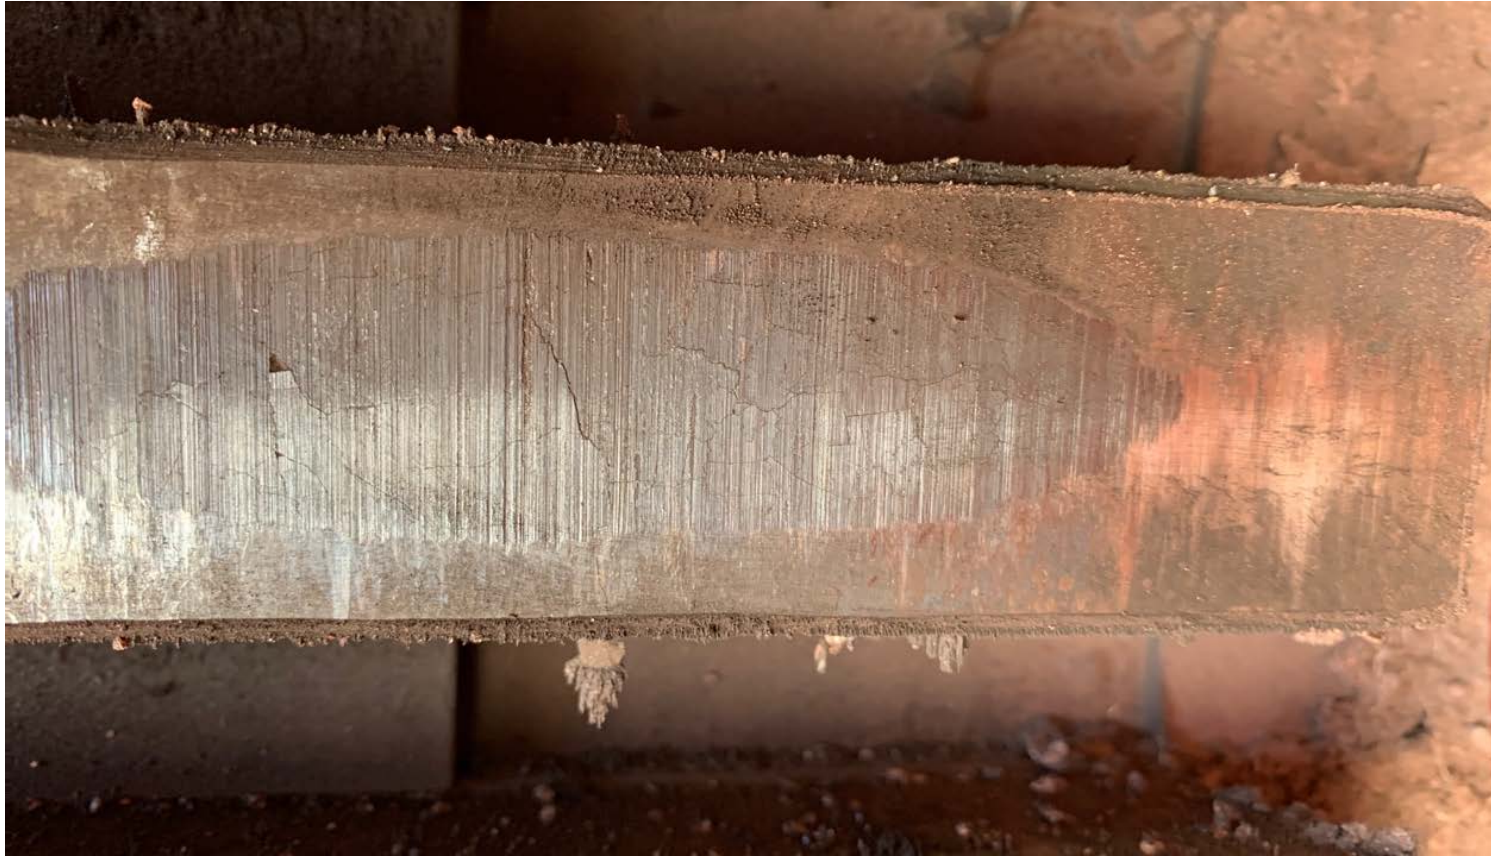
Fig. 10 PMG Magnet Cracking

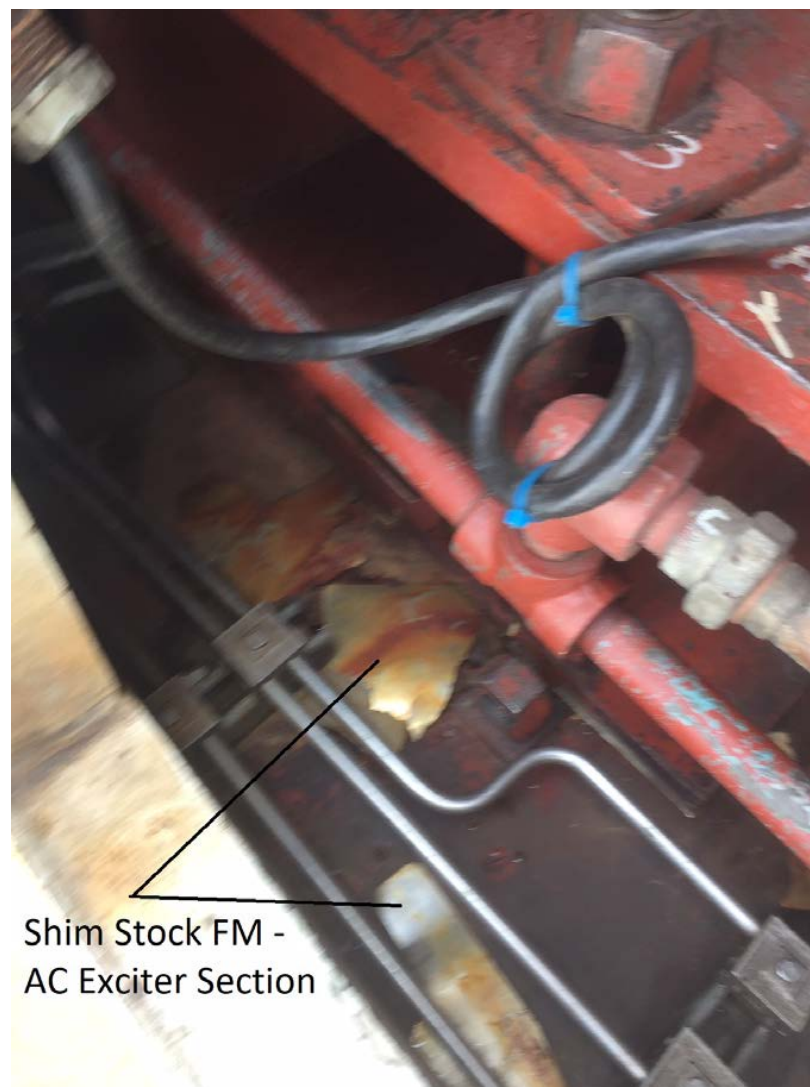
Shim Stock FM -
AC Exciter Section

Fig. 11 Foreign Material (Shims) Found in AC Exciter Section

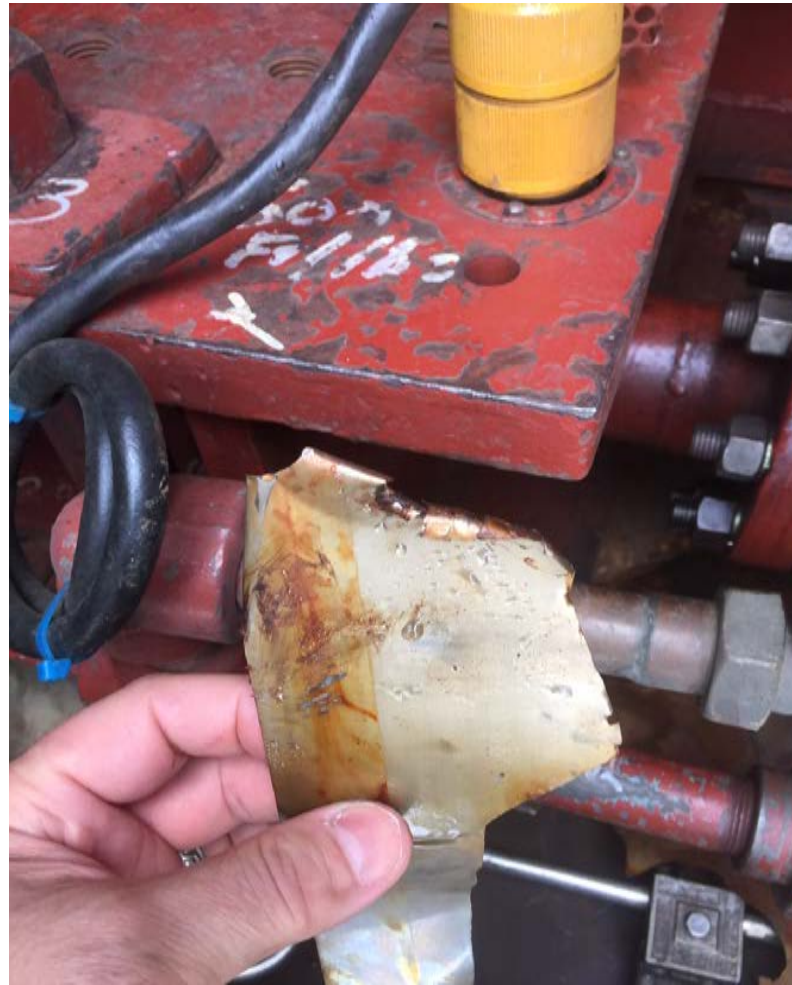
Fig. 12 Liberated Shim Stock Found in AC Exciter Section

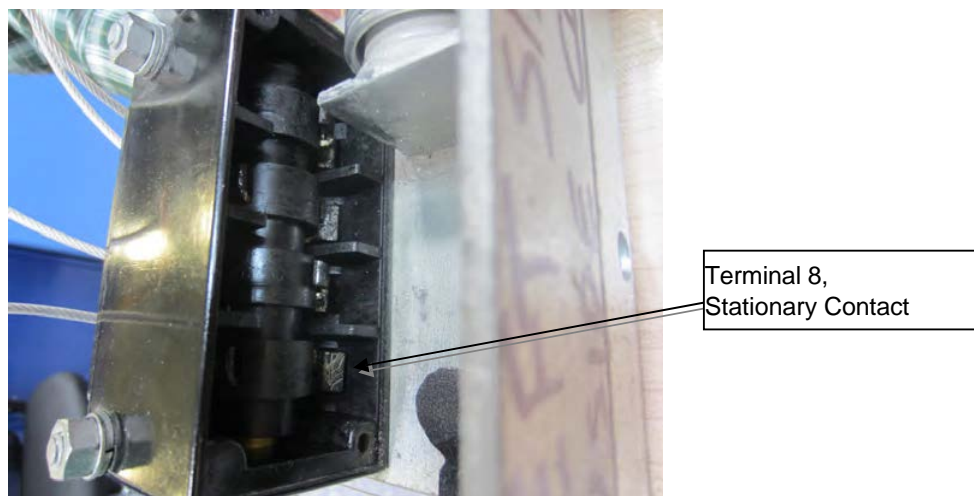
The rear cover of the switch was removed, the contact rotor can be seen moving. The resistance was then measured between the terminal screws and the stationary contacts. It was a closed circuit between terminal 7 and the top stationary contact, it was an open circuit between terminal 8 and the bottom stationary contact. The switch plunger was cycled 50 times while monitoring the switch contacts. Switch contacts 1, 2 and 3 changed state each time the plunger was cycled. Switch contact 4 (terminals 7 & 8) remained open for each of the cycles. The bottom stationary contact associated with terminal 8 appears to be out of place as seen in the photo below.

Left Side Switch - Switch Contact 4, Terminal 8

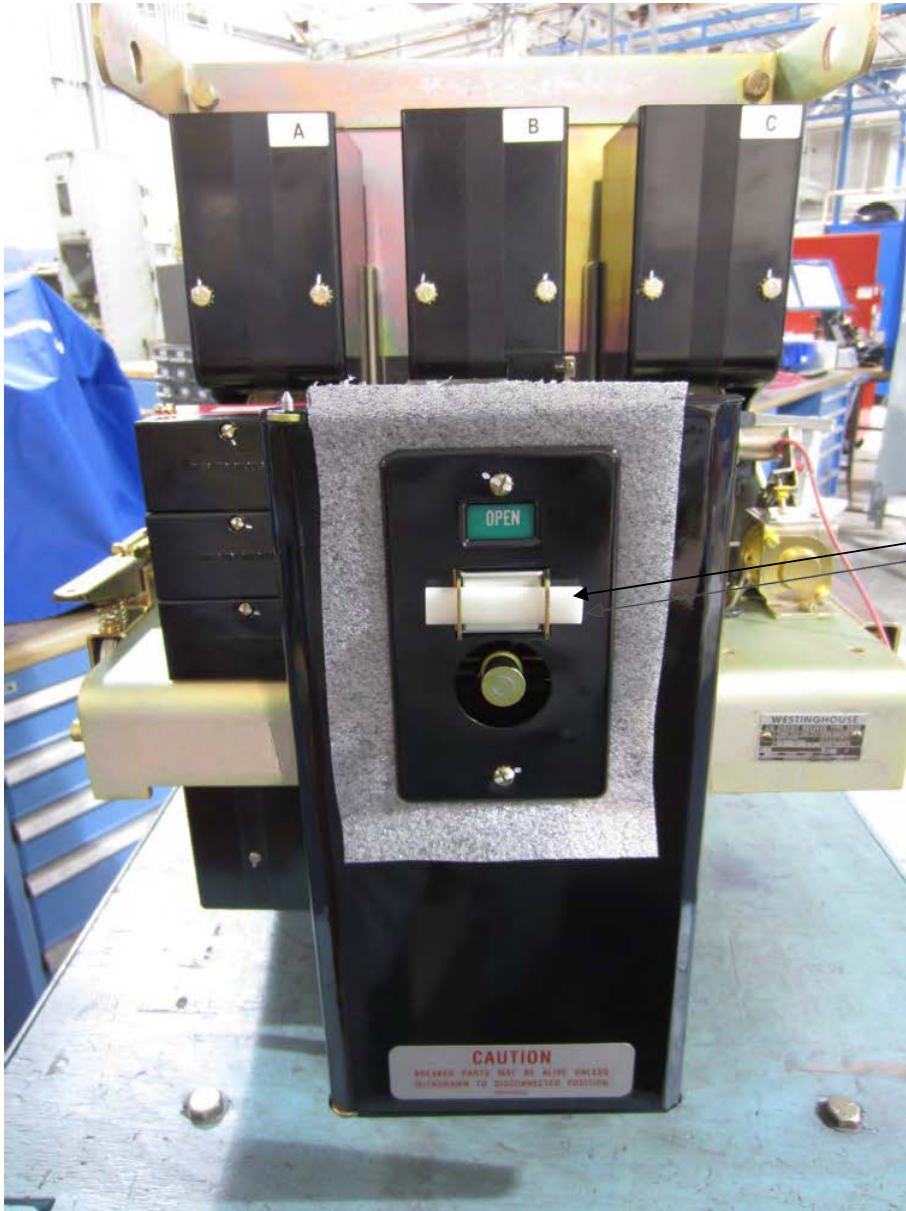
Refurbished DB-50 Breaker with Operating Mechanism Lock-Out Bar

It is recommended that the breaker be handled outside the switchgear cubicle with additional care. The breaker lock-out tabs on the front of the operating mechanism can cause the breaker not to function properly. When a breaker is shipped from Westinghouse the breaker lock-out tabs will include an operating mechanism lock-out bar as shown below.
