# Sumter Electric Cooperative, Inc. (SECO) Report to the Florida Public Service Commission Pursuant to Rule 25-6.0343, F.A.C. Calendar Year 2013

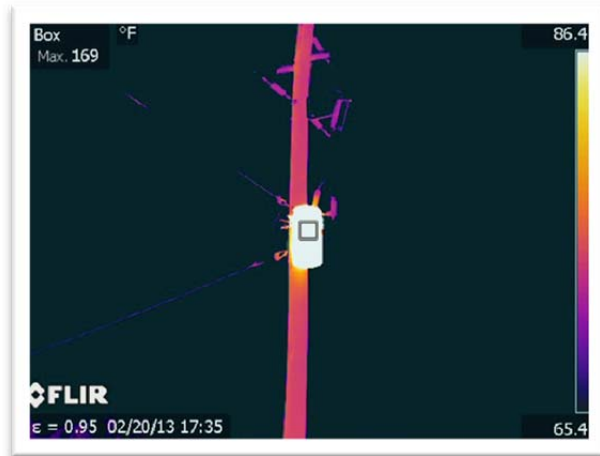
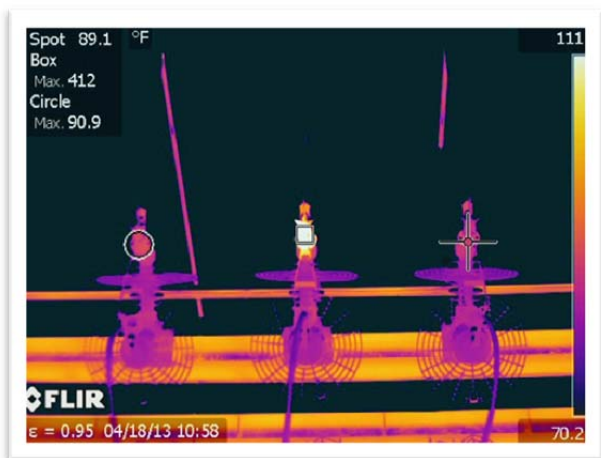
As illustrated by the infrared photos of a distribution pole (right) and a substation (below), this proactive approach allows SECO to detect hotspots and identify devices before they fail in order to minimize service interruptions to its members.
