KISSIMMEE UTILITY AUTHORITY

**CALENDAR YEAR 2014
STORM HARDENING REPORT TO THE
FLORIDA PUBLIC SERVICE
COMMISSION**

PURSUANT TO RULE 25-6.0343, F.A.C.

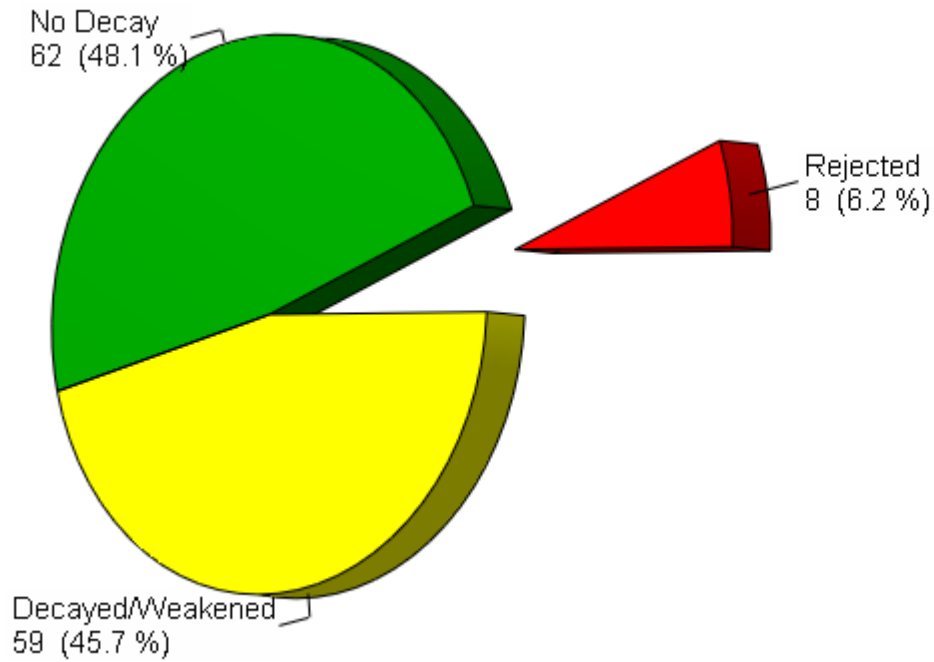
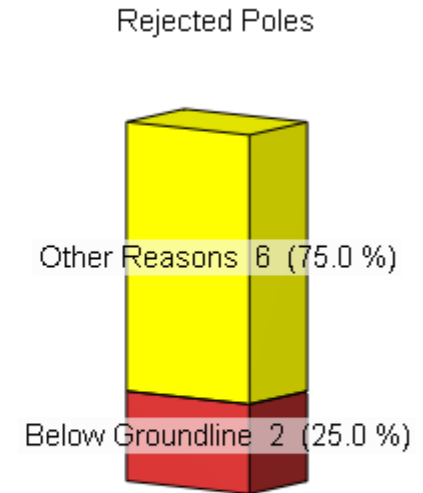
**Kissimmee Utility Authority
Florida / 2014 Transmission Poles**

Reject Poles List

Woodpecker Holes	4
Decay Pocket	2
Heart Rot Above	1
Enclosed Pocket Above.	1

Composite 129 Total Poles

Average Age: 33.7 Years

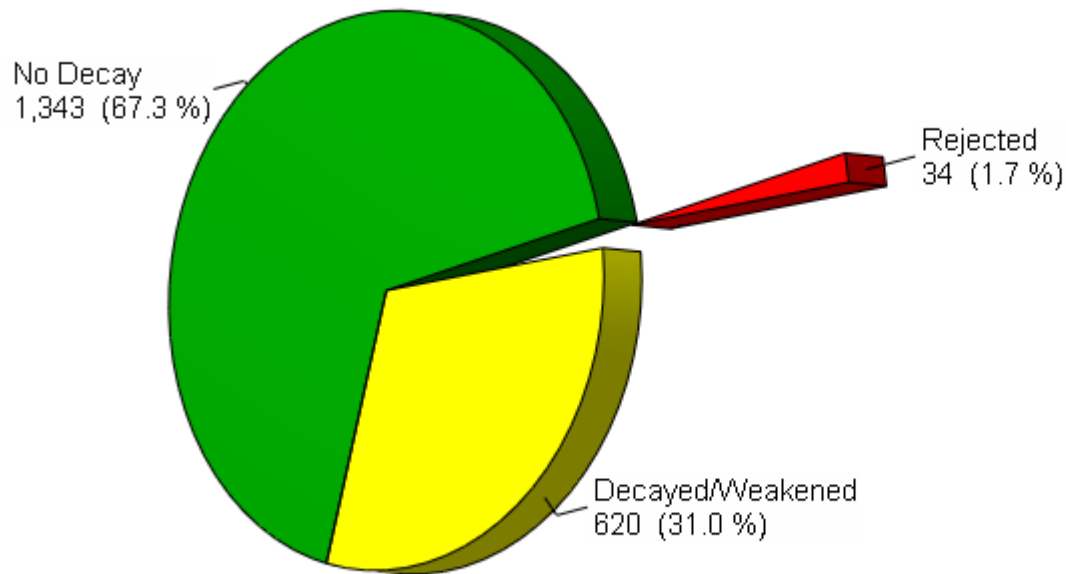
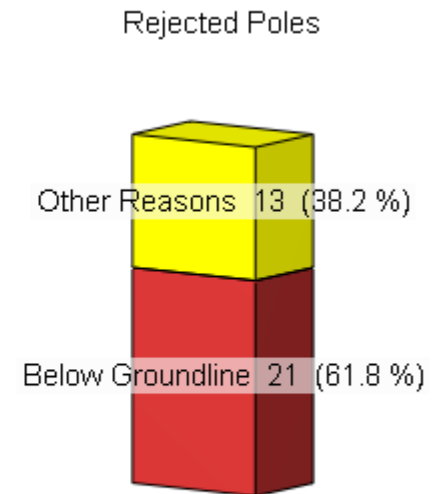
Kissimmee Utility Authority
Florida / 2014 Distribution Poles

Reject Poles List

Shell Rot	19
Split Top	6
Decayed Top	3
Internal Decay Above	2
Decay Pocket	2
Woodpecker Holes	1
Mechanical Damage Above	1

Composite 1,997 Total Poles

Average Age: **27.1 Years**
