# Sumter Electric Cooperative, Inc. (SECO) Report to the Florida Public Service Commission Pursuant to Rule 25-6.0343, F.A.C. Calendar Year 2014

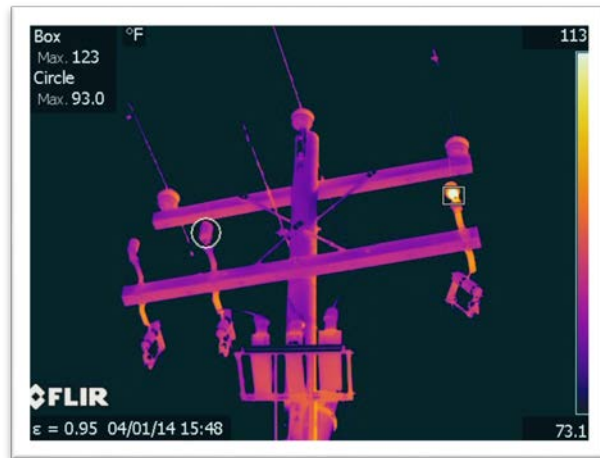
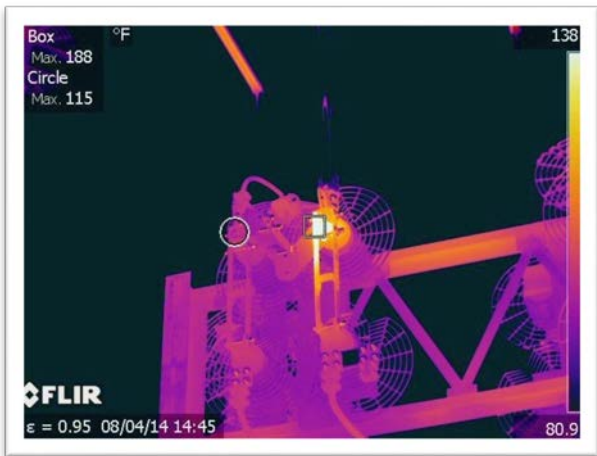
As illustrated by the infrared photos of a distribution pole (right) and a substation (below), this proactive approach allows SECO to detect hotspots and identify devices before they fail in order to minimize service interruptions to its members.
