(CONFIDENTIAL) Hearing Exhibit No. 115 from 2/4/20 DOAH Hearing. [CLK Note: See DN 10935-2019 for Exh Nos. 1, 68-75, 80, 82, 100]

DESCRIPTION: RCA Draft Exhibit

OPC RCA EXHIBIT Table of Contents

February 6, 2018

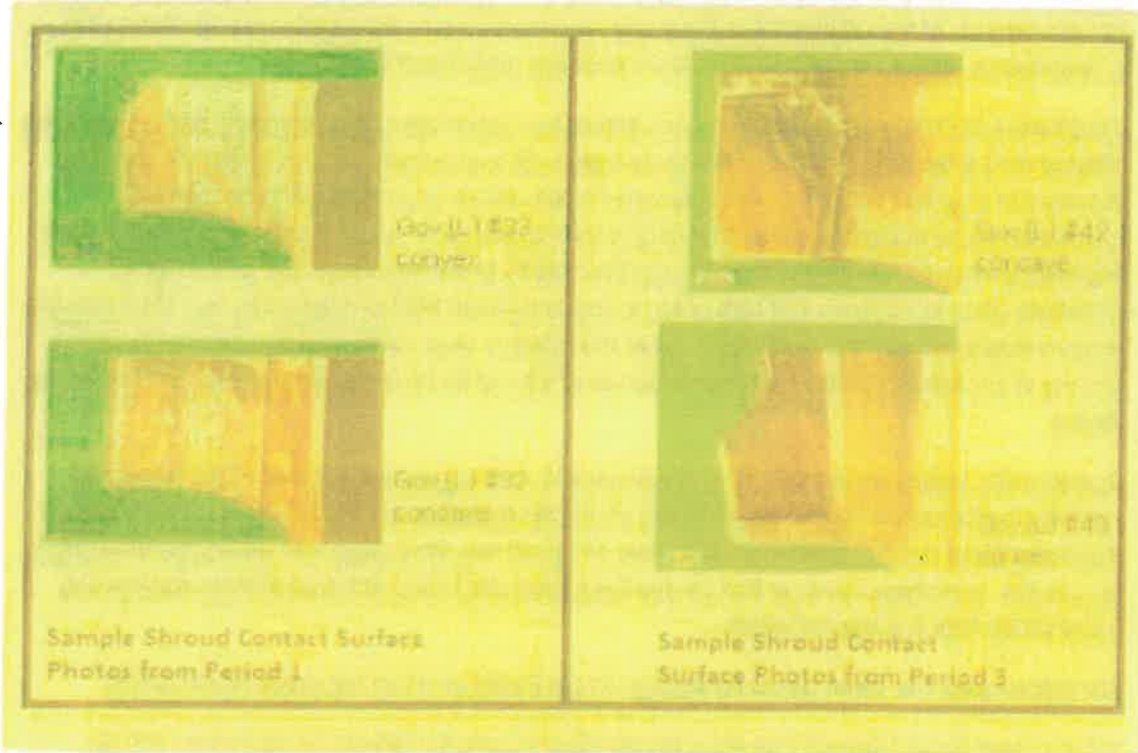
Figure 1 –Photos of Shroud Contact Surface Wear for Periods 1 and 3

Then and now, Duke Engineering does not agree that back-end loading above 15,000 lb/hr-ft² has been the failure-driving mechanism for the documented L-0 events. As Table A illustrates, Periods 2, 4 and 5 saw operating hours in the MHPS defined “Avoidance Zone” of only 1 hour, 1.15 hours and 0 hours, respectively, and still Bartow suffered damaged blades. Period 3 had only 240 hours in the avoidance zone, less than 2% of its total operating hours. Furthermore, by a considerable margin, Period 1 had the greatest amount of run hours in exceedance of the “avoidance zone” – 2,466 out of 21,734 total hours – but despite the greatest number of hours, blade damage in this Period was limited to five (5) broken mid-span snubbers on the TE of the machine and a lesser degree of fretting on the shroud Z-Lock contact surfaces for both TE and generator end (GE) of the machine than seen in other Periods. The next highest period in the avoidance zone, Period 3, with 240 hours (out of 10,286 total hours – (11 hours of which were during approved instrumented blade telemetry tests performed by MHPS in December 2014), showed significantly greater amounts of blade damage and fretting to the Z-Lock contact surfaces on both ends of the machine than Period 1.

While the amount of Z-Lock wear cannot be quantified for Periods 1 and 3, photographs show the difference (See Figure 1 below).

Based on comparative run times and damage, it is difficult to conclude that the L-0 blade damage in each Period or any particular Period is due to unit operation in the avoidance zone.⁶

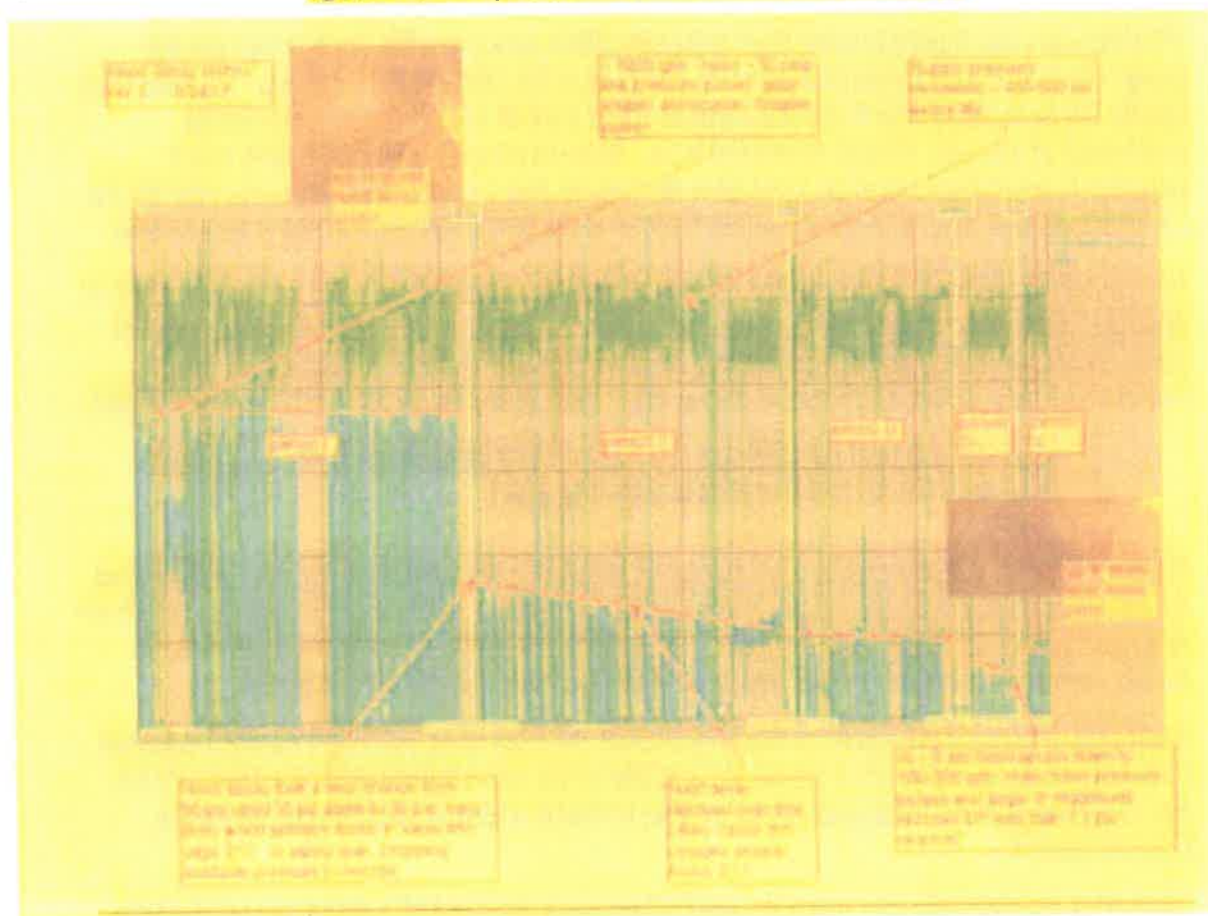
Figure 2 – Hood Spray Pressure Degradation Over Periods 1-5

Having eliminated excessive LP exhaust temperature as a concern, the team looked at hood spray pressure and found it had steadily decreased over successive Periods likely due to clogged sprays.

Figure 2 depicts the pressure decrease in the hood sprays over time. The decline in water pressure at the hood spray nozzles, likely caused by debris in the valve trim, results in reduced atomization.

At the kind of hood spray pressures shown in Figure 2, the atomization of the hood sprays would have been poor. Larger water droplets will cause pressure pulses as evaporation occurs, during times when the LP exhaust steam temperatures are elevated during blending.

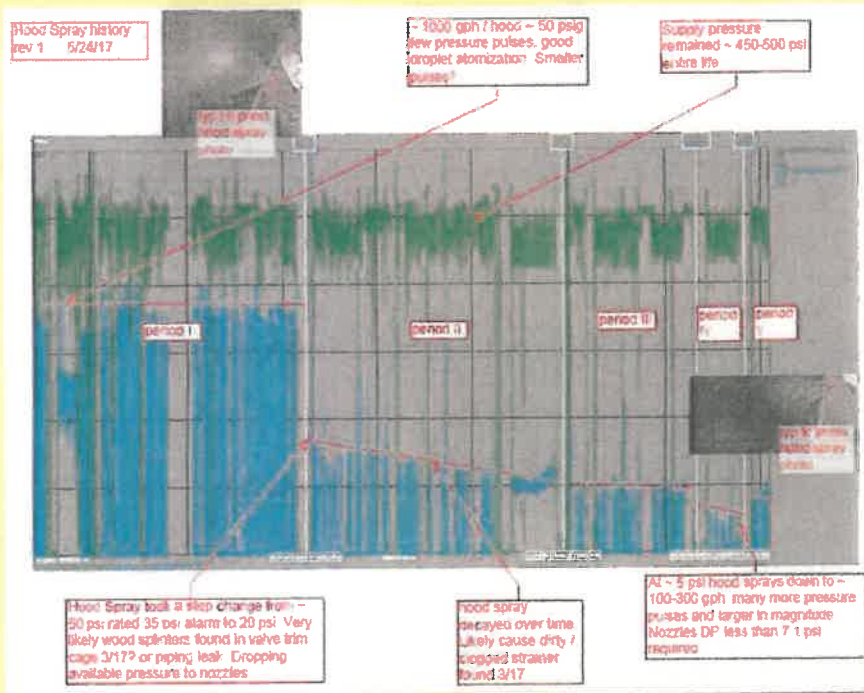
The chart below shows what happened to hood spray pressure over time. The decay in water pressure at the hood spray nozzles will have reduced atomization as these style of nozzle rely on pressure drop to create a vortex inside the nozzle that causes atomization thru centripetal force. The effect of reduced atomization was verified during a test just prior to unit restart in April 2017. A key concern of poor atomization is the effect it might have on generating dynamic pressures which the L-O blades might see as large water droplets evaporate in the exhaust stream.

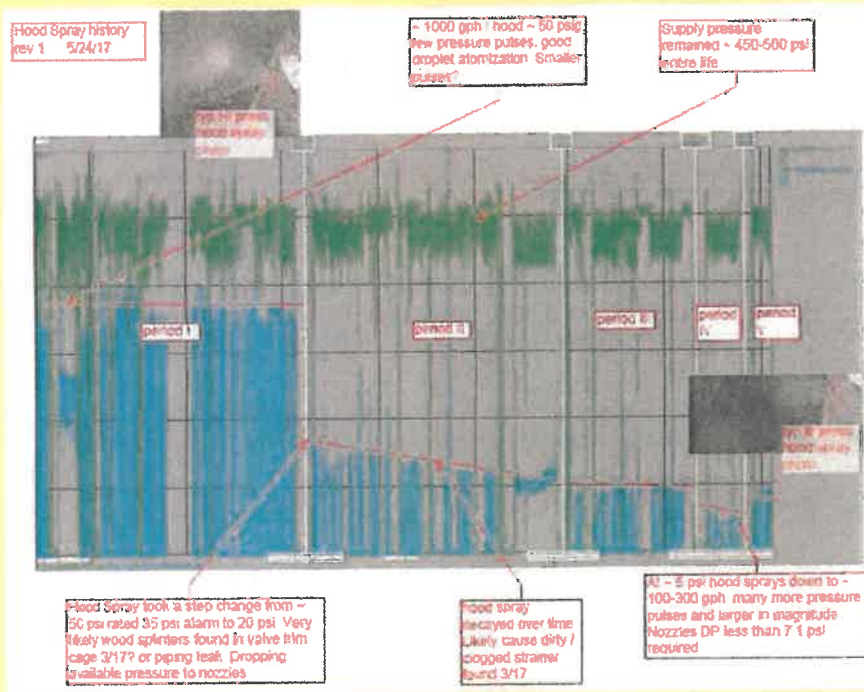
The chart below demonstrates what happened to hood spray pressure over time. The decay in water pressure at the hood spray nozzles will yield reduced atomization as these style of nozzle rely on pressure drop to create a vortex inside the nozzle that causes atomization thru centripetal force. The effect of reduced atomization was verified during a test just prior to unit restart in April 2017. A key concern of poor atomization is the effect it might have on generating dynamic pressures which the L-O blades might see as large water droplets evaporate in the exhaust stream.

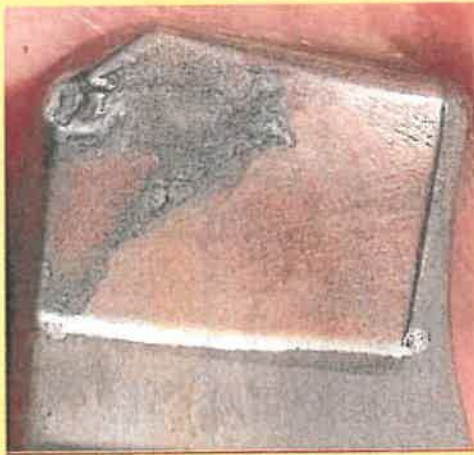
Figure XX: Photo of Z-notch from Period 5 showing wear of contact surface

Figure XX. There was a varying degree of wear seen on the Period 5 Z-notches, however, the wear is higher than what one would expect given the relatively low operating hours.

Period 5 did have its share of higher energy blends as detected by the blend energy method. However, in terms of operating hours in blend mode, Period 5 is not excessive in terms of percentage time blending. The total of 20 hours of blend time does not appear to justify the wear seen.

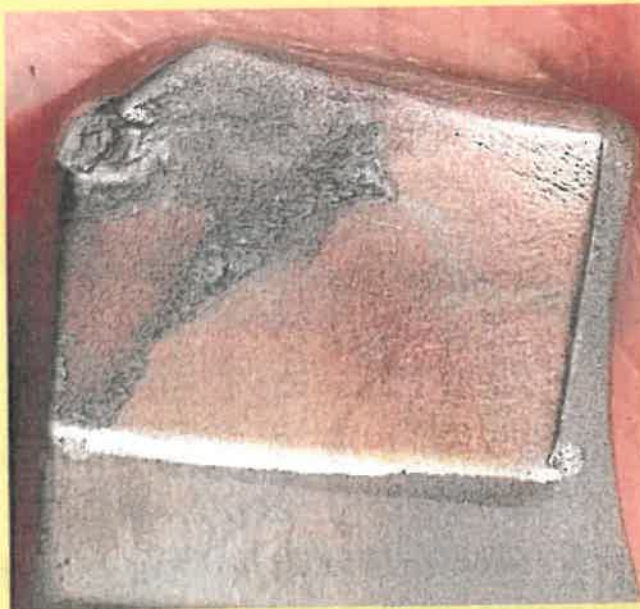
Figure 4 – Photo of an L-0 blade Z-Lock from Period 5 Showing Contact Surface Wear

Period 5 did have its share of higher energy blends as detected by the blend energy method. However, in terms of operating hours in blend mode, Period 5 is not excessive in terms of percentage time blending. The total of 20 hours of blend time does not appear to justify the wear seen.

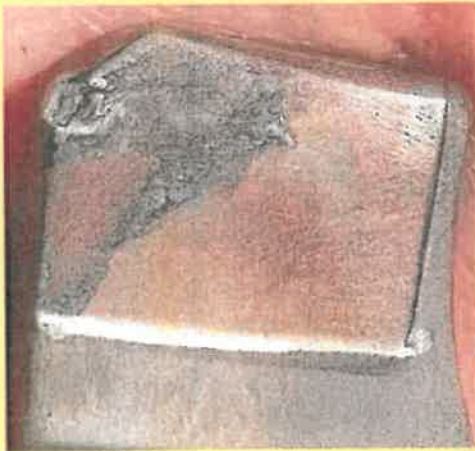
Figure 3 – Photo of an L-0 blade Z-Lock from Period 5 Showing Contact Surface Wear

Period 5 did have its share of higher energy blends as detected by the blend energy method. However, in terms of operating hours in blend mode, Period 5 is not excessive in terms of percentage time blending. The total of 20 hours of blend time does not appear to justify the wear seen.

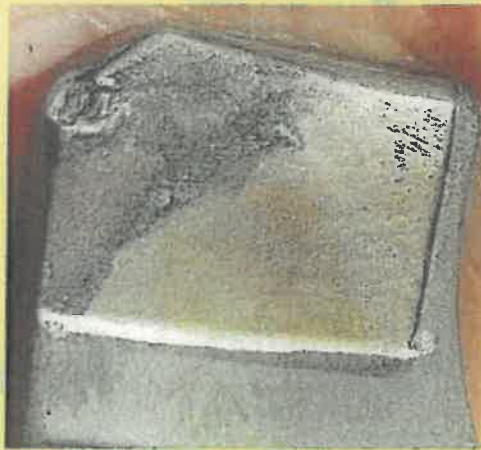
Figure 4 -- Photo of an L-0 blade Z-Lock from Period 5 Showing Contact Surface Wear

Period 5 did have its share of higher energy blends as detected by the blend energy method. However, in terms of operating hours in blend mode, Period 5 is not excessive in terms of percentage time blending. The total of 20 hours of blend time does not appear to justify the wear seen.

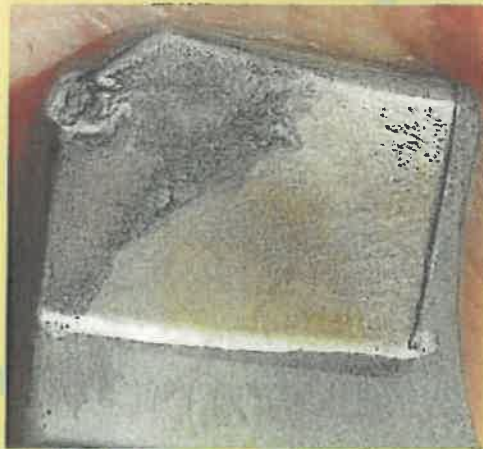
Figure 4 -- Photo of an I-0 blade Z-Lock from Period 5 Showing Contact Surface Wear

Period 5 did have its share of higher energy blends as detected by the blend energy method. However, in terms of operating hours in blend mode, Period 5 is not excessive in terms of percentage time blending. The total of 20 hours of blend time does not appear to justify the wear seen.

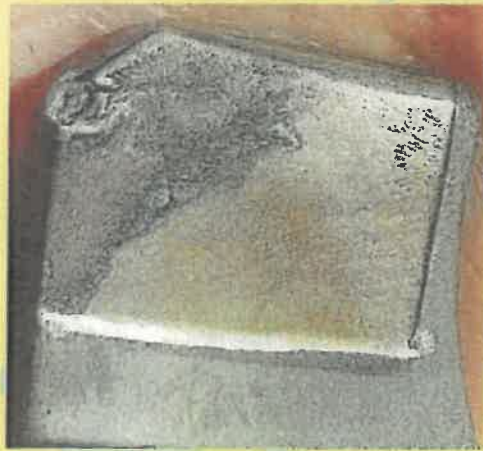
Figure 4 -- Photo of an L-0 blade Z-Lock from Period 5 Showing Contact Surface Wear

Period 5 did have high energy blends as detected by the blend energy method. However, in terms of operating hours in blend mode, Period 5 is not excessive in terms of percentage time blending as compare to time operated in Zone F1.

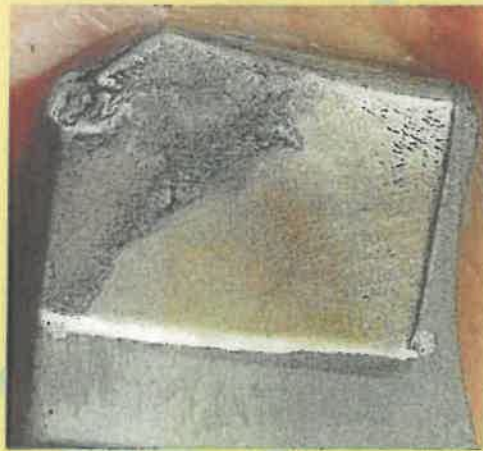
Figure 4 -- Photo of an L-0 blade Z-Lock from Period 5 Showing Contact Surface Wear

Period 5 did have high energy blends as detected by the blend energy method. However, in terms of operating hours in blend mode, Period 5 is not excessive in terms of percentage time blending as compared to operating hours in Zone F1.

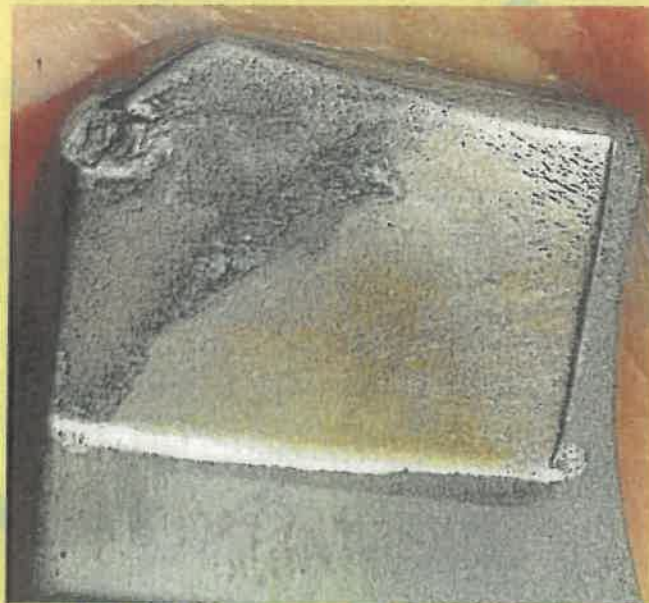
Figure 4 -- Photo of an L-0 blade Z-Lock from Period 5 Showing Contact Surface Wear

Period 5 did have high energy blends as detected by the blend energy method. However, in terms of operating hours in blend mode, Period 5 is not excessive in terms of percentage time blending as compared to operating hours in Zone F1.

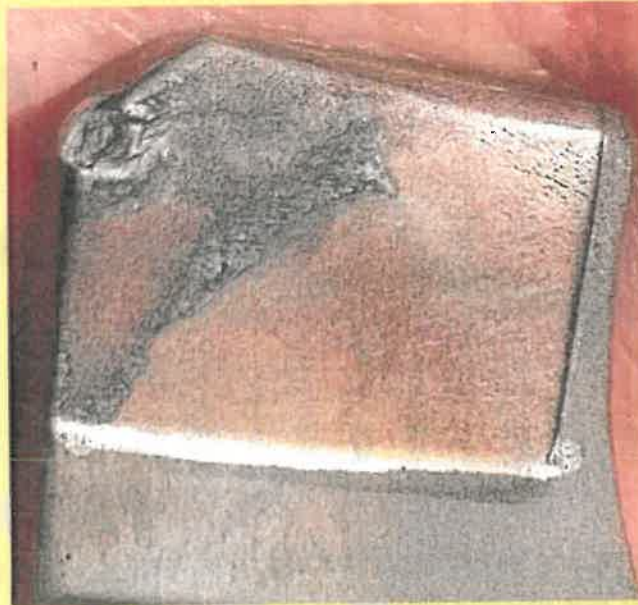
Figure 4 -- Photo of an L-0 blade Z-Lock from Period 5 Showing Contact Surface Wear

Period 5 did have high energy blends as detected by the blend energy method. However, in terms of operating hours in blend mode, Period 5 is not excessive in terms of percentage time blending as compared to operating hours in Zone F1.

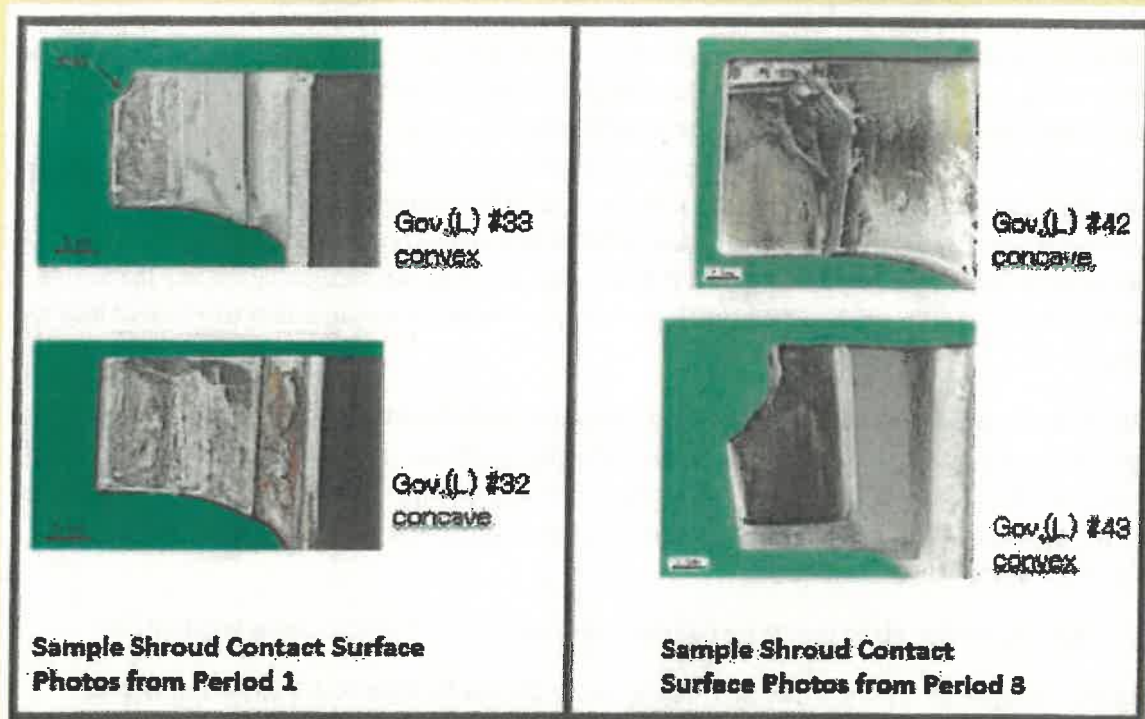
Figure 1 –Photos of Shroud Contact Surface Wear for Periods 1 and 3

Based on comparative run times and damage, it is difficult to conclude that the L-0 blade damage in each Period or any particular Period is due to unit operation in the avoidance zone.⁶

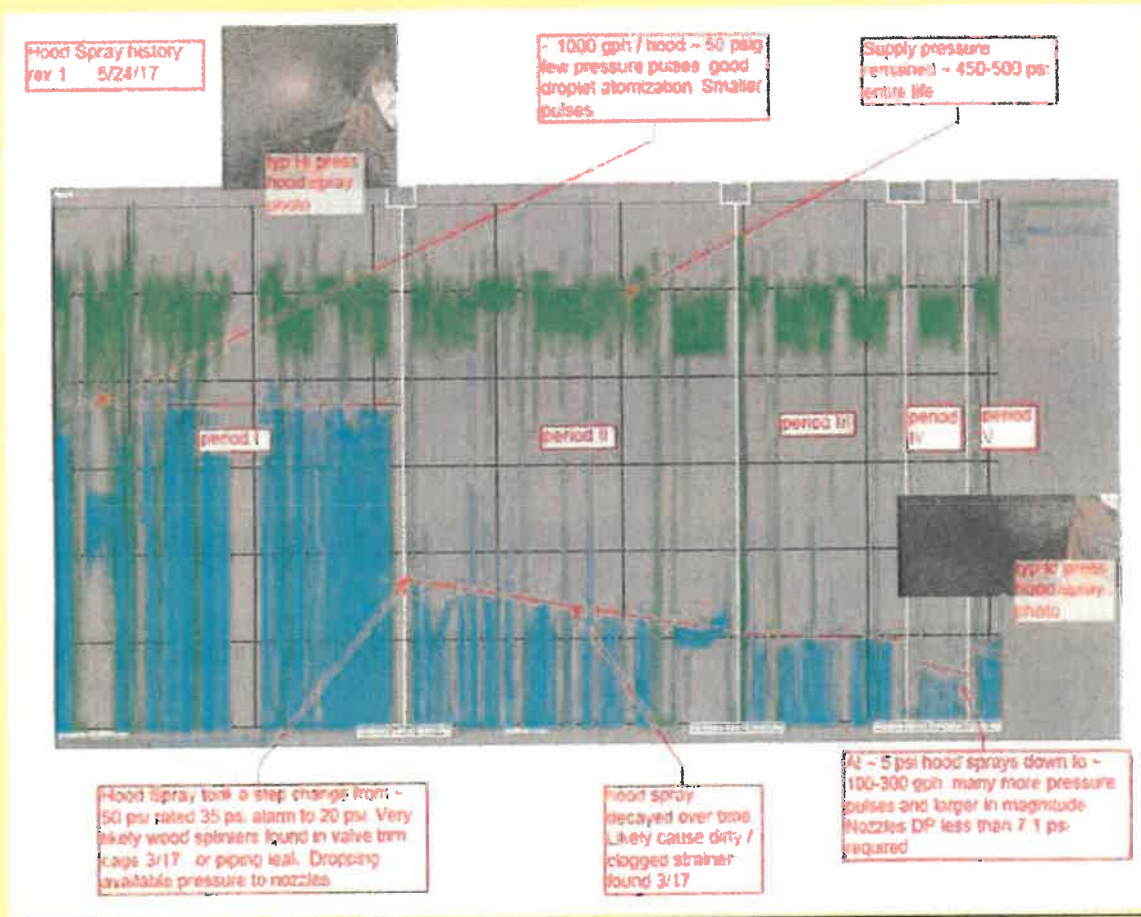
Figure 2 – Hood Spray Pressure Degradation Over Periods 1-5

Control of the hood sprays is automated within the plant-wide control system and not controlled by the operators. After a plant is commissioned, the hood sprays are not normally checked for accuracy and again, until there had been successive failures, there was no reason to focus on the hood spray system's functionality. Although the review that was conducted after the 5th failure revealed lower pressure which may have contributed to some additional wear of the blades, the Duke team does not believe this is the root cause of the failures as the design of the blades should have been robust enough to withstand some increased pressure pulses. Further, MHPS does not believe that any pressure pulses from the hood spray would have been strong enough to harm blades.
