REBUTTAL TESTIMONY & EXHIBITS OF:

IN RE: APPLICATION FOR INCREASE IN WATER RATES IN FRANKLIN COUNTY BY WATER MANAGEMENT SERVICES, INC.

DOCKET NO. 100104-WU

BEFORE THE FLORIDA PUBLIC SERVICE COMMISSION

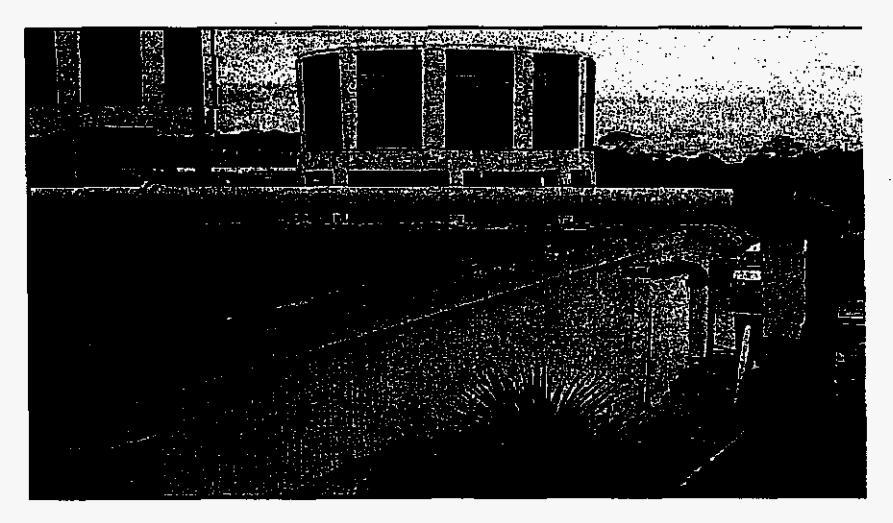
Figure 2- Tray aeration system

Figure 2 illustrates the tray aeration system. One aerator unit was installed in 1987 and a second unit was installed in 2001. Both units are typically in service. The condition of both tray aerator units is in good to fair condition and operable. Paint is peeling from the exterior of the aerators, and stair access up to each aerator is missing handrails.

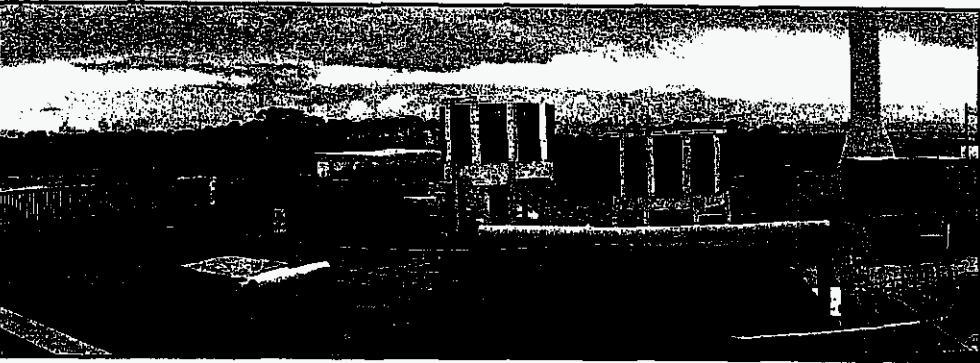
The roof drainage does not appear adequate, as is a low slope roof with very little pitch. This allows for pooling and puddling that can compromise the tank via the hatch. The roof access system is lacking proper safety considerations such as handrails, and more importantly a lock to keep unauthorized and untrained people out of a confined space. The roof maintenance does not appear to be adequate and this may result in breeches in the tanks integrity via the roof. It is not known if the roof is watertight.

FIGURE 5.6 Panoramic view of the roof facing south. The roof is generally flat and puddling was observed.

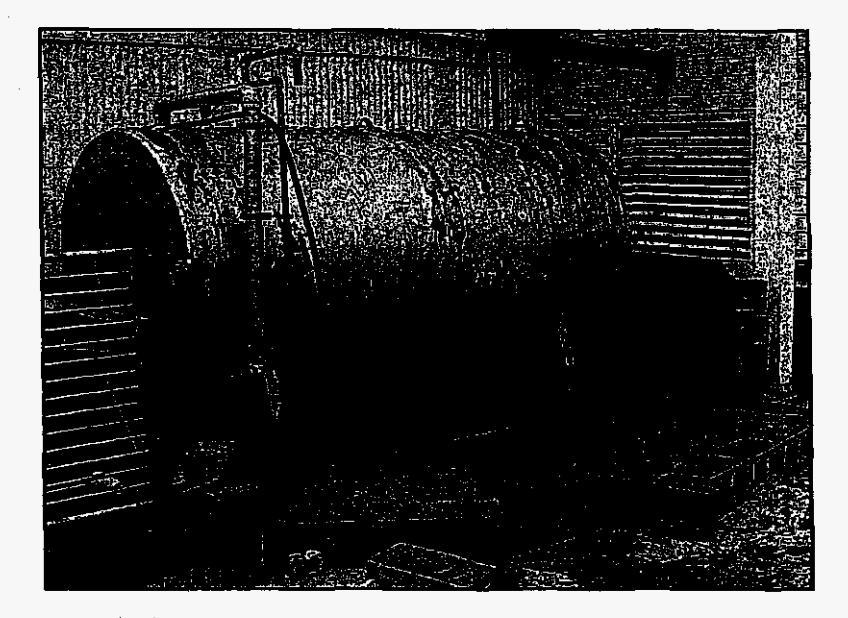
• During inspection of the fuel tank containment area, the containment wall fell due to a heavy rain from the previous night (see Figure 5.9). The new containment area must comply with local and state codes for fuel containment. Failure to comply with state codes risks potential site contamination in the event of a tank leak, resulting in an extremely costly clean up and possible post clean-up site-monitoring requirement per FDEP. It is also recommended that the new containment area be covered to prevent rainfall from entering containment structure.

FIGURE 5.9 Diesel Fuel Tank and containment area after containment wall failure

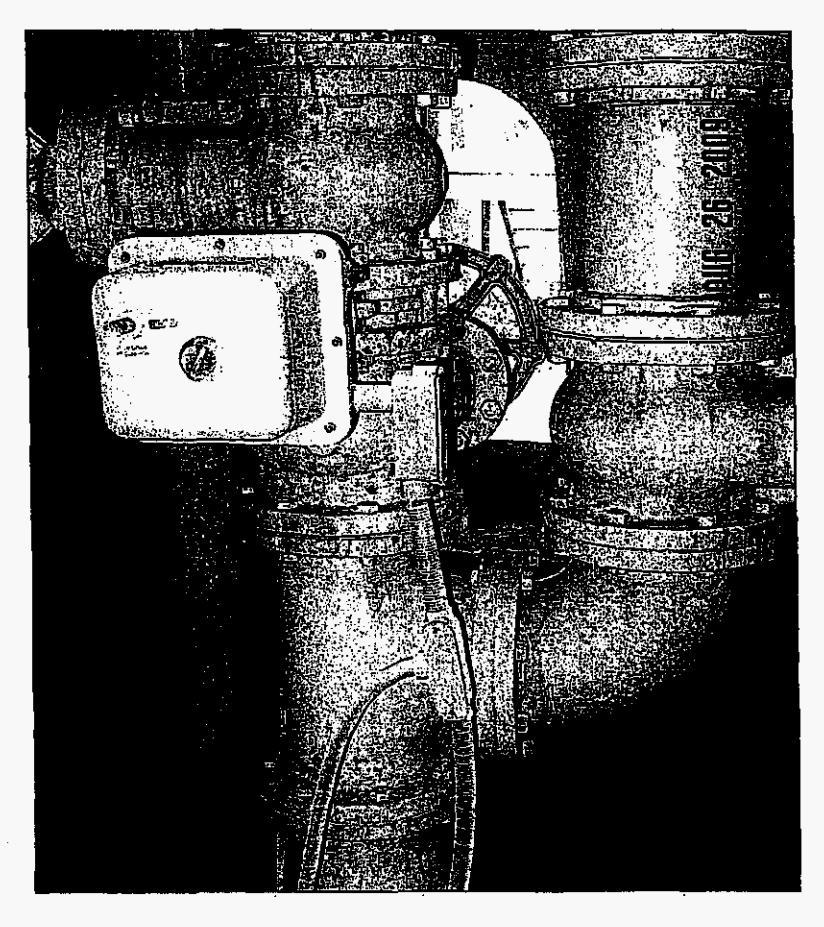
Based on the limited access to the lower level of the tank, visual inspection of the interior and minimal exterior inspection appears the elevated storage tank is in good condition. Minor rust is present on piping and valves, but no significant rust was observed on tank structure itself (See Figure 5.10).

FIGURE 5.10 Minor rust on steel piping and tank structure observed.

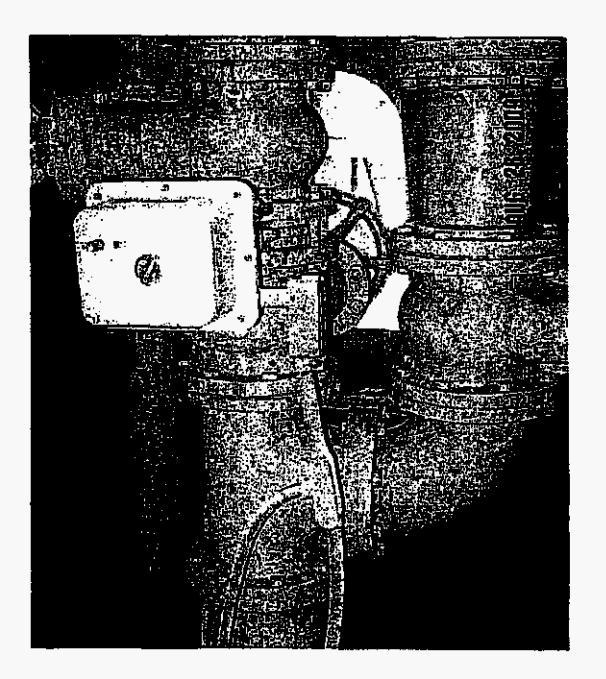
FIGURE B.13 Minor rust on steel piping and tank structure were observed.

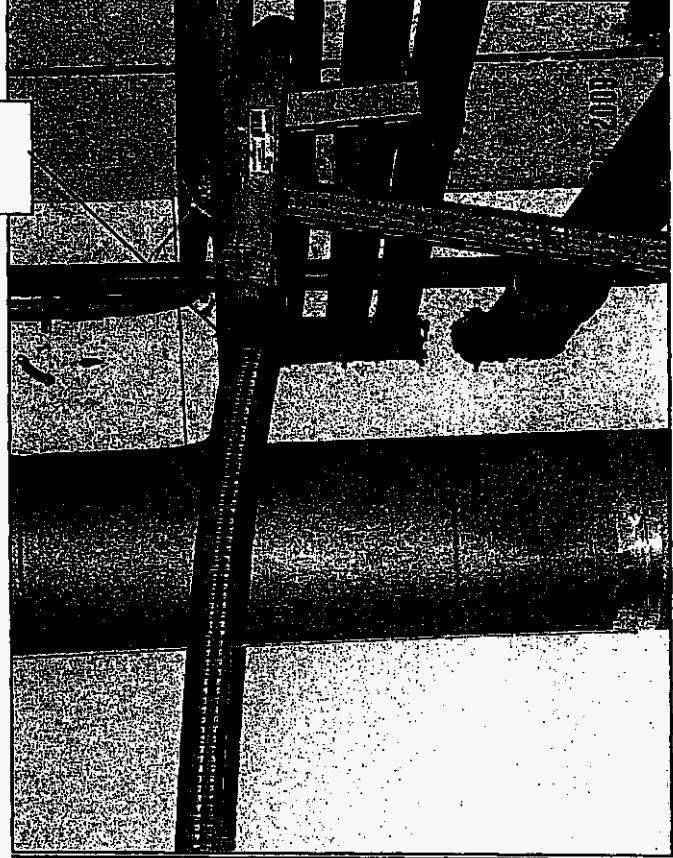
Figure 4.17-High service pump room

Improperly installed flex conduit has exposed pump feeder cable.

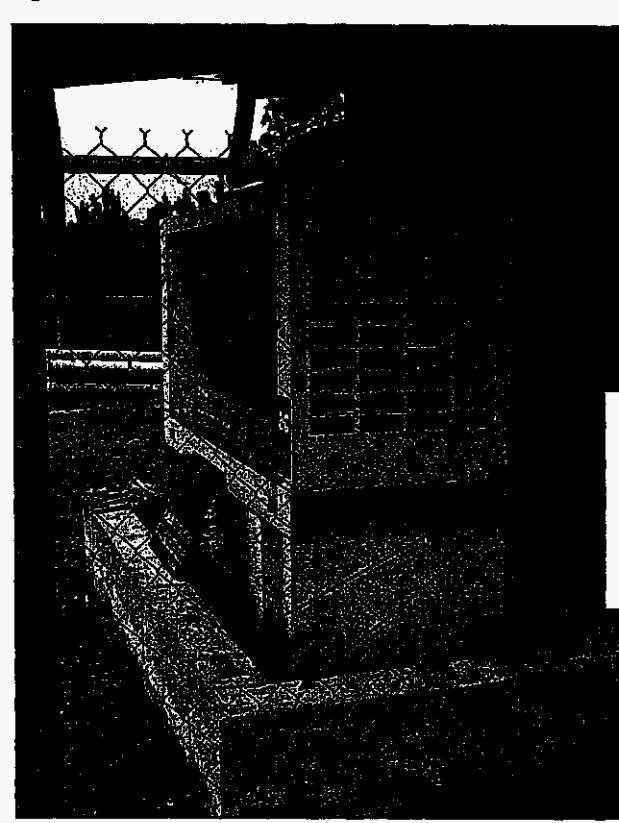
Figure 4.18-Well No.3

Generator containment has caused major corrosion to the diesel tank. Fuel containment structure does not appear to be sufficient size to contain 115% fuel capacity of diesel tank.

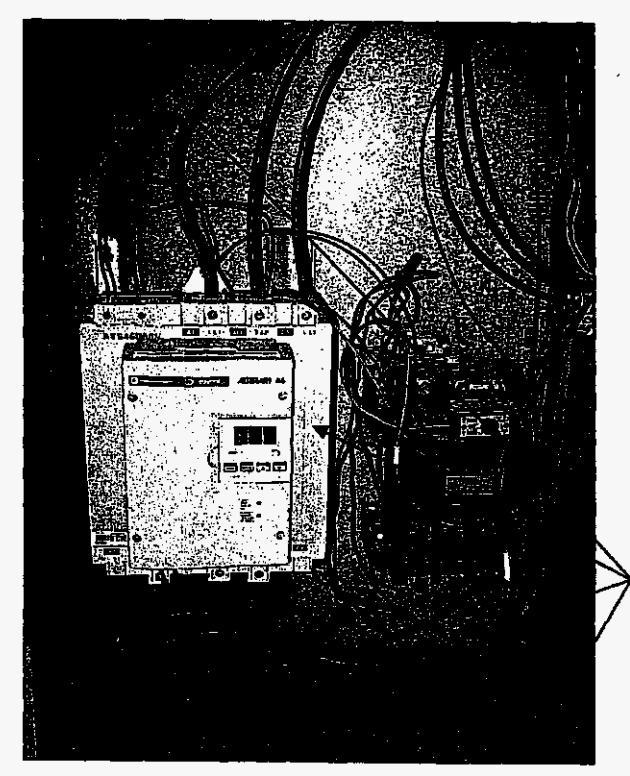
Figure 4.27-Well head junction box

Pump motor starter enclosure houses an old across-the-line-starter and a newer solid state soft start starter. Enclosure shows signs of past fires, wiring is in poor condition.
