# Brevard Waterworks, Inc.

*Re: Docket No. 140186-WU - Application of Brevard Waterworks, Inc. for Staff Assisted Rate Case in Brevard County – Staff Third Data Request Response*

Docket No. 140186-WU

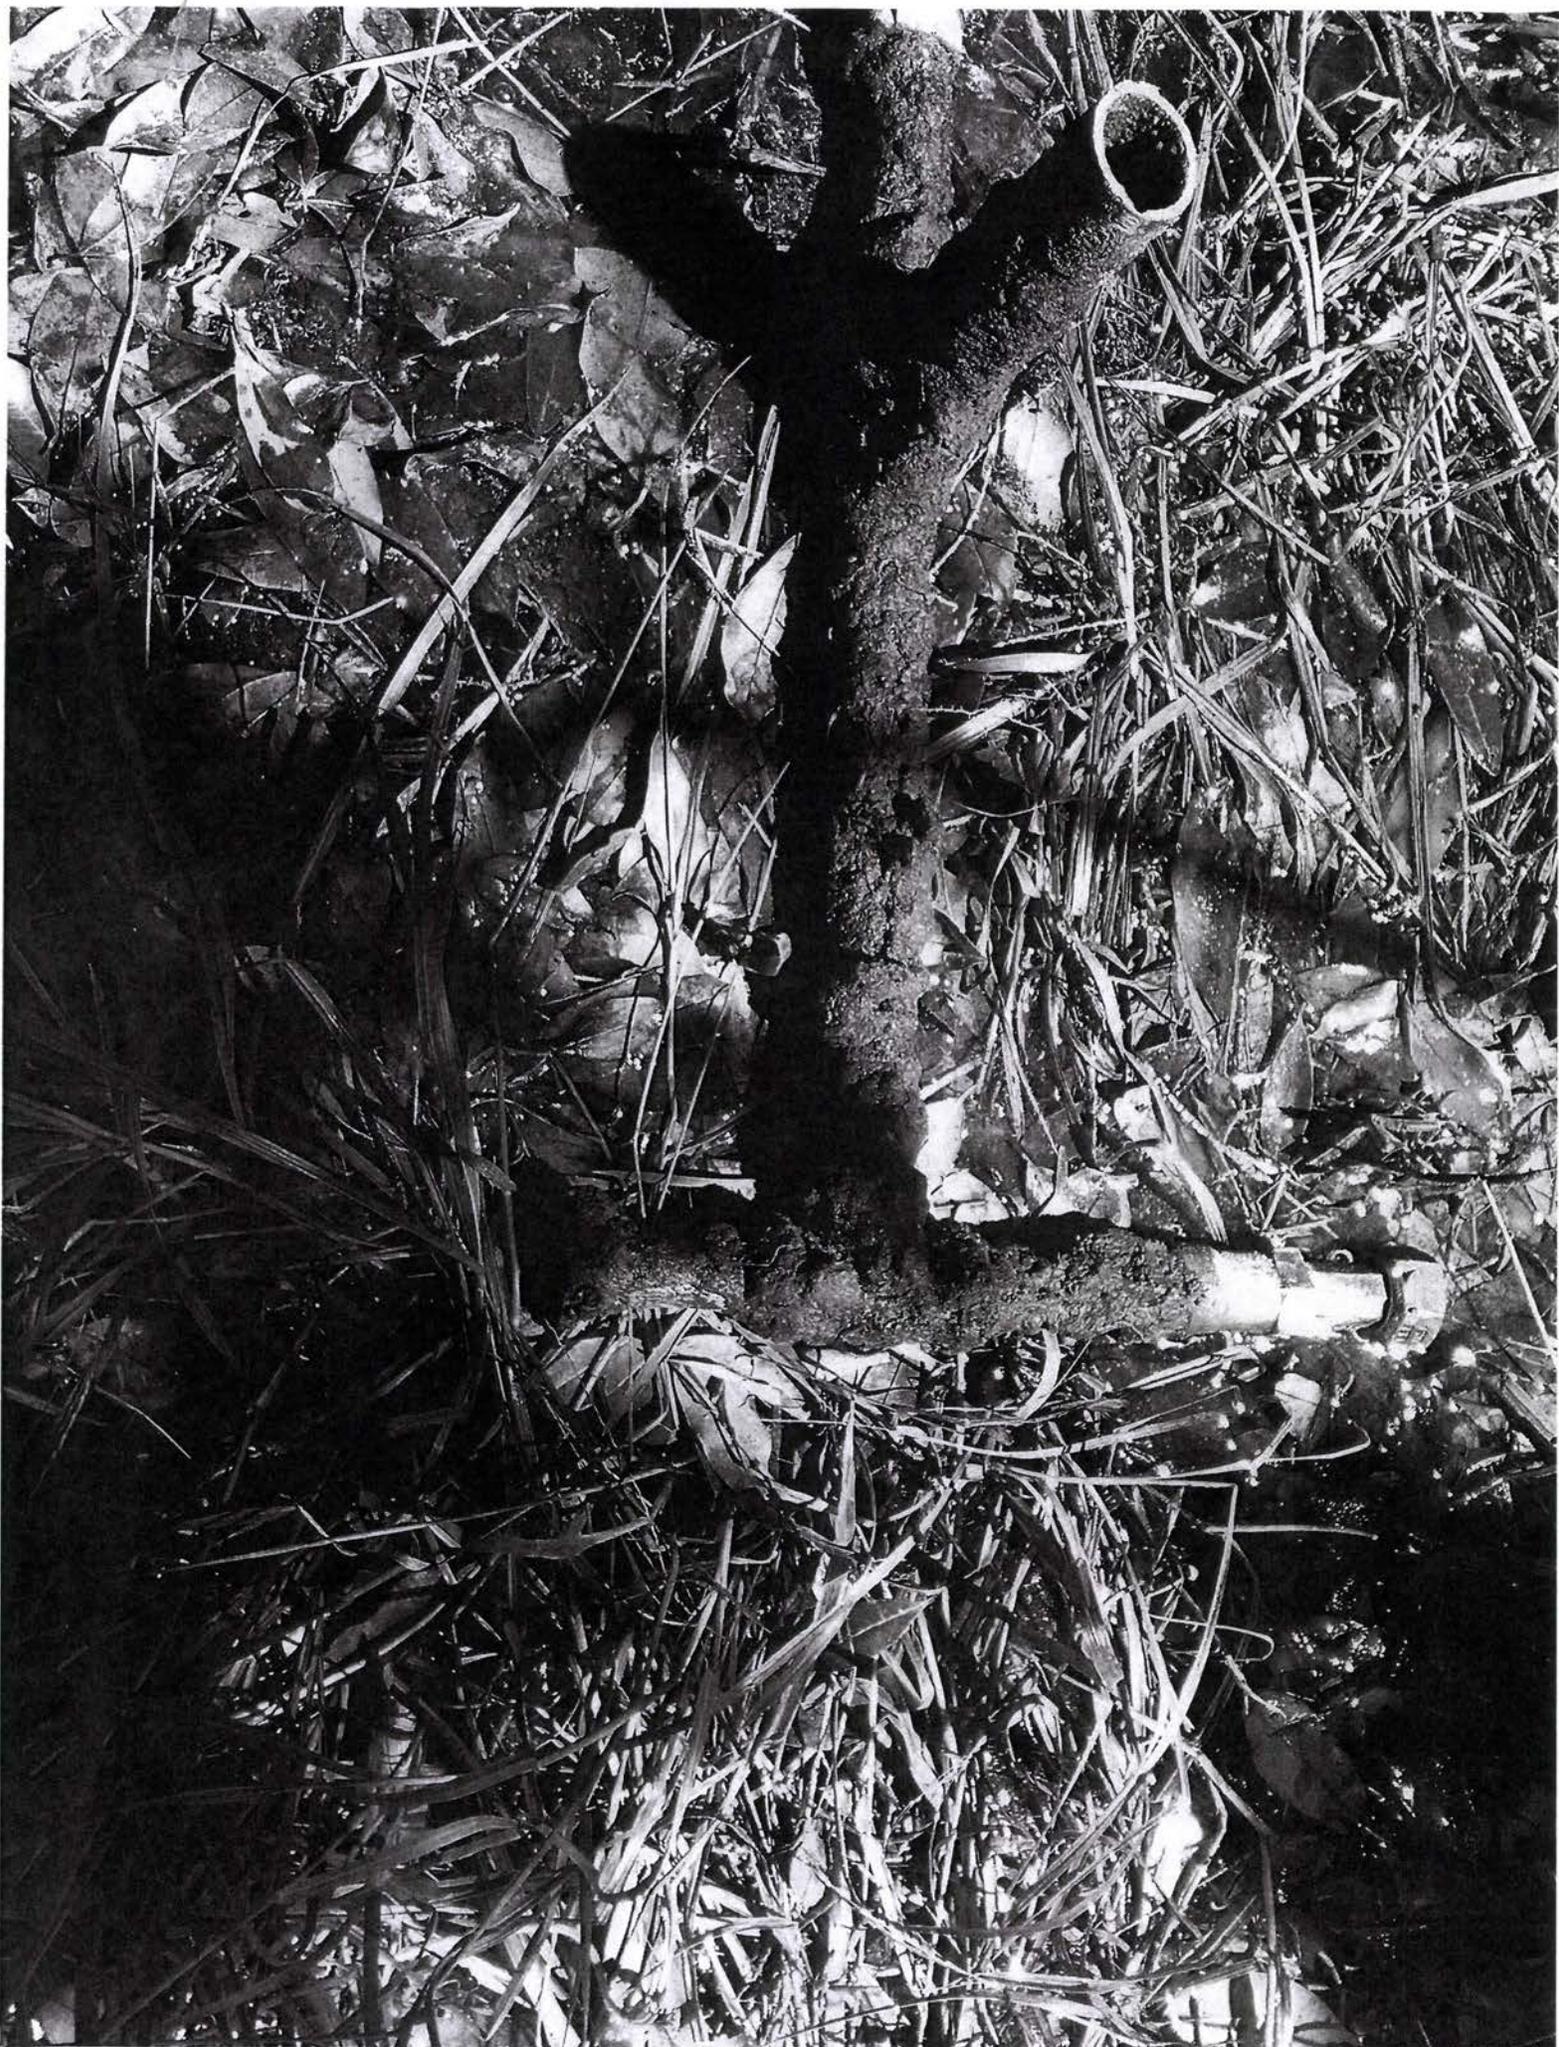
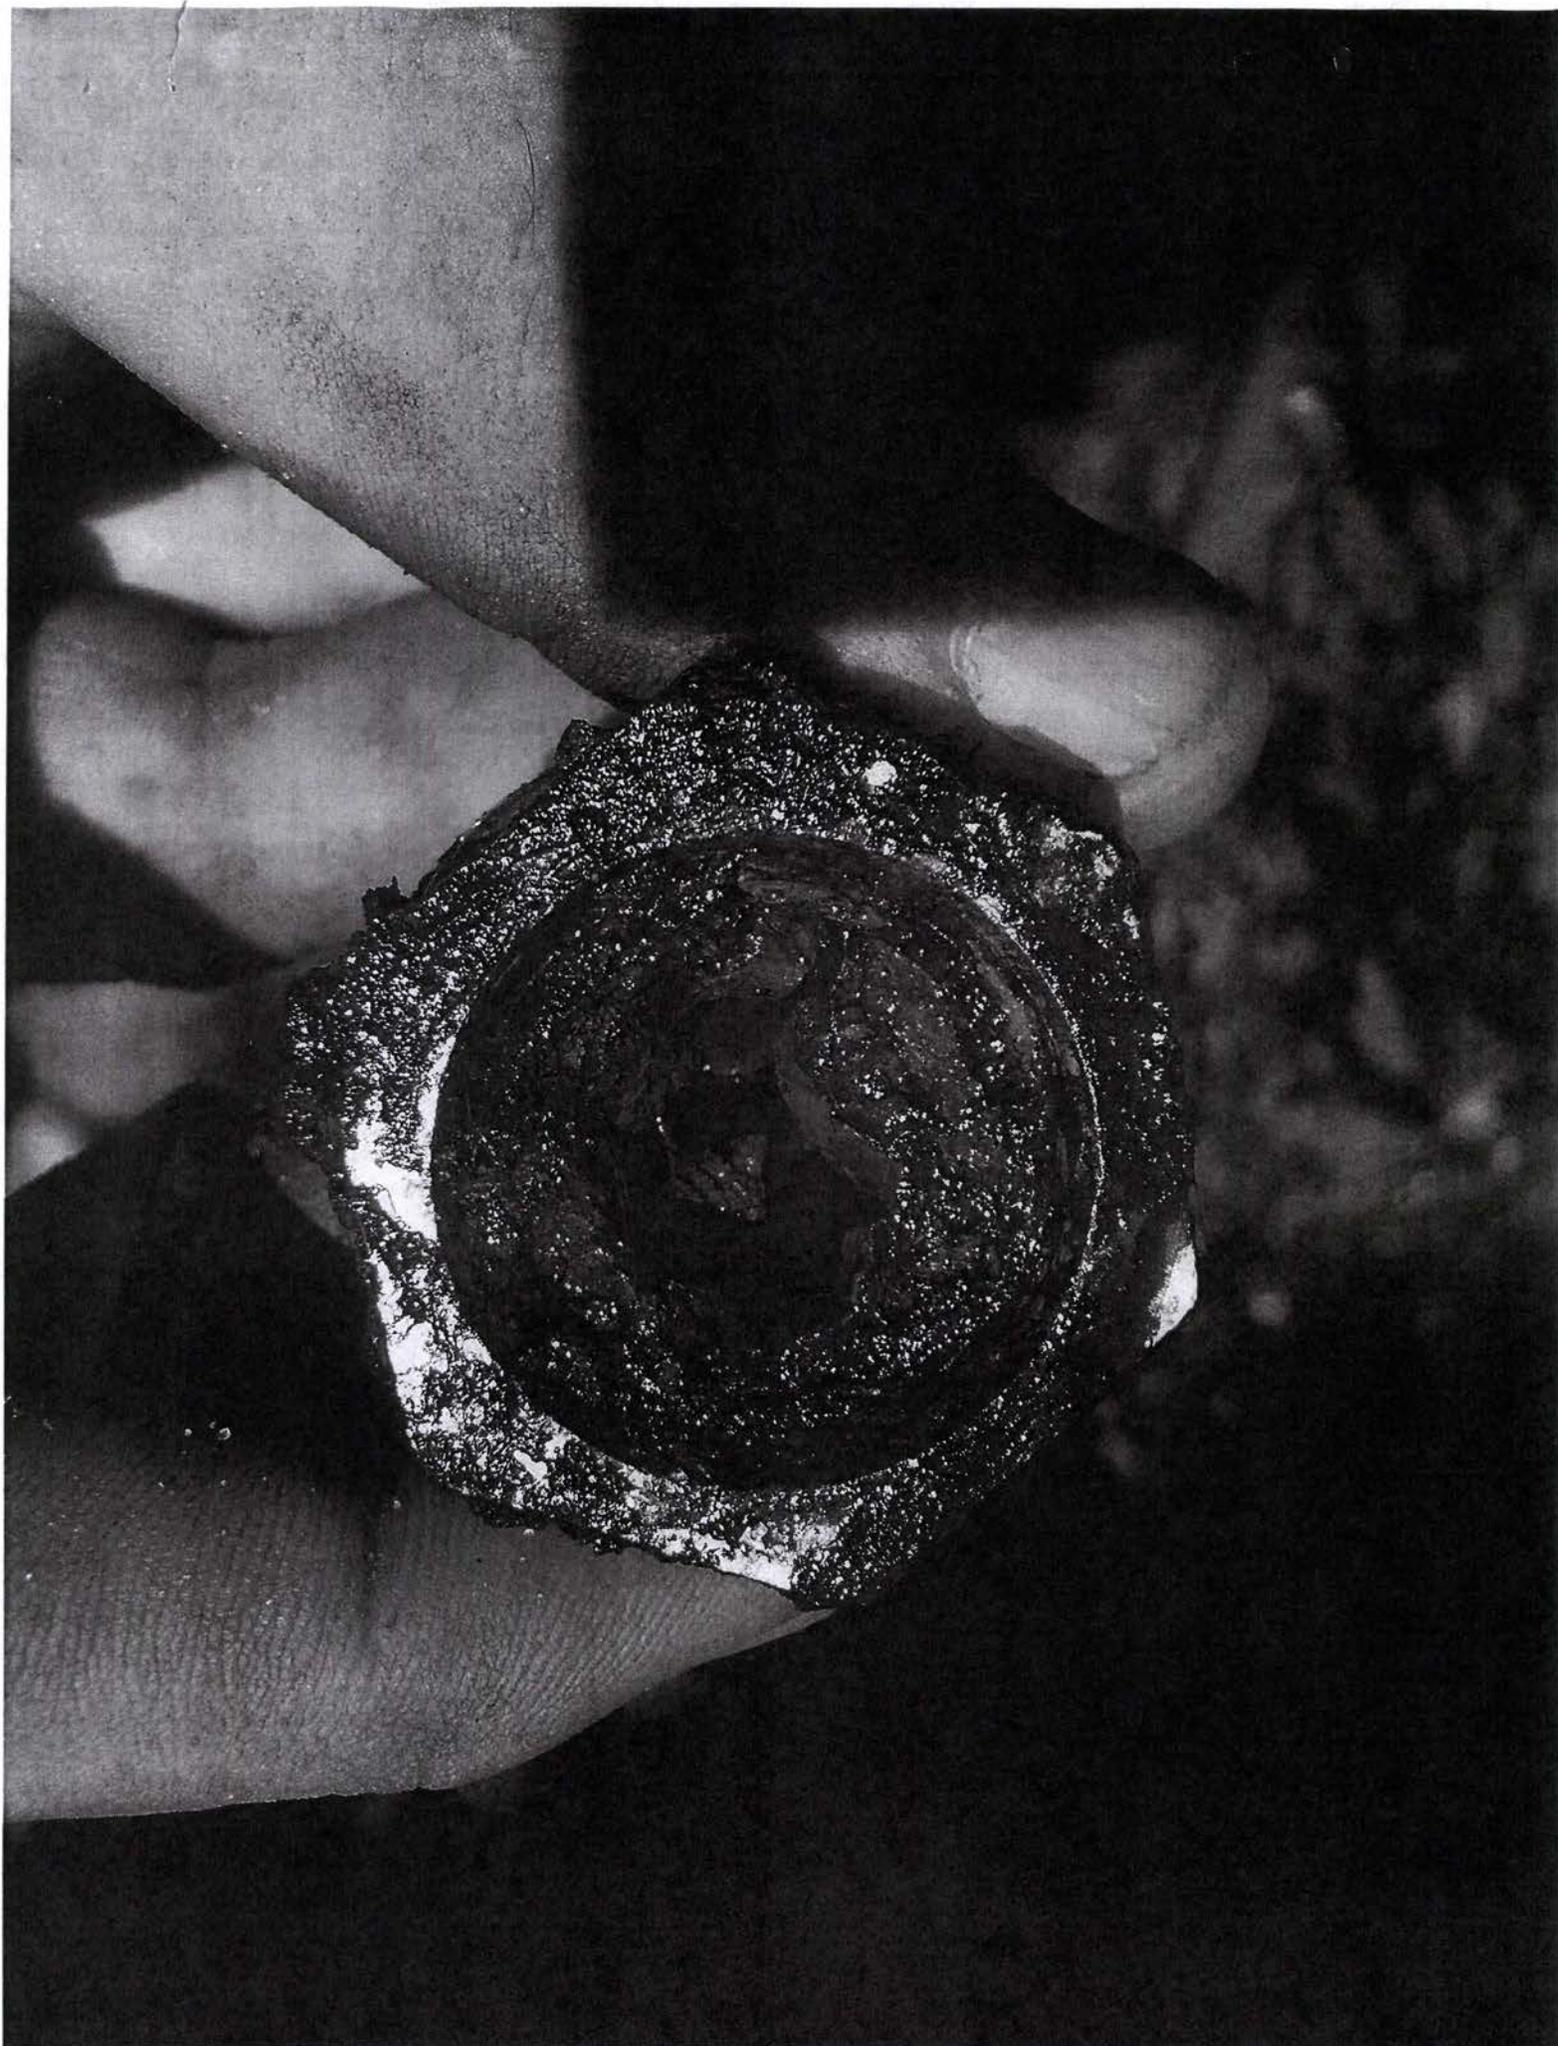
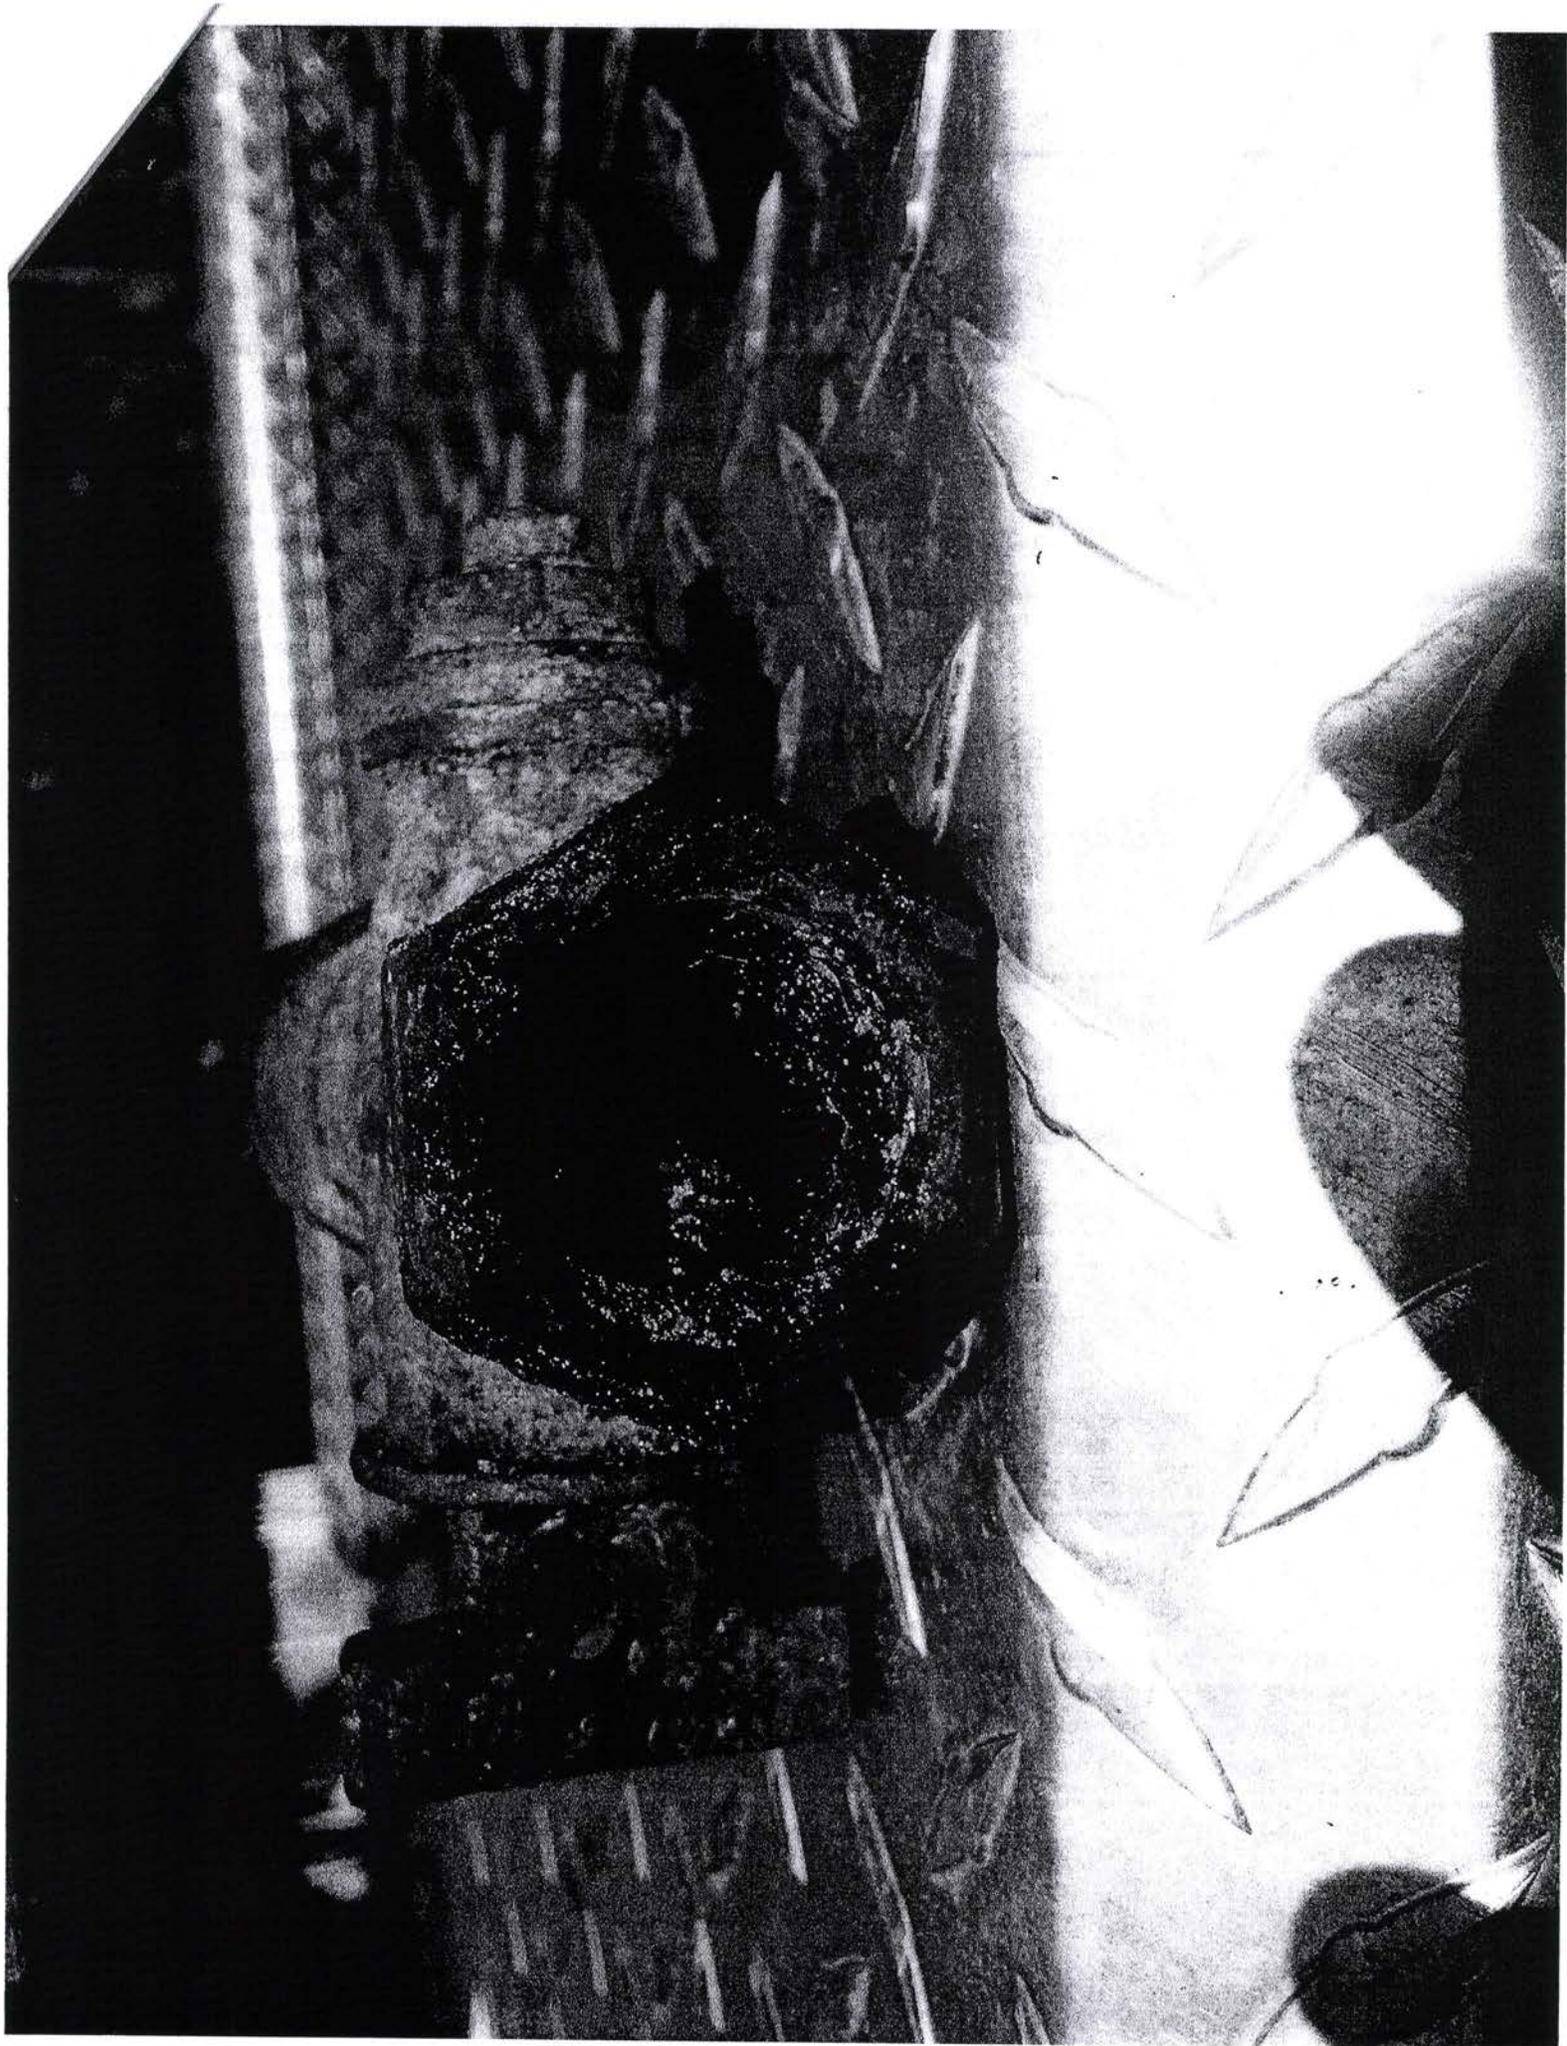
The old galvanized service connections are covered with rust and have small drips throughout the service area. (See attached photos) There also are some 2" galvanized mains. These pipes build up with sediment on the inside, making the inside diameter of the pipe smaller and smaller over time, eventually to the point where water flow is unusable. These pipes also corrode at the joints, which can lead to leaks. Galvanized steel pipe was often used for water supply piping in homes until the early 1970s. It is rarely used today because corrosion problems limit its useful lifespan to between 40 and, at best, 50 years. Rust-corrosion accumulates inside the pipe and causes a plumbing version of arteriosclerosis, with the gradual hardening-of-the-arteries narrowing the diameter of the pipe in horizontal runs to the size of a soda-straw in places. Essentially, it rusts from the inside out. This restricts the flow of water to faucets and showers and, eventually, the corrosion causes the pipe to spring leaks.

In October 2014, Brevard Waterworks did discover two large main and service breaks. These repairs were made and the attached invoices reflect the costs of repairs. Brevard Waterworks has calculated the leak amounts to be 207,360 gallons per month.
