STORM HARDENING PLAN  
OF  
FLORIDA PUBLIC UTILITIES COMPANY

# Florida Public Utilities Company

Storm Hardening Plan  
2016 - 2018

Rule 25-6.0342 F.A.C.

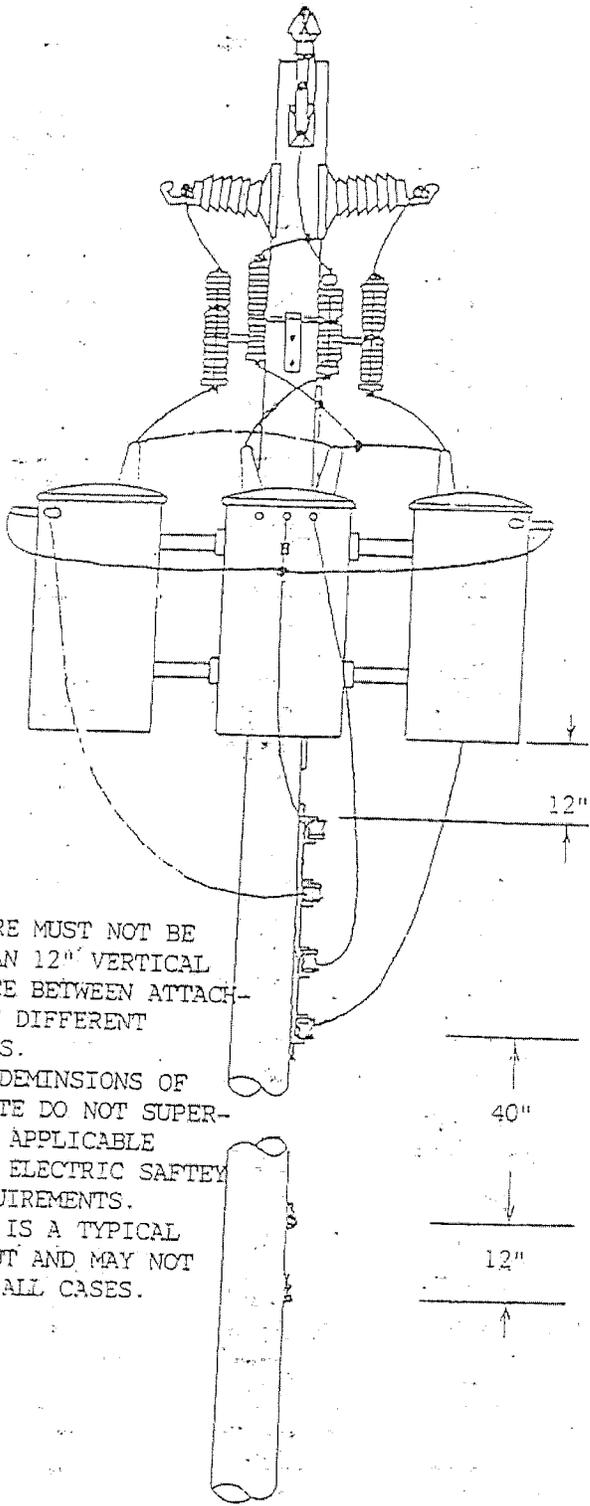
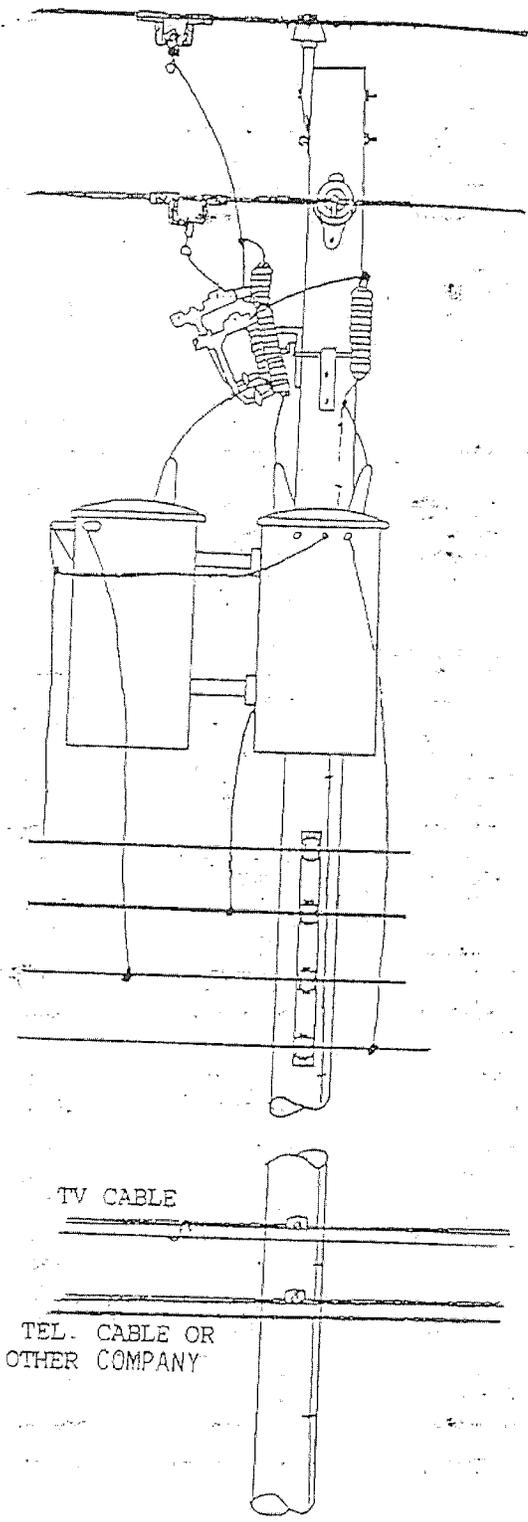
TYPICAL COMPANY ATTACHMENT TO FPU COMPANY

12"  
40"  
12"

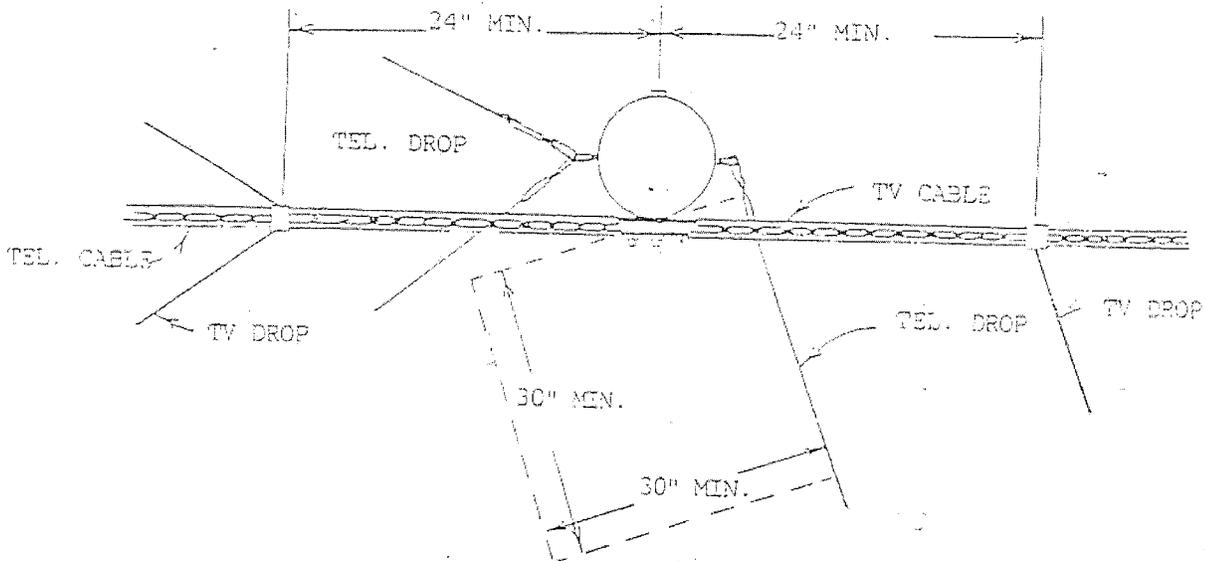
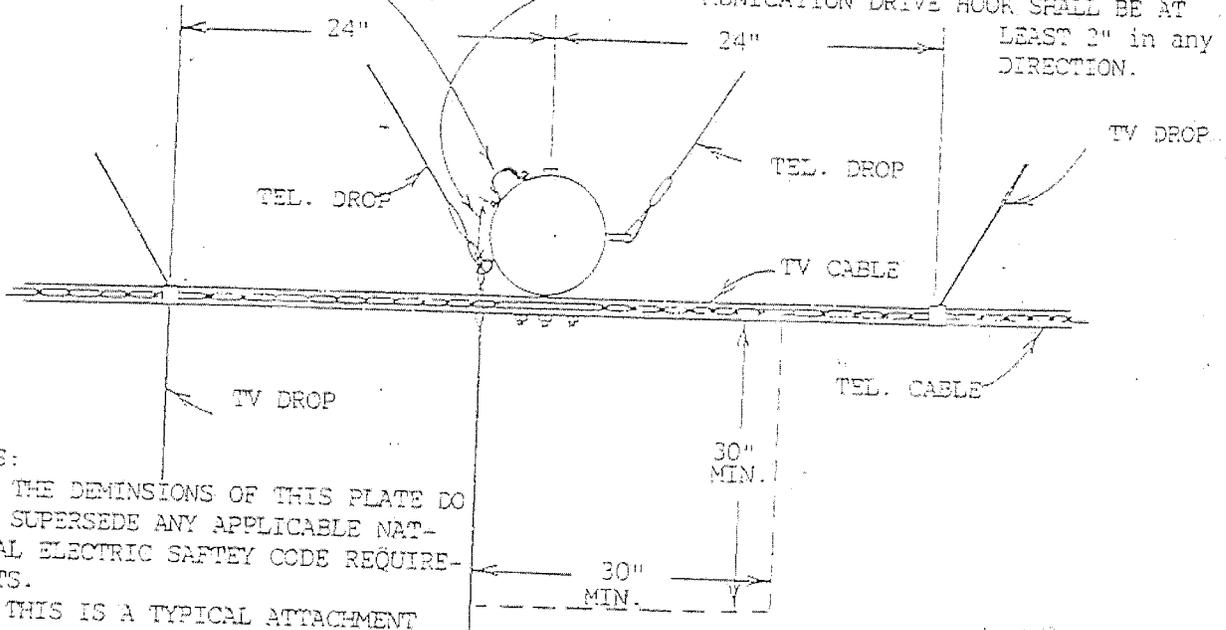
T CAL COMPANY ATTACHMENT TO FPU POLE

POWER SYSTEM VERTICAL RUN OR GRND. WIRE

SEPARATION BETWEEN VERTICAL RUN, INCLUDING STAPLES OR OTHER DEVICES USED TO FASTEN IT TO POLE & COMMUNICATION DRIVE HOOK SHALL BE AT LEAST 2" IN ANY DIRECTION.

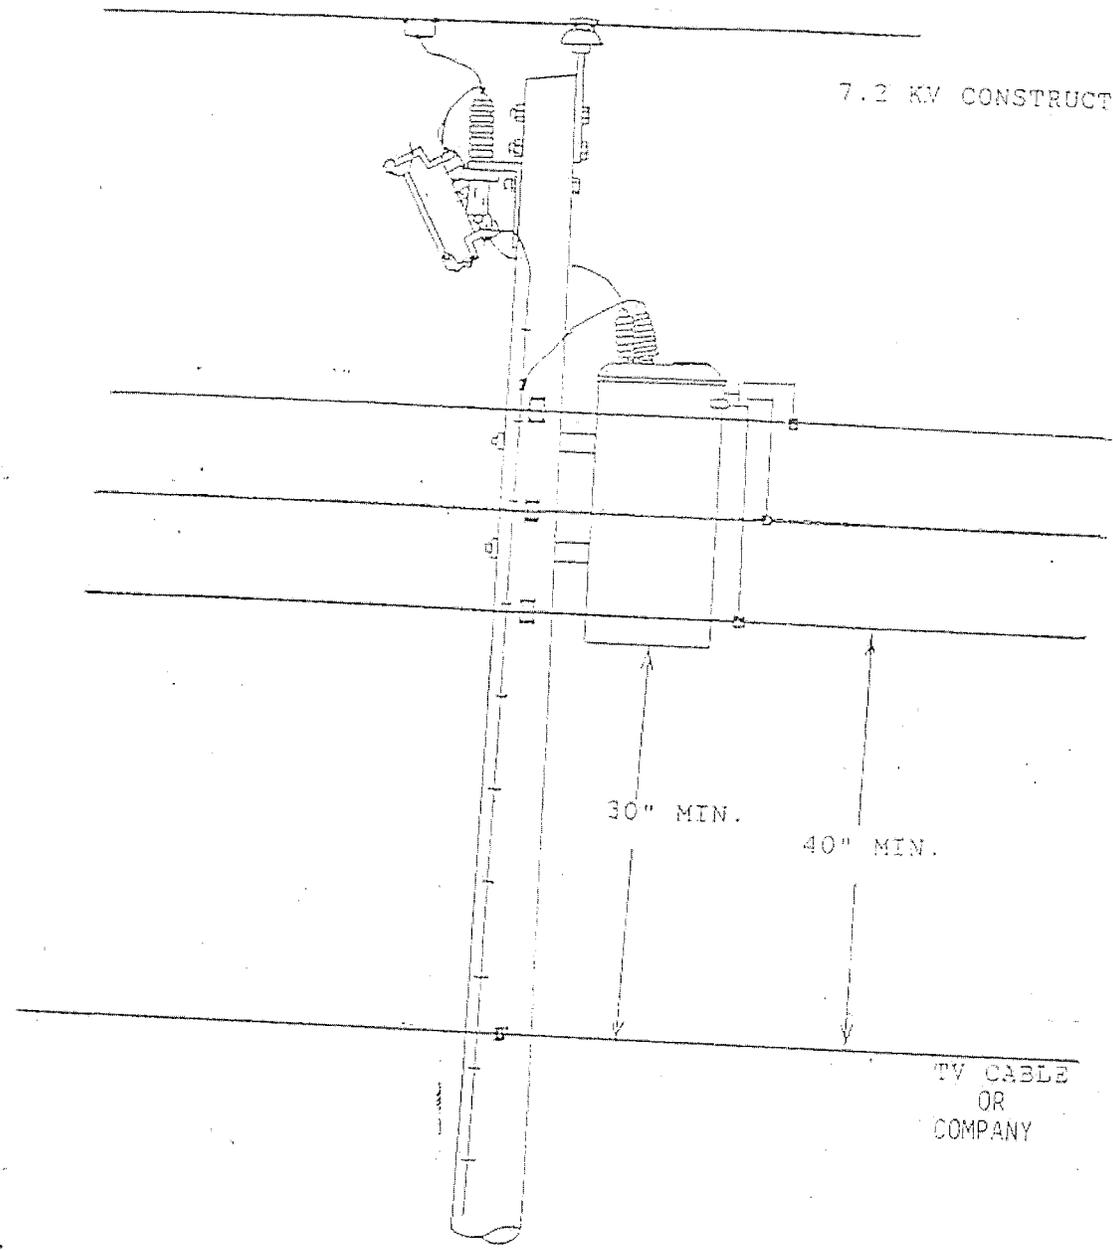
TYF CAL CO. ATTACHMENT TO FPU POLE  
 SINGLE TRANSFORMER INSTALLATION

7.2 KV CONSTRUCTION
