Taming the Jungle:

The quest to reduce vegetation related outages

April 9, 2013

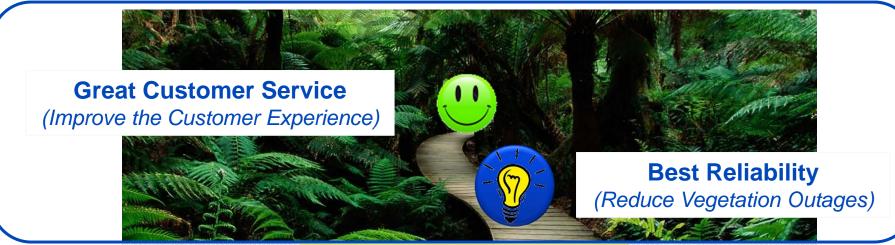
Reduced lateral cost per mile by 47% and kept spend relatively flat while trimming more miles to meet FPSC lateral mandate

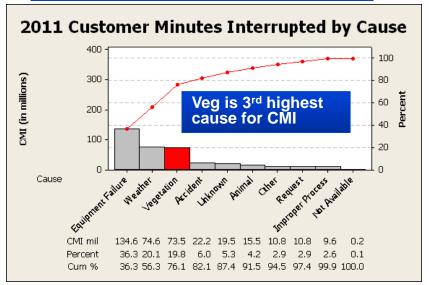
Customer Minutes Interrupted

Vegetation is the 3rd leading cause for Reliability and customer interruptions have been relatively flat since 2006

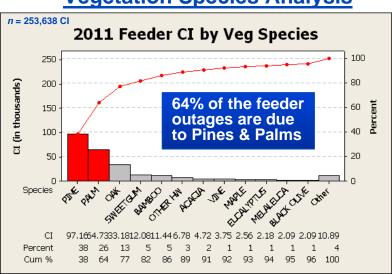
Vegetation Species Analysis

Slash Pines, Washingtonia & Royal Palms pose the highest risk to our feeders

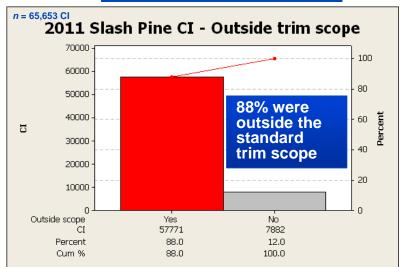
Outside of Trim Scope?

Slash Pine outages mainly driven by tree failures outside the standard trim scope in the North region

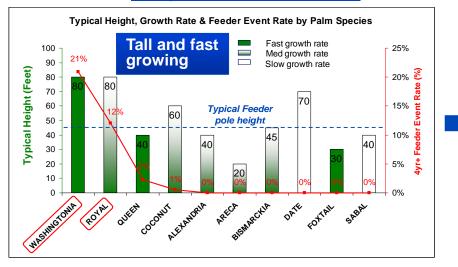
Height & Growth Rate*

Washingtonia & Royal (W&R) Palm outages mainly driven by blow-in conditions in the southern-most regions

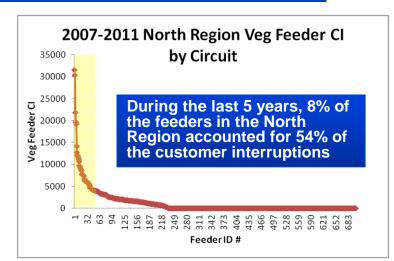
- Identified feeders with recurring outages
- Over the past 5 years, 56 feeders (8% of total) accounted for 54% of the feeder CI in the North region
- Assigned 15 arborists & tree crew supervisors to perform hazard tree inspections on these feeders
- The 56 feeders account for 688 miles (15% of total) and were inspected on a quarterly basis
- Identified and worked 2,860 high risk tree conditions

Initiated quarterly Hazard Tree inspections and addressed 2,860 high risk tree conditions in 2012 that could have caused a feeder outage

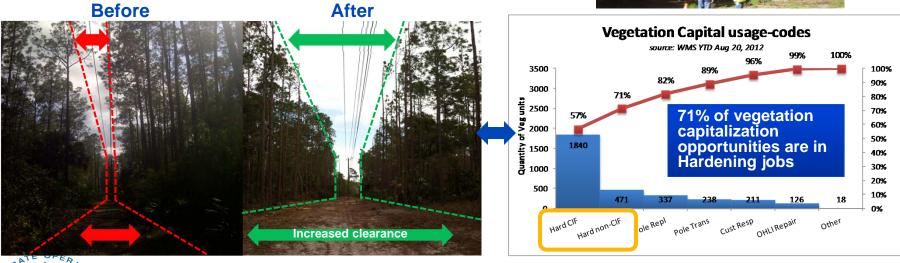
- 92% of North Region tree related feeder interruptions were due to conditions outside current trim specifications
- Costly to perform full off right-of-way & overhang removal for all feeder circuit miles (\$8K incremental cost per mile)
- In 2012, surgically executed \$115K in selected off right-ofway tree & overhang removals on 2,100 NF & CF feeder miles at a cost of \$55 per mile
- Leveraged Hardening capital jobs to target reliability improvements and reduce current and future O&M spend.

Performed surgical tree removals and overhang trimming on North & Central Florida feeders and also looked for opportunities to capitalize vegetation work

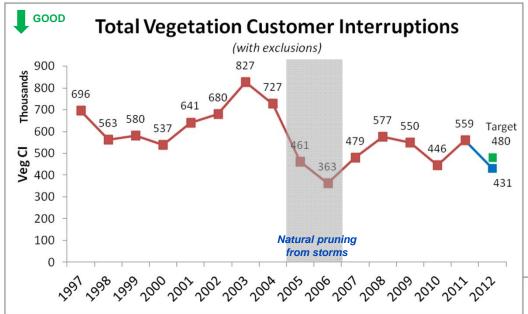
Achieved the best total Vegetation customer interruption performance since the start of Storm Secure!

128K fewer customer outages vs 2011

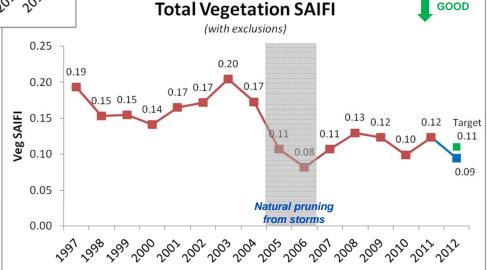
Achieved the best overall **Vegetation SAIFI since the start of Storm Secure!**

0.03 improvement over 2011

Feeder countermeasures drove overall vegetation improvements - contributed to best Dist SAIFI on record

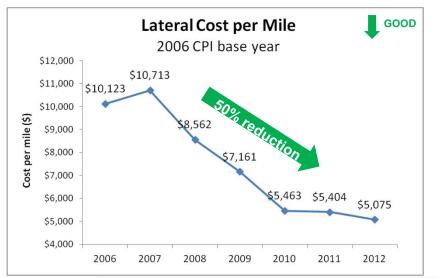
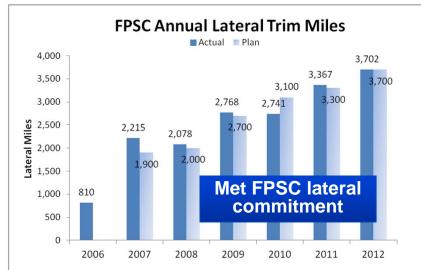
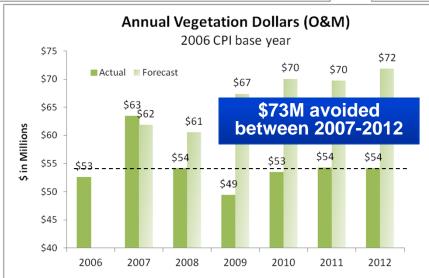
- Lateral cost per mile down by half since 2006
- Increased lateral miles per PSC mandate
- \$73M in avoided costs during 2007-2012 period

Overall Vegetation spend remained flat despite an increase in lateral miles to meet FPSC commitment
