Public Service Commission

**STAFF'S FIRST DATA REQUEST
VIA EMAIL & US MAIL**

Re: Docket No. 20190080-WS - Application for limited proceeding rate increase in Brevard County, by Aquarina Utilities, Inc.

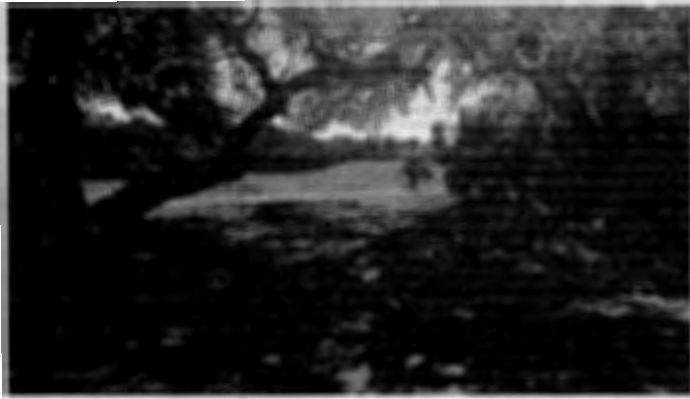
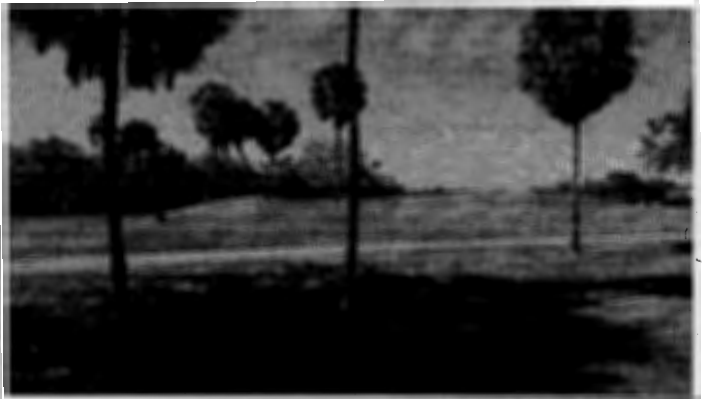
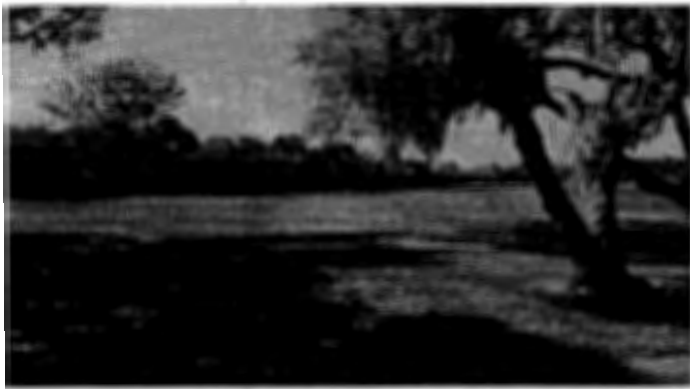
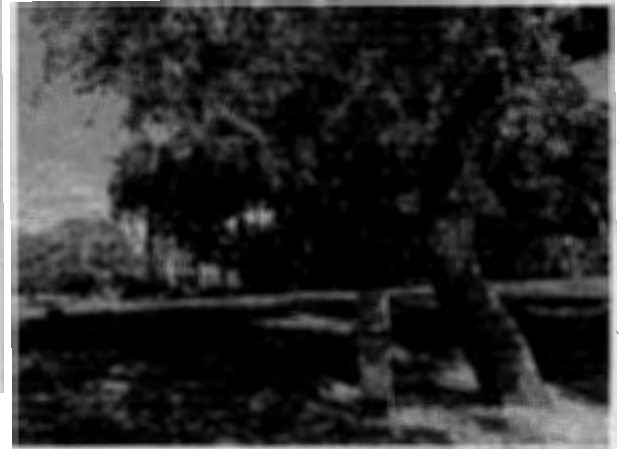
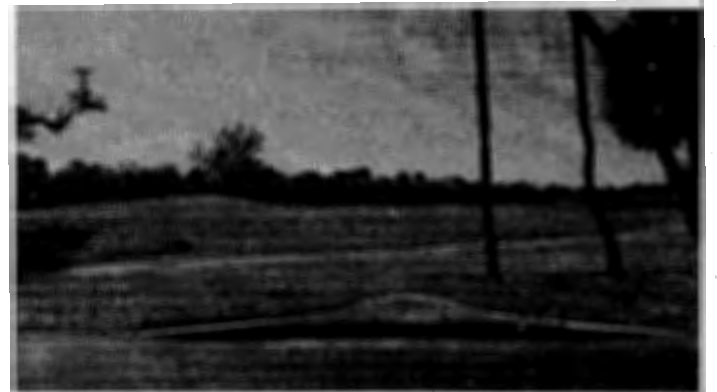
Photos:

Please review the attached photos of both the golf course and the newly sodded areas that Aquarina Golf claim to be damaged or destroyed by this "outage". In all cases the grass is green and healthy. Any areas that are not so are more likely due to the sod sitting on pallets for a week before it was laid, as noted by utility staff, than to any lack of availability of water once it was laid. Also, there are brown and rough areas that have more to do with poor course management than watering, that have been noted by golfers that have played the course regularly for years.

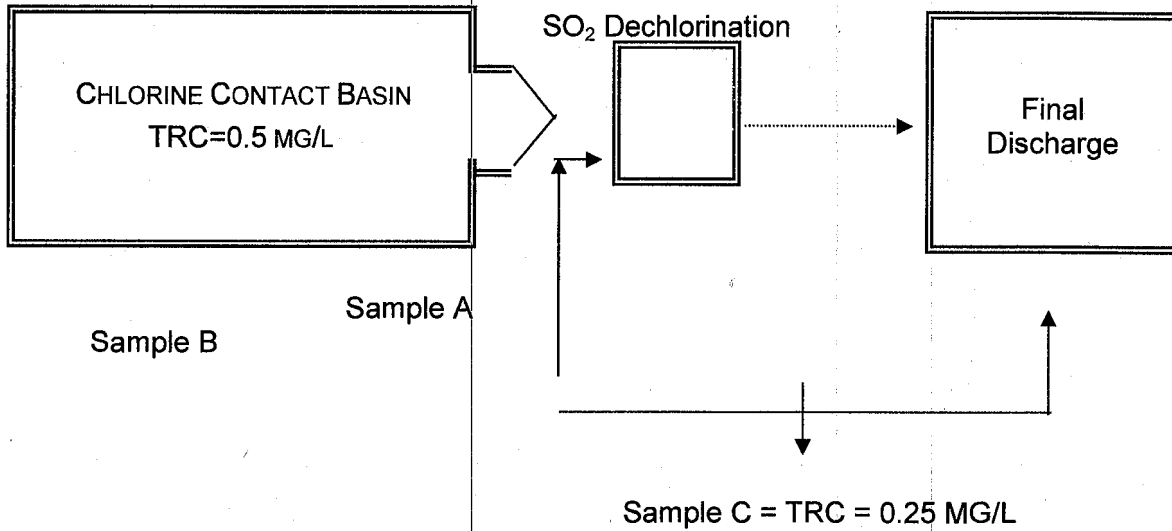
Figure FT 2000-1

SCREENING METHOD FOR DETERMINING ABSENCE OF RESIDUAL CHLORINE

A = Grab sample collected just prior to dechlorination.

B = Grab sample collected downstream of dechlorination at final discharge point.
