PETITION BY DUKE ENERGY FLORIDA, LLC FOR APPROVAL OF ACTUAL STORM RESTORATION COSTS AND ASSOCIATED RECOVERY PROCESS RELATED TO HURRICANE MICHAEL AND TROPICAL STORM ALBERTO

- 20 A. Yes. I am sponsoring the following exhibits to my testimony:
- 21 • Exhibit No. __ (JC-1) – Forensic Analysis of Storm Damage to DEF's
 - 22 Distribution System as a Result of Hurricane Michael ("Accenture Report")
 - 23 • Exhibit No. __ (JC-2) – Path of Hurricane Michael
 - 24 • Exhibit No. ____ (JC-3) – Path of Tropical Storm Alberto

**DRONE ANALYTICS FOR
FORENSIC DAMAGE
ASSESSMENT**

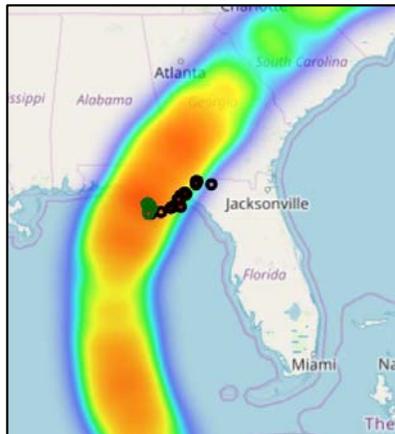
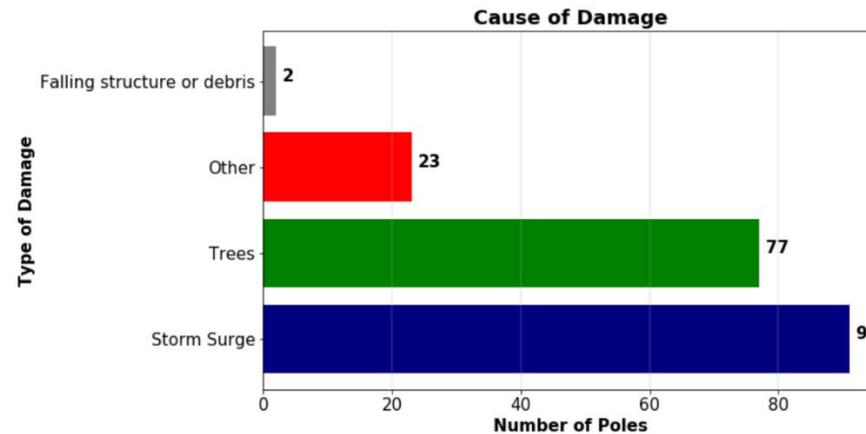
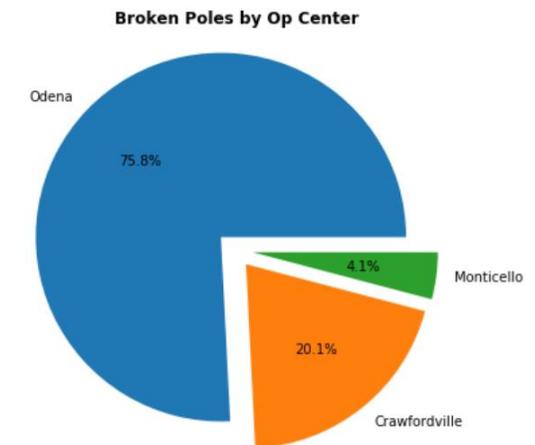
- Three pronged approach was used in forensic analysis: Geospatial analysis, descriptive statistics and logistic regression.
 - Geospatial analysis showed 16% of poles in the Florida panhandle area were exposed to hurricane force winds. DEF was unable to collect pole data in areas of total devastation.
 - Descriptive statistics on available data showed storm surge as the most common cause of failure with most poles breaking at the base. The Odena Op Center experienced the majority of the pole failures.
 - Results from the logistic regression showed the strongest relationship can be attributed to weather related factors, i.e. storm surge and hurricane force winds; as opposed to pole attributes, i.e., height or year manufactured.

***Higher intensity winds shown as red

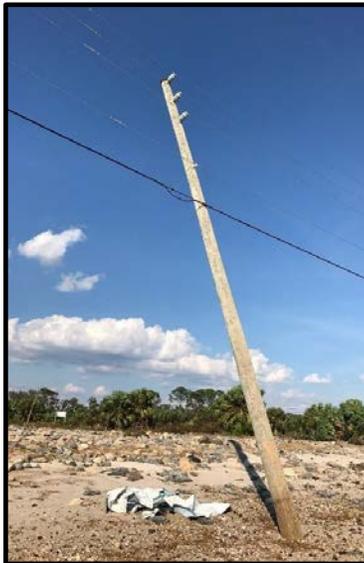
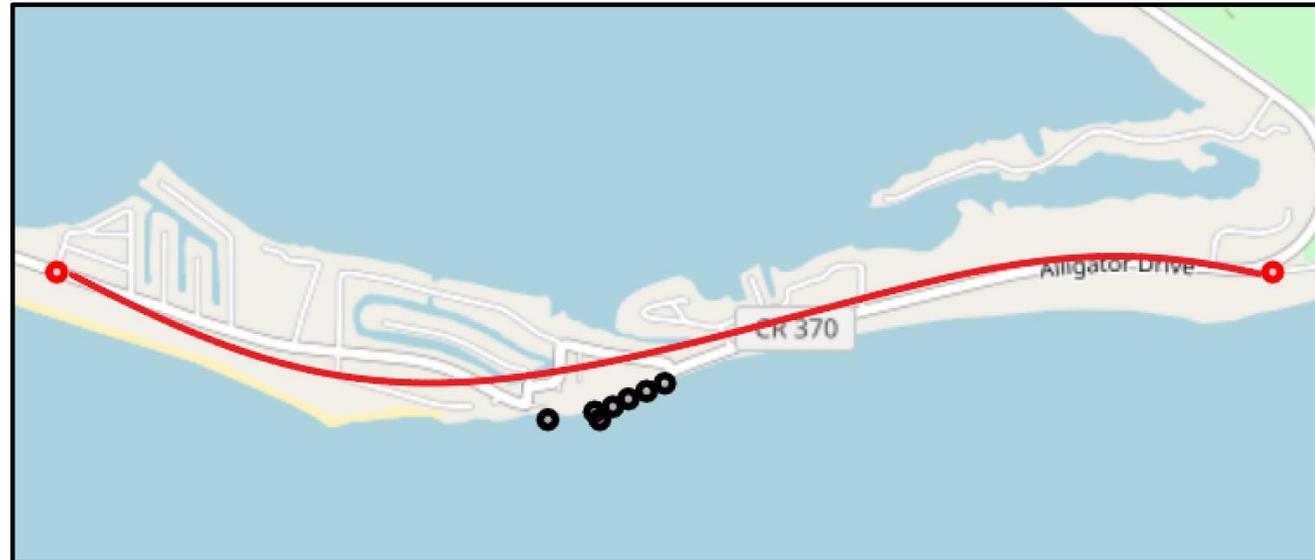
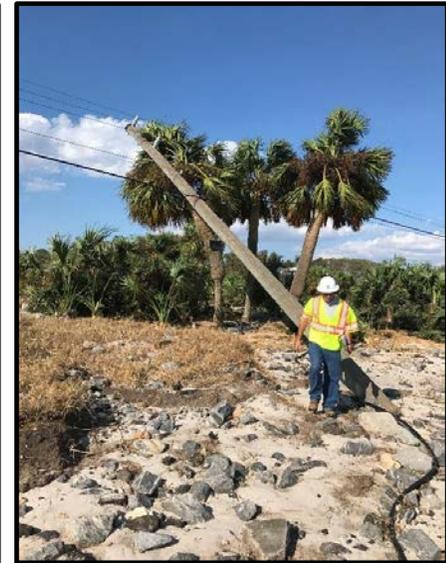
- A forensic assessment of two hundred nineteen (219) randomly selected poles was conducted across DEF's total broken pole population.
- One (1) Class 5 pole was broken and six (6) Class 2 were leaning poles within a storm hardening project Alligator Point Extreme Wind - Phase 2 of 4 (constructed in 2014). Other storm hardening projects experienced no damage.
- Alligator Point experienced tropical storm force windspeeds of 65-75 mph and storm surges of 9-13 ft. As seen in the pictures below the ground gave way and they did not break which shows evidence that extreme wind standards improved their performance.

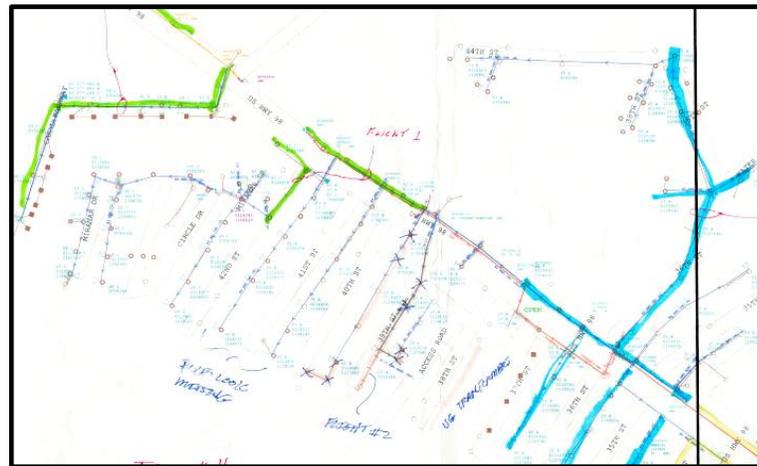
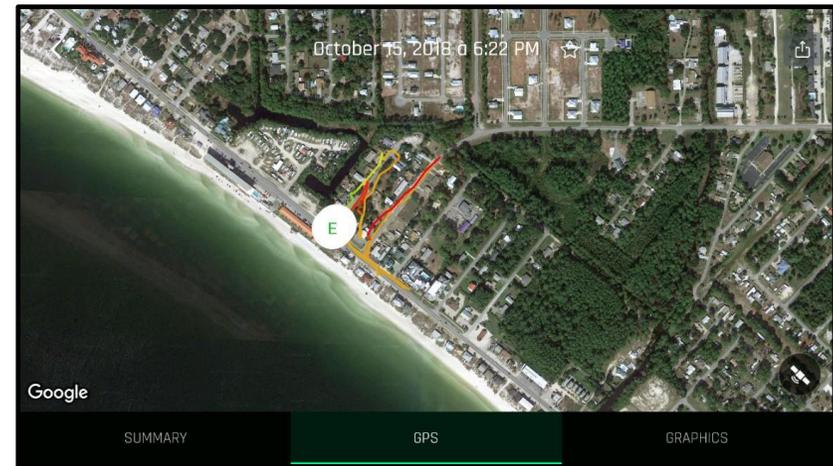
- DEF Forensic Damage Assessment deployed Drone Technology for the first time in the Hurricane Michael response
- This deployment demonstrated the potential for additional benefits to the forensics process by augmenting the existing forensics data collection process with an aerial component
- A total of four hundred forty-nine (449) pictures and forty-two (42) videos were obtained using Drone Technology

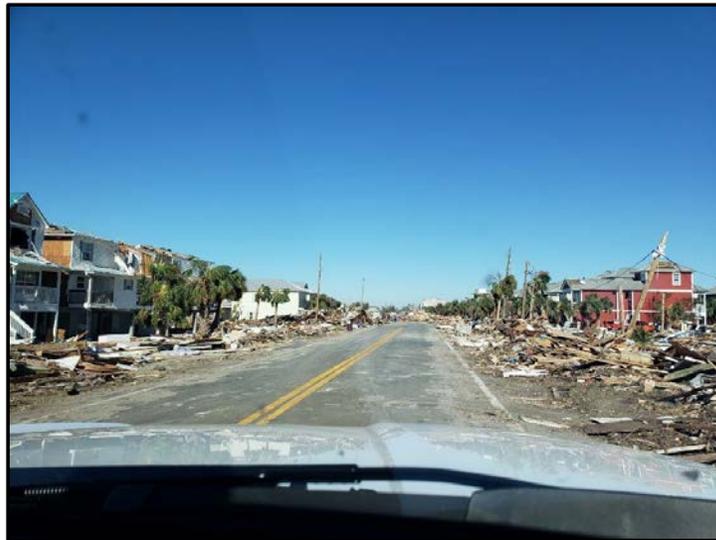
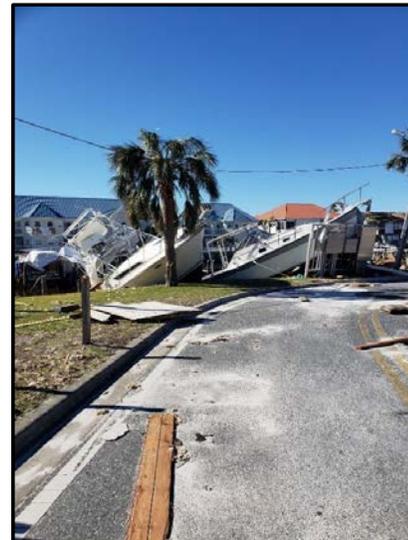
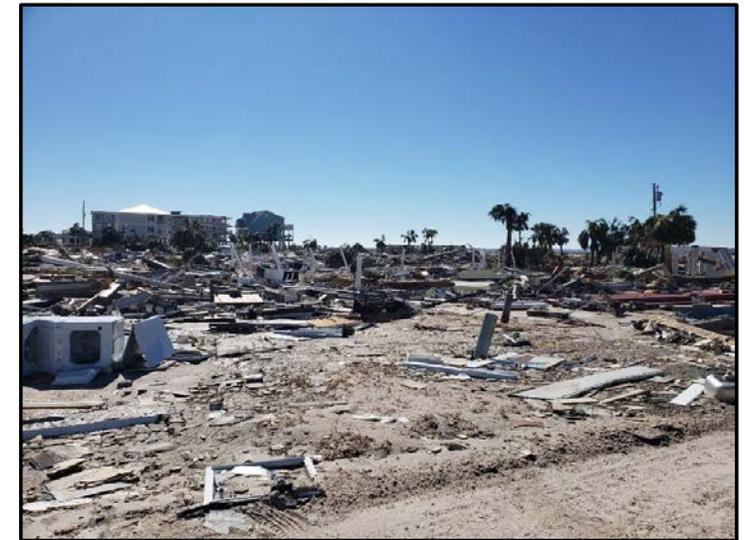
- In the aftermath of Hurricane Michael, DEF collected data on 219 broken poles. However, Michael hit several coastal areas where pole failure information could not be assessed or collected due to total devastation. Poles were destroyed and unable to identify, buried underneath other debris, or washed away. As such, this forensic analysis used the available broken pole attribute data. Poles without these data were visually assessed using geospatial analysis.
- In response to Hurricane Michael, DEF employed a two pronged strategy:
 - Normal restoration of damaged facilities impacted by Hurricane Michael
 - Rebuild of 3 distribution circuits in the area of total devastation (Mexico Beach, Port St. Joe)

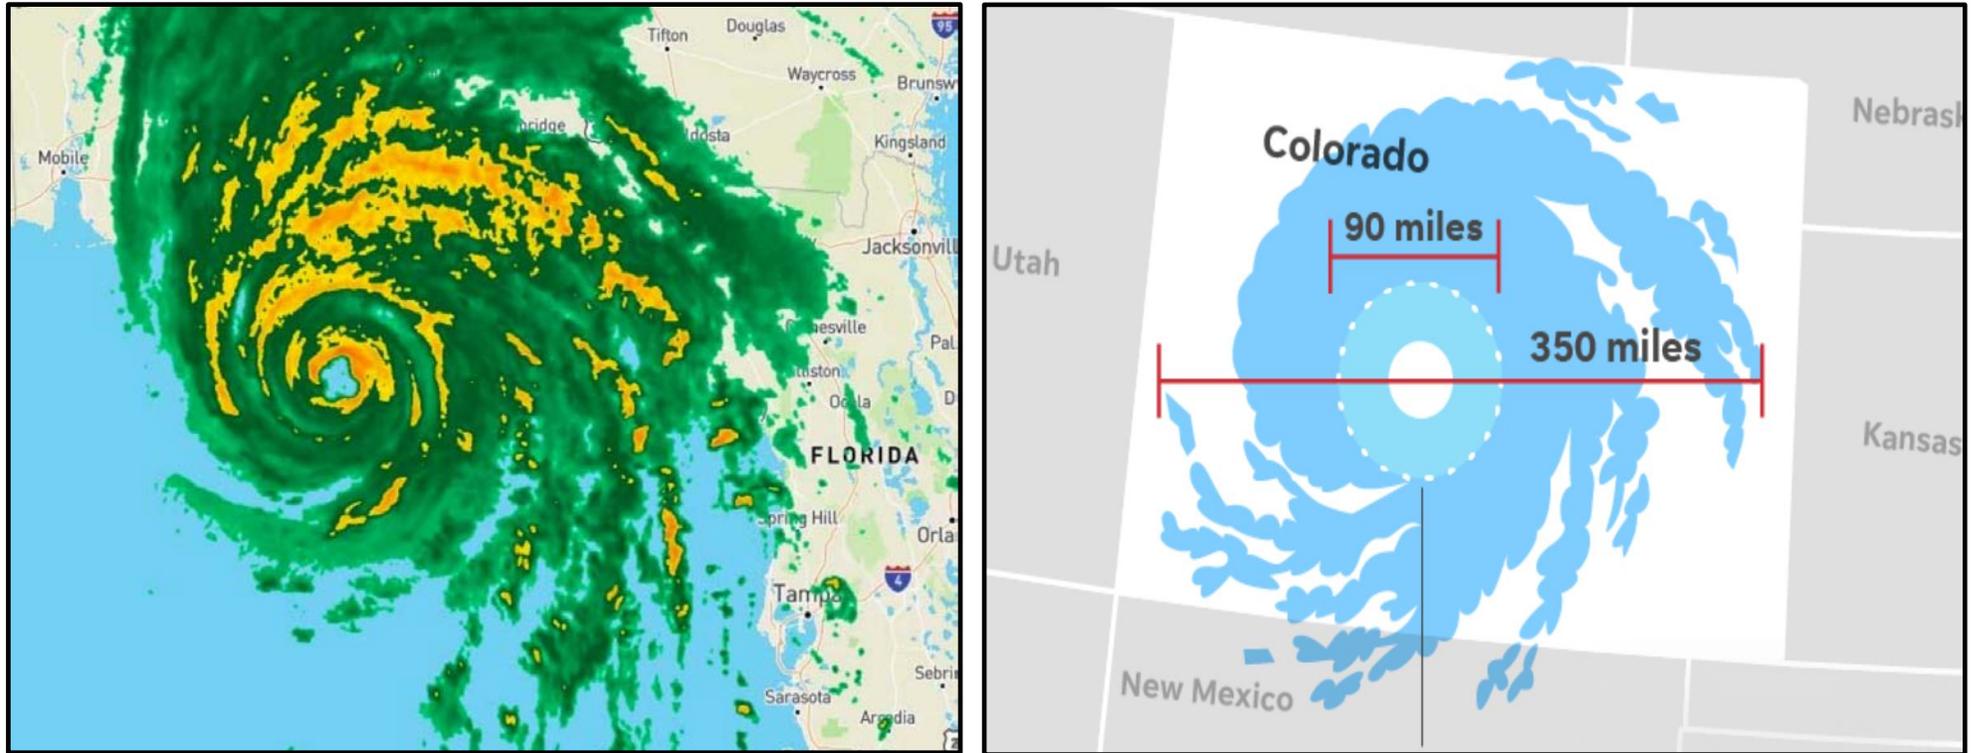
STORM BREADTH

- Hurricane Michael was about 350 miles across. The hurricane-force winds were near 90 miles in diameter and tropical-force winds affected about 96,211 square miles, which is near the size of the entire state of Colorado.

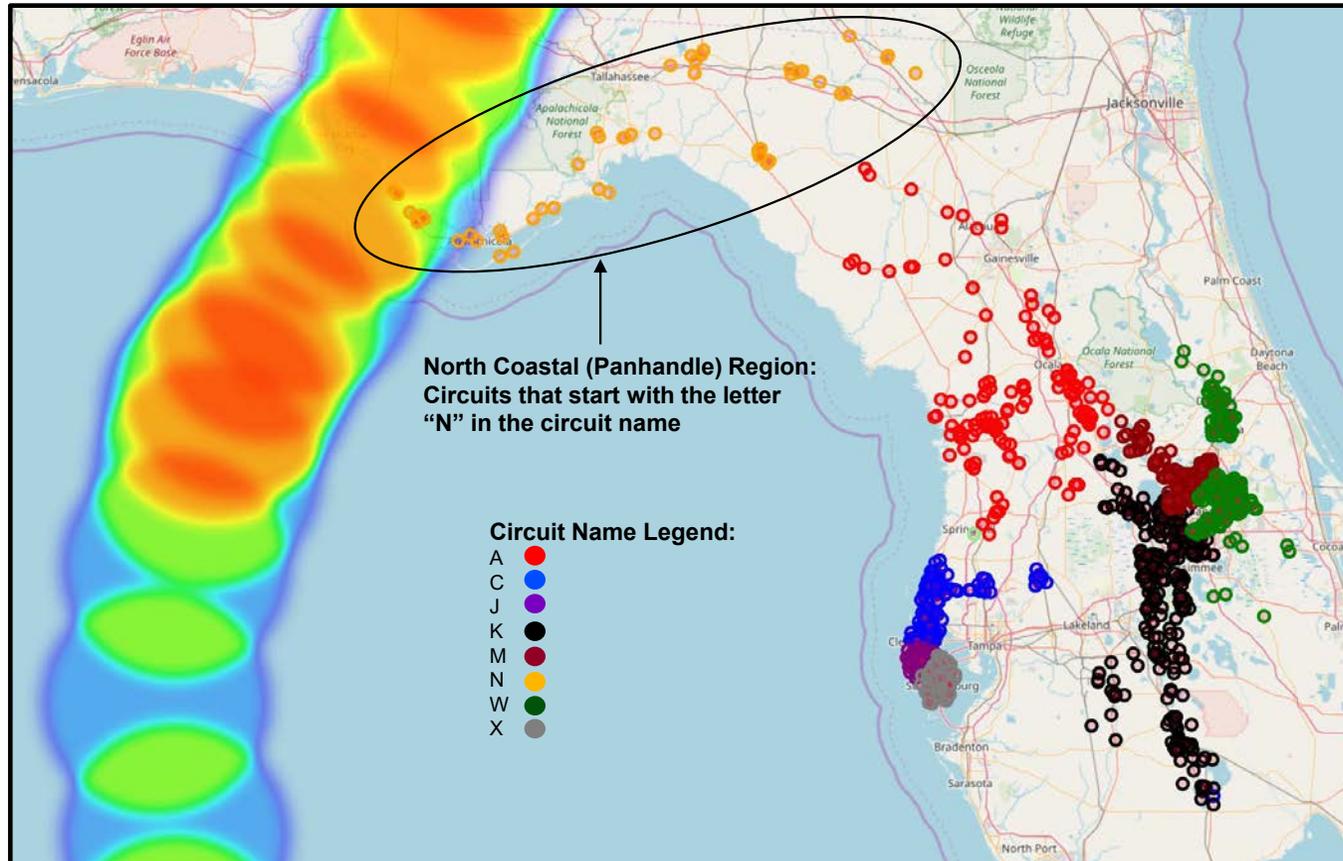
NORTH COASTAL REGION

***Higher intensity winds shown as red

- Hurricane path only affected the panhandle of the North Coastal Zone (orange points). In addition, all broken poles were in the panhandle.
- Since the hurricane path only affected the North Coastal Zone, the forensic analysis focused on the pole population within the panhandle of the North Coastal Zone.

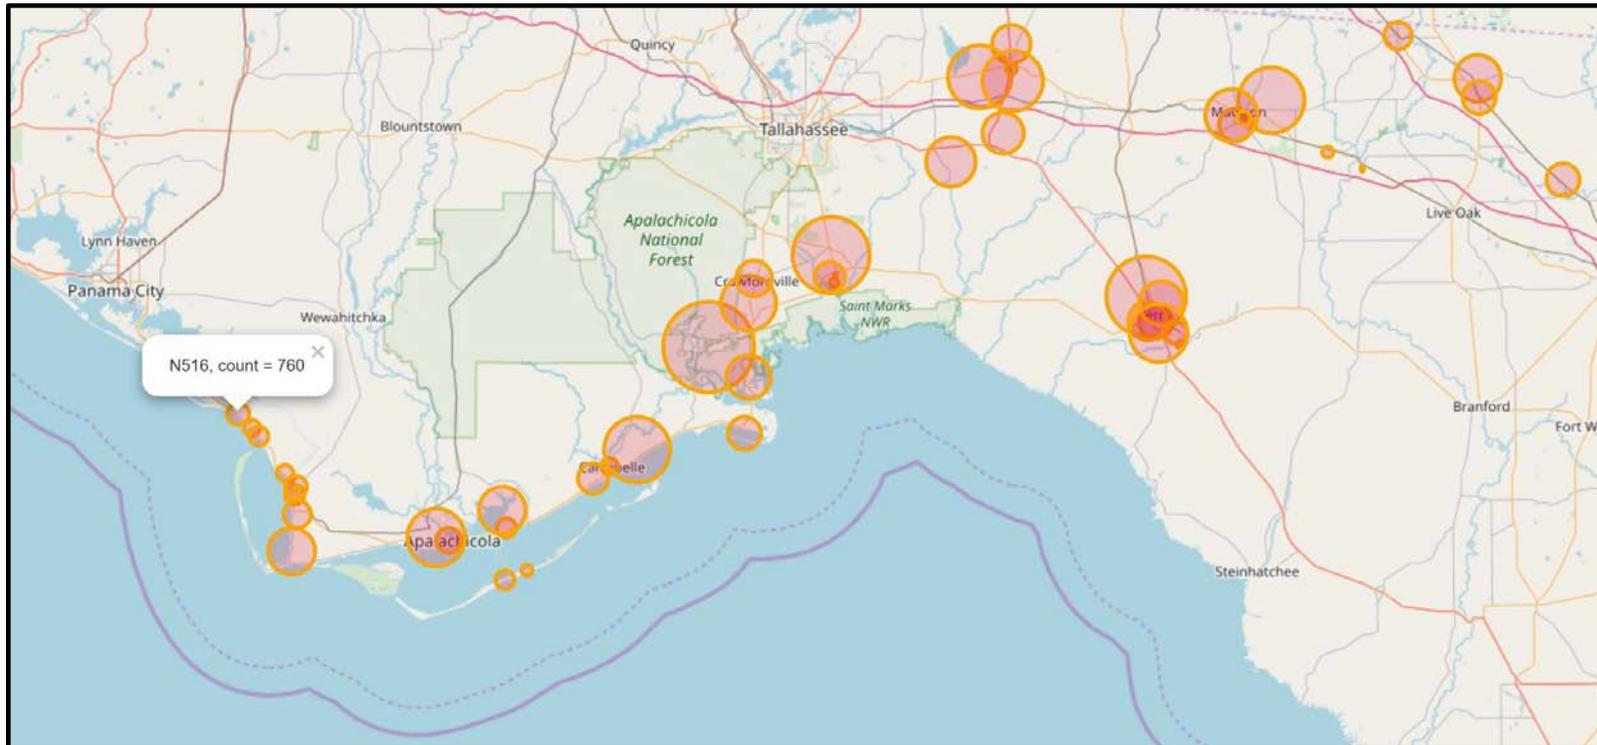
NORTH COASTAL REGION - RELATIVE CIRCUIT SIZE AND EXPOSURE

- The size of orange circles represent the general location and the number of poles on a circuit.
- Circle size is relative to all other circuits. (For example, circuit N516 is comprised of 760 poles and is smaller than circuits comprised of more poles and correspondingly bigger than circuits comprised of fewer poles.)
- This graphic shows pole population exposure and potential risk along coastal areas verses inland areas.

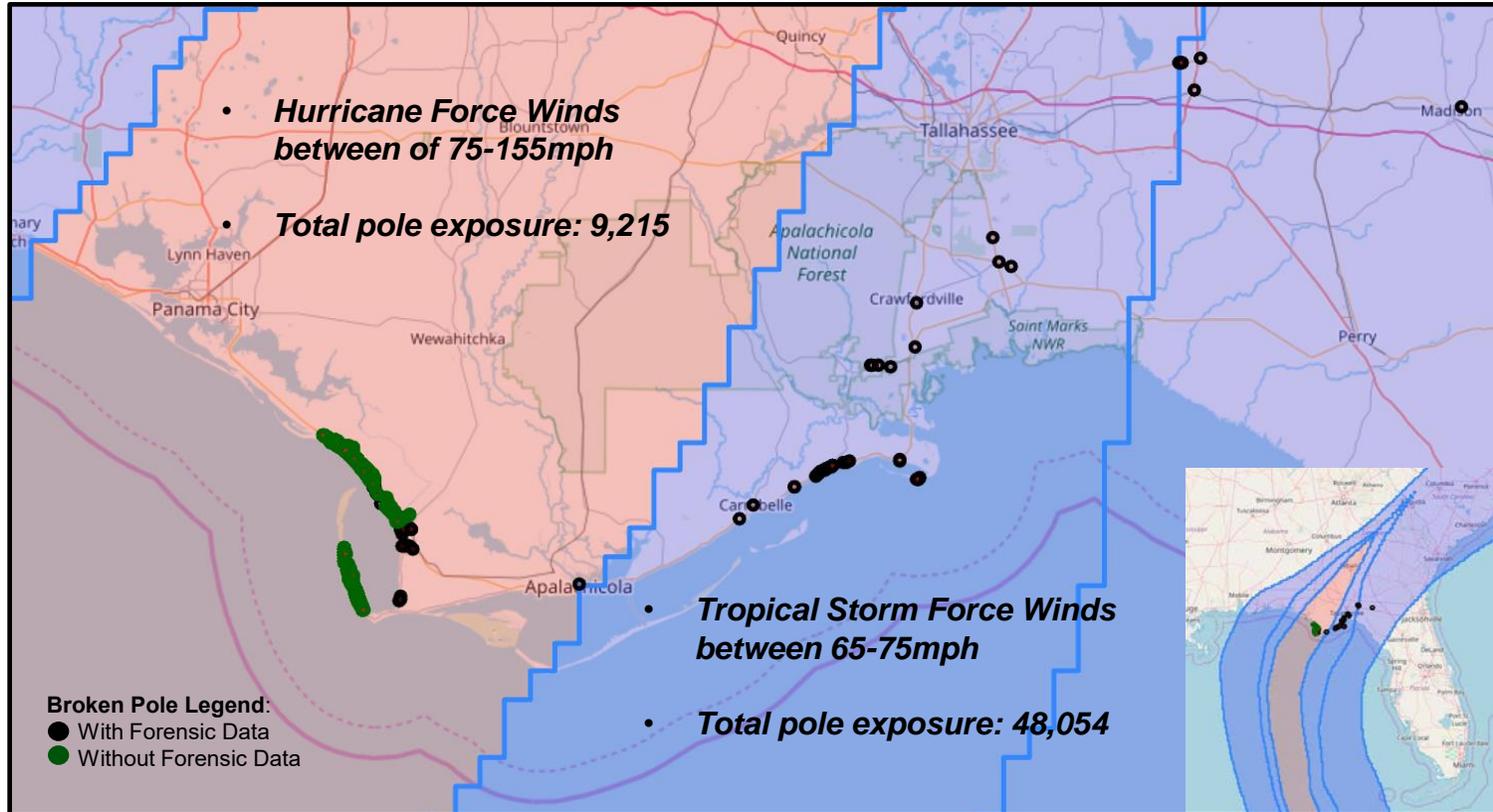
BROKEN POLES AND EXPOSURE

- Over nine thousand (9,215) poles exposed to hurricane force winds (measured near 155mph at landfall)
- Over forty-eight thousand (48,054) poles were exposed to tropical storm force winds (wind speeds between 65 and 75 mph)

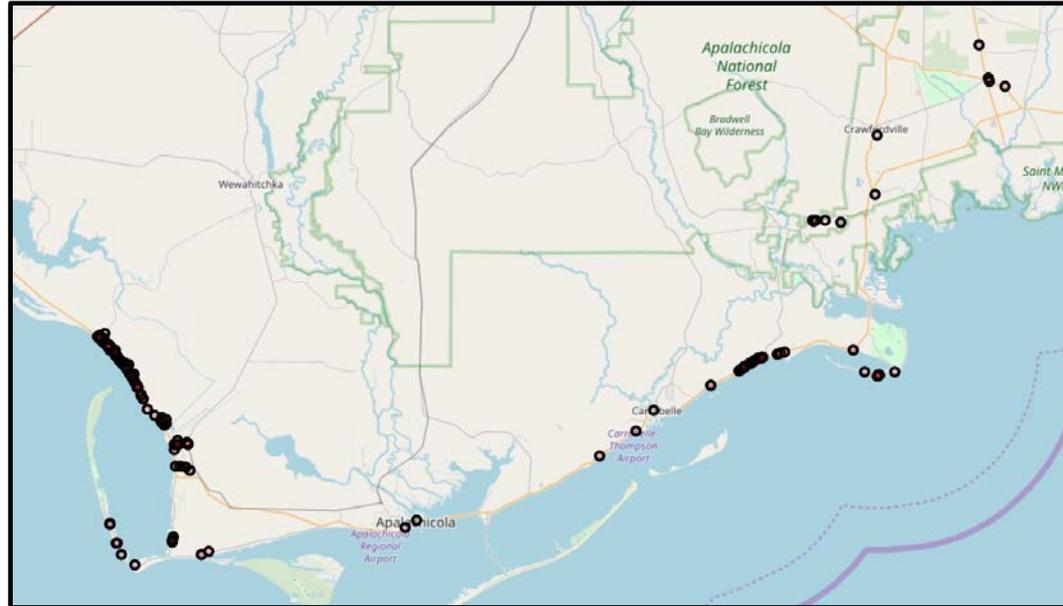
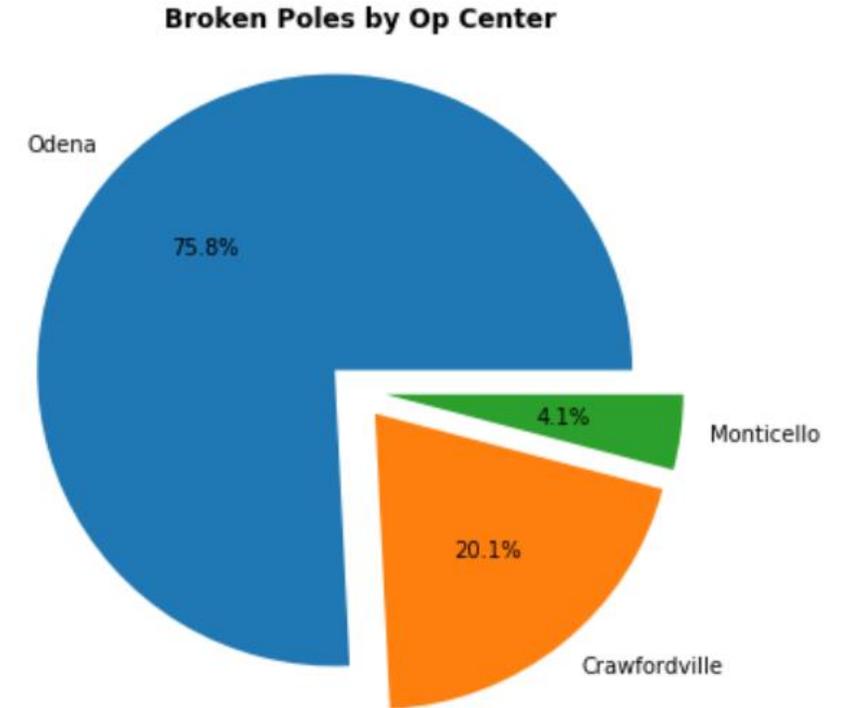
BREAKOUT – POLES WITH DATA

- Graphic depicts only broken poles that have forensic data. The majority of broken poles are in the Odena operating area (75.8%) followed by the Crawfordville operating area (20.1%) followed by the Monticello operating area (4.1%).

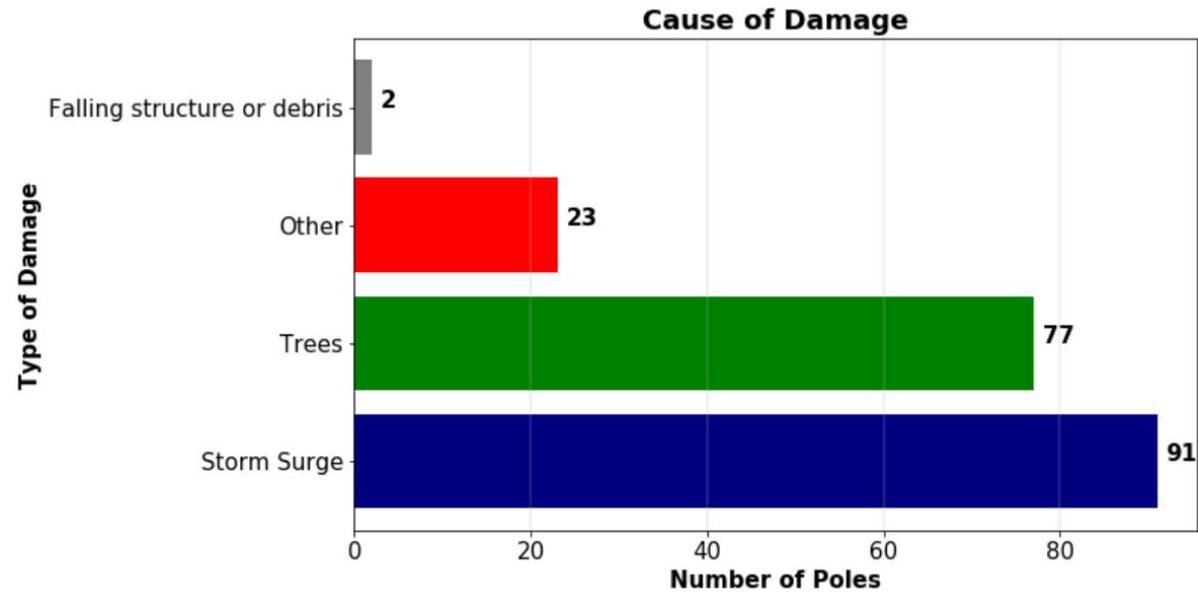
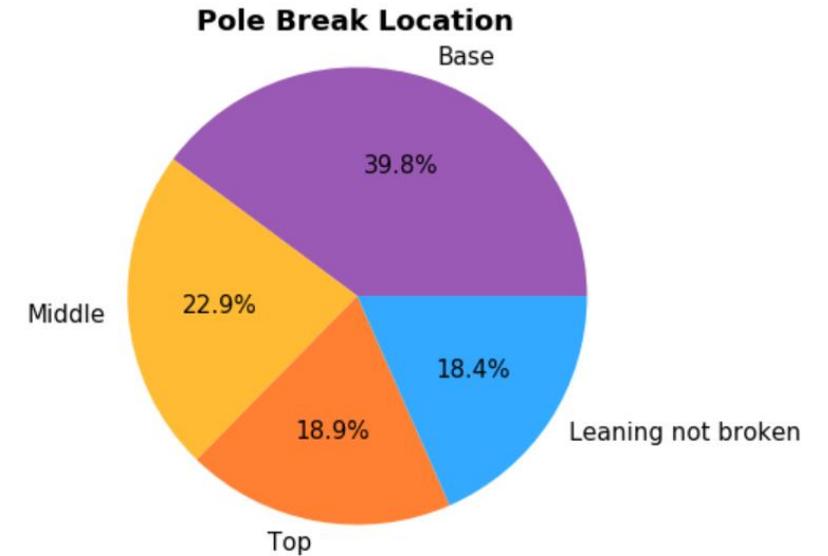
BREAKOUT – POLES WITH DATA

- The predominate cause of recorded damage was Storm Surge (91), followed by Trees (23).
- Twenty-three (23) poles were recorded as 'Other.'
- The majority of broken poles failed at the base of the pole.
- Nearly 20% of poles were not broken, but leaning.

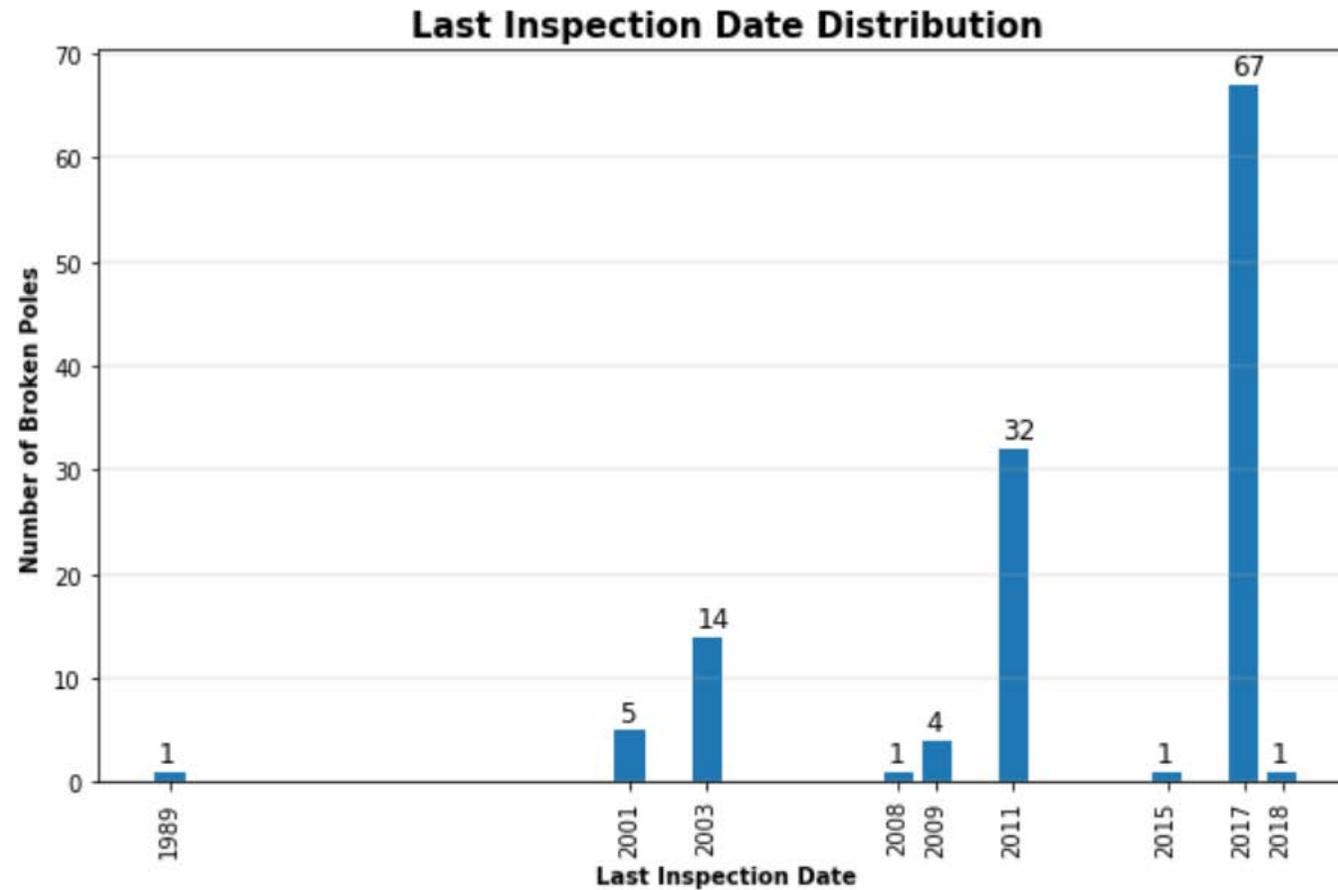
BREAKOUT – POLES WITH DATA

- The majority of the broken poles were last inspected in 2017, 2011 and 2003 respectively.

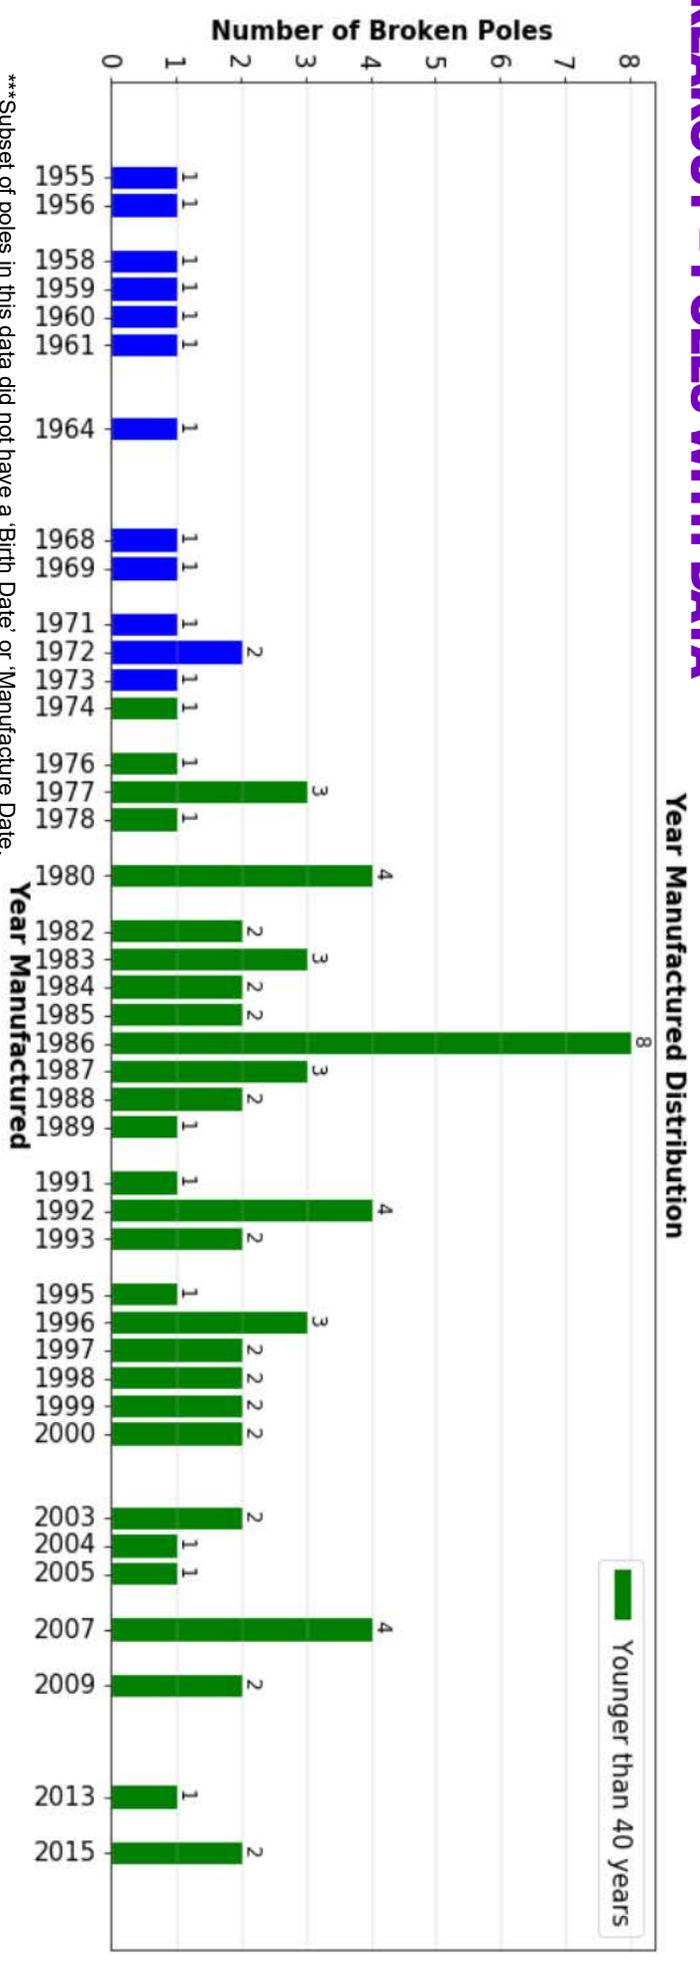
BREAKOUT - POLES WITH DATA

- From an accounting perspective, the life expectancy of a wood pole is forty-two (42) years. Actual DEF operating experience and Accenture benchmarking data confirms that the expected life of a wood pole is fifty (50) years or more. Additionally, industry research has produced studies that suggest the life expectancy of wood poles can be in the range of ninety (90) years.
- The majority of broken poles were less than 40 years old. The broken poles that were older than forty years did not dominate this distribution.

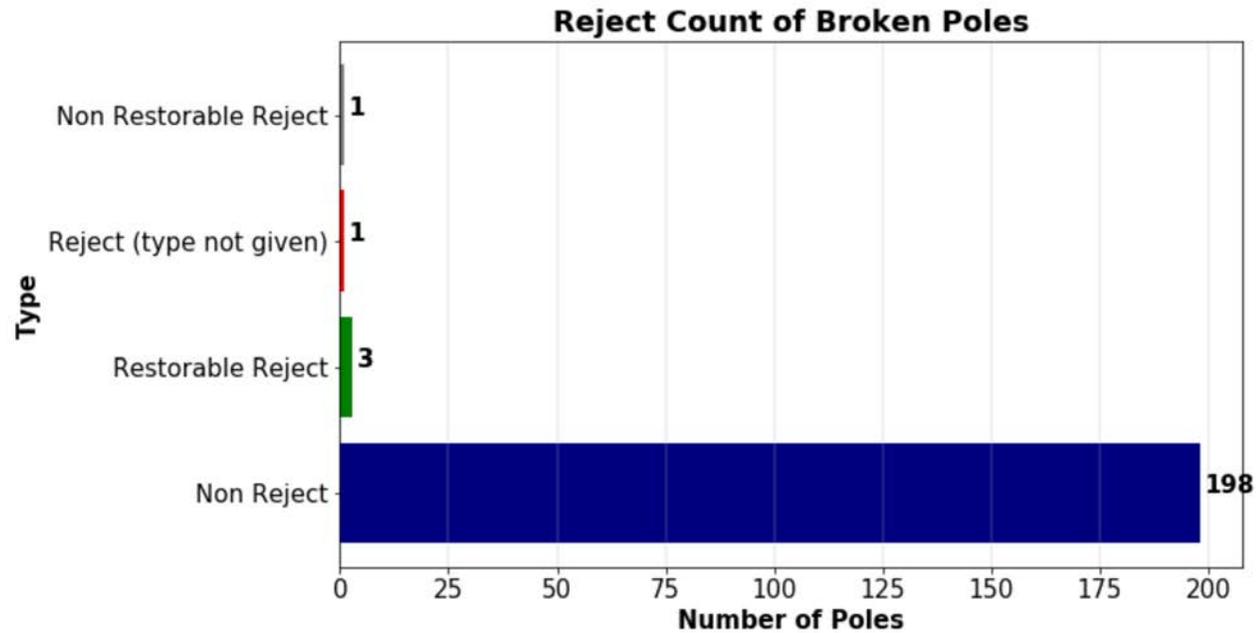
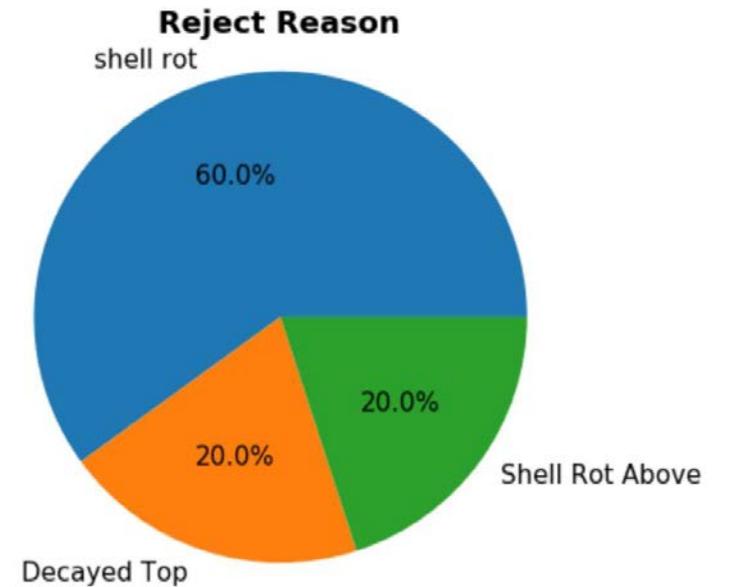
BREAKOUT – POLES WITH DATA

- After reviewing pole inspection data for the 203 broken poles, only 1 pole was not replaced prior to Hurricane Michael. This pole was scheduled to be replaced in January 2019.

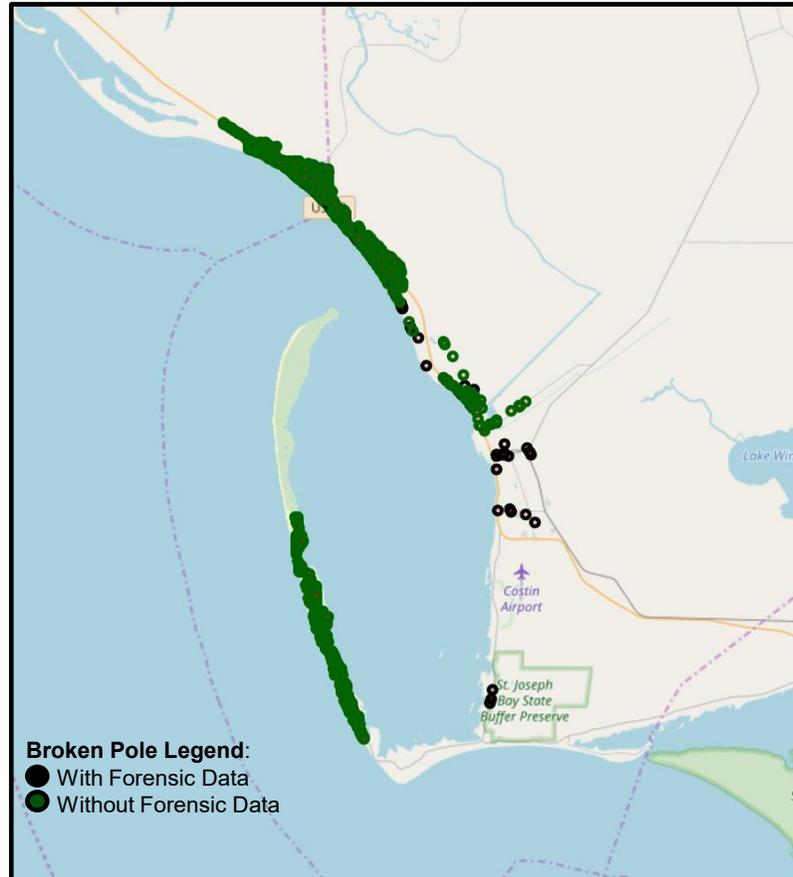
POLES IN DEVASTATED COASTAL AREA – POLES WITH NO FORENSIC DATA

In addition to broken poles analyzed using forensic data, Accenture also assessed broken poles along the coastline that were totally devastated and were unable to be forensically assessed. These poles are shown in green on the map.

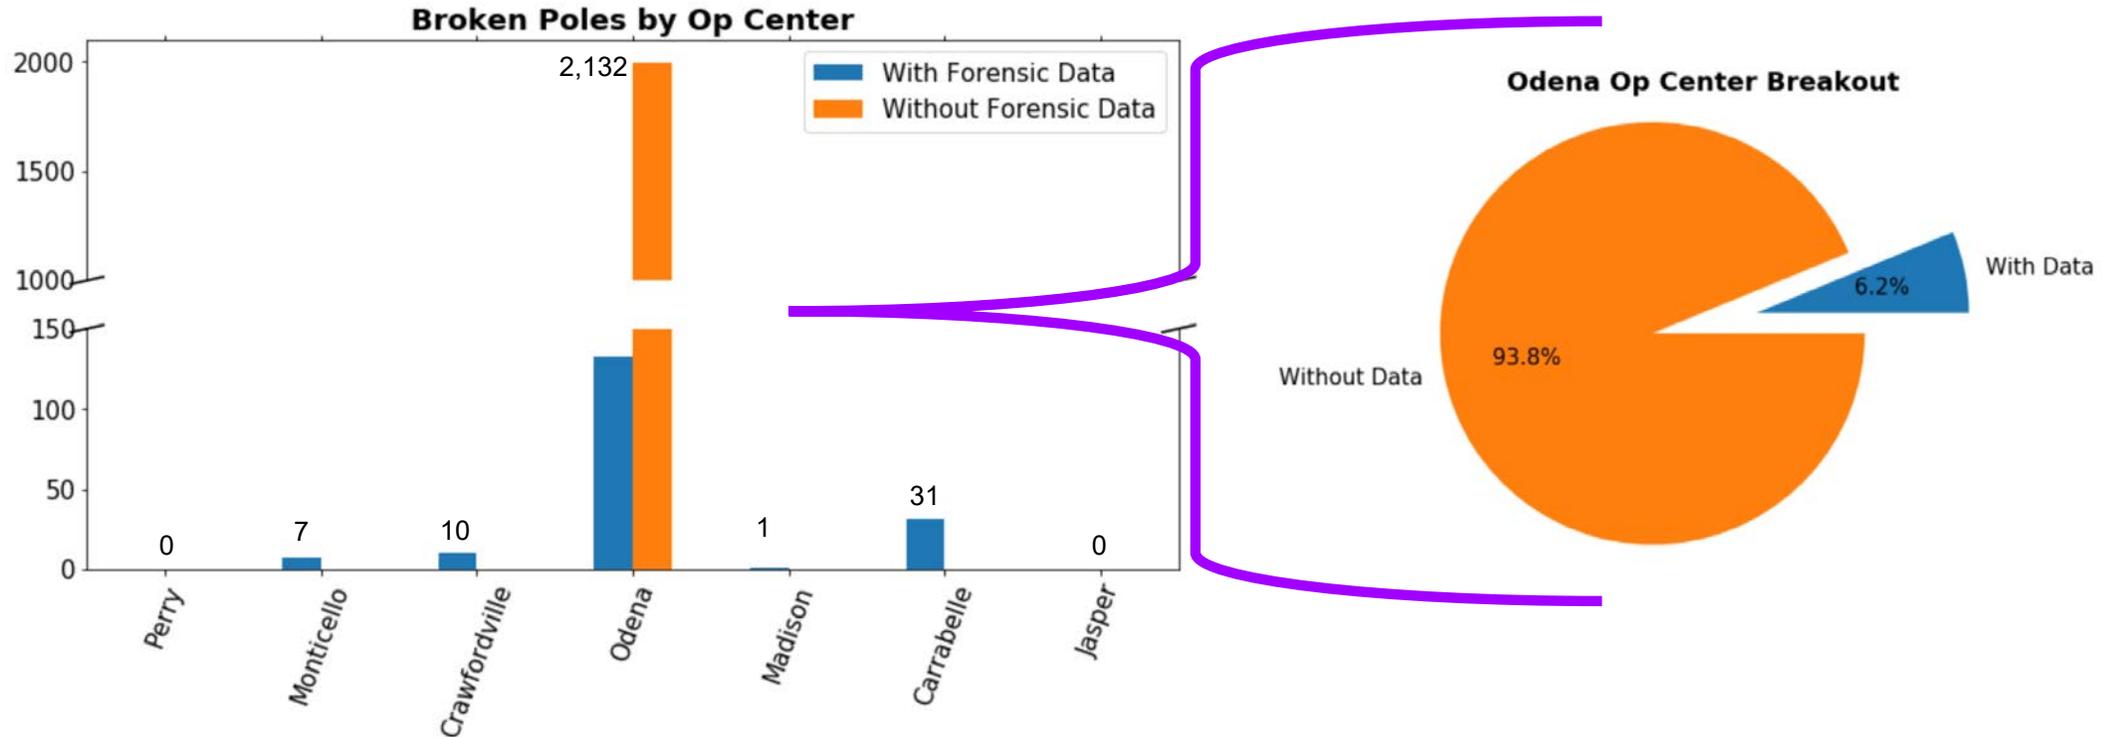
BREAKOUT – POLES WITH AND WITHOUT DATA

- 6.2% of Odena poles have forensic data when combined with poles in devastated coastal circuits.

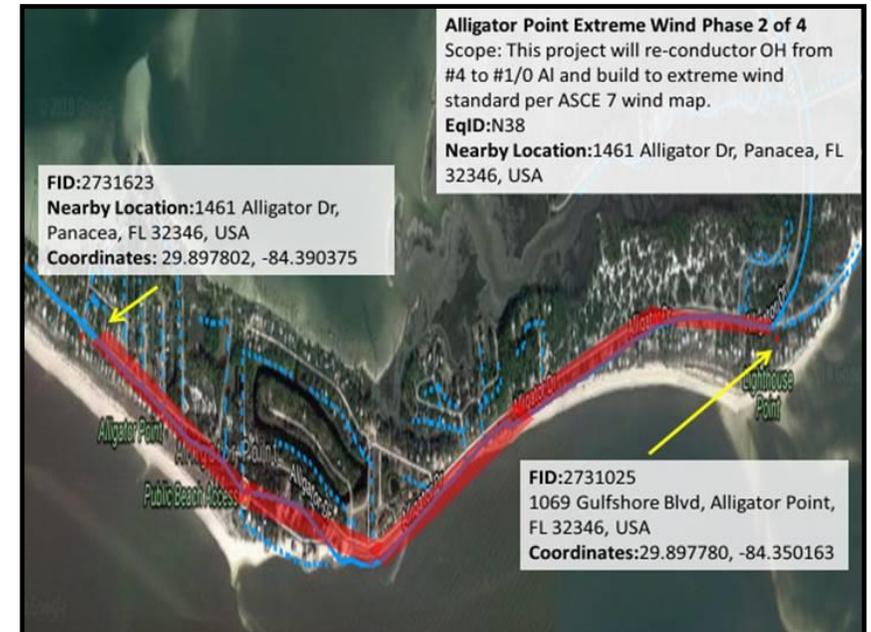
METHODOLOGY/APPROACH

- DEF performed storm hardening on a number of distribution line sections since 2006
 - Selected storm hardening targets that were previously completed from an established repository
 - Traveled to the geotagged location identified for the project
 - Patrolled the entire scope of the project
 - Record any damages to the facilities
- Determined if any poles that failed during Hurricane Michael were a part of the storm hardened circuits by:
 - Mapped broken poles that were reviewed by the forensics team
 - Overlaid storm hardened projects
 - Identified if any broken poles were a part of the storm hardened projects

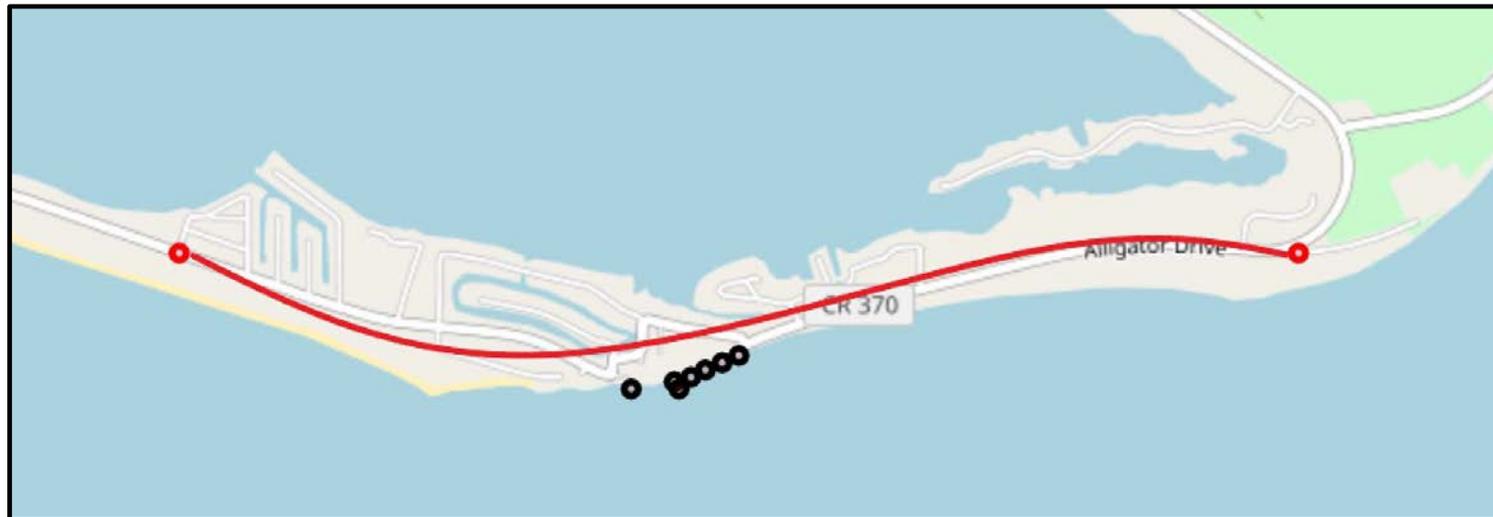
BROKEN POLE WITHIN STORM HARDENED AREA

- There appeared to be 7 poles within the range of Storm Hardening program labeled Alligator Point Extreme Wind - Phase 2 of 4.
- Of these 7 poles, only 1 broken pole was lying flat on the ground. This pole was class 5 which is smaller than the leaning poles, which were class 2.
- Although this area was impacted by Tropical Storm force winds and not Hurricane force winds, it experienced high storm surge.

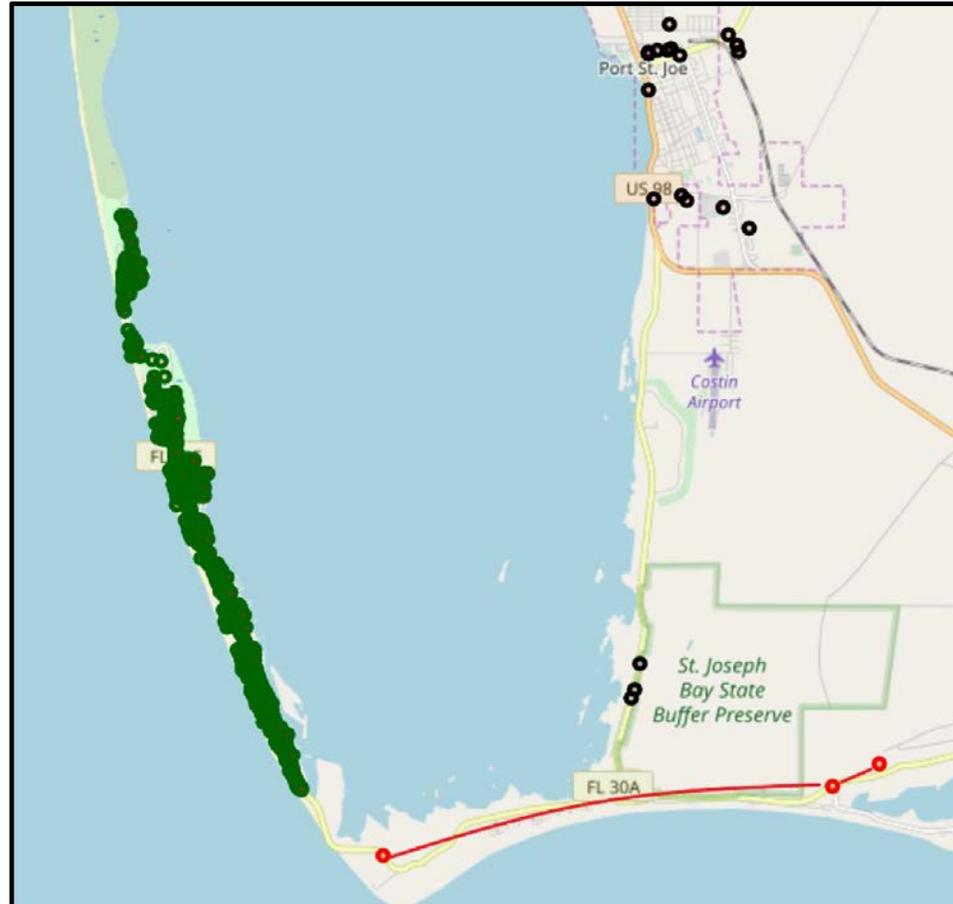
NO BREAKAGE

- The area in this map experienced hurricane force winds and storm surge. Although St. Joseph's Peninsula provided some protection, several poles failed.
- The storm hardened poles, in red, experienced similar surge and wind speeds and storm surge. Hardened poles were able to withstand these forces.

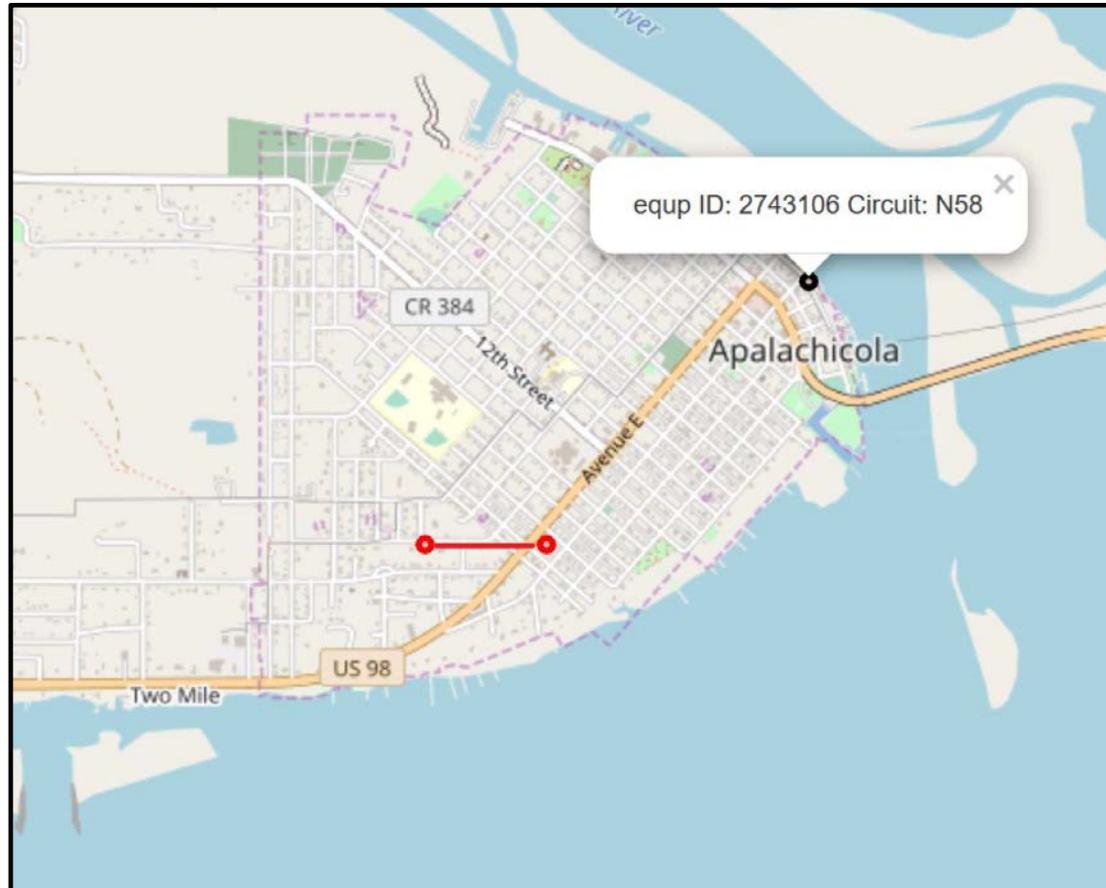
NO BREAKAGE

- Although one pole is listed as broken in data, the storm hardening project does not appear to include this broken pole.

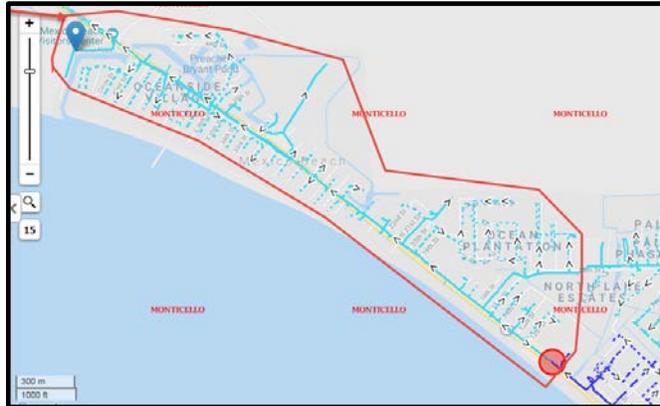
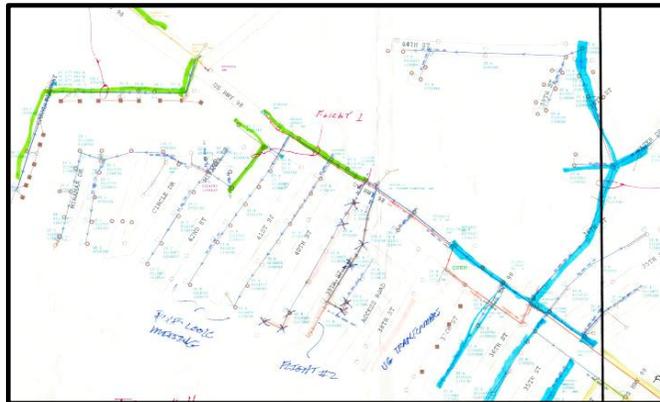
LOCATION:
 • 2MILES ALONG HWY 98. MEXICAN BEACH

- DEF Forensics Damage Assessment deployed drone technology for the first time in the Hurricane Michael response
- This deployment demonstrated the potential for additional benefits to the forensics process by augmenting the existing forensics data collection process with an aerial component
