DESCRIPTION: Duke Energy Bartow – Report of Telemetry Test

Duke Energy Bartow Report of Telemetry Test for 40" L-0

March 18, 2015

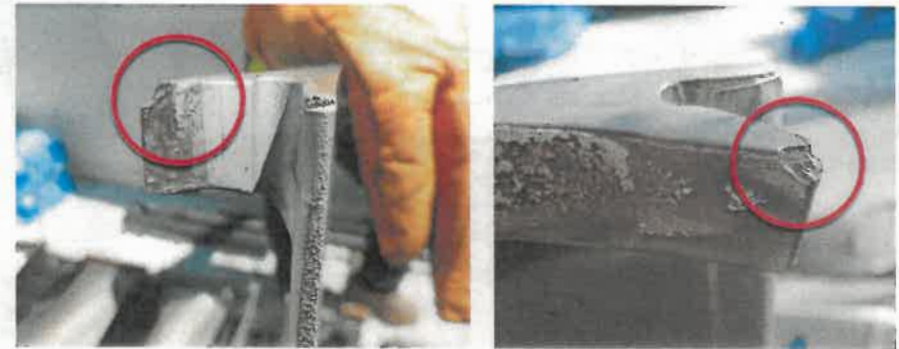
Shroud Chipping Resolution

- Along with mid span damage, Edge chipping on the shroud was observed on Bartow blades.
- As a countermeasure, a chamfer is applied to reduce stress concentration caused by blade twist and contact pressure.

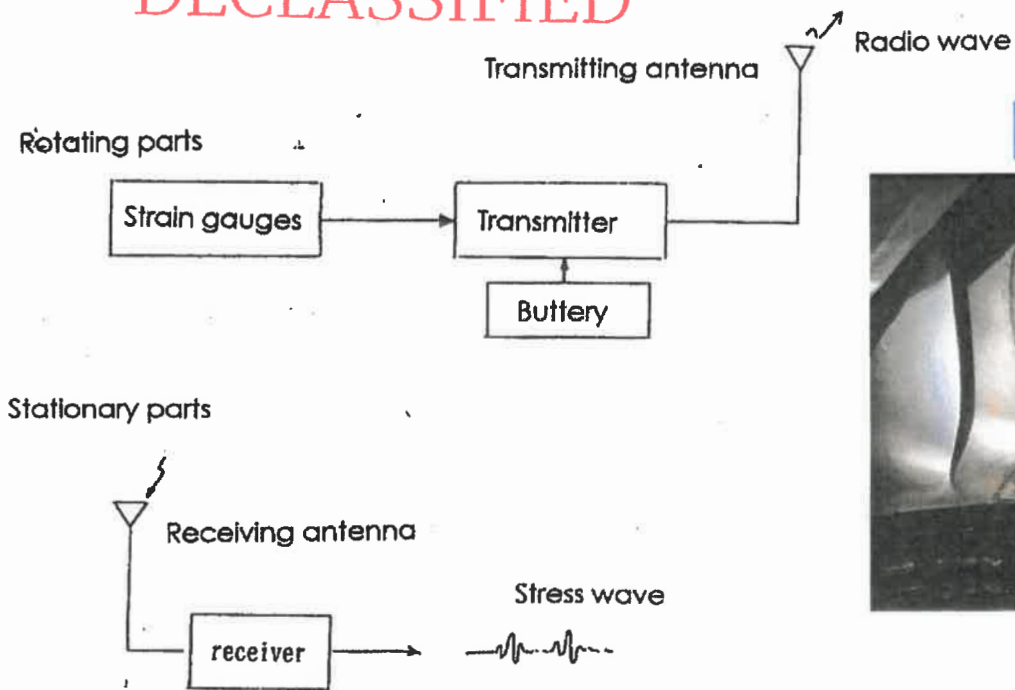
Telemetry Test of Last Stage Blades

- Vibratory stress of moving blades are measured by telemetry system.
- Strain gauges and transmitters are mounted on blades and rotor.

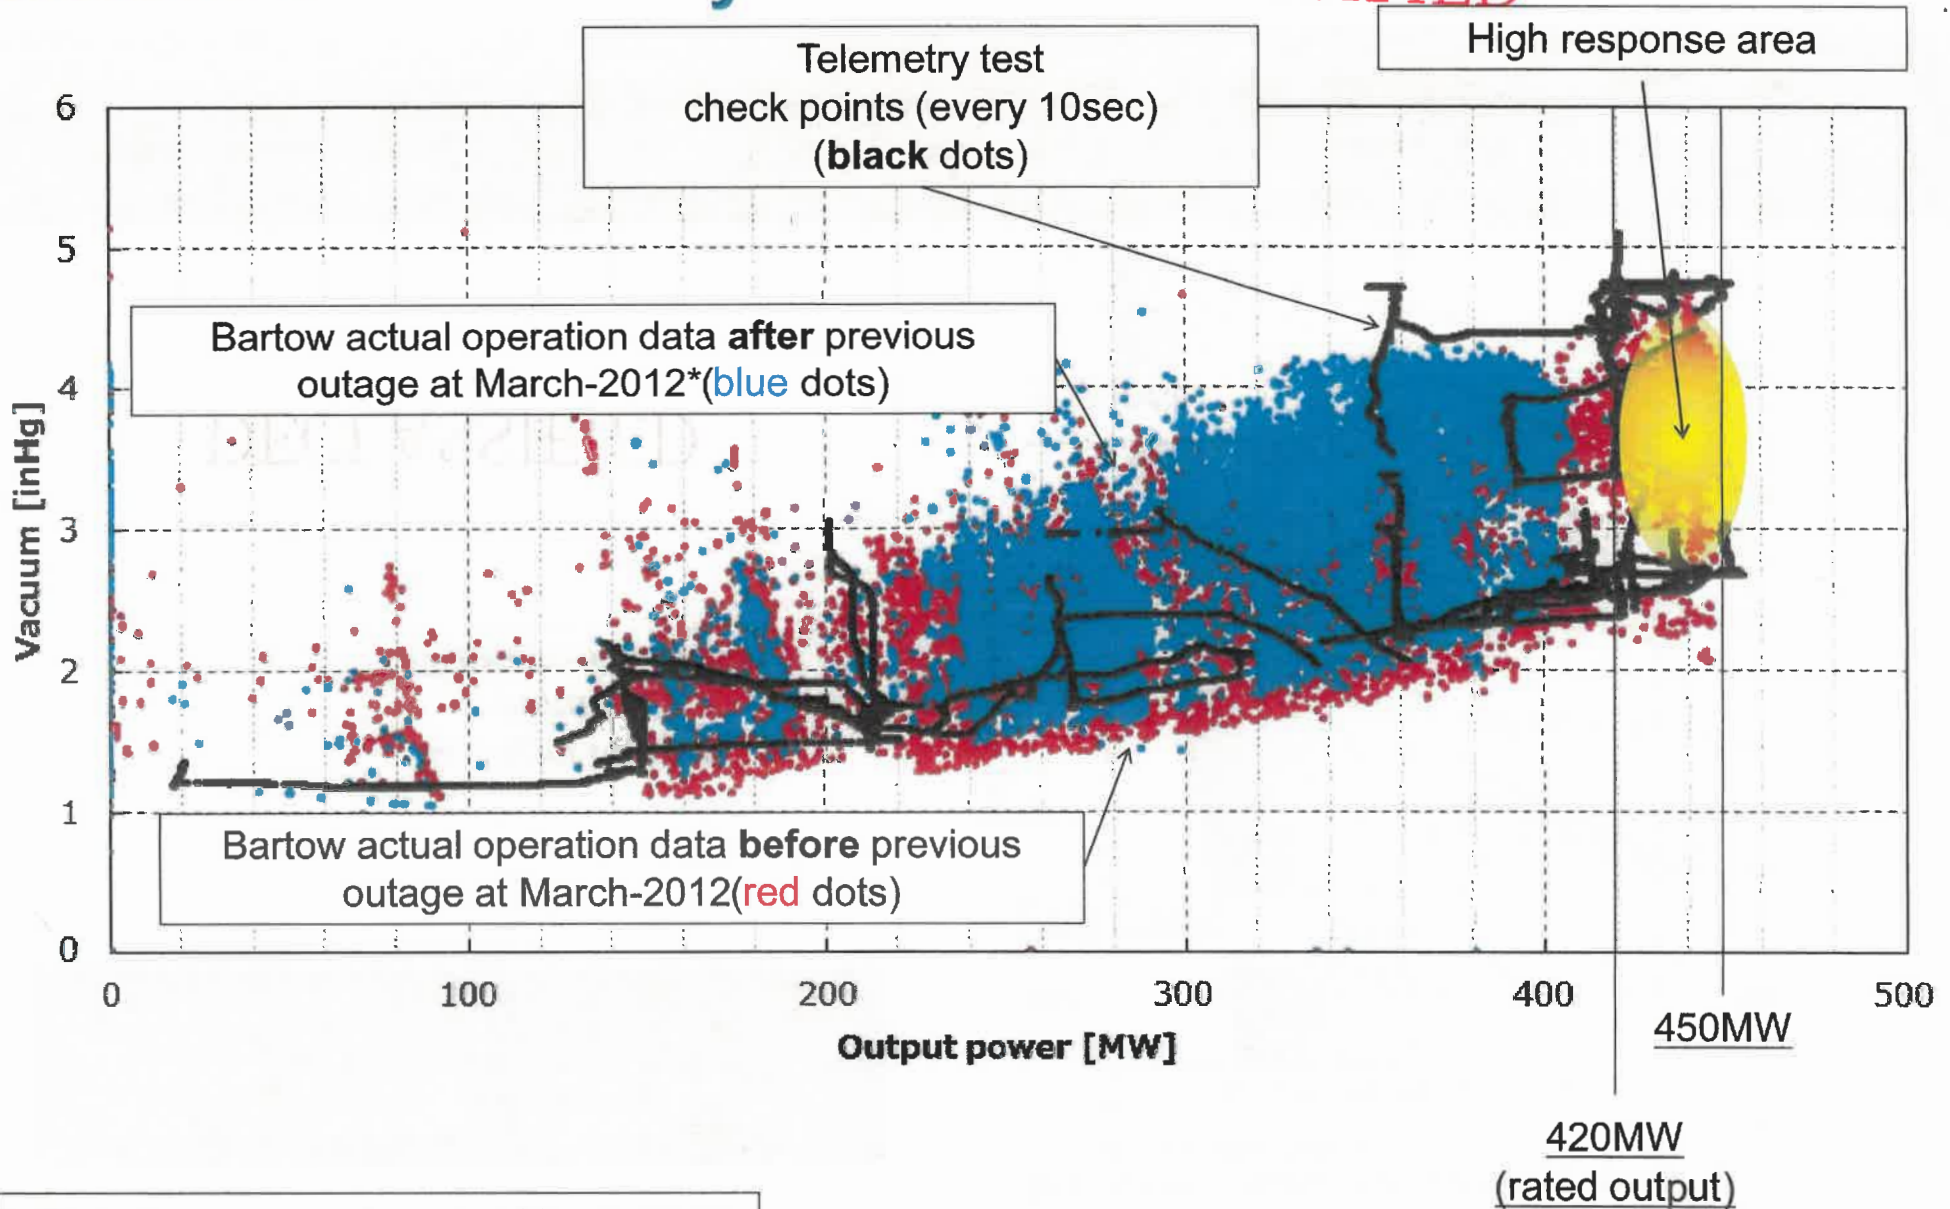
Outline of Telemetry Test

* Stub damage was found at March-2012

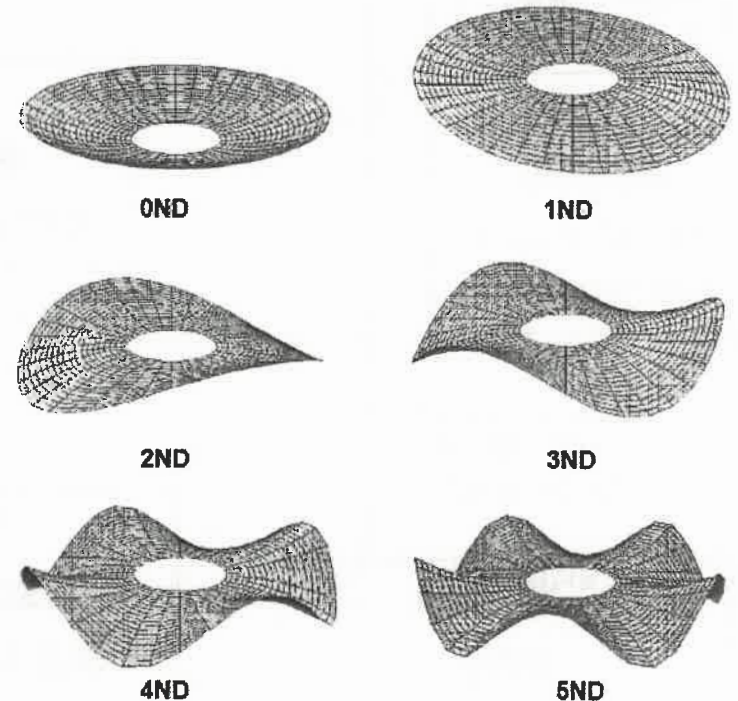
Nodal Diameters

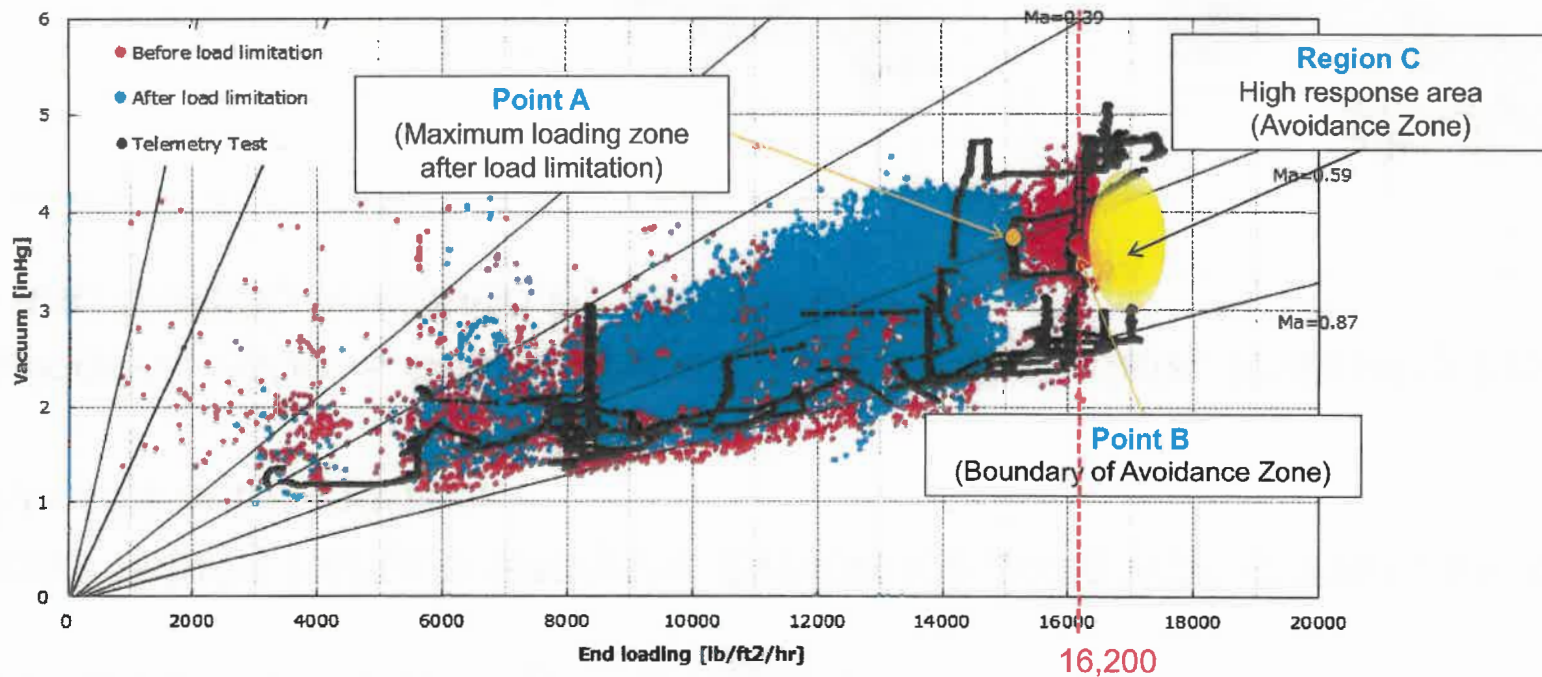
Stub fretting evaluation at all tested region was conducted.

3 key evaluation points are shown :

- Point A : Max loading after 2012 load limitation.
- Point B : Minimum safety factor point during the telemetry test.
- Region C : Unexamined area due to high vibratory response observed during the telemetry test.

Point B achieved acceptable stress and safety margin after the stub coating.

Region C exceeds the stress limit and safety margin after the stub coating becoming the avoidance zone.

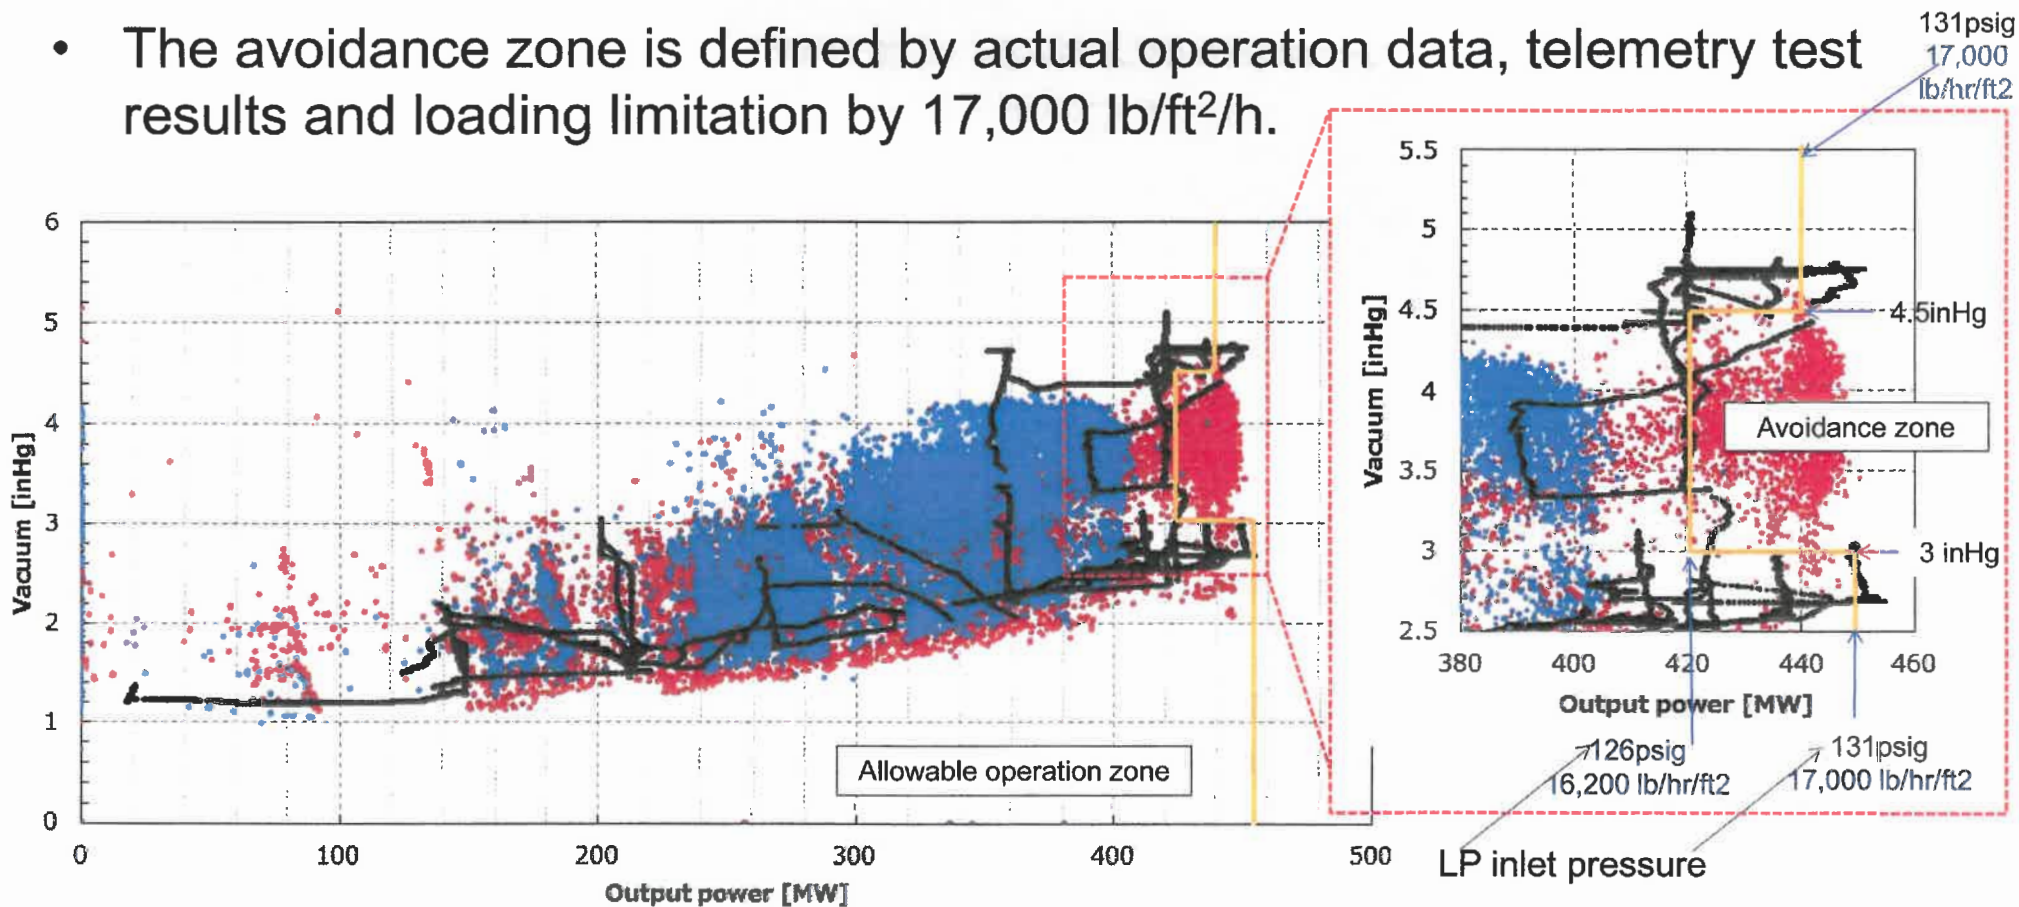
Results: Stub Fretting Fatigue Evaluation

- Based on Fretting Fatigue analysis, avoidance zone was created for safe operation of the L0 blades.
- The avoidance zone is defined by actual operation data, telemetry test results and loading limitation by 17,000 lb/ft²/h.

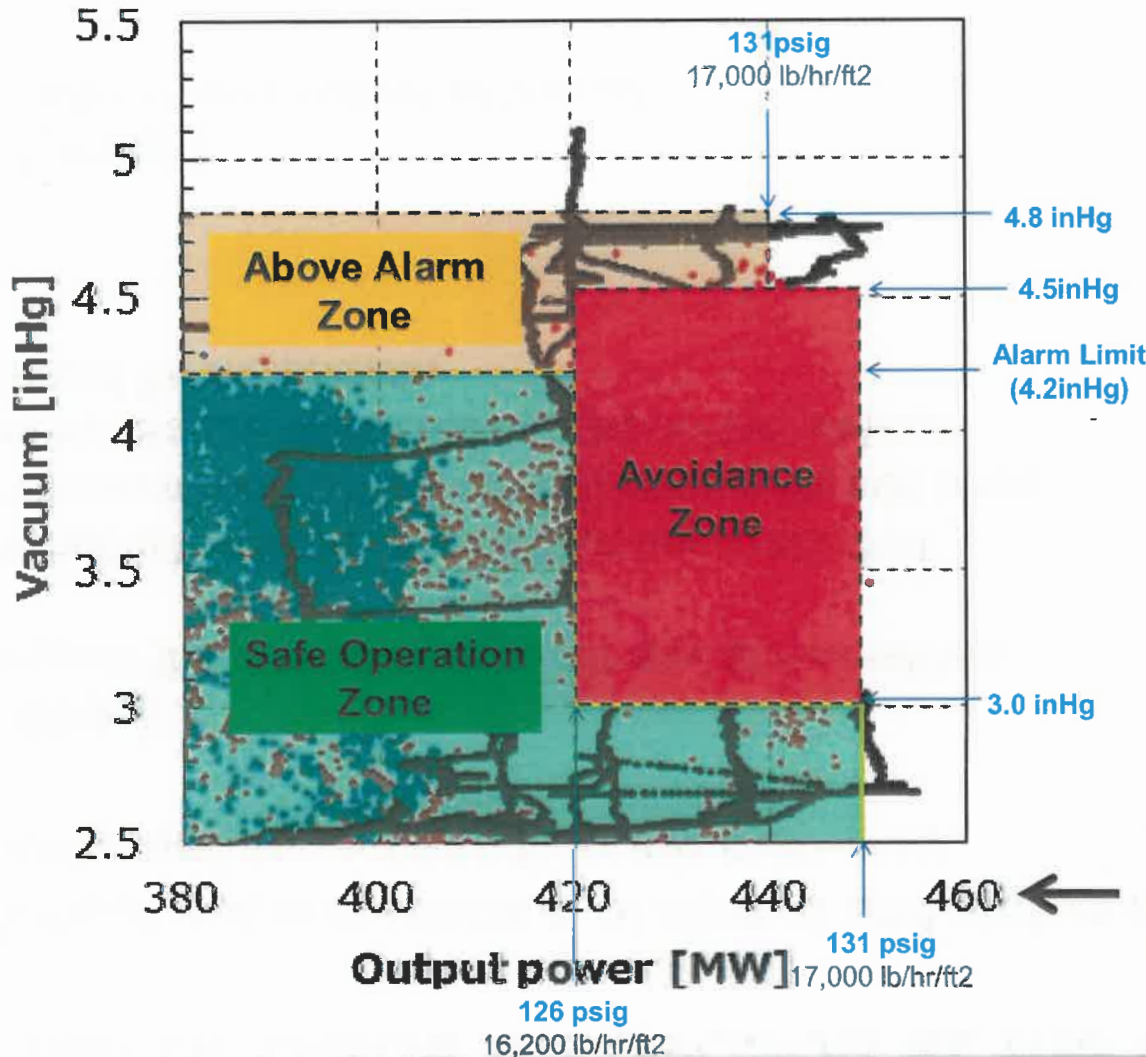
40" L0 Blade Limits

- Based on Fretting fatigue and HCF evaluation of the blade below "Avoidance Zone" is established

Safe Operation Zone:

Continuous operation permitted.

Avoidance Zone:

Operation is not recommended.

Above Alarm Zone:

Short term operation is permitted between 4.5 inHg and 4.8 inHg with LP inlet pressure limit of 131 psig during peak power seasons in summer.

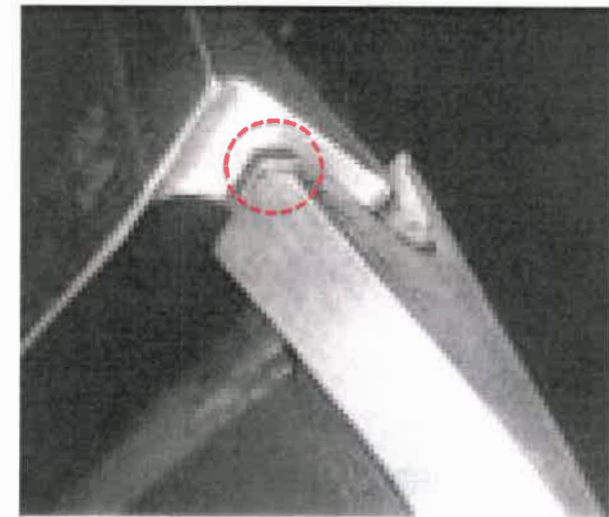
Plan of blade inspection at the next outage

[Stub]

Inspect the coated surface for any abnormalities.

Bending test have proved that any crack that initiates in the coating will not propagate into base metal. So any cracks observed on the surface should be acceptable.

[Shroud]

Confirm the condition of shroud.

Annual visual inspection of shroud and stub is recommended. This can be performed by access through man-way.

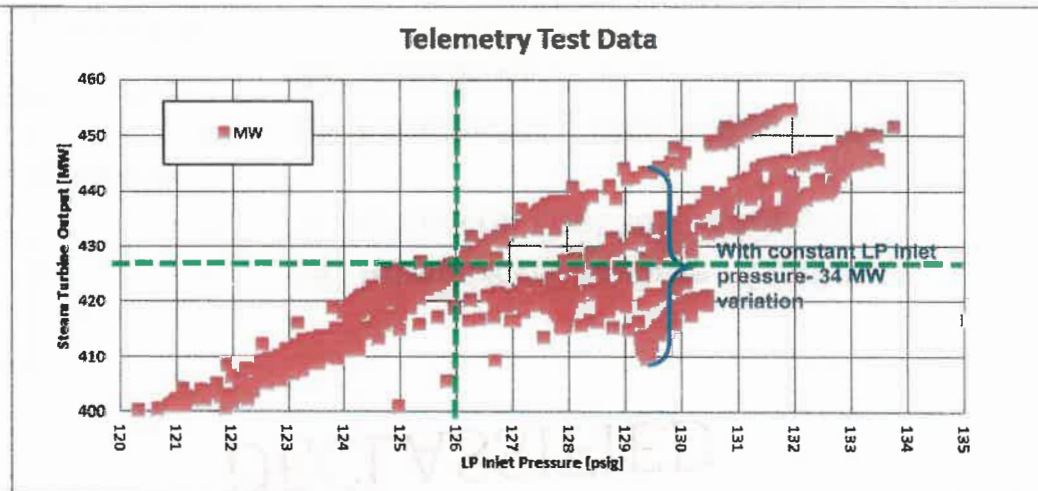
- Based on L0 blade review for operation above 3 inHg, maximum allowed load on L0 blade is set at 16,200 lb/hr/ft².
- Review of test data shows that 16,200 lb/hr/ft² can be achieved with LP inlet pressure of 126psig and unit output as 426.7MW. (12/22 17:30Hrs)
- With constant LP inlet pressure, variation of power output is observed. This is largely related to loading change in HP and IP sections.
- If more steam is put through HP section, higher output greater than 426MW can be achieved by keeping LP inlet pressure under 126psig or L0 blade loading under 16,200 lb/hr/ft².

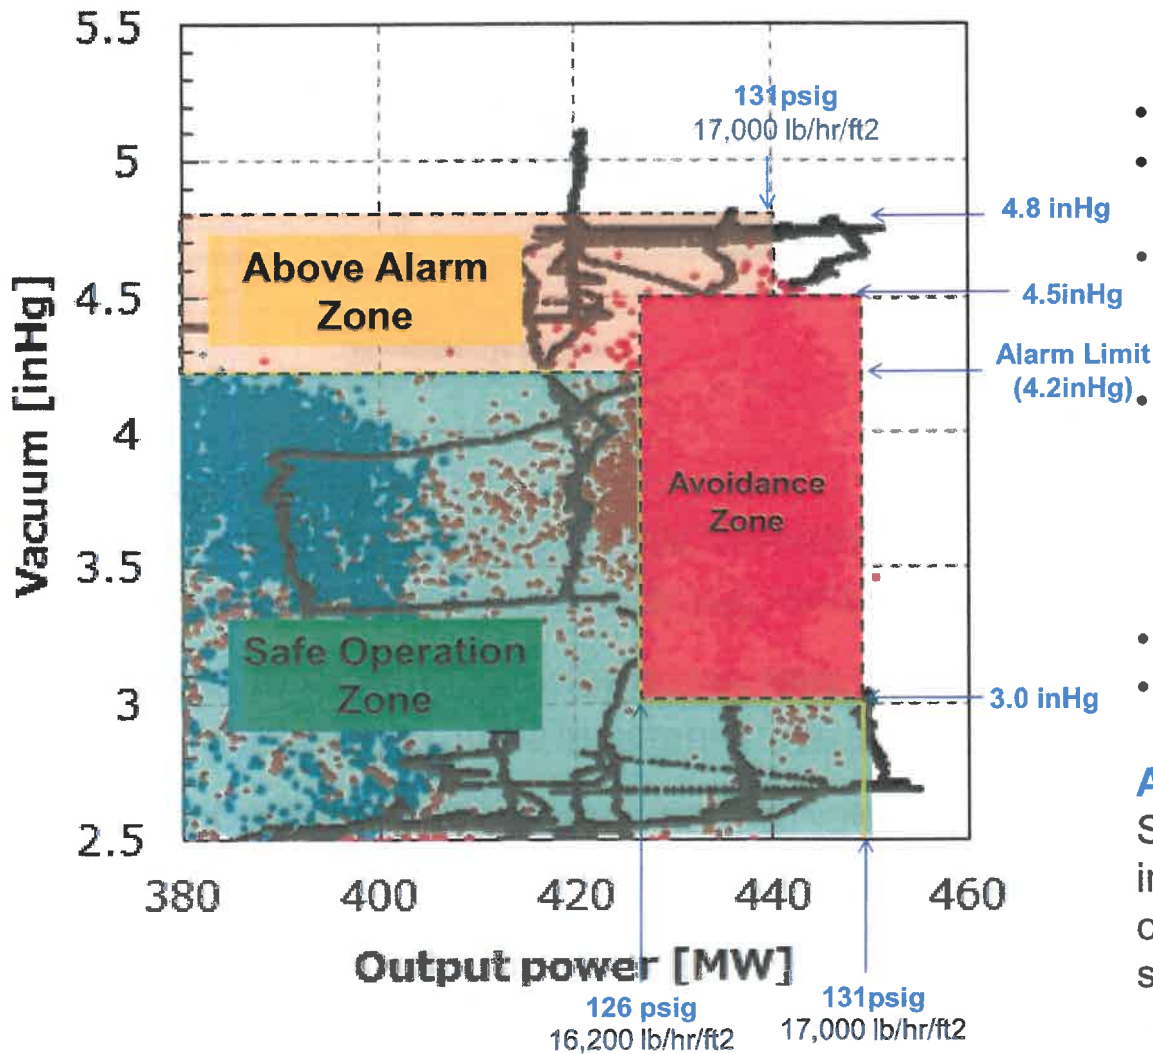
- HP Admission Pressure : 2240 psig
- IP Admission Pressure : 569 psig
- LP Admission : Max 126 psig for exhaust pressure up to 4.3 inHg
- LP Admission : Max 131 psig for exhaust pressure < 3 inHg
(Customer to confirm BOP capability for 131 psig LP Inlet System.)
- Exhaust Pressure Alarm: 4.2 in.Hg
- Max Gen Output : 450MW

Above Alarm Zone:

Short term operation is permitted between 4.5 inHg and 4.8 inHg with LP inlet pressure limit of 131 psig during peak power seasons in summer.
