Re: NC Real Estate Projects, LLC dba Grenelefe Utility  
Request for Staff Assisted Rate Increase - Utility Response on Establishing Final  
Service Availability Charges  
Docket No. 20250023-WS

## **WATER STORAGE TANK 5 YEAR - WASHOUT INSPECTION REPORT**

**25,000 Gallon Well #10 Water Storage Tank**

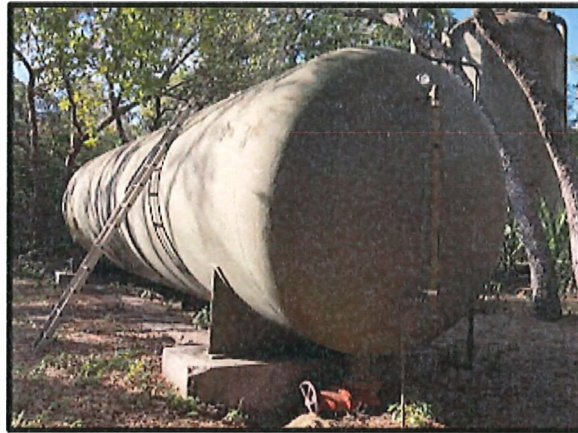
The exterior of the tank is in fair condition. The following deficiencies were observed within the exterior coating system:

- Chalking – Observed on most tank surfaces.
- Fading – Observed on most tank surfaces.
- Irregular Shape Corrosion – Observed on the piping hardware covering less than 5% of total surfaces.

- The tank rests on two (2) steel saddles, which appeared to be in good condition.
- The concrete foundations appear to be in good condition. Minor gouging can be observed.
- The tank features a clamp style manway.
- One end cap features a sight glass.

At this time, the tank is in need of interior and exterior coating rehabilitations. No immediate structural repairs are recommended beyond routine maintenance and continued periodic inspections in accordance with Rule 62-555.350(2), FAC. Southern Corrosion recommends an interior and exterior renovation at this time and continued monitoring of all tank components during future inspections and prompt addressing of any future deficiencies that may develop.

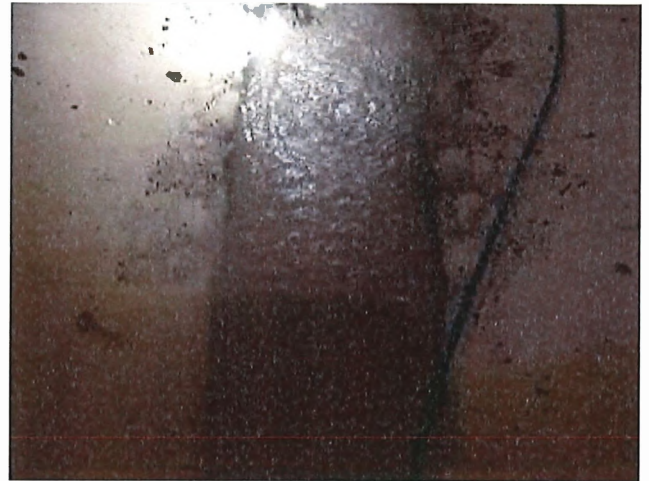
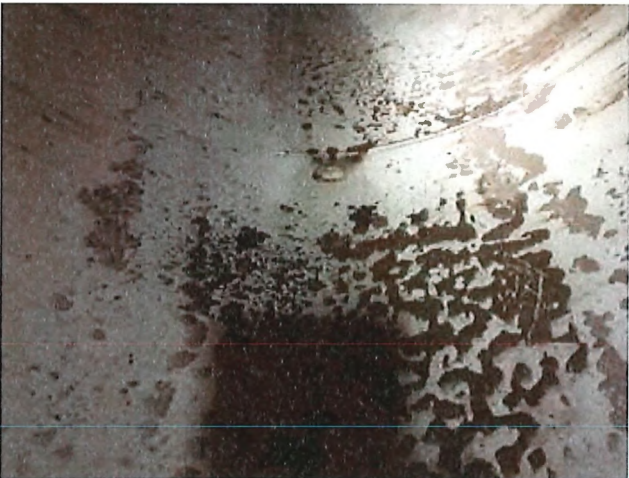
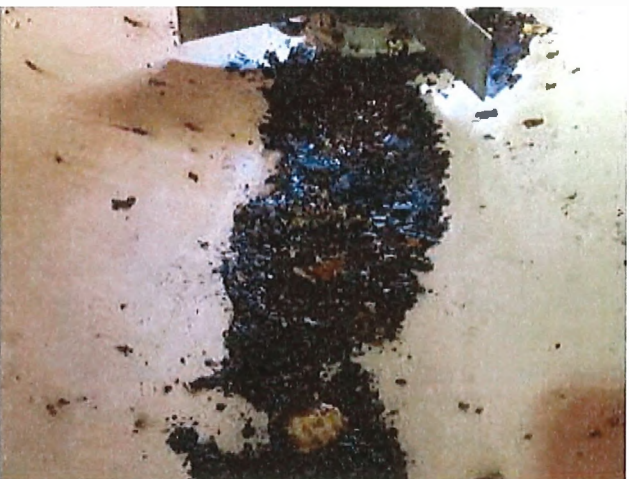
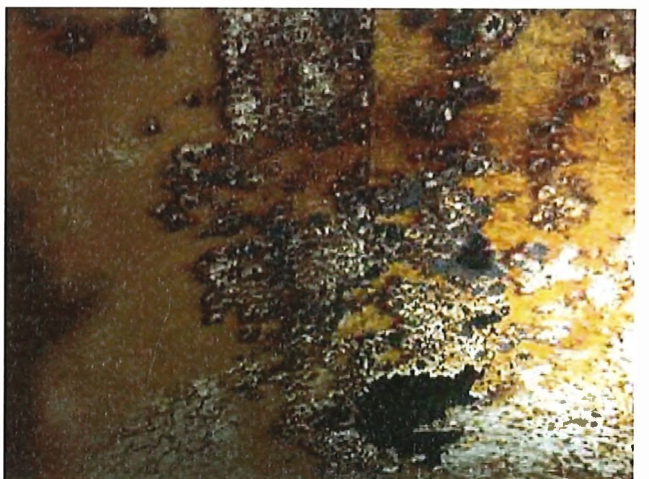
## Interior Photos Before Washout

At the time of inspection, a washout procedure was performed and all sediment and debris were removed. The interior coatings are in poor condition. The following deficiencies were observed within the interior (wet) coating system:

- **Discoloration/staining** – Observed on all interior surfaces.
- **Undercutting** – Observed on the roof of the tank.
- **Adhesion Failure** – Observed throughout the interior on the floor, end caps, and roof.
