Re: Docket 20250130-WS – Petition for an acquisition adjustment for a non-viable utility, by CSWR-Florida Utility Operating Company, LLC.

CSWR-Florida Utility Operating Company, LLC (“CSWR-Florida”) submits the following responses to Staff’s January 27, 2026 First Data Request.

Please refer to CSWR-Florida Utility Operating Company, LLC (CSWR-FL or Utility) petition for an acquisition adjustment relating to its 2022 acquisition of the Neighborhood Utilities, Inc. (Neighborhood) water system for the following questions (Document No. 14784-2025, filed on October 24, 2025):

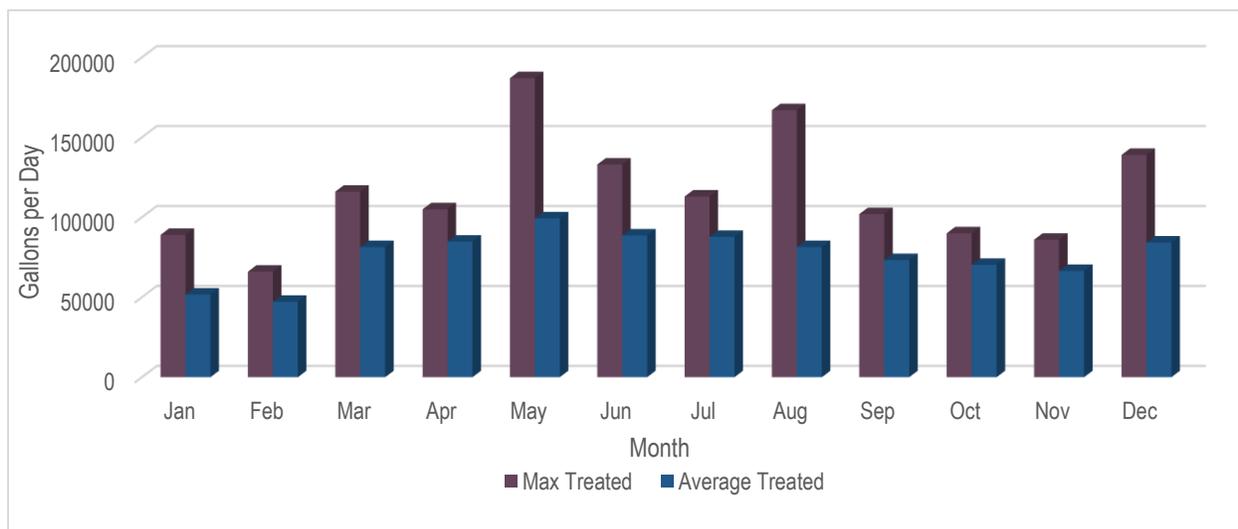
Figure 1-1: Neighborhood Utilities Average Water Use 2020

Potable water usage at the Neighborhood Utilities Plant is depicted in Figure 1-1.

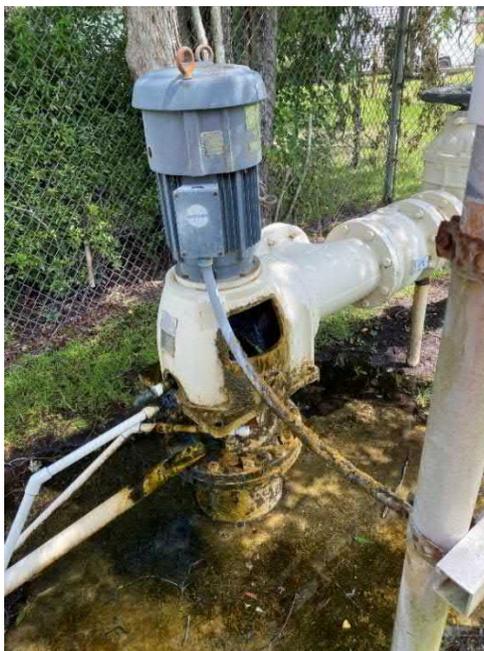
Figure 2-1: Well 2

The Neighborhood Utilities main well (Well 2) is located within a small locked fenced in area and approximately 840 feet south of the water treatment plant and about 25 feet from Rothbury Drive. The top of well casing is about 12 inches above grade and within a concrete pad. The well is 1,000 feet deep with one vertical turbine Peerless 350 gpm pump, 10 HP motor, and 230 Volts.

The well pump motor has a leak that has been noted in the previous sanitary survey report. The leak sprays water when the pump is active and causes a pool of standing water surrounding the well and buildup of algae on the well casing, conduit, and associated piping. The motor should be replaced, and the well casing and associated parts should be cleaned and disinfected.

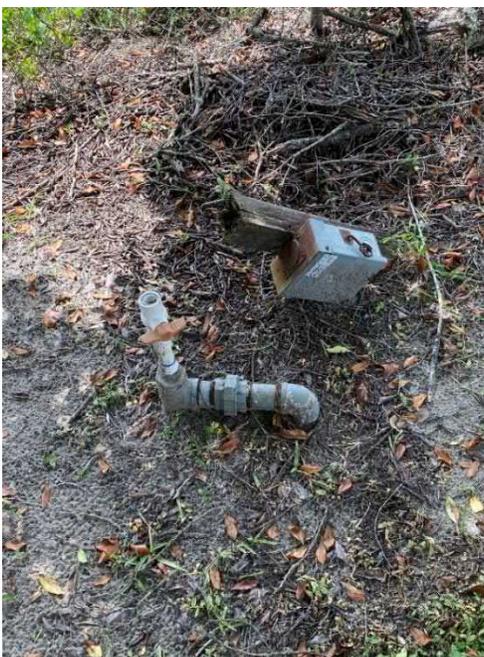
Figure 2-2: Well 1

Well 1 is located approximately 50 feet from the pump station building but is not used or listed on the FDEP operating permit. Well 1 is 100 feet deep and has a 100 gpm well pump of unknown make and age. Piping from the well is connected to GST1. Well 1 is not included as a ground water source on the most recent FDEP sanitary survey report or the 2020 FDEP Source Water Assessment & Protection Program (SWAPP).

The station currently only has one functioning groundwater well, Well 1 has not been used by the facility in many years, is currently valved-off, and does not have a similar capacity to Well 1. Neighborhood Utilities stated that Well 1

is a 100-foot deep well with a capacity of 100 gpm. Given the condition of Well 1, as shown in Figure 2-2, the existing Well 1 should be abandoned, and the existing pipe connections should be removed.

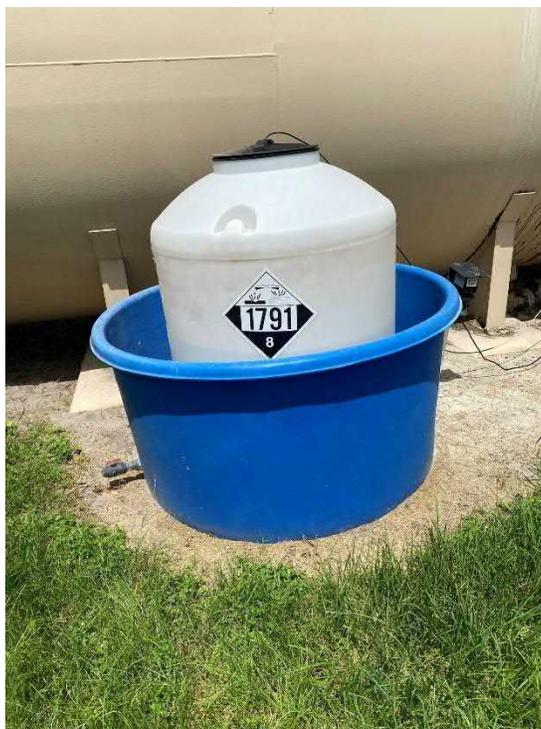
Figure 2-3: Sodium Hypochlorite Treatment

Chemical Pump	Chlorine
Number of Pumps	1
Brand	Stenner
Model	85MPHP17
Size	17 GPD

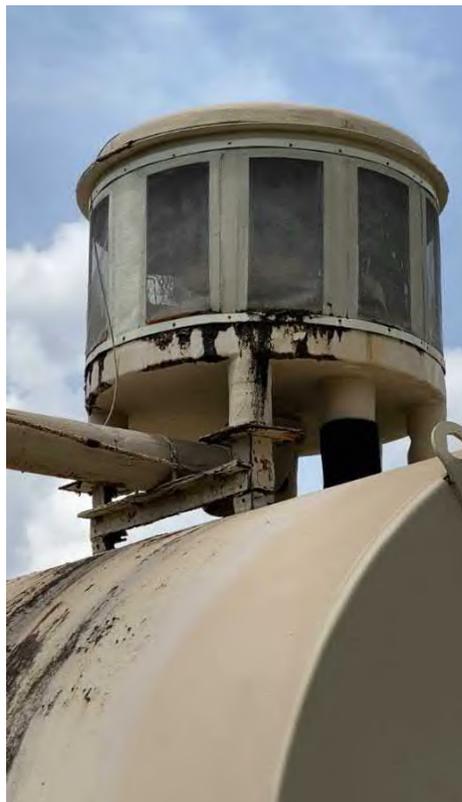
Figure 2-4: Aerator Treatment

The plant uses a 350-gpm aeration treatment system to address hydrogen sulfide. The aeration system is located on the top of Tank 2 and is steel fabricated and fiber glass coated in a steel enclosure with fiberglass fine mesh screen.

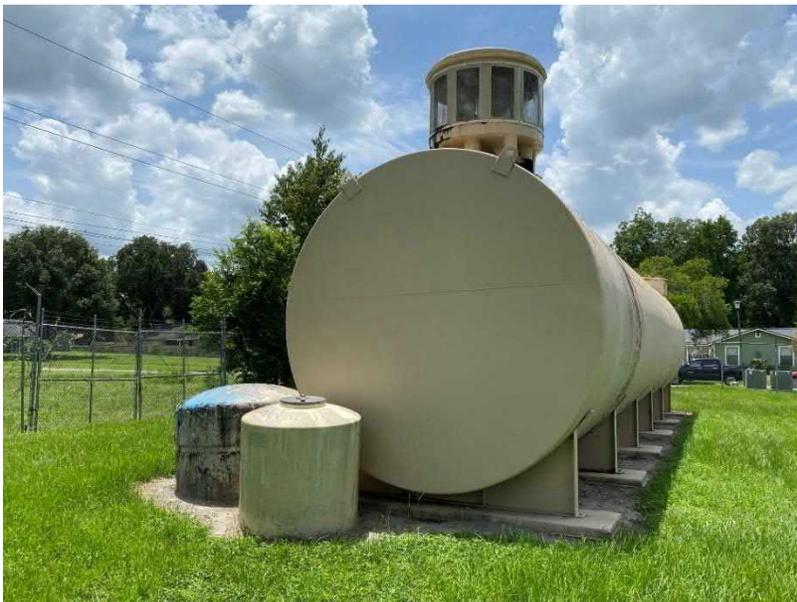
Figure 2-5: Ground Storage Tank 2

The most recent inspection on GST2 was performed by In Depth Services, Inc. on July 27, 2018. The tank inspection report stated that the aerator was causing heavy signs of corrosion throughout the adjacent tank walls with heavy corrosion and metal loss noted on access hatch and riser. The tank interior has up to 14 inches of silt and iron sediment on the central tank floor with corrosion, oxidation noted above the waterline and throughout the tank roof, and ambient light was visible at multiple locations throughout the tank roof. The report recommended to seal exterior openings on

roof to prevent contaminations, to repair areas of metal loss on the tank walls, recoat the interior and exterior surfaces of the tank, and to repair/replace the access hatch and riser.

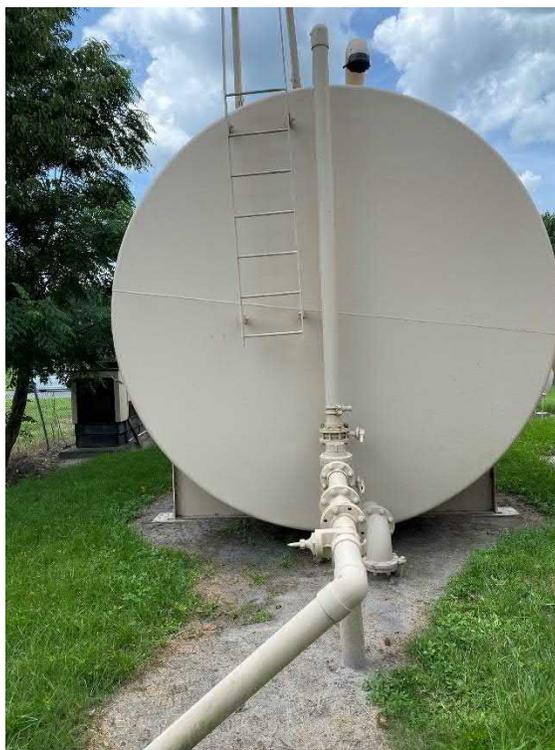
Figure 2-6: Ground Storage Tank 1

Ground Storage Tank 1 (GST1) is a 20,000-gallon steel atmospheric storage tank. The tank is plumbed with 4-inch isolation gate valves at the inlet and outlet of the tank with an underground 4-inch tank bypass line which is normally closed. The storage tank does have a connection to the inactive Well 1 but the gate valves to the well are normally closed. The tank has no direct control or inlet but is connected via an underground pipe to Storage Tank 2 so that the flow from Well 2 equalizes in both storage tanks to allow for additional water storage. The tank has a J-type screened vent and a 4-inch drain valve.

The most recent inspection on GST1 was performed by In Depth Services, Inc. on July 27, 2018. The tank inspection reported stated that there was a complete failure of access hatch/hinges due to rust and de-alloying and uncovered openings present on roof allowing bio life and growth inside of the tank as well as clogged and torn screens on the vent. The tank interior had visible signs of daylight present to do unsealed openings on roof, waterline staining present throughout the roof and walls, and corrosion noted above the waterline localized on weld seams primarily throughout roof. The report recommended to repair the vent screen and access hatch, to seal the exterior openings on roof to prevent contaminations, and to schedule internal epoxy repairs to coating in areas with pitting and heavy delamination.

The most recent tank inspection report for GST1 stated that the access hatch had complete hinge failure and heavy metal deterioration which does not allow the access hatch to seal properly. The access hatch provides an opportunity for contaminants to enter the storage tank and should be repaired. The report also noted corrosion above the waterline throughout the weld seams throughout the tank and uncovered openings present on roof allowing bio growth inside the tank. The tank interior and exterior should be inspected and any areas with metal loss should be repaired. The interior should also be sand blasted and re-coated with minimum of 5 mils DFT with epoxy to prevent further corrosion.

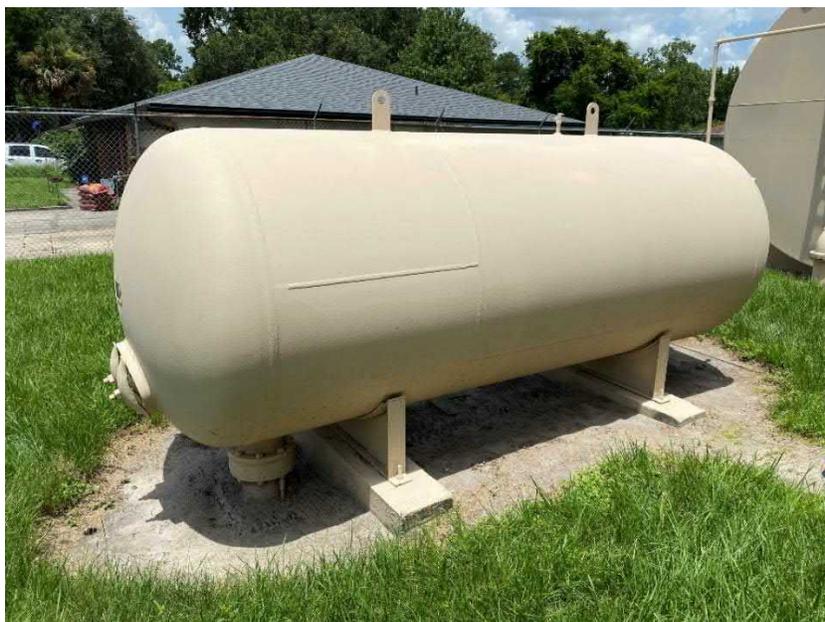
Figure 2-7: Hydropneumatic Tank

The hydropneumatic storage tank is a 2,000-gallon steel tank. The tank is plumbed with 4-inch isolation gate valves at the inlet and outlet of the tank with no bypass line. The hydropneumatic storage tank controls the high service pumps and air compressor. The on/off pressure of the tank is 40/60. The tank level gauge is kept in the pump station building and has a sensor to activate an air compressor if the water level gets too high in the tank to keep the tank from being waterlogged.

The most recent inspection on the hydropneumatic tank was performed by In Depth Services, Inc. on July 27, 2018. The report stated that the hydropneumatic storage tank had moderate surface corrosion and oxidation noted throughout the tank above the water line, moderate signs of blistering noted in the coating throughout the central tank floor, erosion in the surrounding terrain related to a poor tank drainage system, and that during the inspection the tank was not able to fully isolated from water flow due to incoming flow from the tank outlet, likely due to a failed valve. The tank recommended that the interior coating should be repaired in areas of corrosion throughout the tank roof, the addition of a “splash zone” pad or plumbing to redirect discharge runoff from the tank drain, and to diagnose and repair the valve system to allow the tank to be fully isolated from incoming water flow.

The most recent storage tank inspection for the hydropneumatic storage tank noted the interior of the tank had moderate surface corrosion and oxidation noted throughout the tank above the water line and suggested repairs to the interior coating in the report. The interior should be sand blasted and re-coated with minimum of 5 mils DFT with epoxy to prevent further corrosion. The tank also stated that the tank could not be fully isolated due to a possible failed valve on the outlet causing incoming flow. The outlet valve should be replaced.

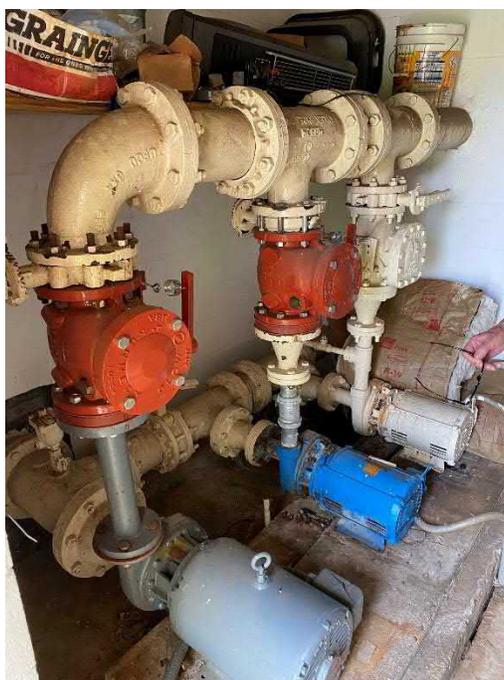
Figure 2-9: High Service Pumps

The pump station building houses three high service pumps. High Service Pump 1 (HSP1) is a 20 hp pump and is intended to be used for high demand such as fire flow conditions and turns on whenever the hydropneumatic tank drops below 40 psi. HSP2 and HSP3 are both 15 hp pumps and are intended to maintain the pressure in the hydropneumatic tank between 40 psi and 60 psi. HSP2 is the lead pump and supplies most of the water flow to the community, while HSP 3 is currently inoperable, and the discharge valve is closed. The check valves for HSP1 and HSP2 were recently replaced after a leak was found during a Sanitary Survey inspection.

Chemical Pump	HSP1	HSP2	HSP3
Type	Centrifugal	Centrifugal	Centrifugal
Brand	Balder	Emerson	Sterling
Model	39E15Z88	DJ15A1AM	C8W0AN-AF
Motor HP	20	15	15

High Service Pump 3 is not functioning and should be replaced with a new 15hp pump.

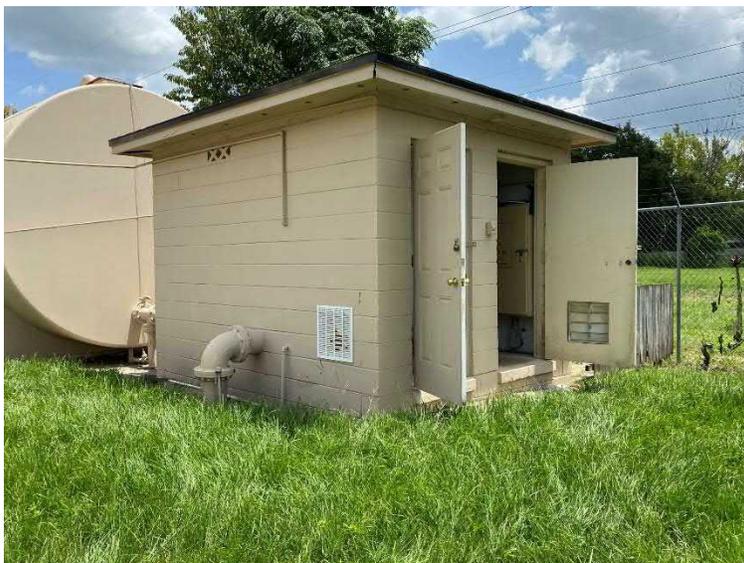
Figure 2-10: Pump Station Building

The pump station building is a 13 by 513-foot CMU building with primarily used for storage of the high service pumps, hydropneumatic storage tank sight tube, electric panels, and facility logbook. The building has a door with a width of 43 inches. The building had no evidence of roof leaks or rodents, but the open door provides no containment for spills or protection from weather, rodents, and insects. The building is within a fence with a locked gate, and has no fire extinguisher, floor drains, PPE, or lighting available on-site.

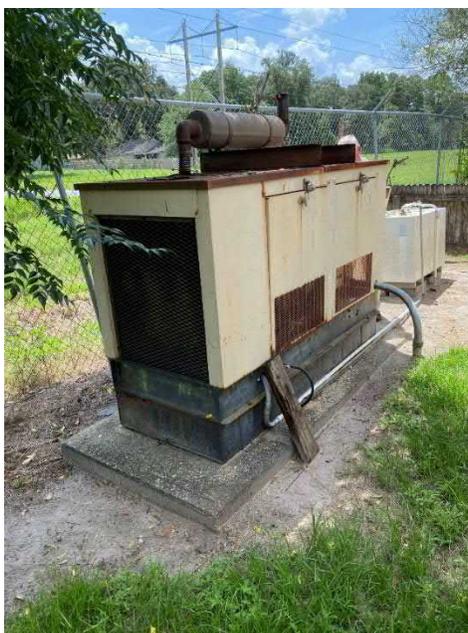
Figure 2-11: Emergency Generator

The Neighborhood Utilities plant has an inoperable 25 kW generator unit onsite to power the well pumps if there is an interruption in power supply. The generator has been inoperable since 2017 according to the most recent sanitary survey report. The generator has a diesel fuel tank that was half filled with fuel. The water system does have an emergency water source connection to the JEA major grid, a City of Jacksonville public utility, for up to 360,000-gallons of emergency water capacity to use if the water system is down.

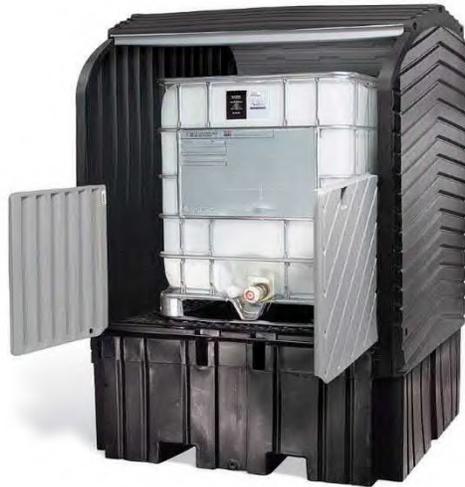
Figure 2-15: PIG 275-gallon IBC and Enclosure

The secondary containment for the sodium hypochlorite should be replaced, the current secondary containment has holes in the walls that would not allow the containment to contain the entire volume of the chemical tank. In order to improve secondary containment for the chemical storage, a structure should be installed to prevent the secondary containment from filling with rainwater. In addition, a structure around the chemical drums will offer an added protection from damage. This can be accomplished by changing out the bulk tanks with a more compact 275-gallon intermediate bulk container (IBC), and storing the chemicals in an enclosed container such as the PIG IBC Roll Top Hardcover Spill Pallet, with a 360-gallon containment capacity. An example is shown in Figure 2-15.

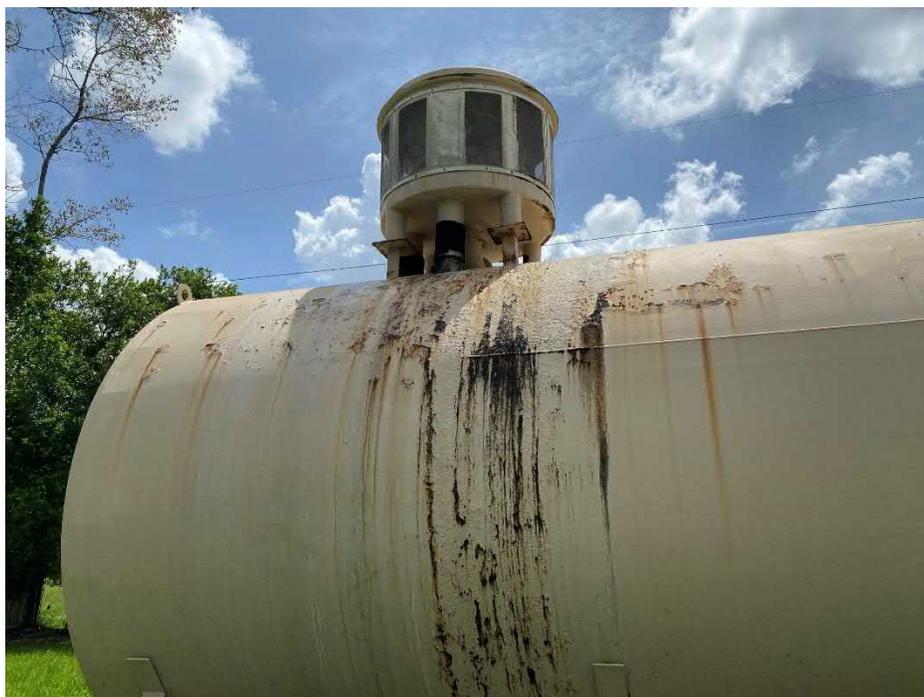
Figure 2-16: GST2 Exterior Corrosion

The most recent tank inspection report for GST2 stated that there were areas of heavy corrosion and metal loss along the tank walls, so the interior and exterior should be inspected and any areas with metal loss should be repaired. The interior should also be sand blasted and re-coated with minimum of 5 mils DFT with epoxy to prevent further corrosion. The aerator on top of GST2 has a constant stream of overspray of water and sodium hypochlorite onto the exterior of the tank which causes major surface corrosion. Neighborhood utilities stated that they will periodically scrape away the corrosion and apply new paint to the tank once there is too much corrosion on the tank. The exterior of the tank should be coated to mitigate the corrosion of the aerator overspray.

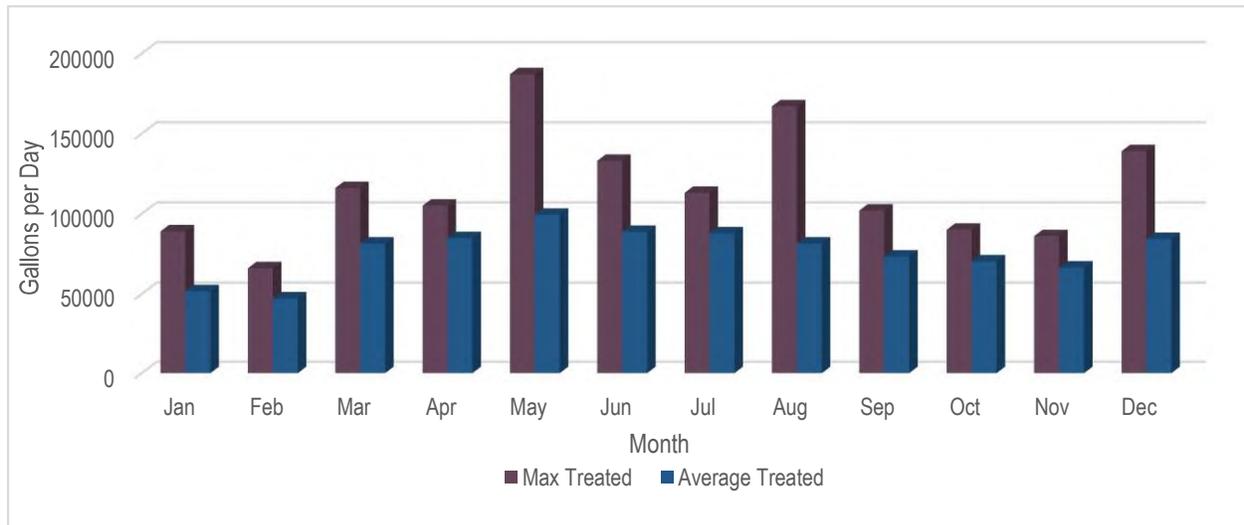
Figure 1-1: Neighborhood Utilities Average Water Use 2020

Potable water usage at the Neighborhood Utilities Plant is depicted in Figure 1-1.

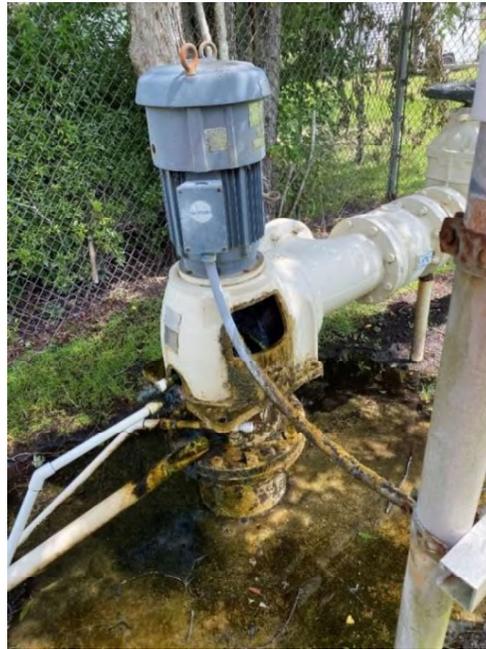
Figure 2-1: Well 2

The Neighborhood Utilities main well (Well 2) is located within a small locked fenced in area and approximately 840 feet south of the water treatment plant and about 25 feet from Rothbury Drive. The top of well casing is about 12 inches above grade and within a concrete pad. The well is 1,000 feet deep with one vertical turbine Peerless 350 gpm pump, 10 HP motor, and 230 Volts.

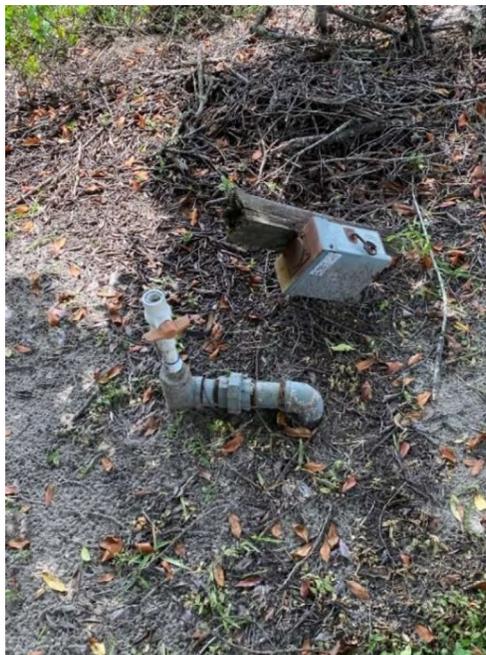
Figure 2-2: Well 1

Well 1 is located approximately 50 feet from the pump station building but is not used or listed on the FDEP operating permit. Well 1 is 100 feet deep and has a 100 gpm well pump of unknown make and age. Piping from the well is connected to GST1. Well 1 is not included as a ground water source on the most recent FDEP sanitary survey report or the 2020 FDEP Source Water Assessment & Protection Program (SWAPP).

The station currently only has one functioning groundwater well, Well 1 has not been used by the facility in many years, is currently valved-off, and does not have a similar capacity to Well 1. Neighborhood Utilities stated that Well 1

is a 100-foot deep well with a capacity of 100 gpm. Given the condition of Well 1, as shown in Figure 2-2, the existing Well 1 should be abandoned, and the existing pipe connections should be removed.

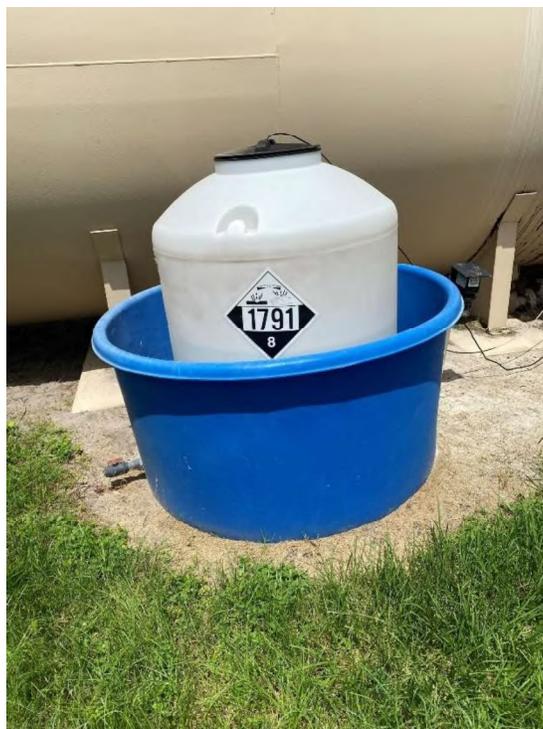
Figure 2-3: Sodium Hypochlorite Treatment

Chemical Pump	Chlorine
Number of Pumps	1
Brand	Stenner
Model	85MPHP17
Size	17 GPD

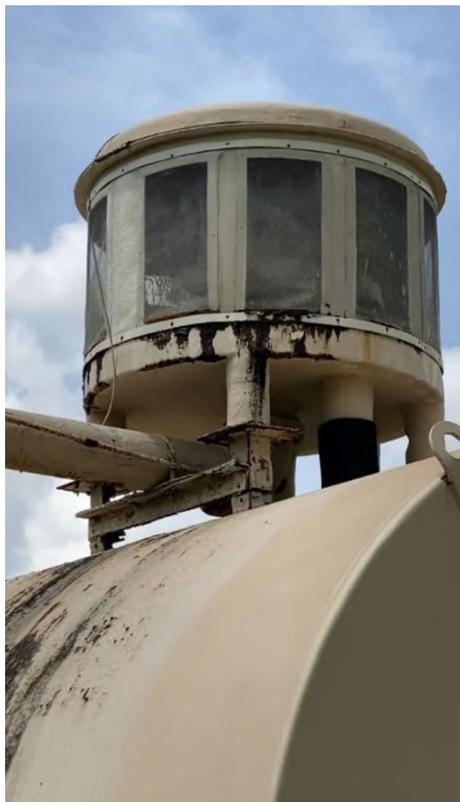
Figure 2-4: Aerator Treatment

The plant uses a 350-gpm aeration treatment system to address hydrogen sulfide. The aeration system is located on the top of Tank 2 and is steel fabricated and fiber glass coated in a steel enclosure with fiberglass fine mesh screen.

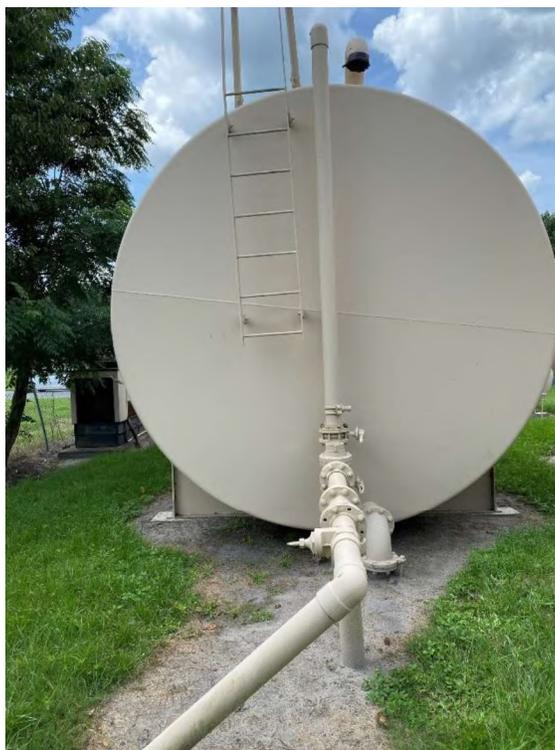
Figure 2-6: Ground Storage Tank 1

Ground Storage Tank 1 (GST1) is a 20,000-gallon steel atmospheric storage tank. The tank is plumbed with 4-inch isolation gate valves at the inlet and outlet of the tank with an underground 4-inch tank bypass line which is normally closed. The storage tank does have a connection to the inactive Well 1 but the gate valves to the well are normally closed. The tank has no direct control or inlet but is connected via an underground pipe to Storage Tank 2 so that the flow from Well 2 equalizes in both storage tanks to allow for additional water storage. The tank has a J-type screened vent and a 4-inch drain valve.

The most recent tank inspection report for GST1 stated that the access hatch had complete hinge failure and heavy metal deterioration which does not allow the access hatch to seal properly. The access hatch provides an opportunity for contaminants to enter the storage tank and should be repaired. The report also noted corrosion above the waterline throughout the weld seams throughout the tank and uncovered openings present on roof allowing bio growth inside the tank. The tank interior and exterior should be inspected and any areas with metal loss should be repaired. The interior should also be sand blasted and re-coated with minimum of 5 mils DFT with epoxy to prevent further corrosion.

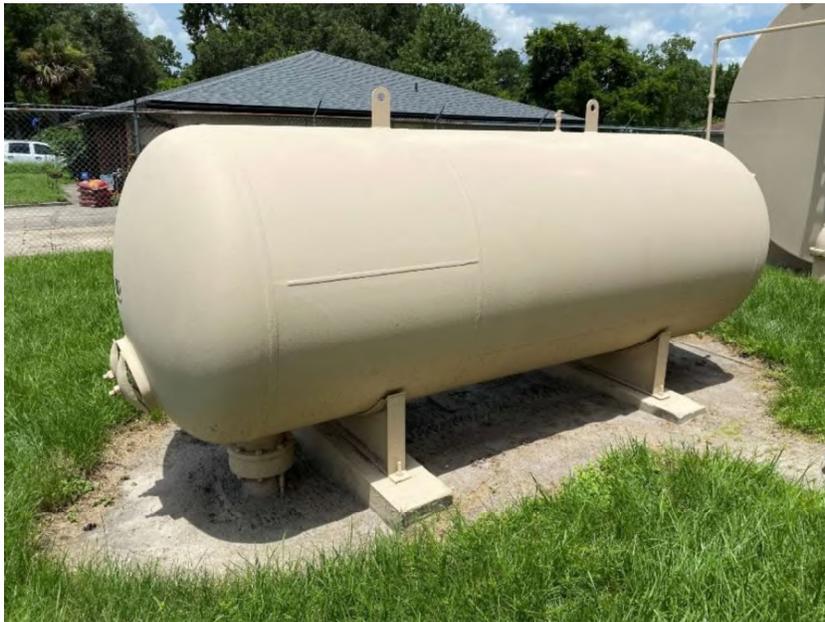
Figure 2-7: Hydropneumatic Tank

The hydropneumatic storage tank is a 2,000-gallon steel tank. The tank is plumbed with 4-inch isolation gate valves at the inlet and outlet of the tank with no bypass line. The hydropneumatic storage tank controls the high service pumps and air compressor. The on/off pressure of the tank is 40/60. The tank level gauge is kept in the pump station building and has a sensor to activate an air compressor if the water level gets too high in the tank to keep the tank from being waterlogged.

The most recent storage tank inspection for the hydropneumatic storage tank noted the interior of the tank had moderate surface corrosion and oxidation noted throughout the tank above the water line and suggested repairs to the interior coating in the report. The interior should be sand blasted and re-coated with minimum of 5 mils DFT with epoxy to prevent further corrosion. The tank also stated that the tank could not be fully isolated due to a possible failed valve on the outlet causing incoming flow. The outlet valve should be replaced.

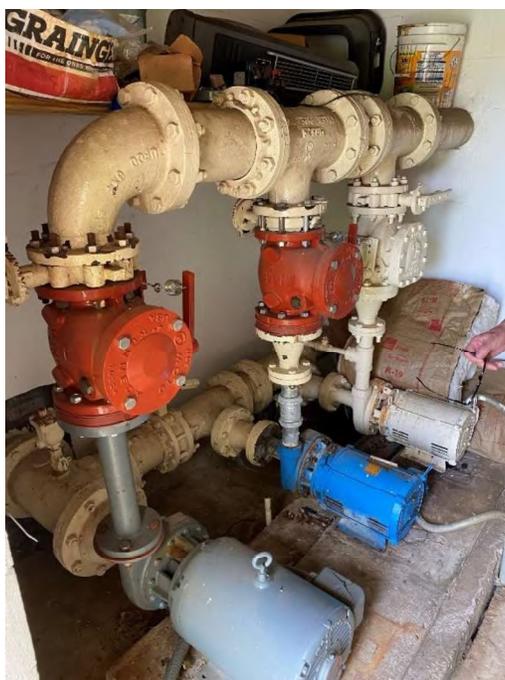
Figure 2-9: High Service Pumps

The pump station building houses three high service pumps. High Service Pump 1 (HSP1) is a 20 hp pump and is intended to be used for high demand such as fire flow conditions and turns on whenever the hydropneumatic tank drops below 40 psi. HSP2 and HSP3 are both 15 hp pumps and are intended to maintain the pressure in the hydropneumatic tank between 40 psi and 60 psi. HSP2 is the lead pump and supplies most of the water flow to the community, while HSP 3 is currently inoperable, and the discharge valve is closed. The check valves for HSP1 and HSP2 were recently replaced after a leak was found during a Sanitary Survey inspection.

High Service Pump 3 is not functioning and should be replaced with a new 15hp pump.

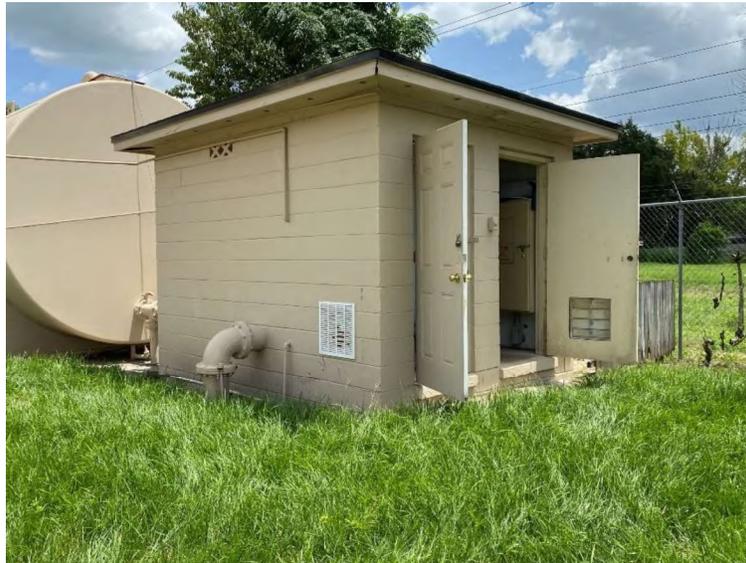
Figure 2-10: Pump Station Building

The pump station building is a 13 by 513-foot CMU building with primarily used for storage of the high service pumps, hydropneumatic storage tank sight tube, electric panels, and facility logbook. The building has a door with a width of 43 inches. The building had no evidence of roof leaks or rodents, but the open door provides no containment for spills or protection from weather, rodents, and insects. The building is within a fence with a locked gate, and has no fire extinguisher, floor drains, PPE, or lighting available on-site.

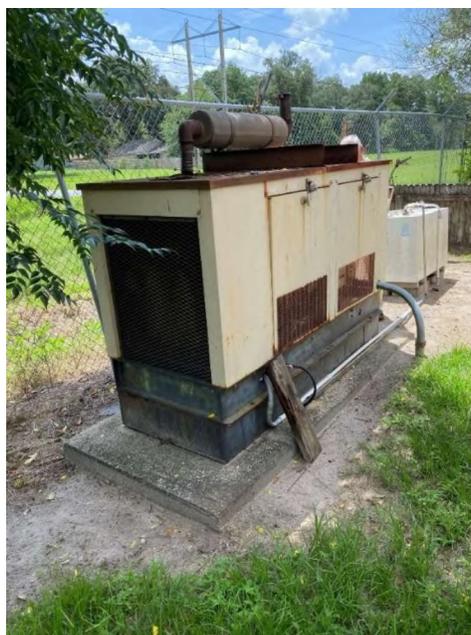
Figure 2-11: Emergency Generator

The Neighborhood Utilities plant has an inoperable 25 kW generator unit onsite to power the well pumps if there is an interruption in power supply. The generator has been inoperable since 2017 according to the most recent sanitary survey report. The generator has a diesel fuel tank that was half filled with fuel. The water system does have an emergency water source connection to the JEA major grid, a City of Jacksonville public utility, for up to 360,000-gallons of emergency water capacity to use if the water system is down.
