# Tampa Electric Company (TECO)
# Coal Yard Assessment
## Stantec Job No. 198800347

September 2010
Revision 2

## EXECUTIVE SUMMARY

Stantec has been retained by Tampa Electric Company to provide a review of the coal field equipment at the Big Bend facility. The review scope boundaries are from the dock through conveyors L1 and L2 that bring the coal to the tripper deck in the power house.

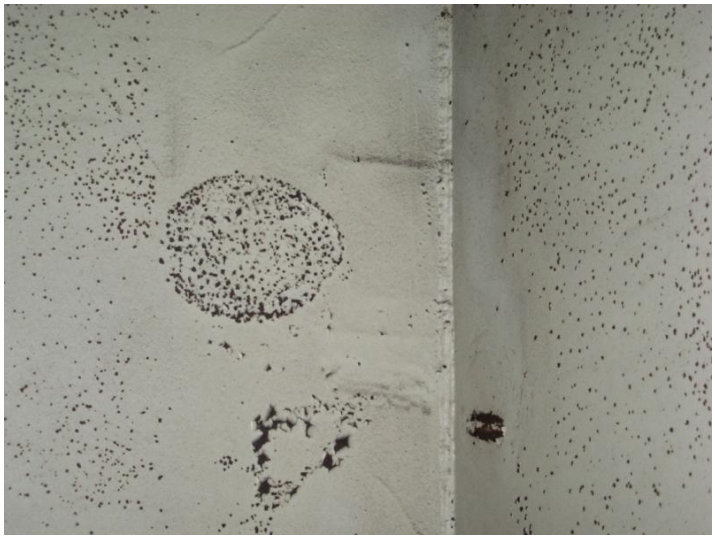
PICTURE DLU-D

The bolts at the various horizontal splice levels within the tower, in general, show no signs of corrosion, as seen in Pictures DLU-D and DLU-E.

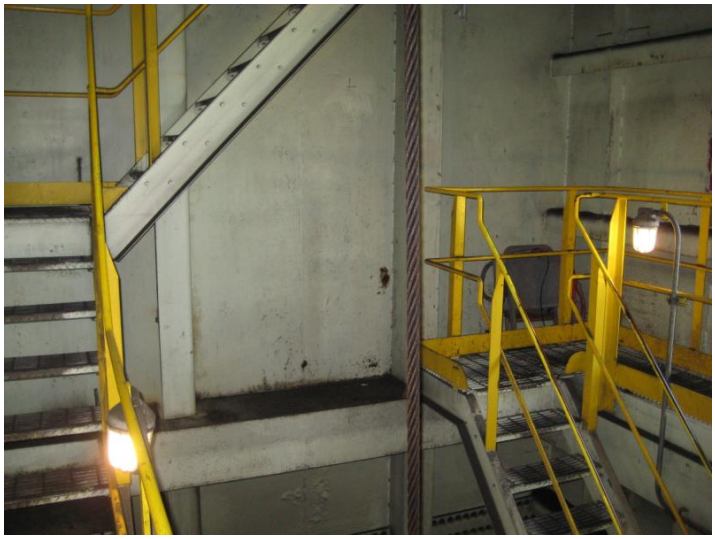
PICTURE DLU-S

Picture DLU-S shows the inside of the Tower with paint still in relatively good condition.

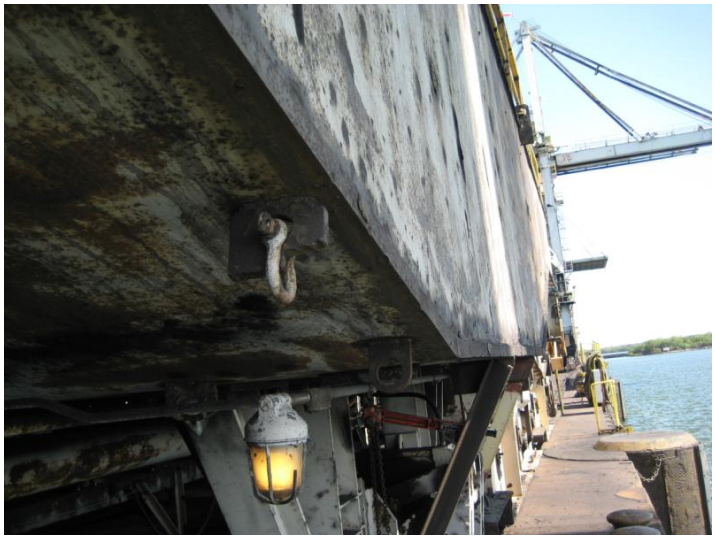
PICTURE DLU-W

Pictures DLU-W thru DLU-AB are along the waterside of the Outboard Travel Trucks showing corrosion of the framing beams and at the pins. Cleaning and painting is recommended. Depending upon the condition once all rust and scale has been removed, some reinforcement or replacement of components may be required. Pins should be checked to insure they function as intended.

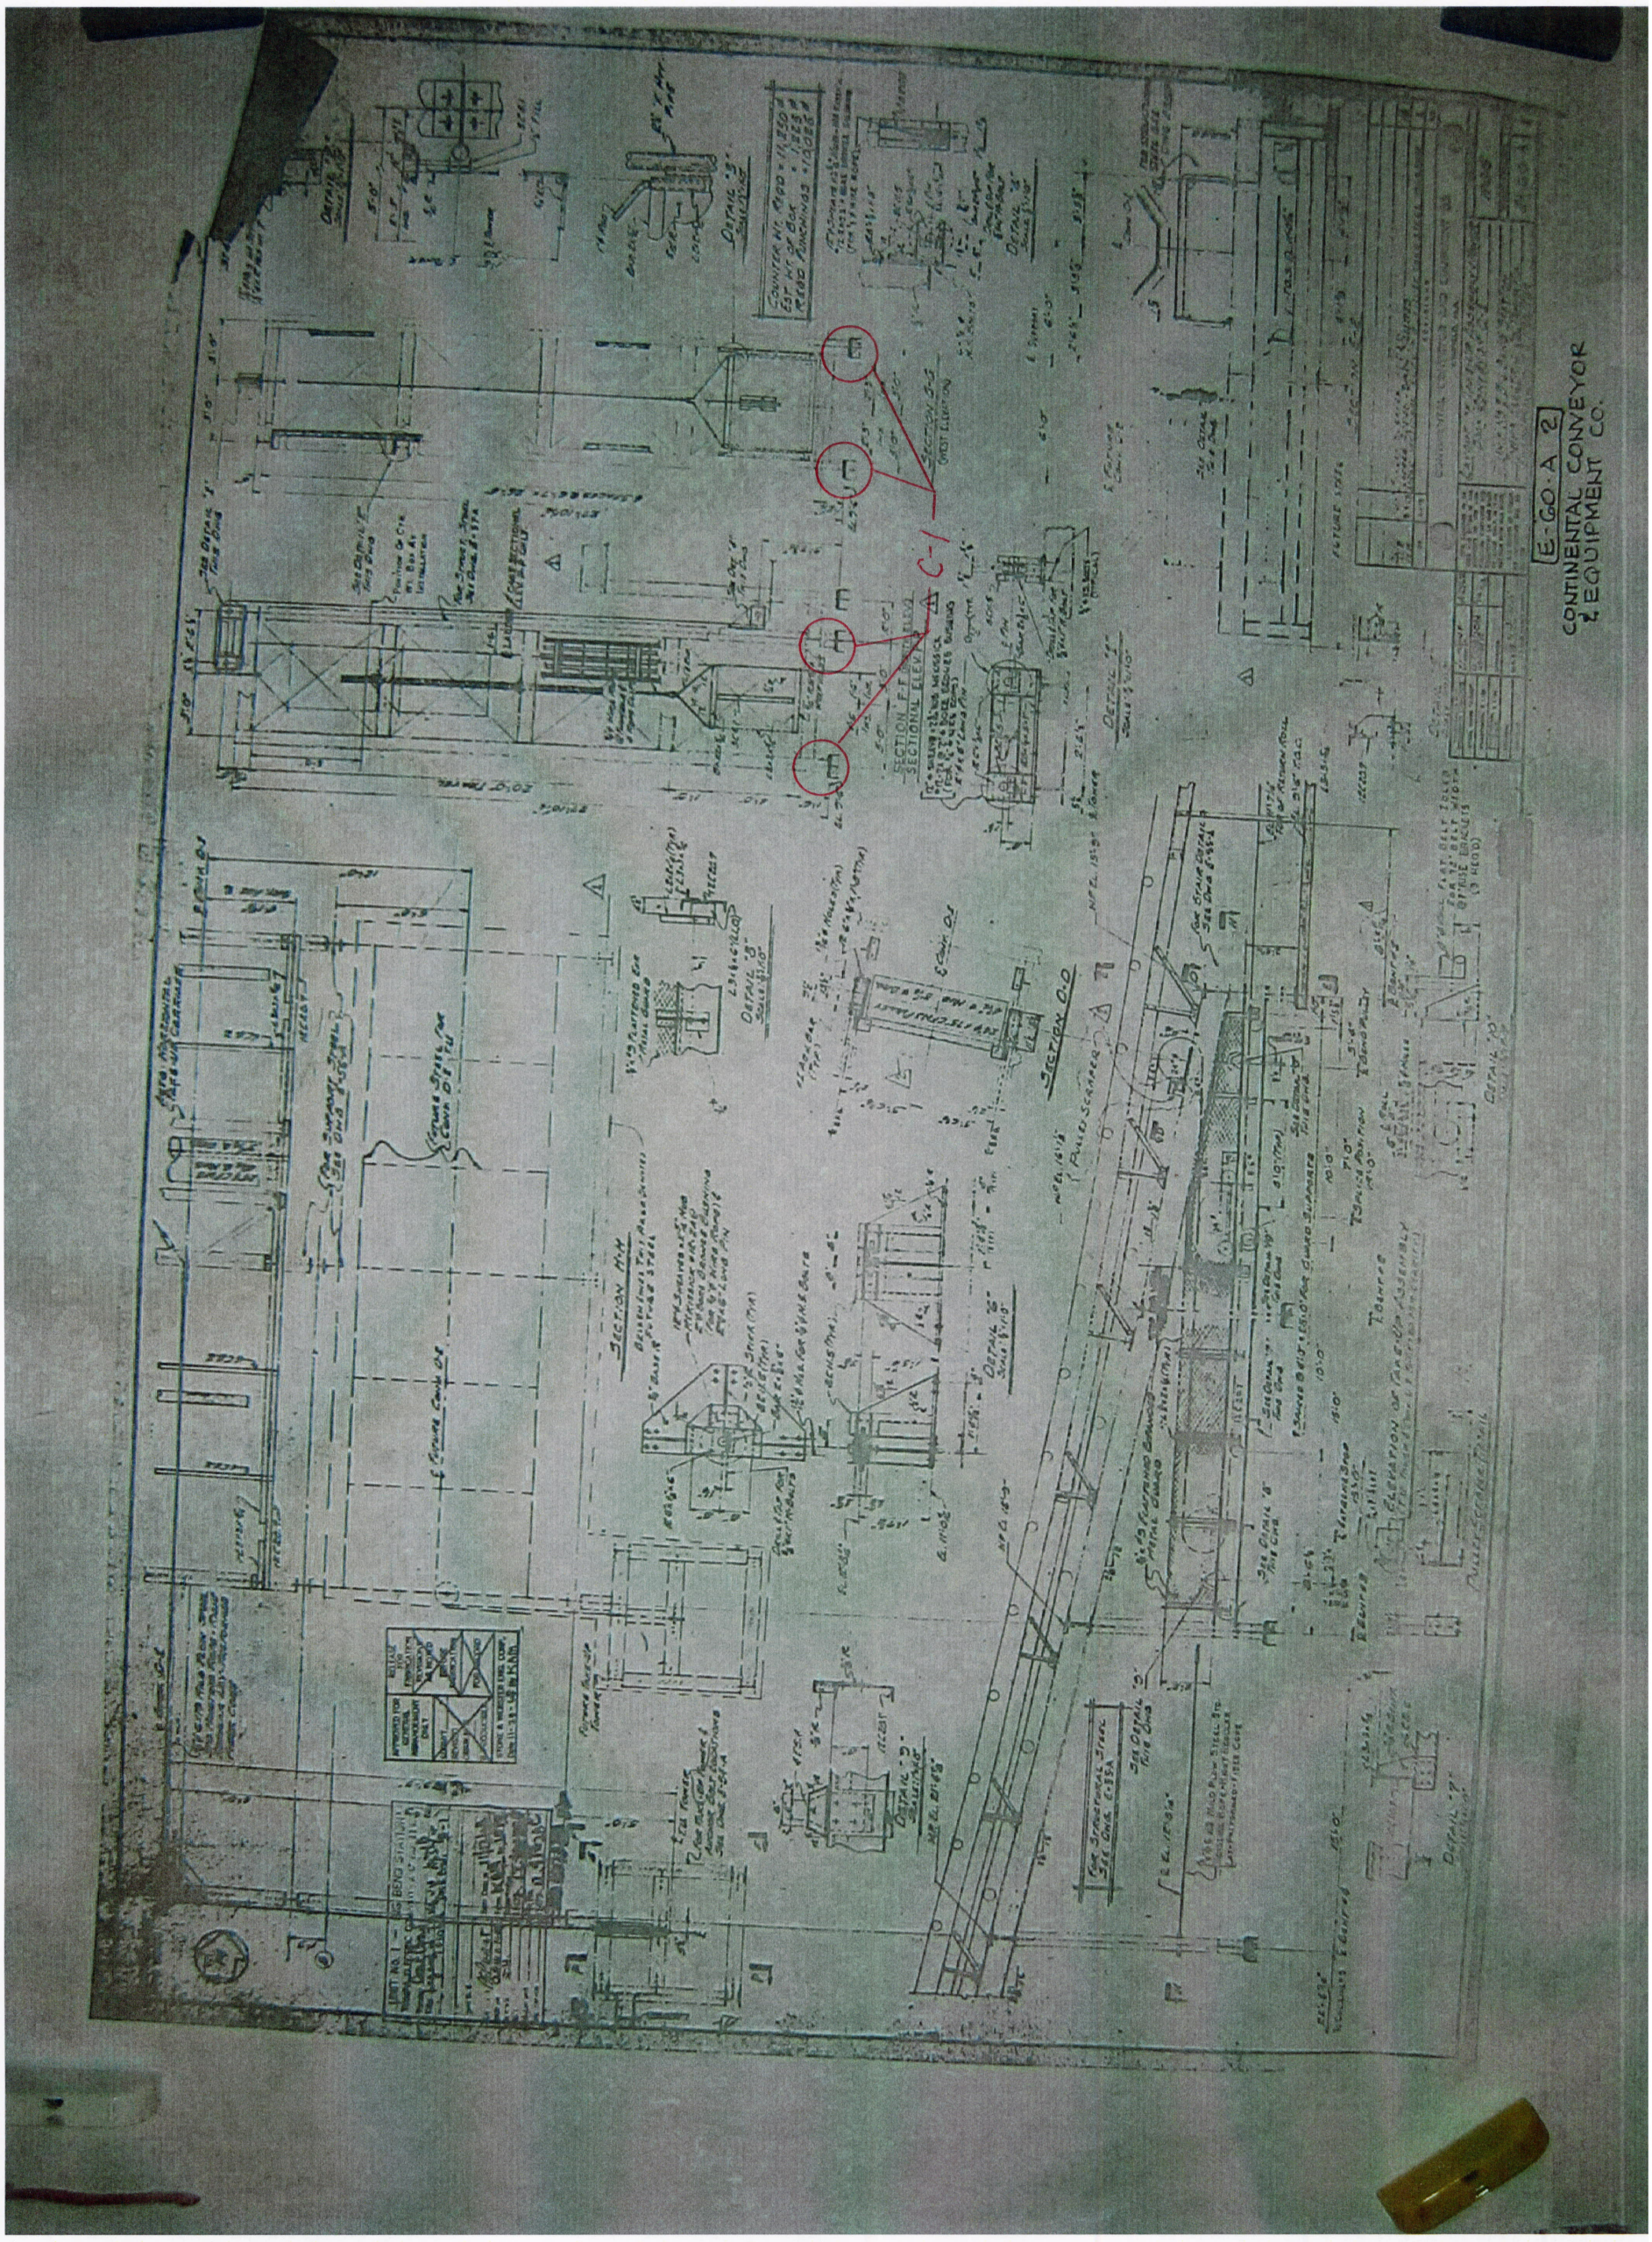
PICTURE CONV-D1-W

Loss of section of members (Pictures CONV-D1-W and CONV-D1-X).

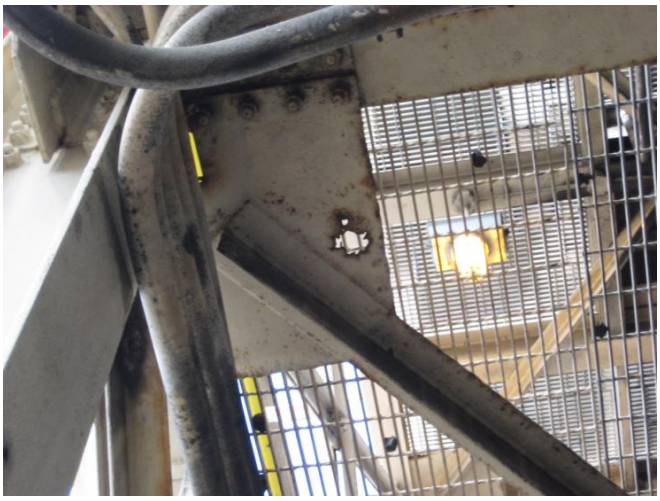
PICTURE TTWR-T2-J

C-2 Horizontal brace and gusset plate have severe corrosion and metal loss. Recommend replacing brace and gusset plate in kind. See included photo TTWR-T2-J.

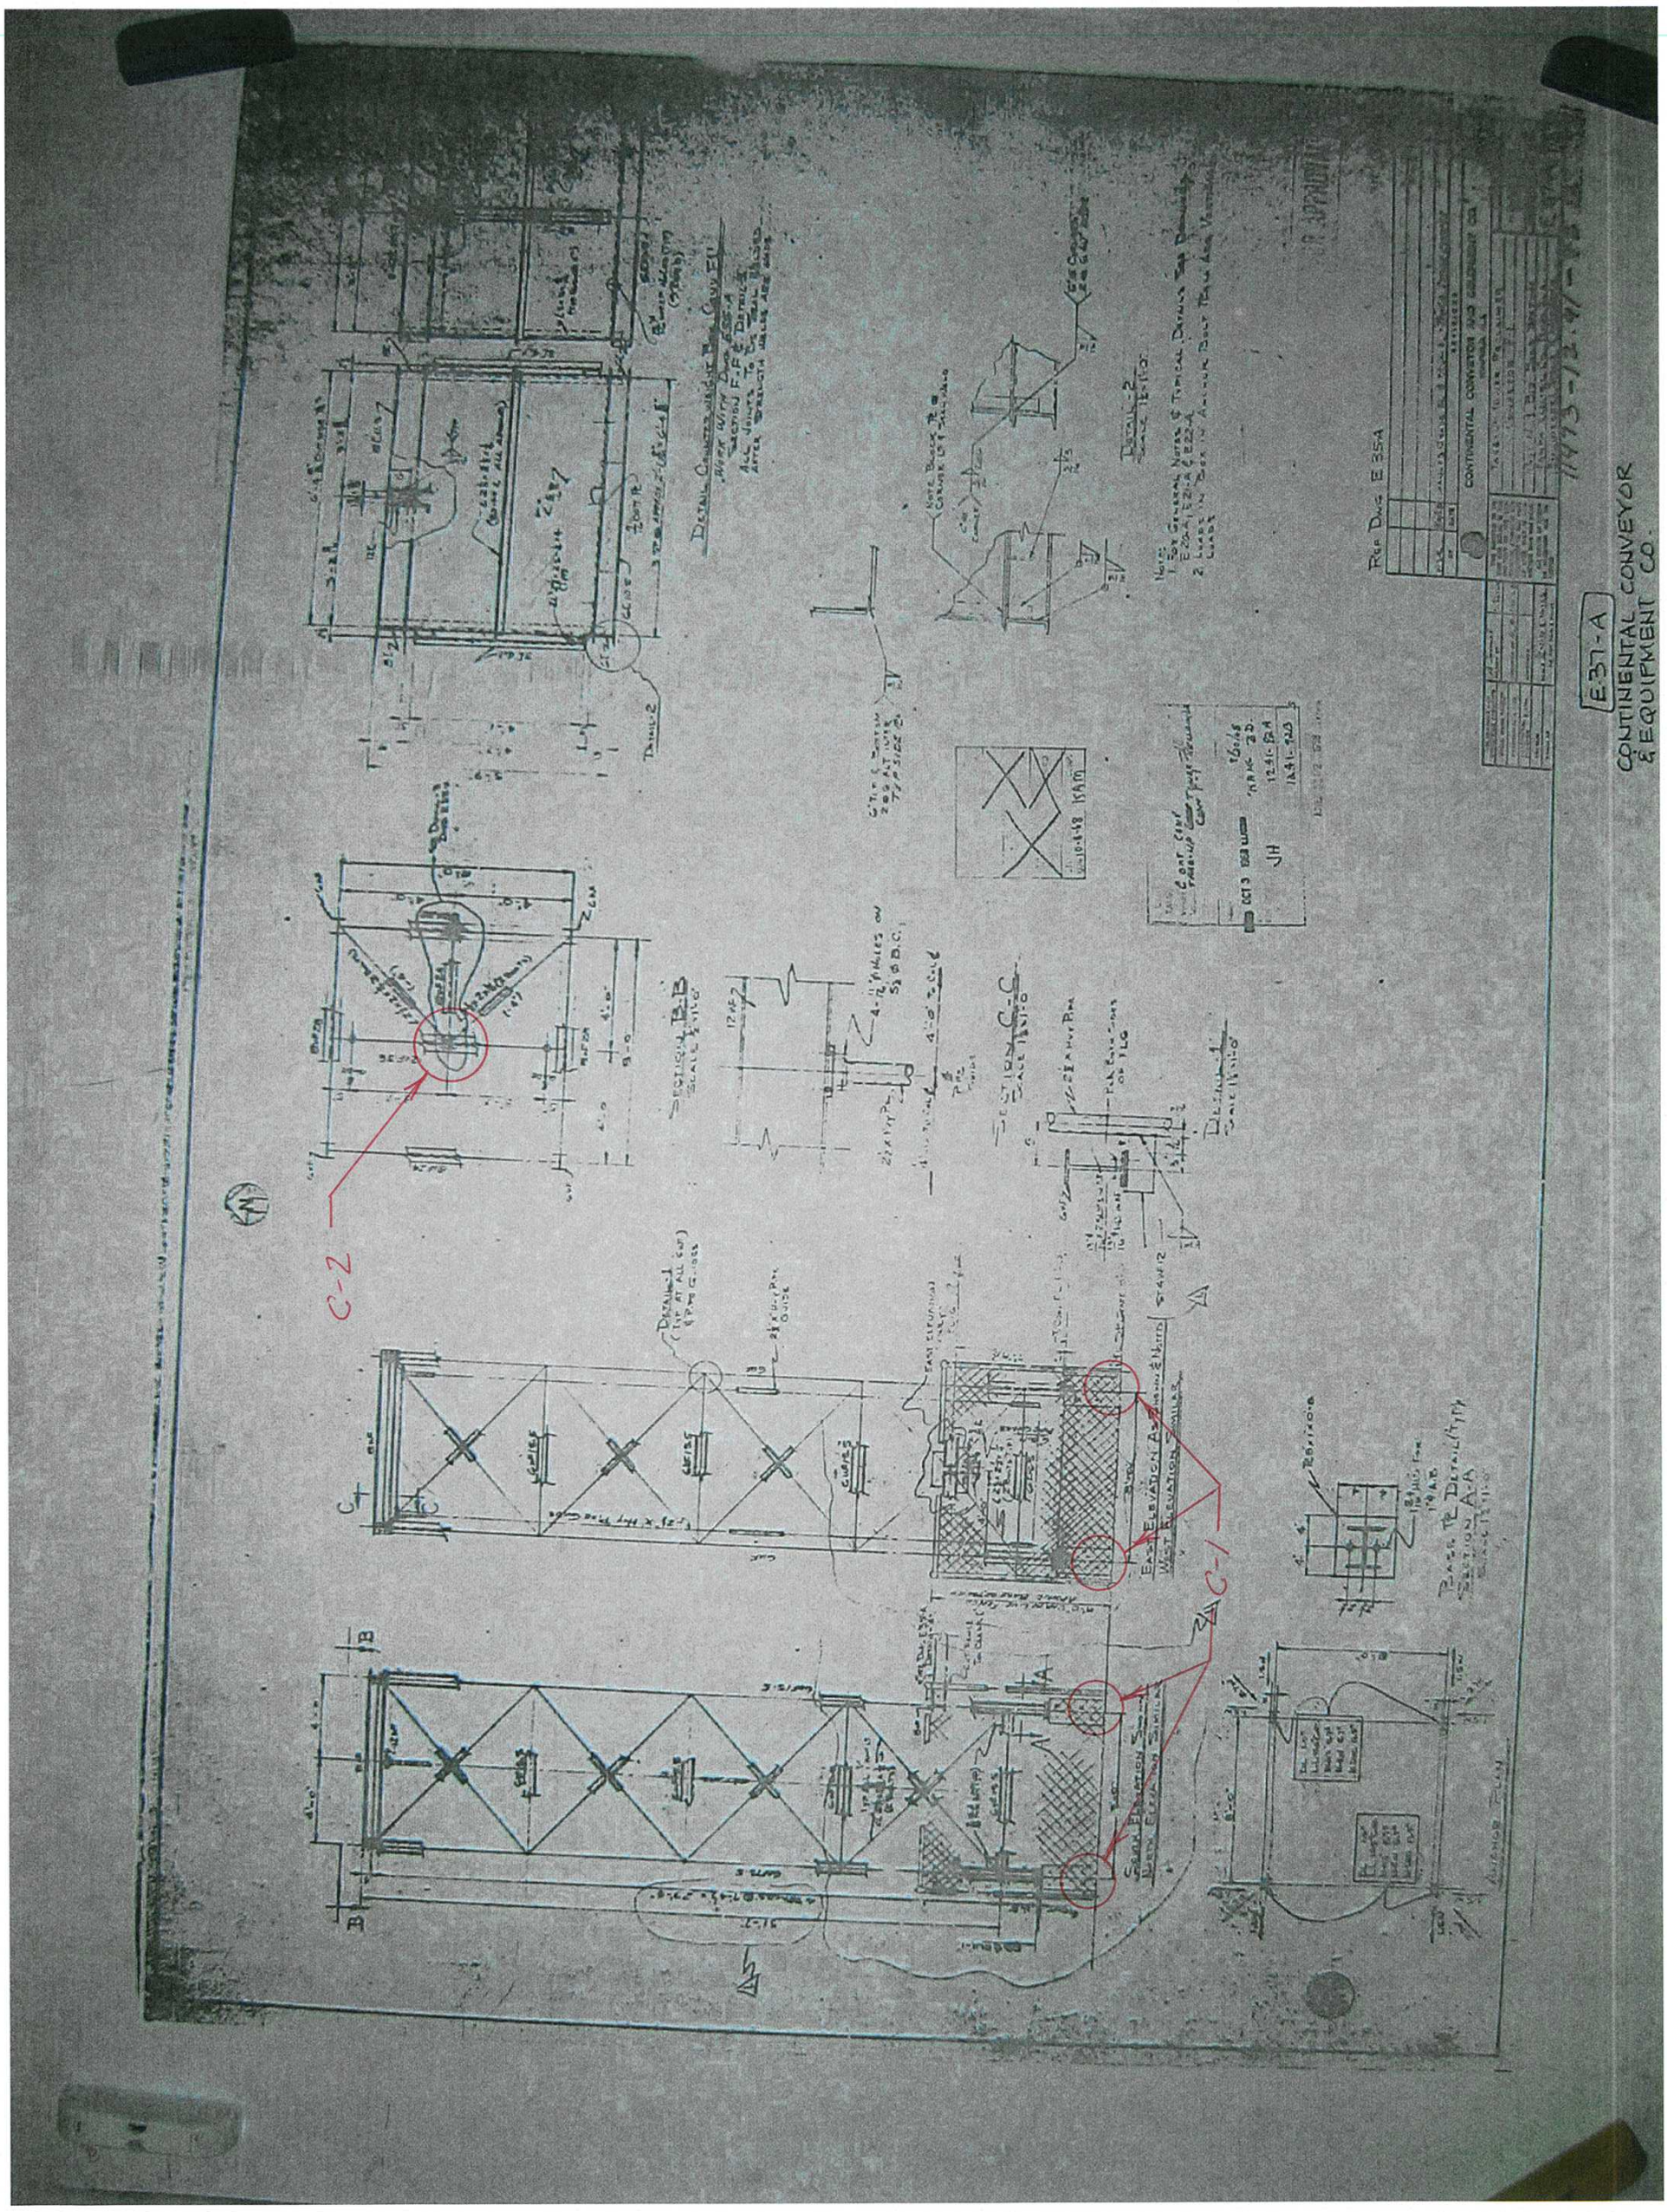
C-2 The framework supporting the horizontal pulley for the Conveyor F1 Take-up is extremely corroded as seen in Pictures CONV-F1-J and CONV-F1-K. This framing will need cleaning and paint, at the least, and possibly repairs if cleaning back to solid metal exposes significant loss of section of the members.

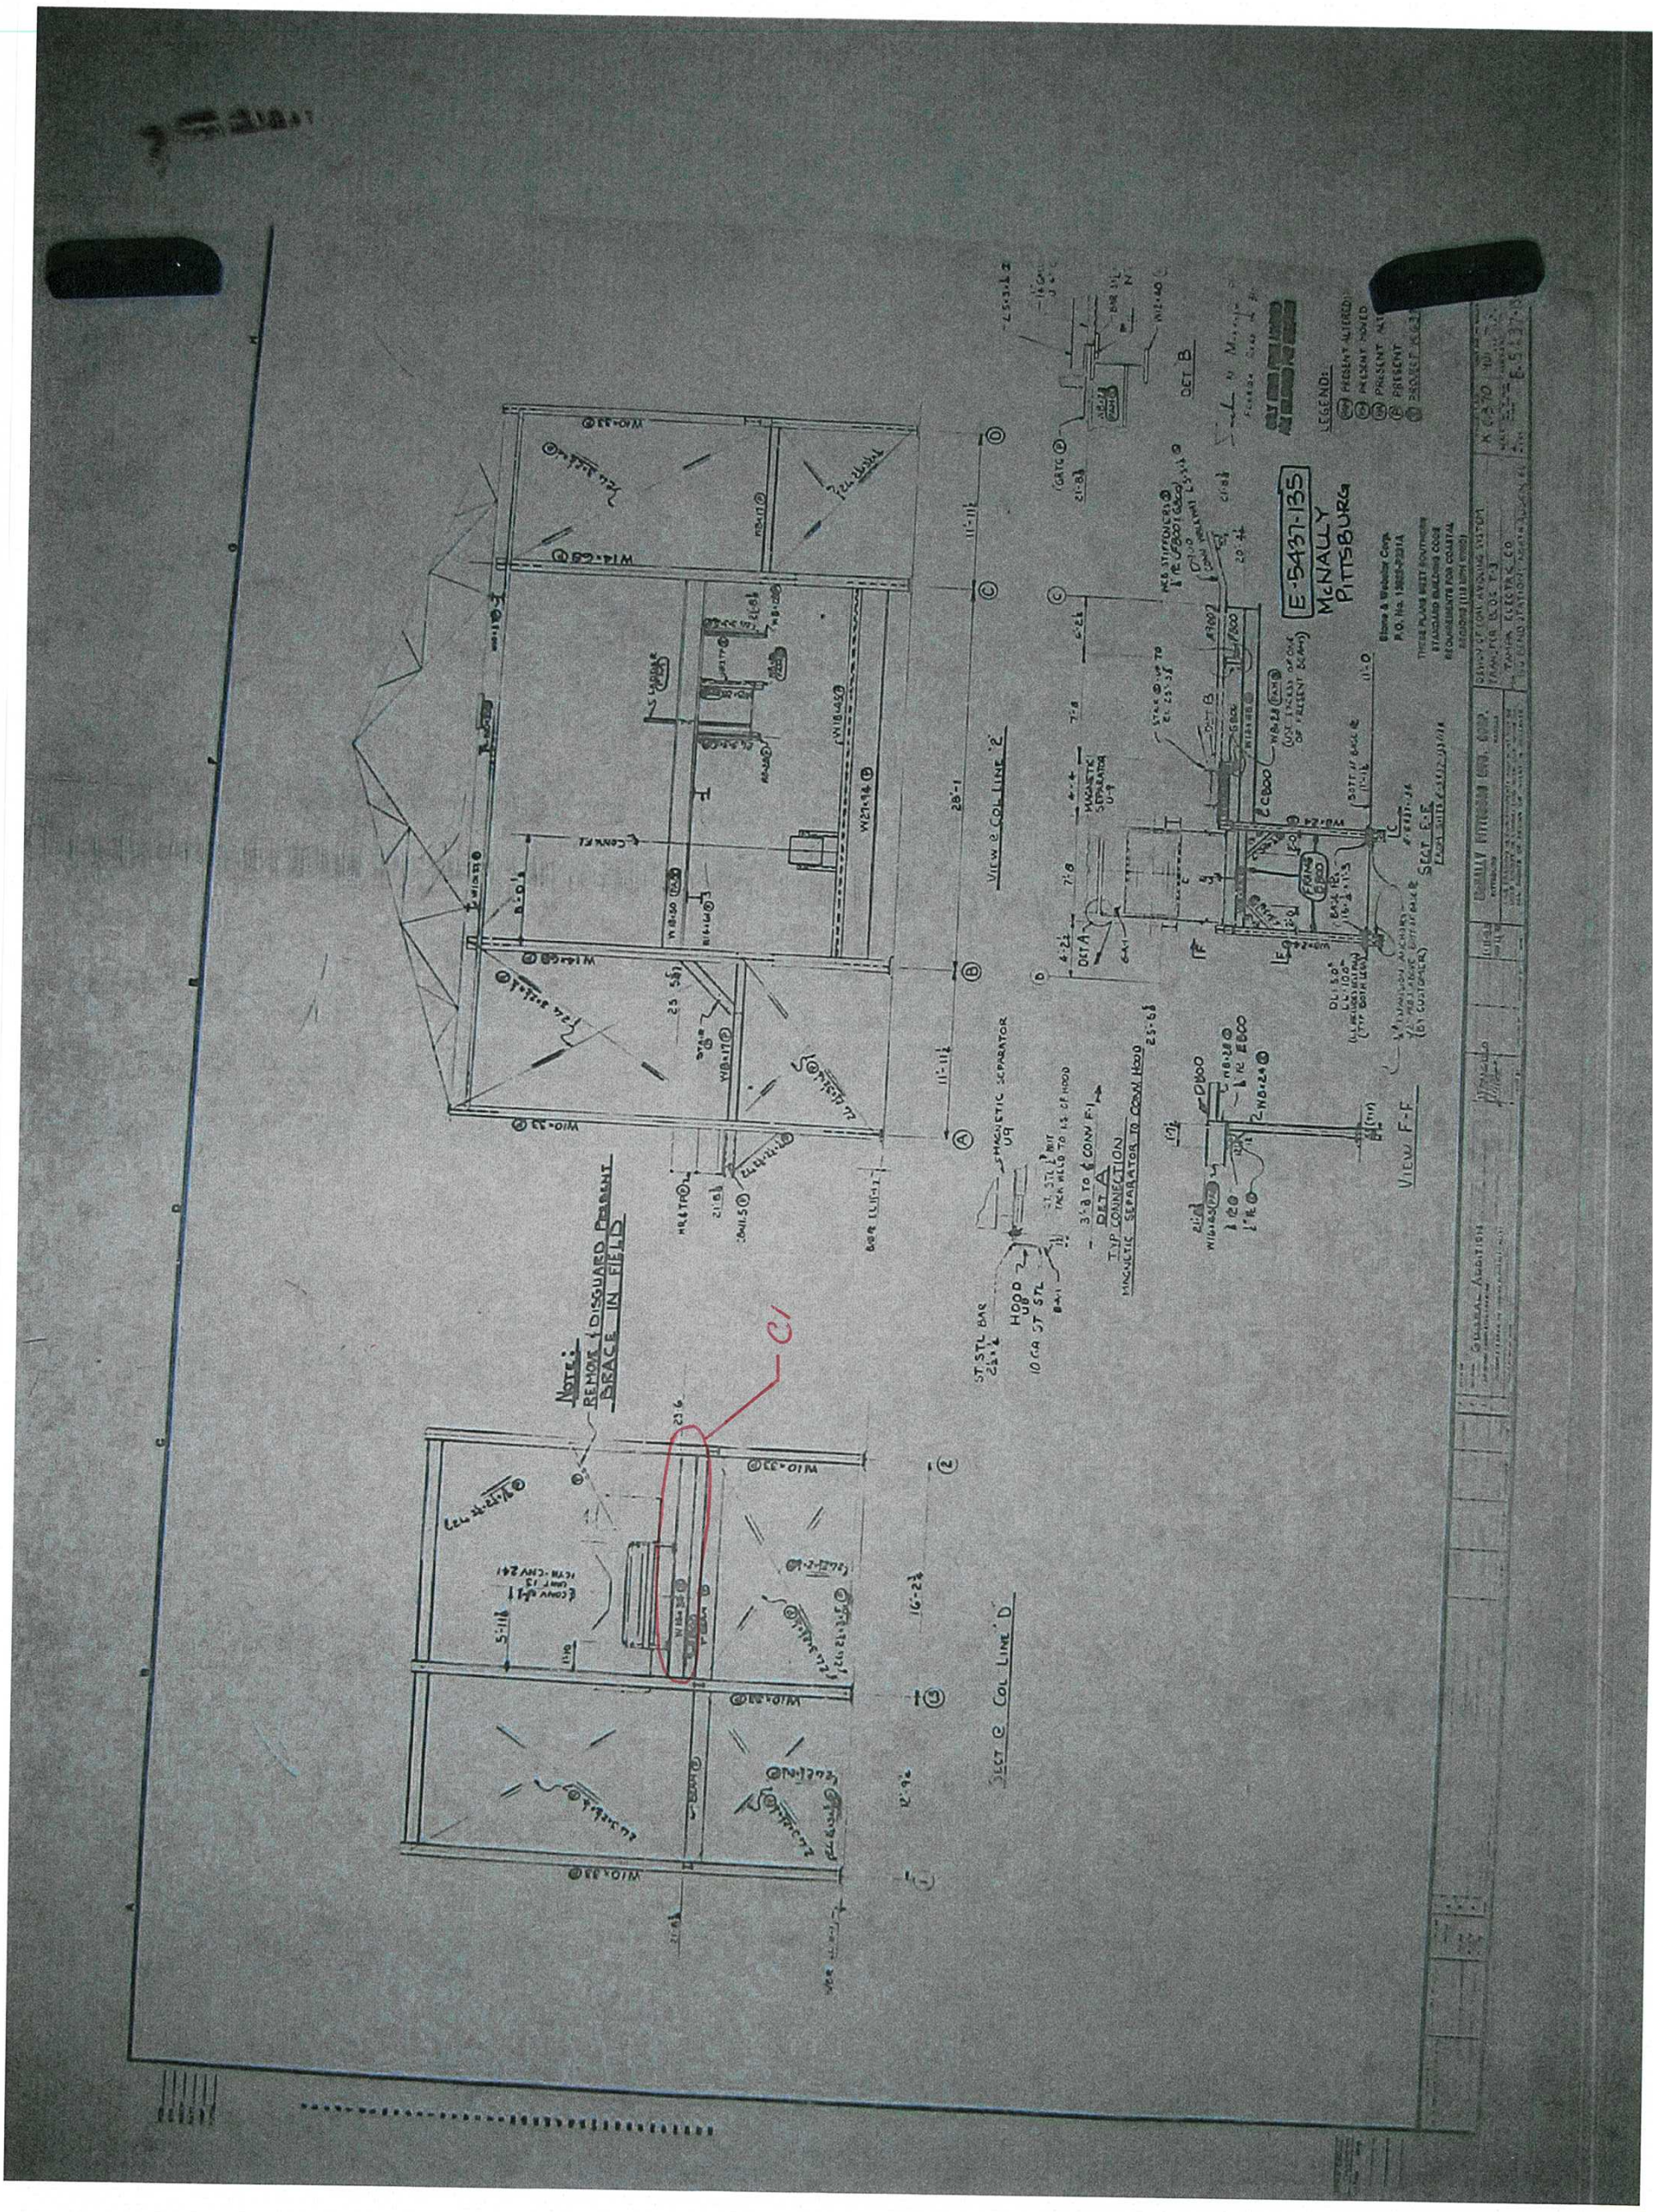
PICTURE TTWR-T3-AD

C-1 Framing supporting Conveyor J1 has severe corrosion as seen in picture TTWR-T3-AD. Framing needs cleaning and painting/repair as required.

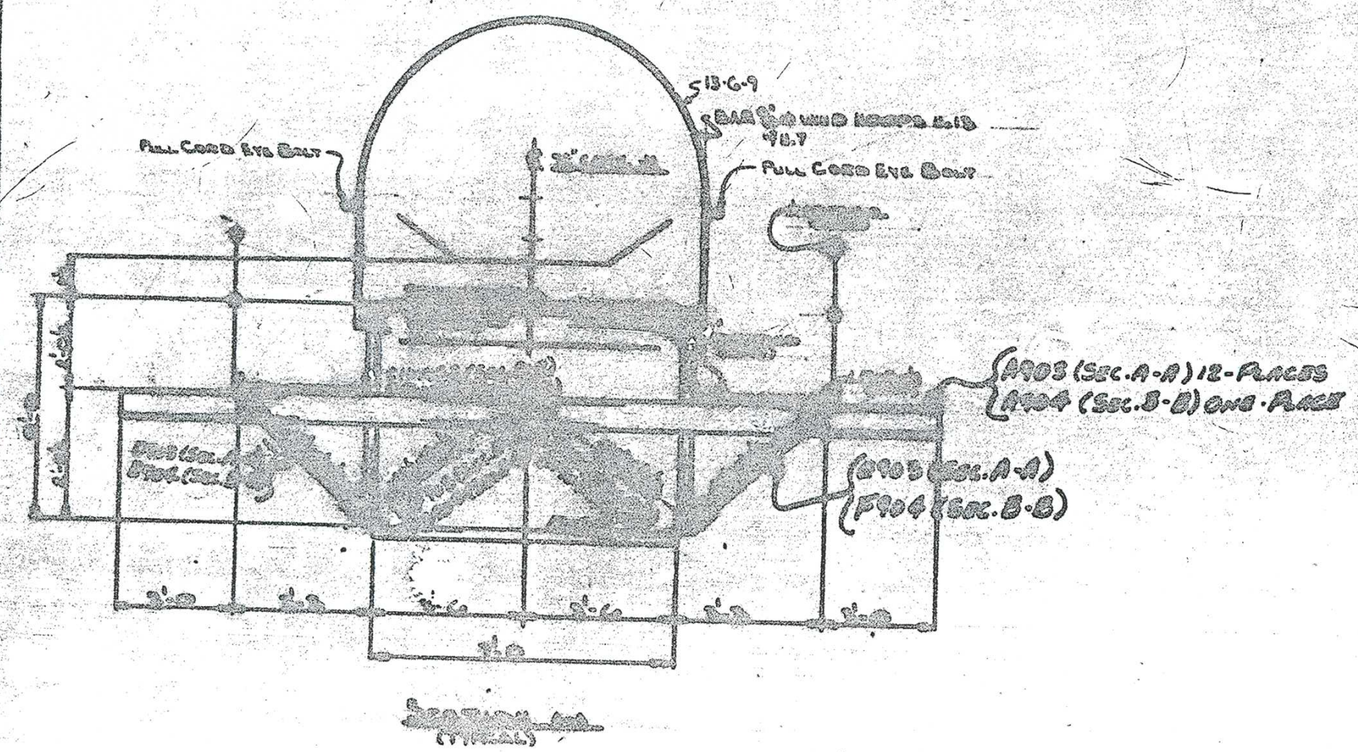
C-6 Chord cross members both in the horizontal and vertical are corroded. Recommend replacing in kind.

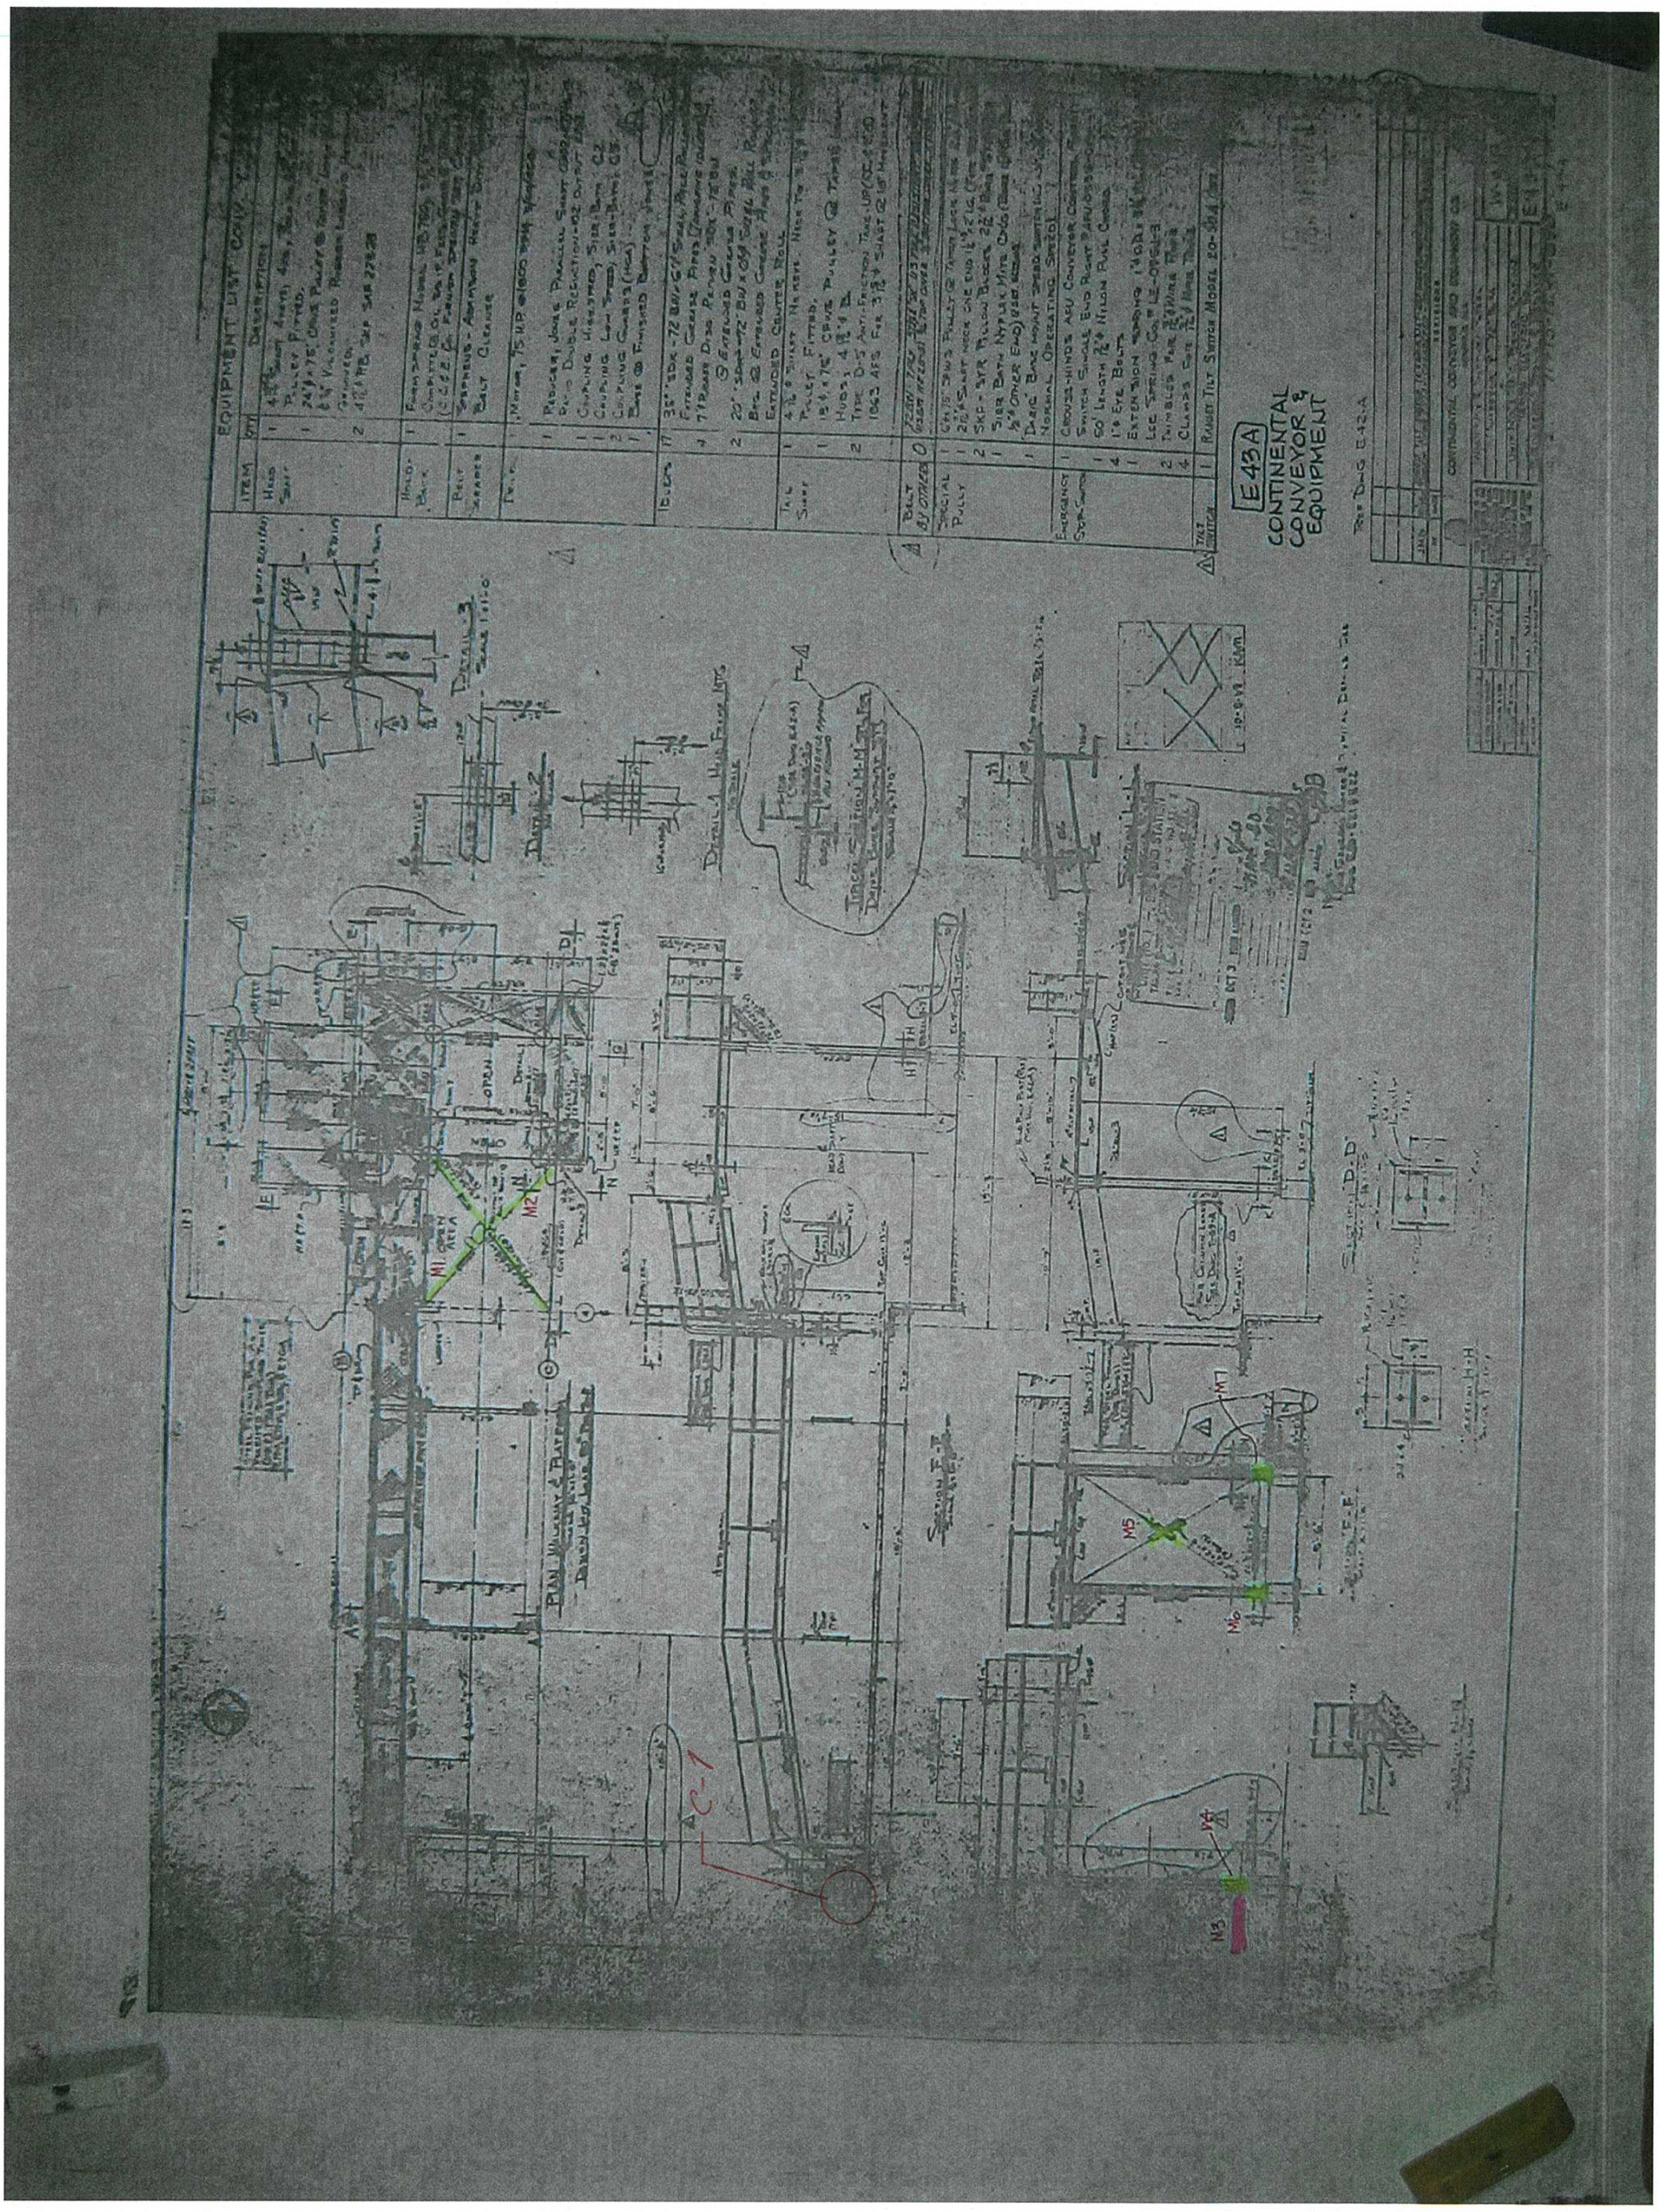
PICTURE CONV-Y-G

C-1 The bottoms of the stair stringers on the west side of conveyor Y have corroded severely, as seen in picture CONV-Y-G and need to be repaired.

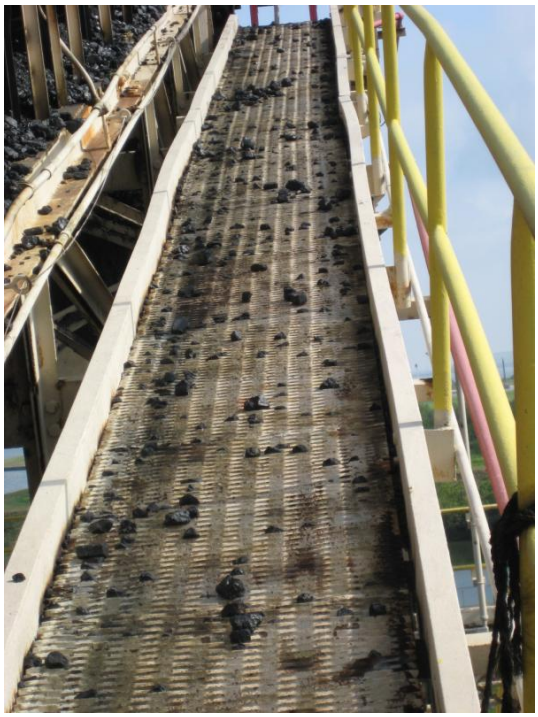
PICTURE CONV-Z-D

C-3 The grating support is separating from the walkway stringers, as seen in pictures CONV-Z-D thru CONV-Z-H. The presence of coal on the inclined walkway also makes walking up the incline difficult. The coal tends to roll under foot.

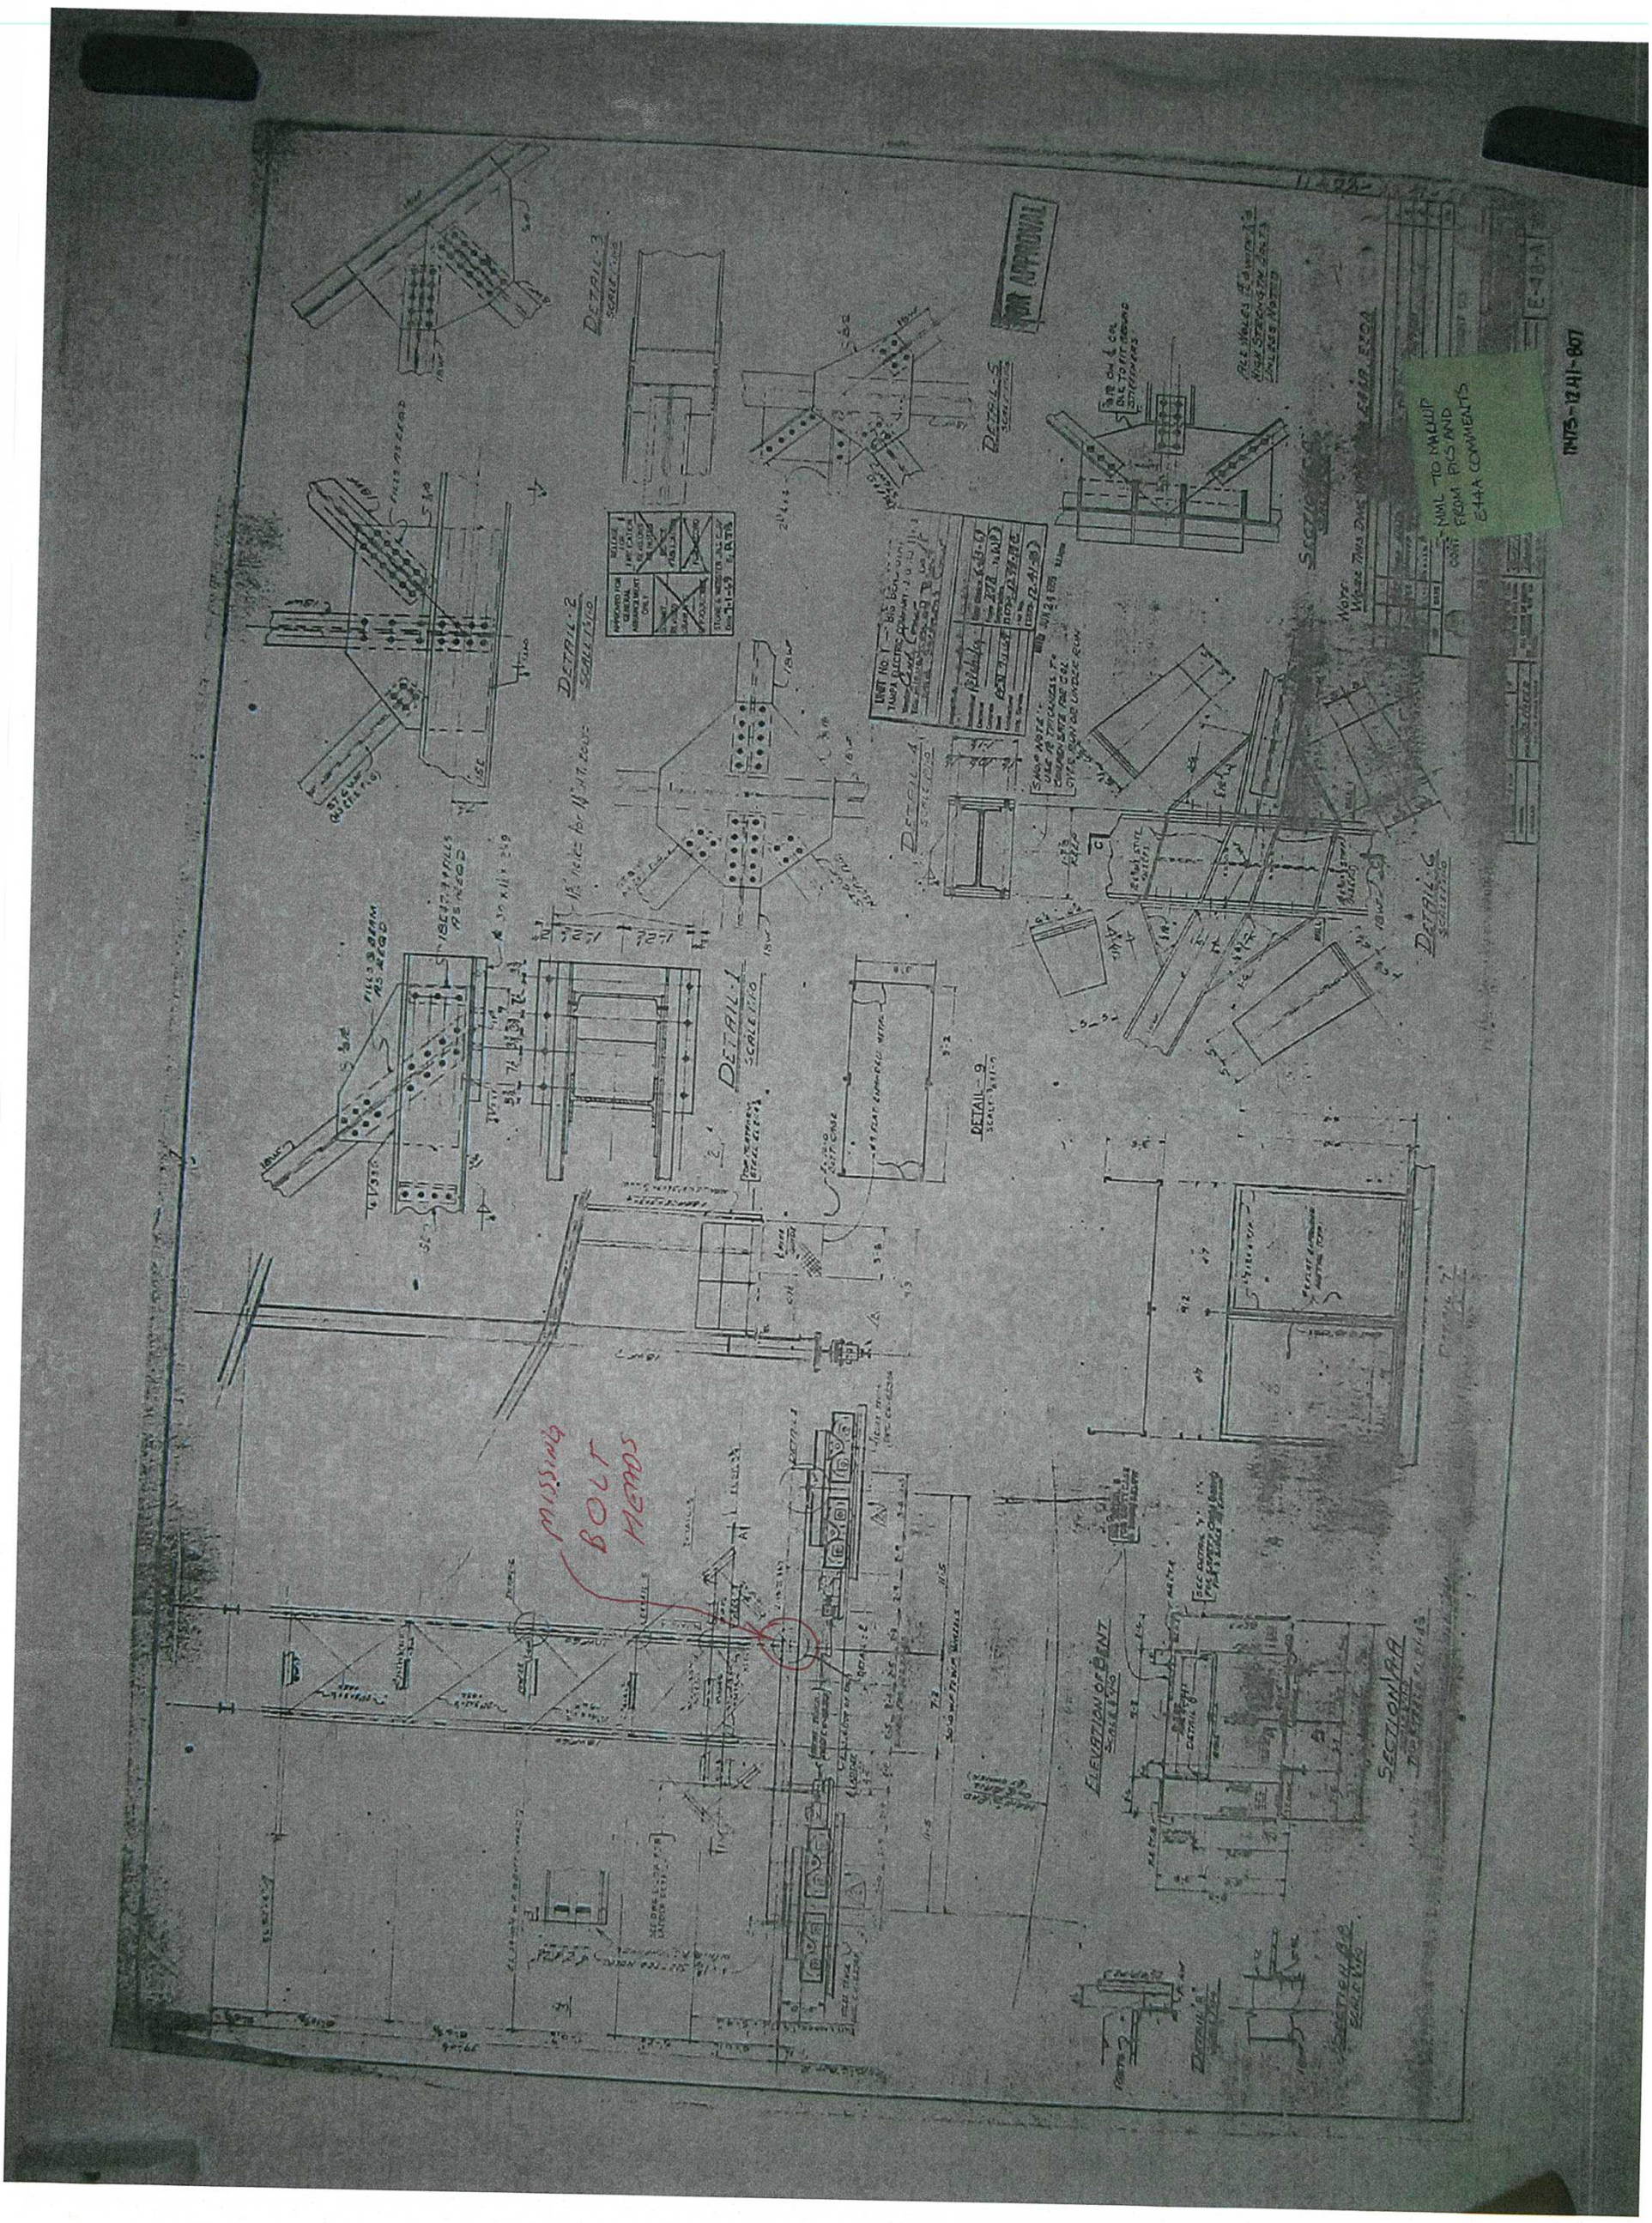
At the bottom of the pivot bent, there are some missing bolt heads on the inside surfaces of the gusset plates at the location of Detail 2 on the drawing on the west end. These may have fractured off when the conveyor overturned previously. This bent also needs some cleaning and painting.
