# Tampa Electric Company (TECO)
# Coal Yard Assessment
## Stantec Job No. 198800347

September 2010
Revision 2

## EXECUTIVE SUMMARY

Stantec has been retained by Tampa Electric Company to provide a review of the coal field equipment at the Big Bend facility. The review scope boundaries are from the dock through conveyors L1 and L2 that bring the coal to the tripper deck in the power house.

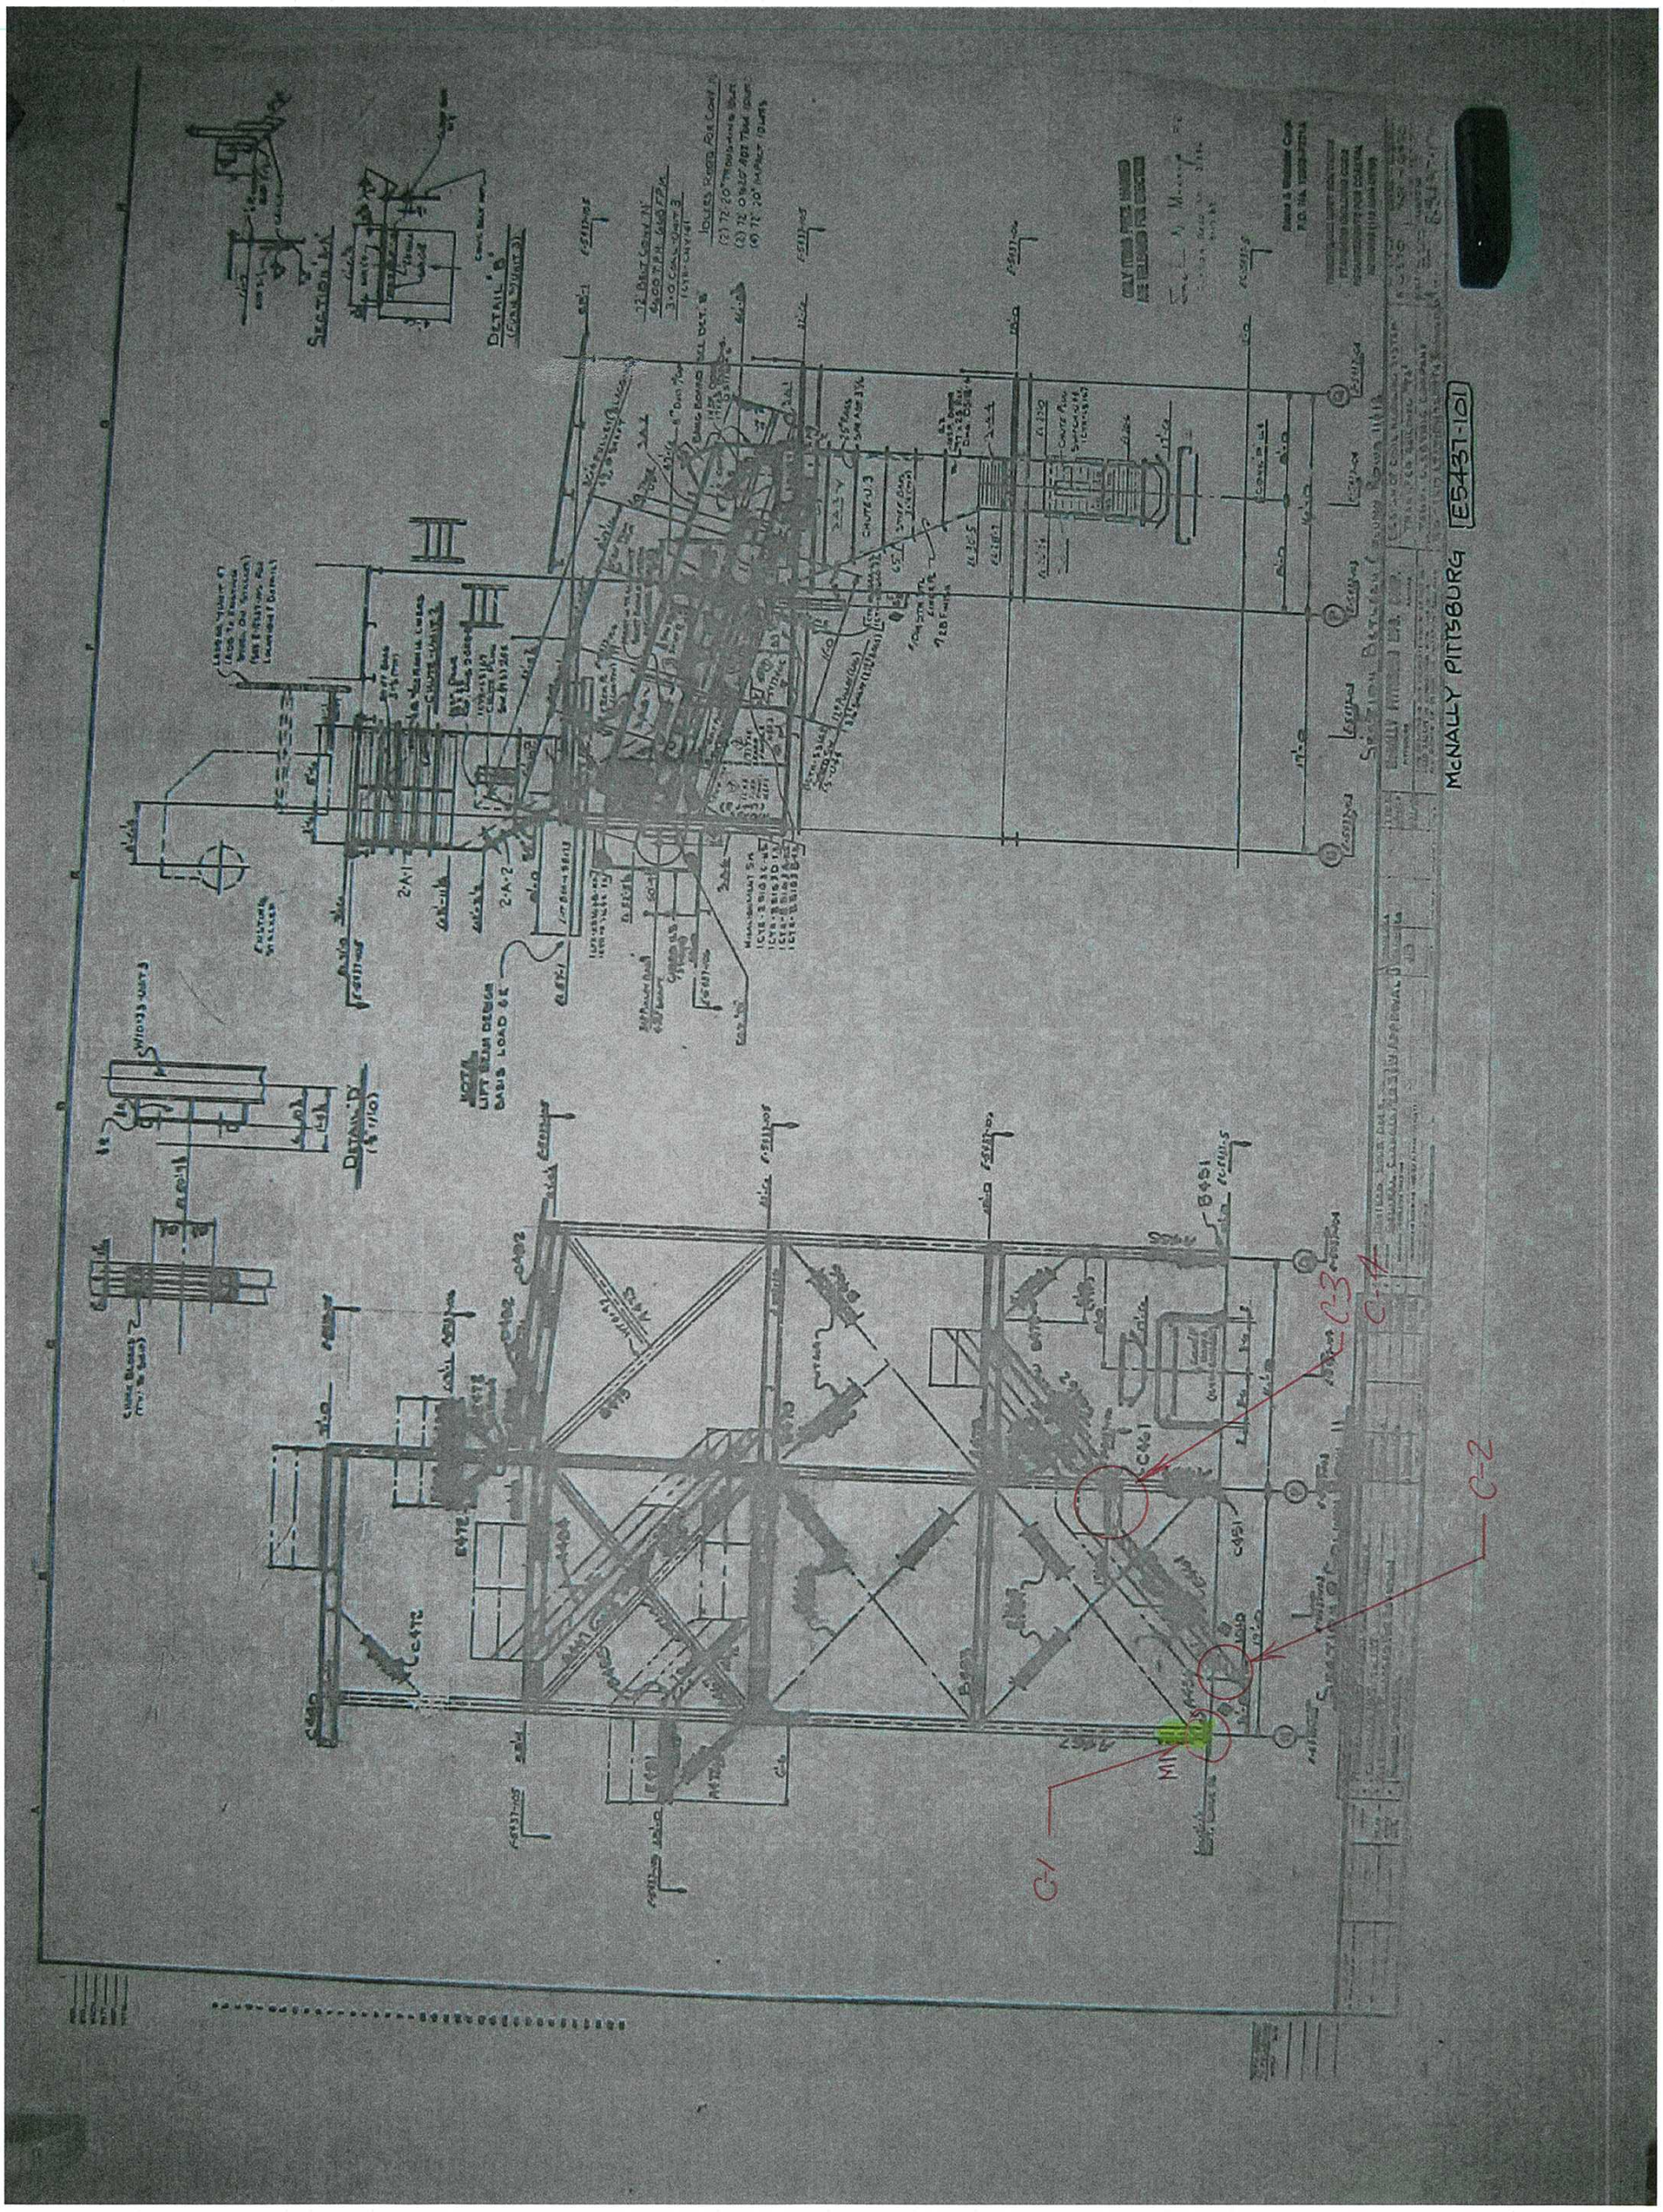
PICTURE TTWR-T4-K

C-1 The ladder from the top of conveyor Z to the top of transfer tower T-4 does not appear to comply with OSHA requirements. The toe plate directly below the ladder, as seen in picture TTWR-T4-K provides a tripping hazard for anyone using the ladder. Also, the ladder itself should be over the grating of the lower platform, not beyond it. The ladder should be extended out over the lower platform or the toe plate removed and a landing behind the ladder added that complies with OSHA regulations.

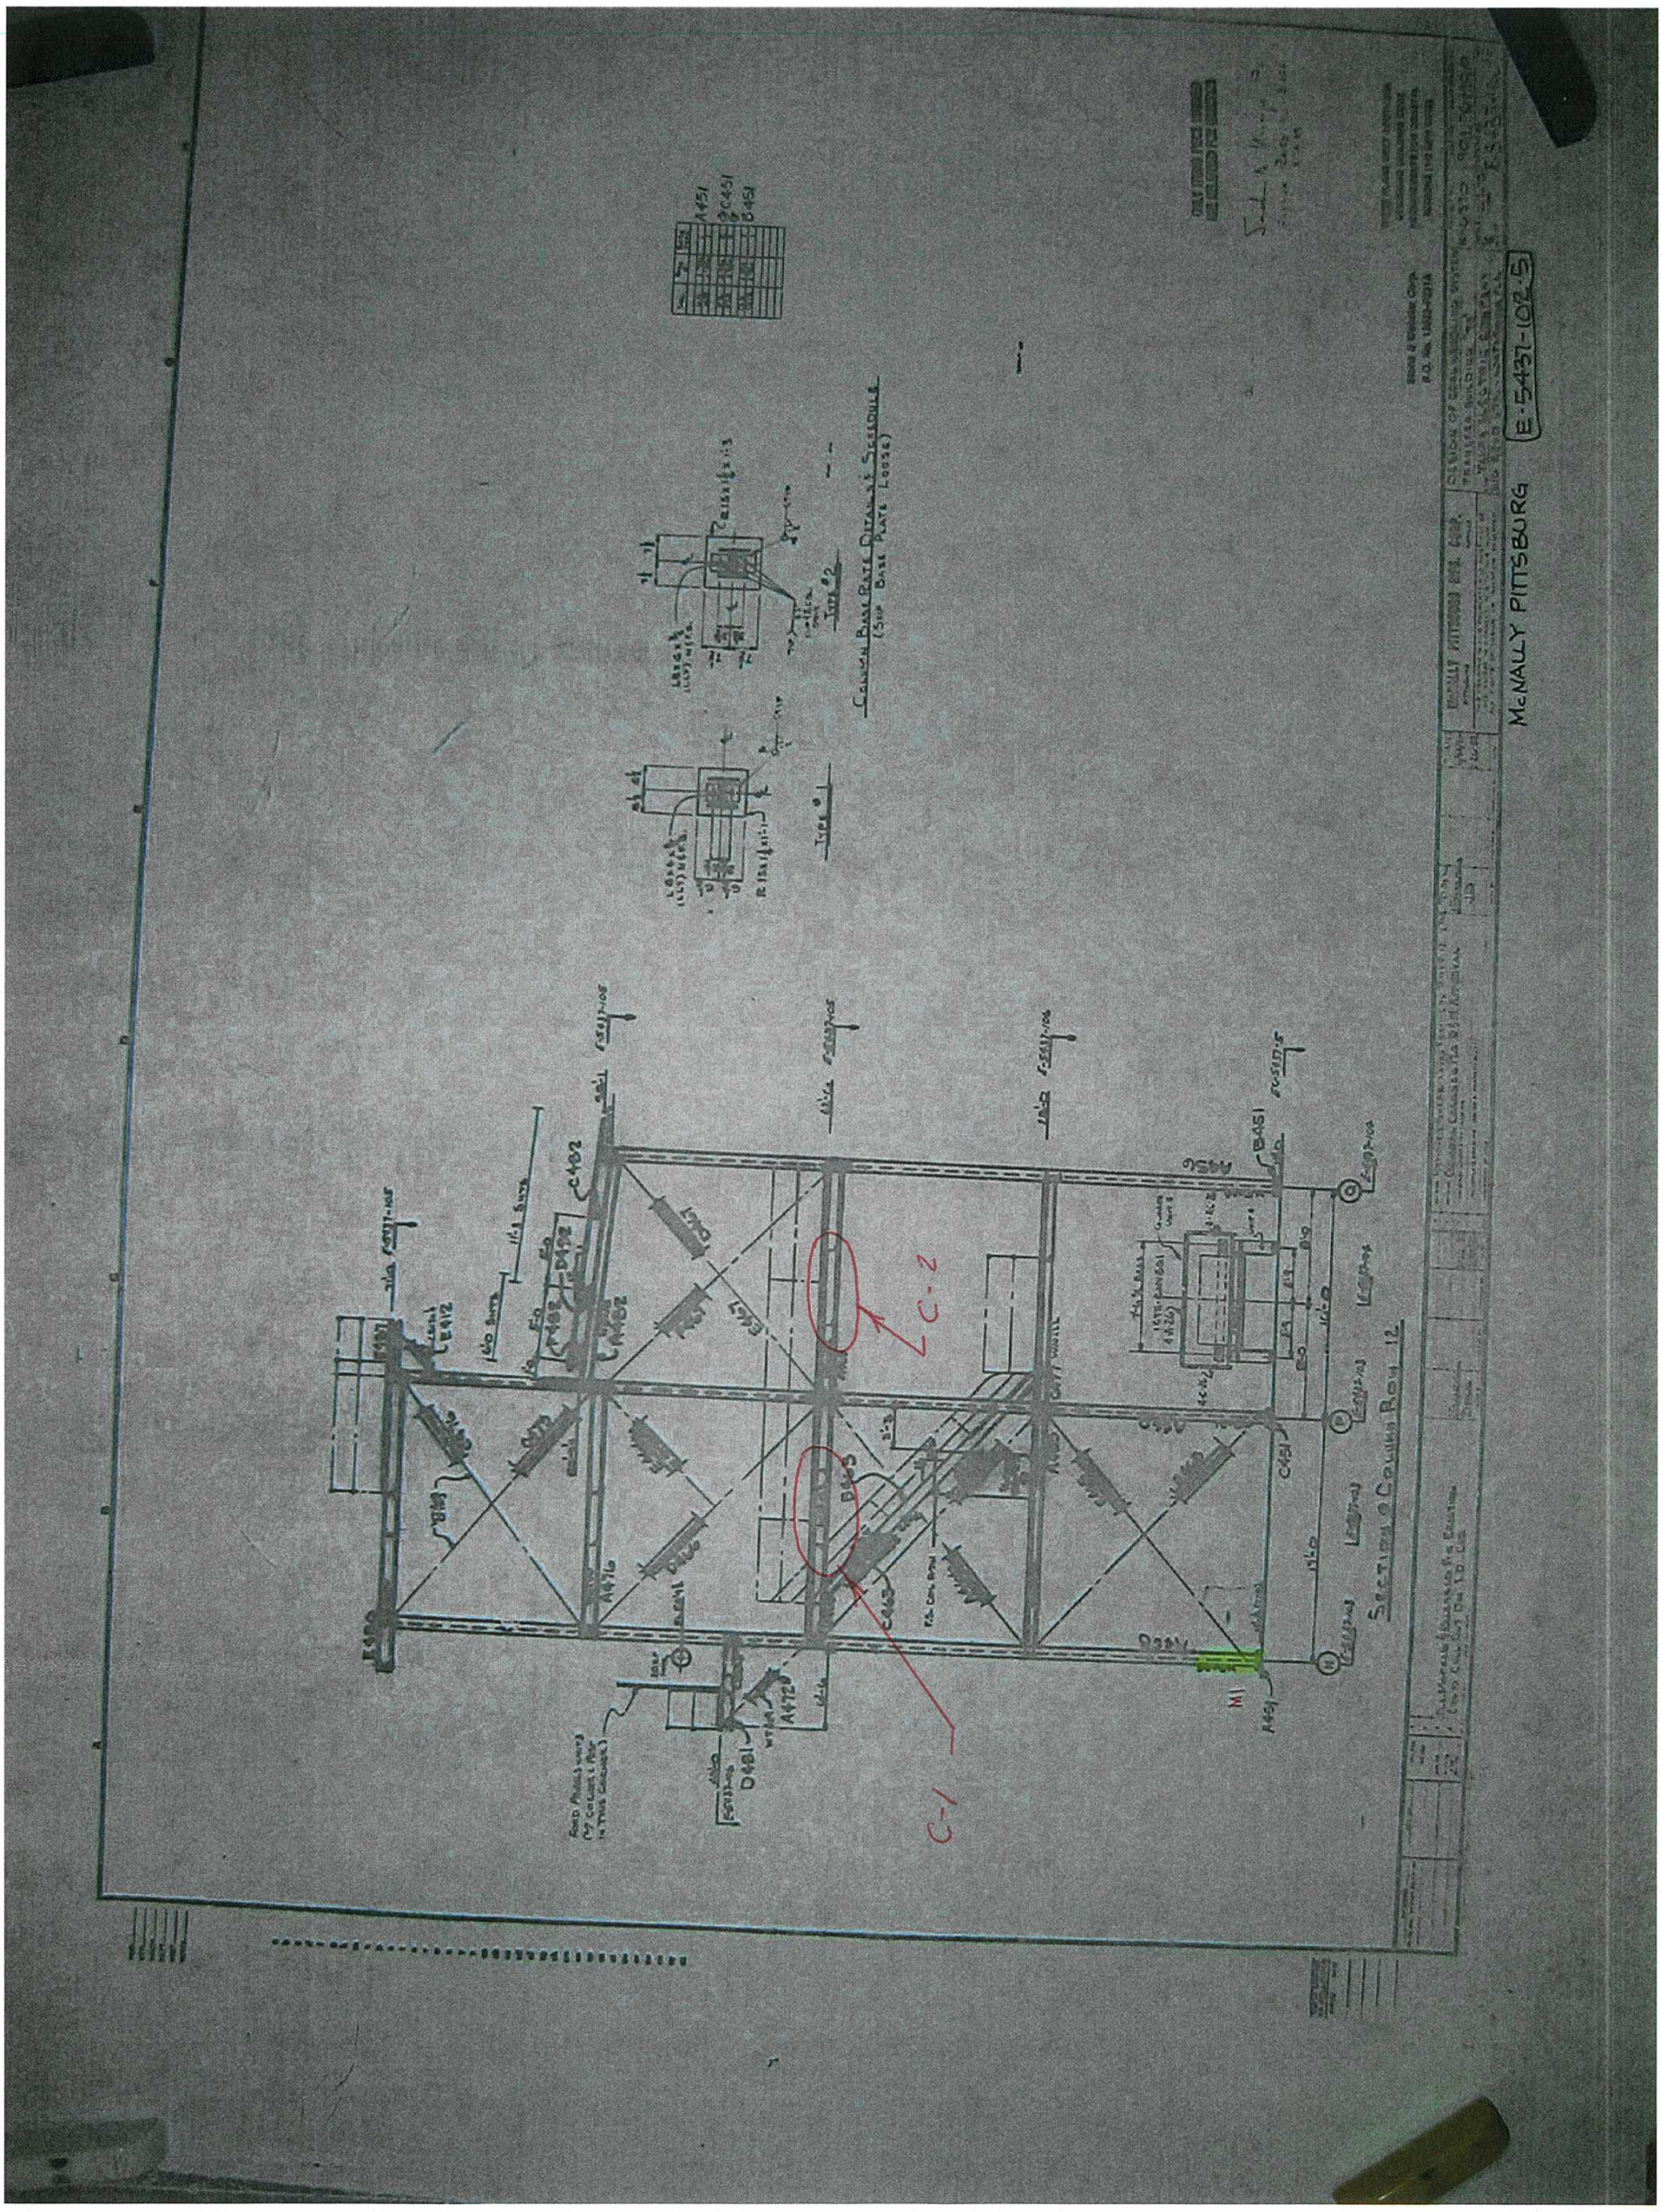
At some locations, the bearing bars of the grating have corroded to the point that they are no longer providing end support for the grating, as seen in picture TTWR-T4-L. In these instances, the grating needs to be replaced, preferably with galvanized grating.

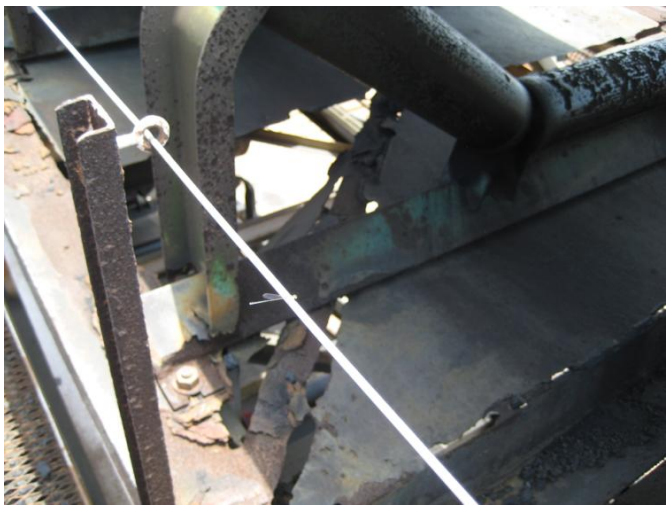
C-3&4 Horizontal brace C-3 has broken free from connection and C-4 has broken at mid-span. See included photo MSR-AA, MSR-E and MSR-G. Recommend replacement in kind. In general all other horizontal braces in the top chord have moderate metal loss and should be cleaned and inspected prior to painting to prevent further damage.

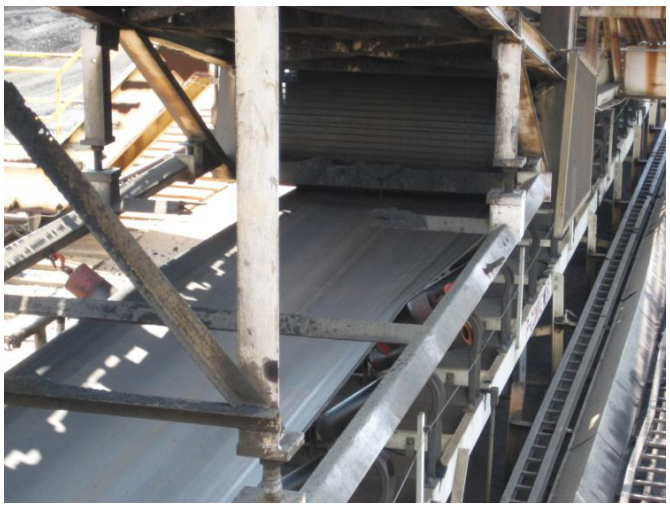
PICTURE MSR-J

C-17 Vertical brace has large portion of stem corroded. See included photo MSR-J. Recommend replacement in kind.

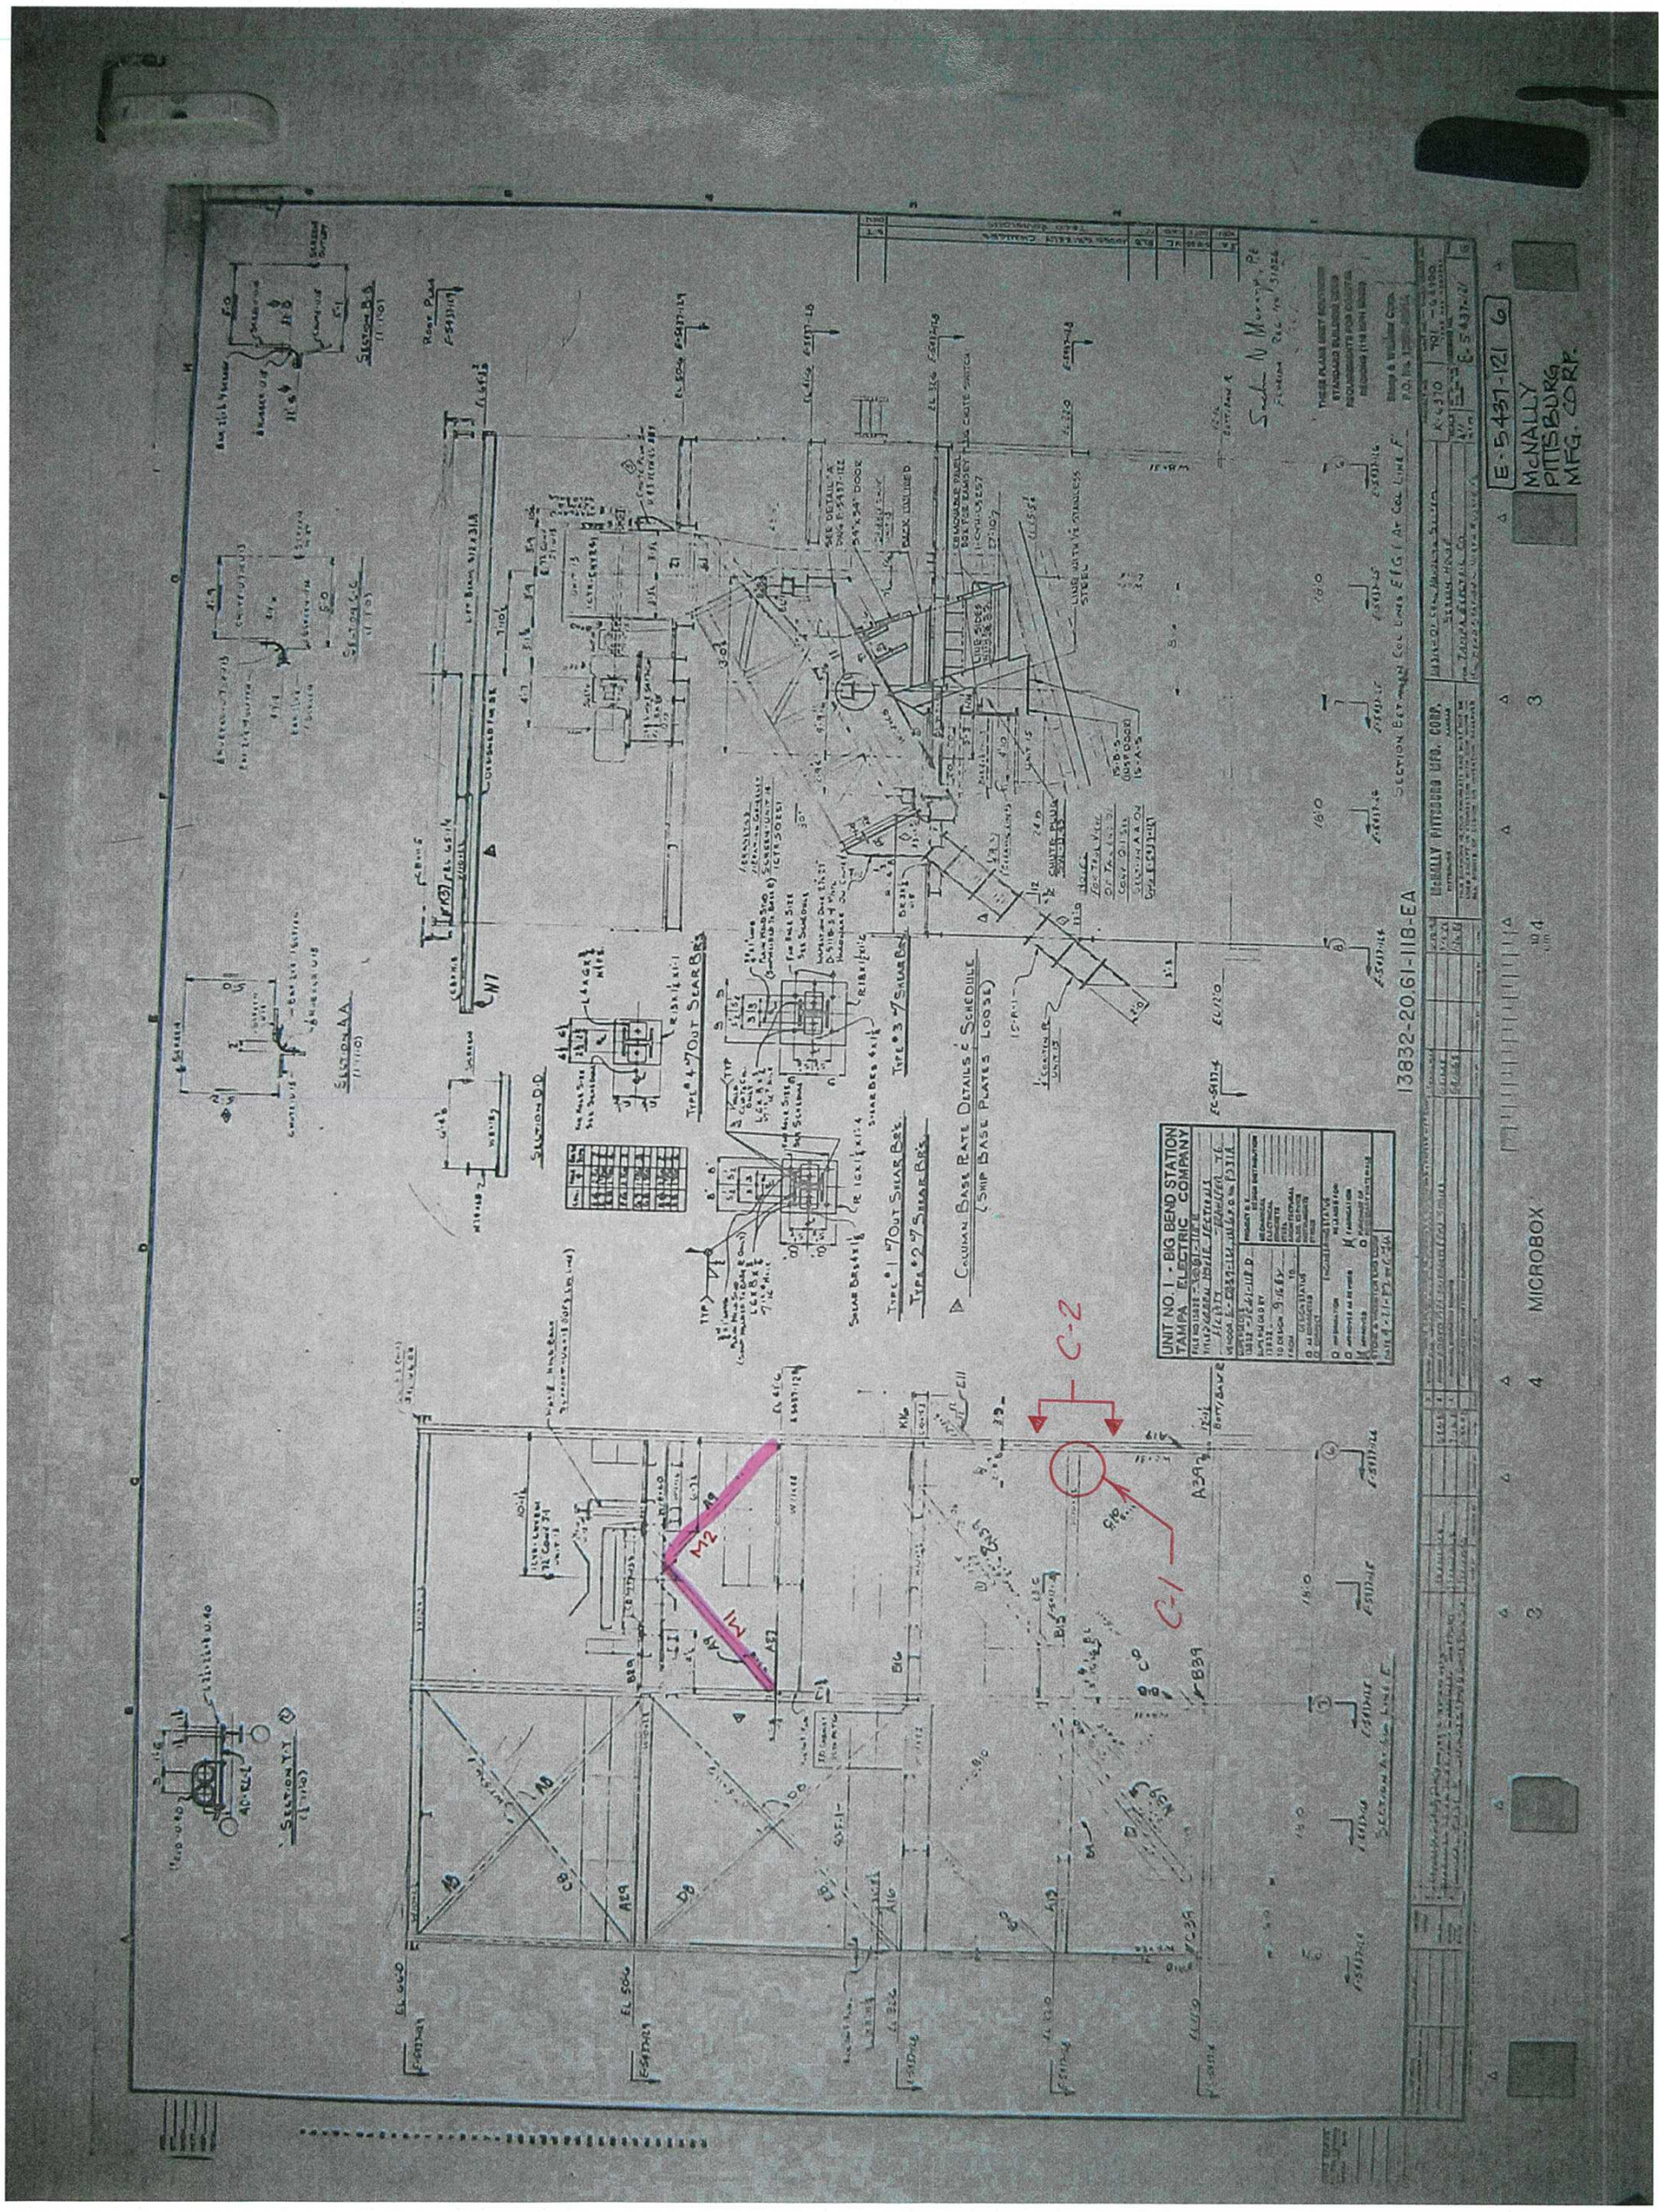
Additionally, pictures TTWR-T6-F and TTWR-T6-G are examples of the condition that the floor framing is in below the grating floor, in part due to the accumulation of coal on the grating mixing with moisture due to rain or humidity.

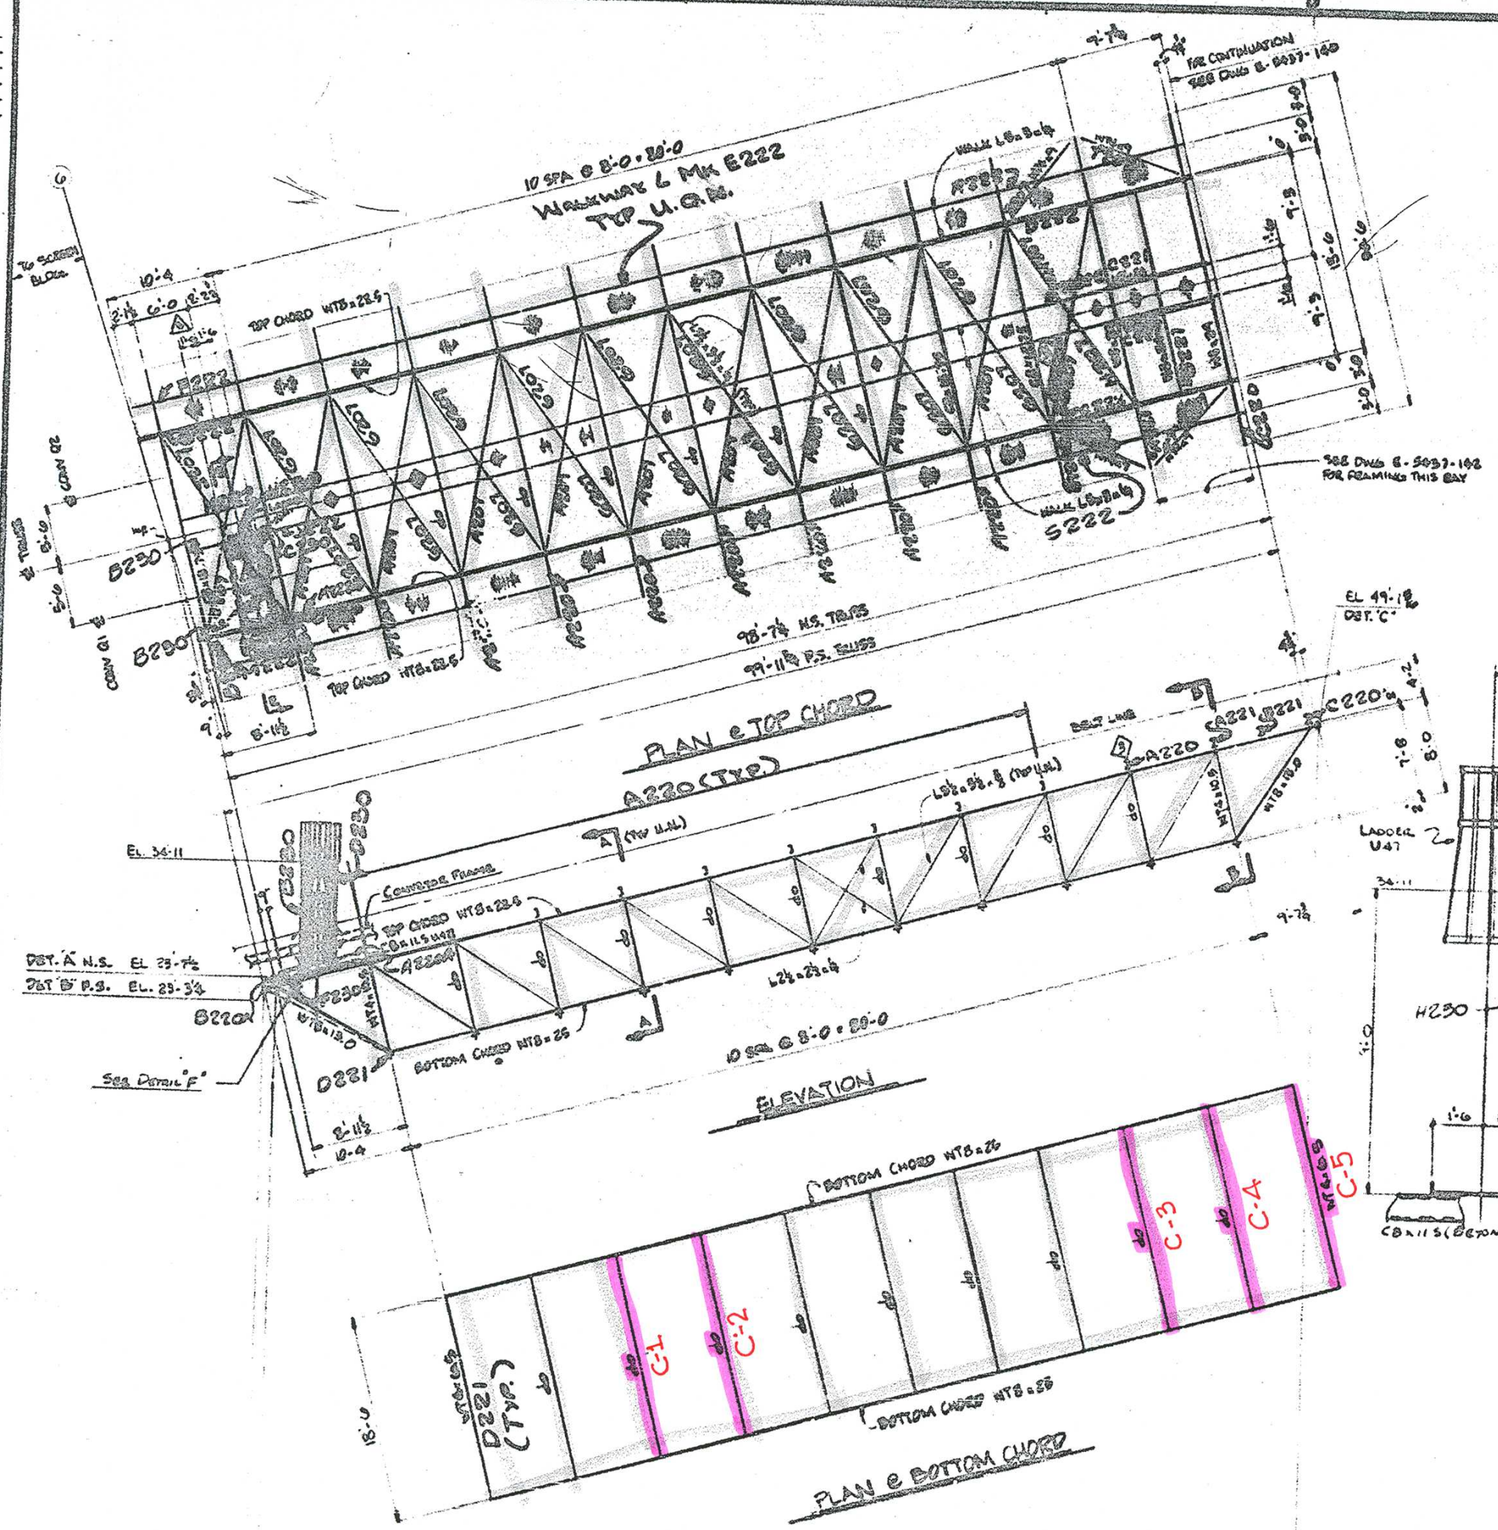
McNally Pittsburg Drawing E-5437-141

C-1 Bottom chord WT cross member has severe metal loss and corrosion. Recommend replacement in kind.

C-2 Bottom chord WT cross member has severe metal loss and corrosion. Recommend replacement in kind.

C-3 Bottom chord WT cross member has severe metal loss and corrosion. Recommend replacement in kind.

C-4 Bottom chord WT cross member has severe metal loss and corrosion. Recommend replacement in kind.

C-5 Bottom chord WT cross member has severe metal loss and corrosion. Recommend replacement in kind.

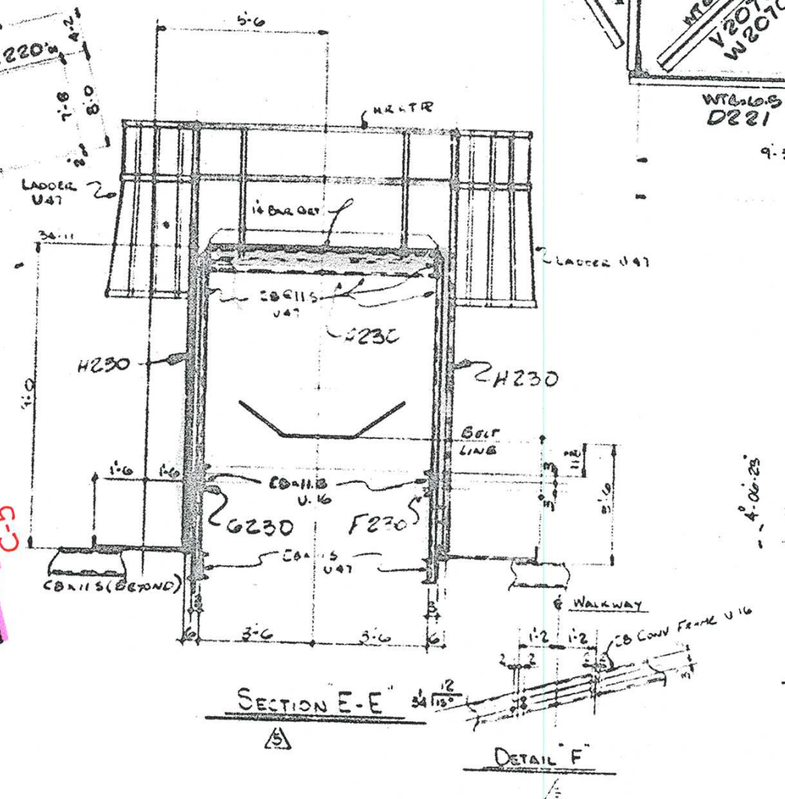
McNally Pittsburg Drawing E-5437-143

C-6 Bottom chord WT cross member has severe metal loss and corrosion. Recommend replacement in kind.

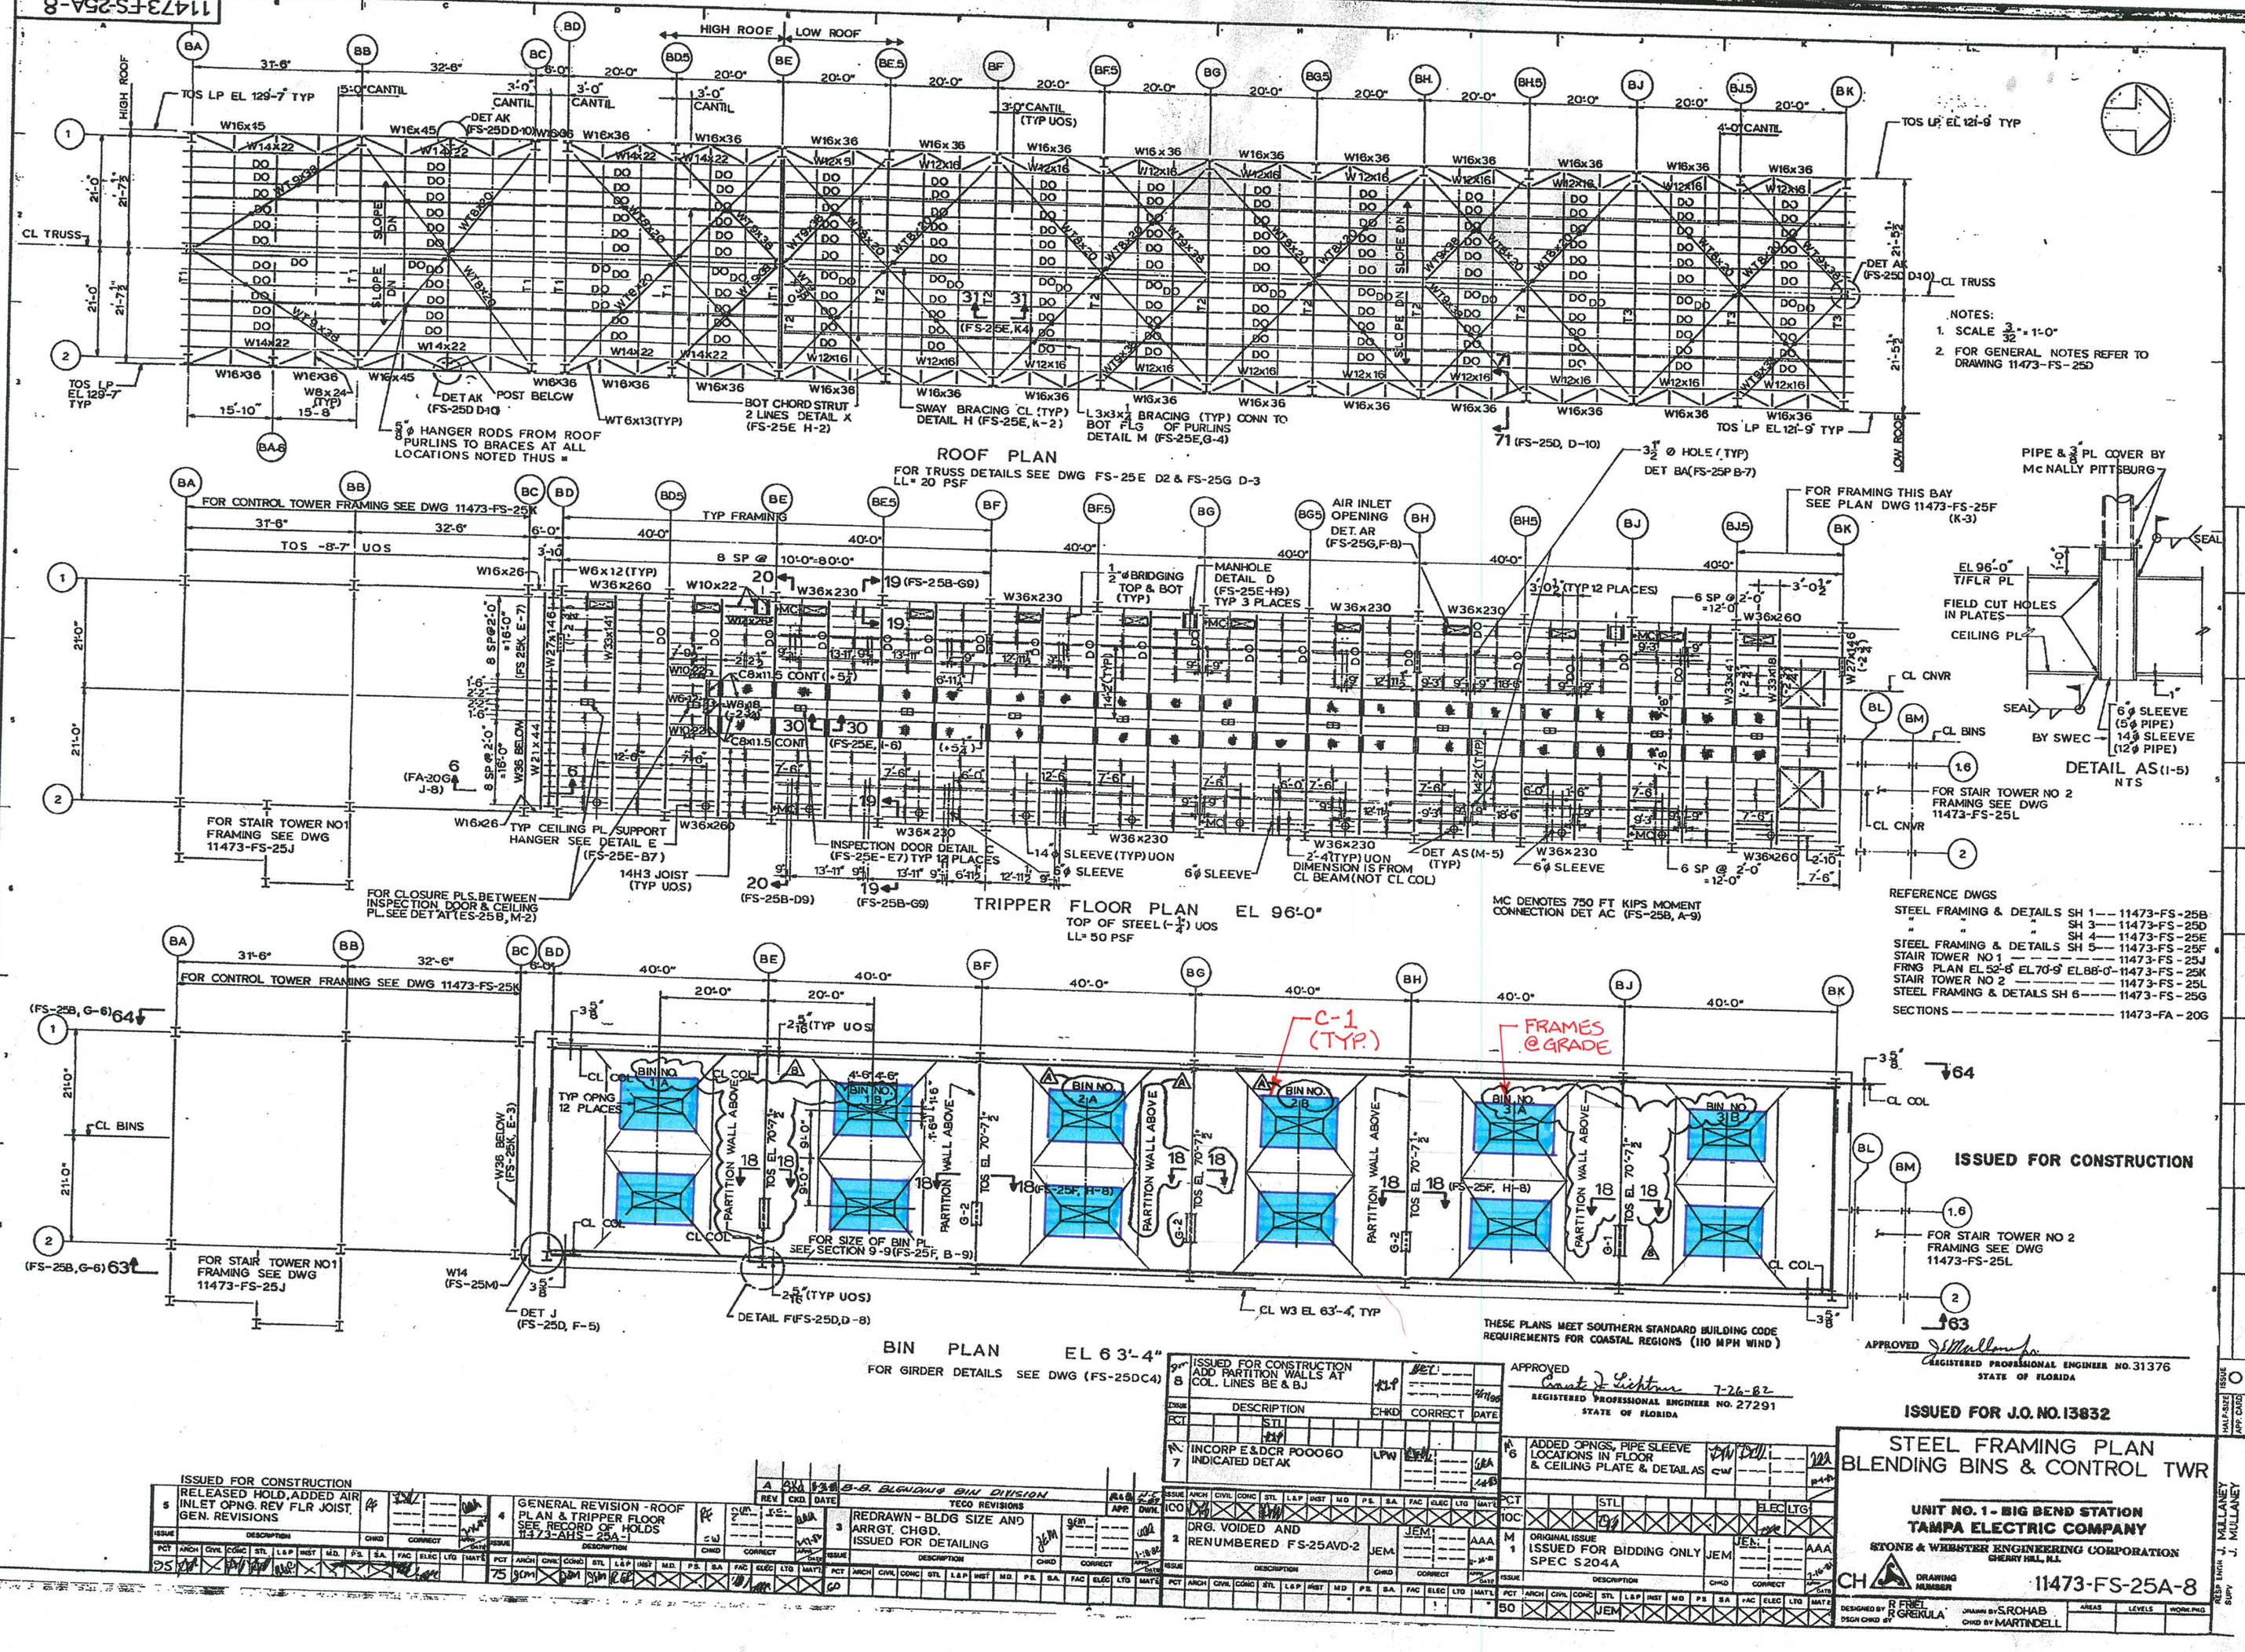
Stone and Webster Drawing 11473-FS-25A-8

C-1 Support frames for the Gravimetric Feeders have severe corrosion at the column bases. Clean and paint to protect from further damage. The vertical angle braces have severe corrosion and metal loss at connections to columns. Many braces should be replaced in kind and others require cleaning and painting.

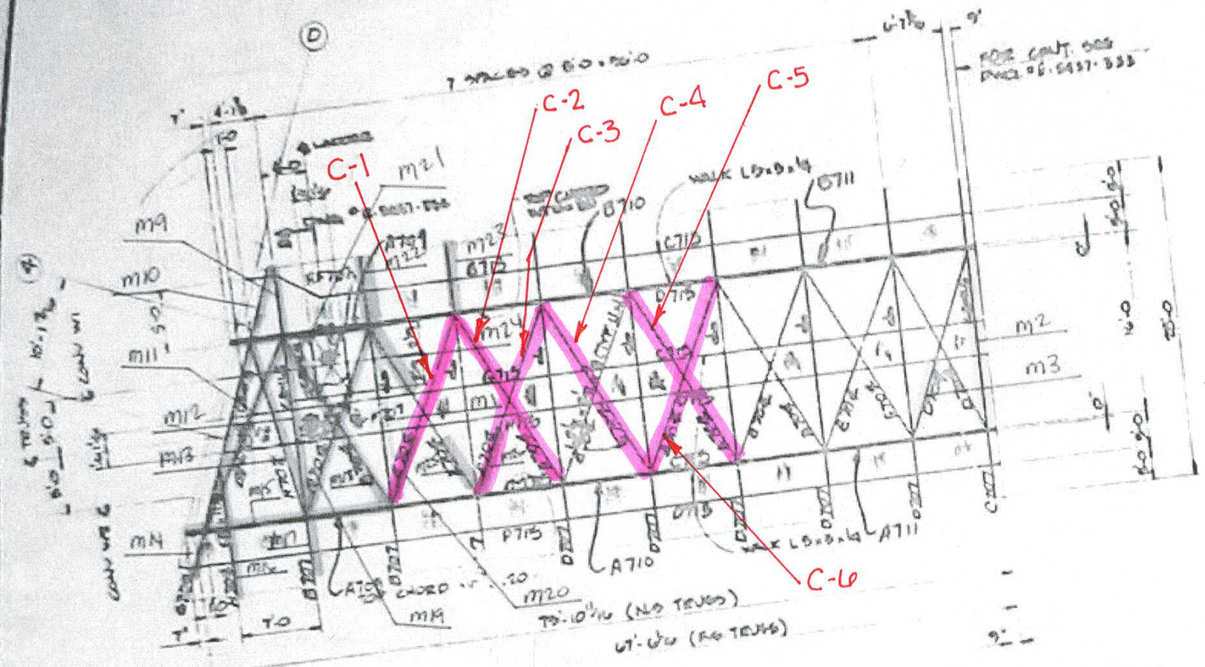
McNally Pittsburg Drawing E-5437-337

C-1 thru 6 Top chord members have heavy corrosion and moderate to severe metal loss. Recommend replacement in kind.

C-7 Top chord member has heavy corrosion and moderate to severe metal loss. Recommend replacement in kind.

C-8 Truss section has moderate corrosion. Recommend cleaning and painting to prevent further damage.

C-9 Truss section has moderate corrosion. Recommend cleaning and painting to prevent further damage.

C-10 & 11 Members at connection on both East and West side have moderate metal loss and delamination. Recommend cleaning, repairing and painting to prevent further damage.

C-12 & 13 Members at connections have heavy corrosion and delamination. Recommend cleaning and painting to prevent further damage.

C-14 Bottom chord of truss has heavy corrosion and mild delamination of the bottom flange. Recommend cleaning and painting to prevent further damage.

| C-15 | Member has moderate to severe corrosion. Recommend cleaning and painting to prevent further damage. |
| C-16 | Member has severe delamination of the bottom flange. Recommend replacement in kind. |
| C-17 thru 20 | Gusset plates have moderate delamination. Recommend cleaning and painting to prevent further damage. |

| C-21 & 22 | Portions of vertical brace have severe corrosion and moderate metal loss. Recommend replacement in kind. |

| C-23 | Flange on west side of bent has severe corrosion and moderate metal loss. Recommend cleaning, repairing of flanges with plates and painting to prevent further damage. |
| C-24 | Lower portion of vertical brace has severe corrosion and metal loss. Recommend replacement in kind. |
| C-24A | Lower portion of vertical brace has heavy corrosion and mild metal loss. Recommend cleaning and painting to prevent further damage. |
| C-25 | Beam has moderate delamination of top and bottom flanges. Recommend cleaning and painting to prevent further damage. |
| C-26 | Flange on east side of bent has severe corrosion and mild metal loss. Recommend cleaning and painting to prevent further damage. |

| C-27 thru 36 | Members have moderate to severe corrosion. Recommend cleaning and painting to prevent further damage. |

| C-27 thru 40 | Base of monorail supports have severe corrosion. Recommend cleaning and painting to prevent further damage. |

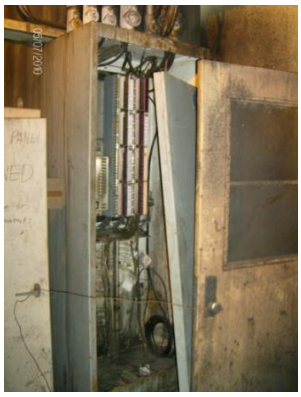
L1 Conveyor Motor Starter

11. There are heat detectors installed on both the L1 and L2 conveyors as part of the Fire Suppression system.
12. The pull cord switches appear to be in good working order.
13. Two floors below the Tripper Hall (6th floor of the powerhouse) there are the Westinghouse Ampgard™ 4160V motor starters for L1 & L2 conveyors, a Modicon 584 PLC rack, a 480V MCC feeding the K1A and K1B Feeders, and a 480V MCC feeding the K2A and K2B Feeders. Also at this location is an obsolete oil filled switch to select the source of 4160V power for the L conveyors from either circuit 117E or 111W. This oil filled switch is a General Electric model 9F31YGA205, 200A, 5kV transfer switch with severe rust on its painted steel case. Due to its age, this switch should be replaced.
