# Tampa Electric Company (TECO)
# Coal Yard Assessment
## Stantec Job No. 198800347

September 2010
Revision 2

## EXECUTIVE SUMMARY

Stantec has been retained by Tampa Electric Company to provide a review of the coal field equipment at the Big Bend facility. The review scope boundaries are from the dock through conveyors L1 and L2 that bring the coal to the tripper deck in the power house.

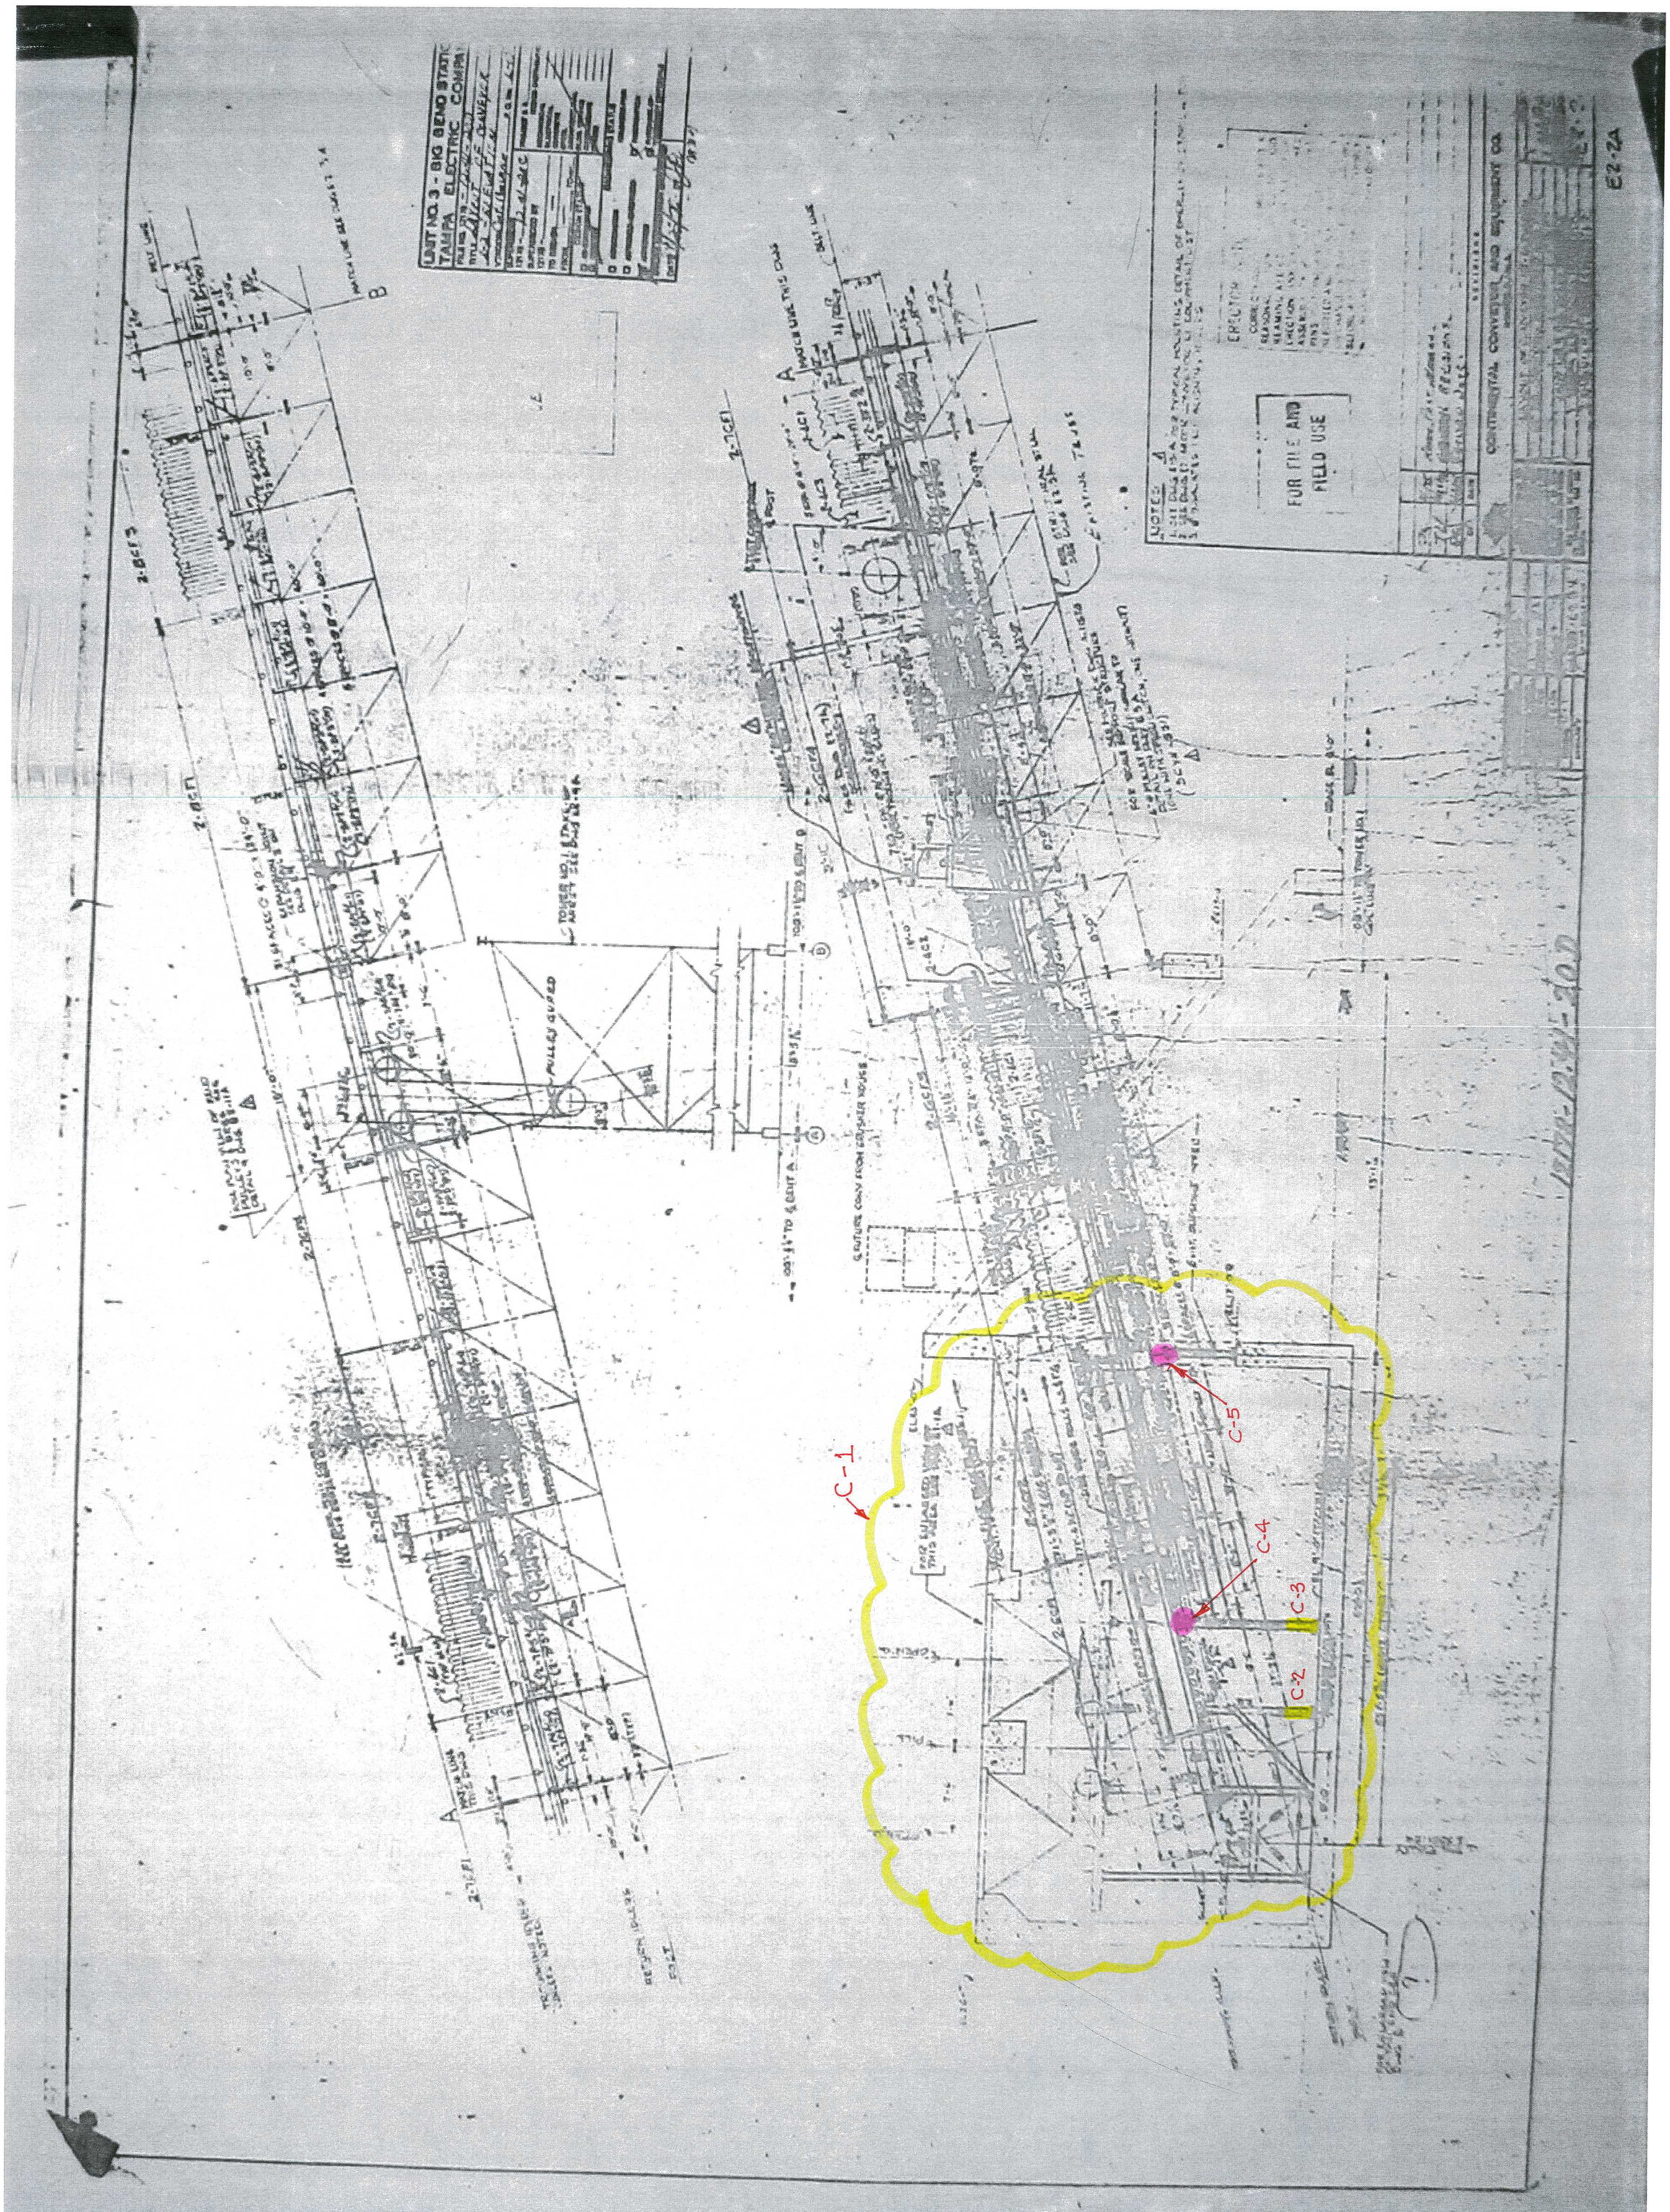
M18
M16
M11
M15
M116
M119
M117
M114
M112
M113
M12
M14
M13
M2
M7
M8
M9
M10
M1
M3
M5
ELEVATION CONVEYOR L1 (No.) 12 (EA)
SECTION B-B
SECTION A-A
FINAL APPROVAL
UNIT NO. 3 - BIG BEND STATION
TAMPA ELECTRIC COMPANY
CONTINENTAL CONVEYOR AND EQUIPMENT CO.
E2-1A

| C-2 & 3 | Base of columns and base plates have moderate corrosion and metal loss. Recommend cleaning and painting 36” of column, including base plate and anchor bolts. |
| C-4 & 5 | Steel beams running north and south that support conveyor L1 & L2 have severe corrosion and metal loss. Recommend replacement in kind. |

Comments for conveyor L1 pertain to conveyor L2 also.
