Power Delivery Performance

Hurricane Irma

Storm Date: September 9, 2017

Report Date: April 19, 2018

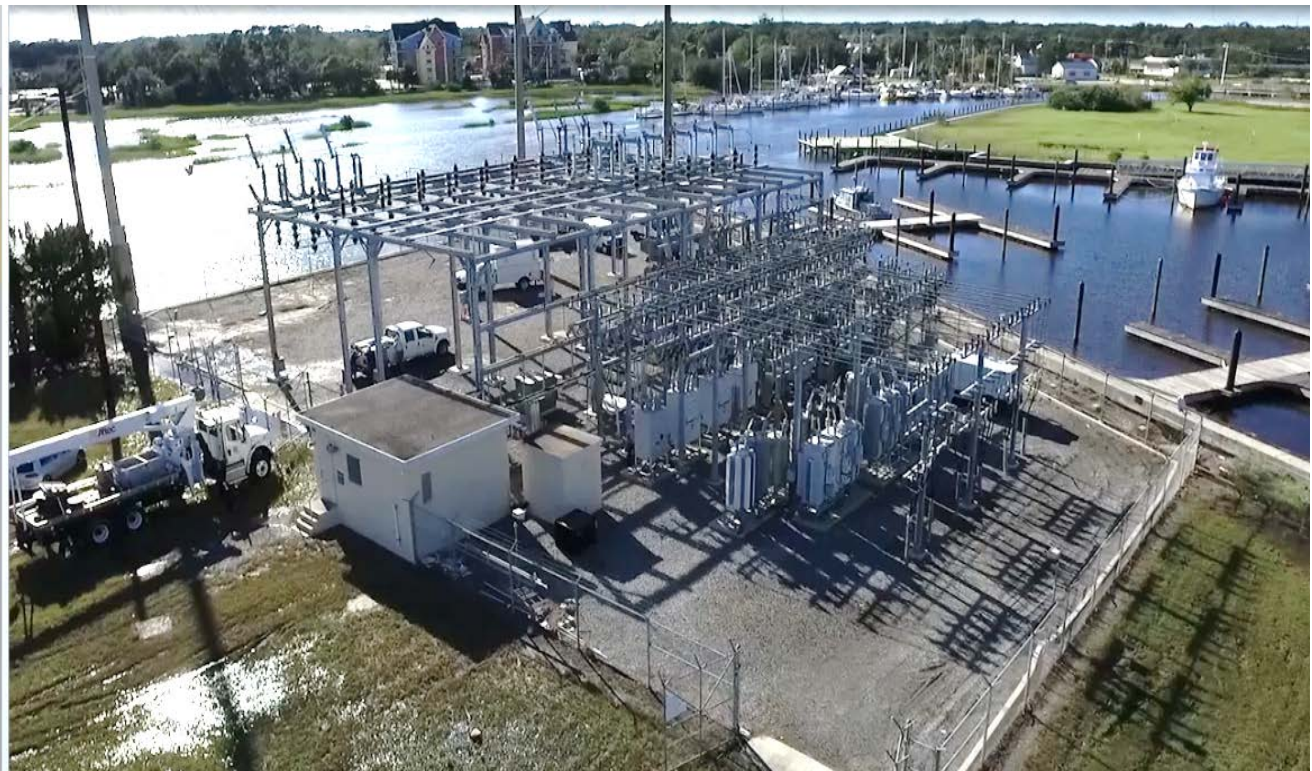
St. Augustine Substation

Only St. Augustine substation had damaged equipment related to flooding.

Station flood monitor emergency alarmed shortly after at 1:00 am

Both outdoor flood monitor alarms cleared at 8:53 pm

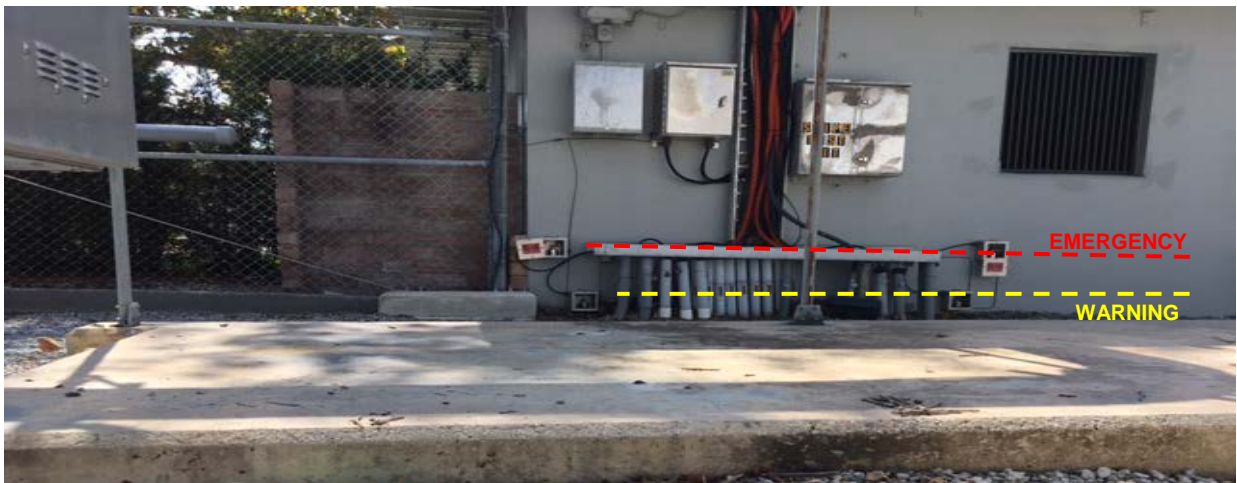
Station flood monitor warning alarm set off at 1:21 am on 9/11

Alarm log for South Daytona Substation

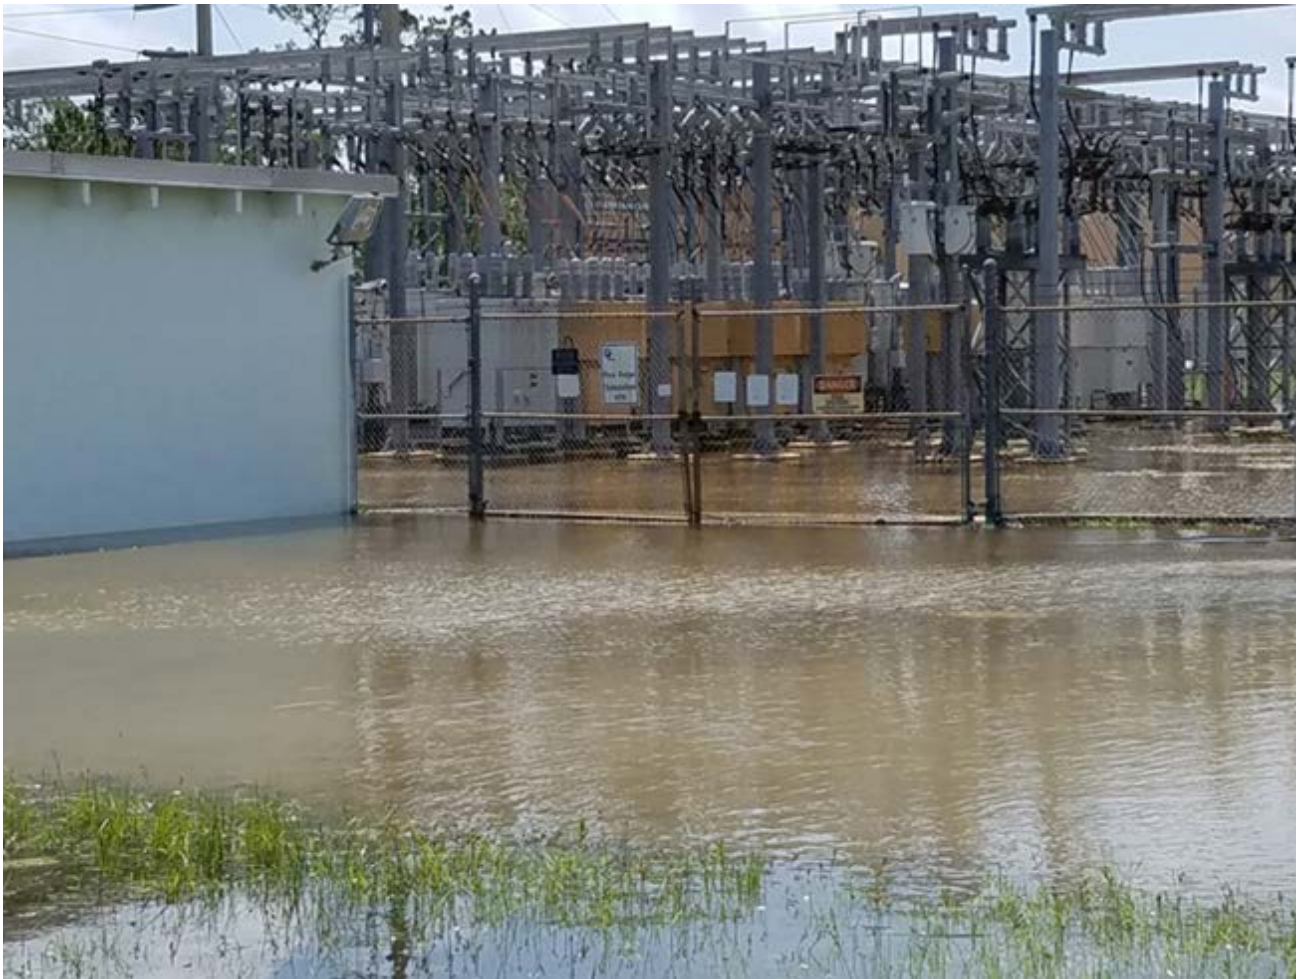
Relay vault does not have flood doors, which allowed flooding to occur inside vault

- Rain Flooding .01 Ft. above Relay Vault small puddle on floor.

Pine Ridge Substation rain event flooding

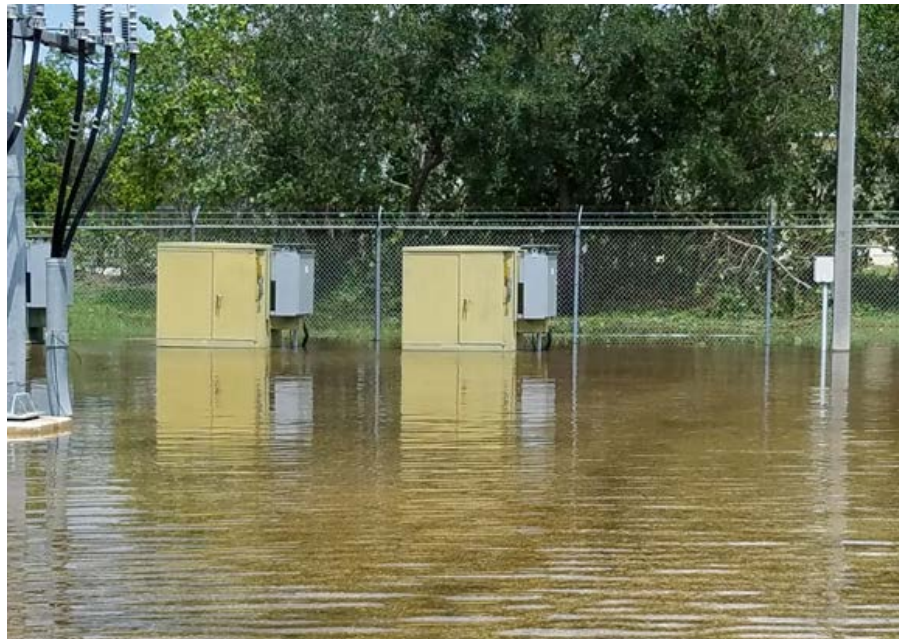
Pine Ridge Substation Flooding

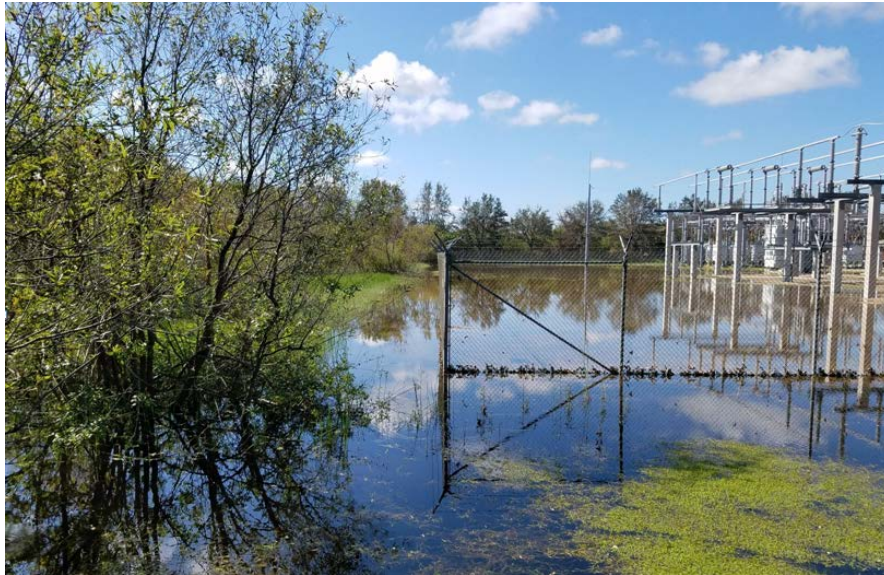
Corkscrew Sub and Corkscrew Access drive (patrol road) flooded, including surrounding area and adjacent subdivision, however homes seems to be above flood levels.

- Flood waters from adjacent property impacted FPL property
- P&C van became stuck on Access drive attempting to access the substation
- Substation was only accessible by off road vehicles
- Rain flooding reported to be 1.5 Ft. to 2 Ft. above access drive.
- Rain flooding inside substation is 0.65 Ft. above average yard grade
- Relay vault does not have flood doors
- Rain flooding did not enter Relay Vault

Corkscrew Substation Rain Event Flooding

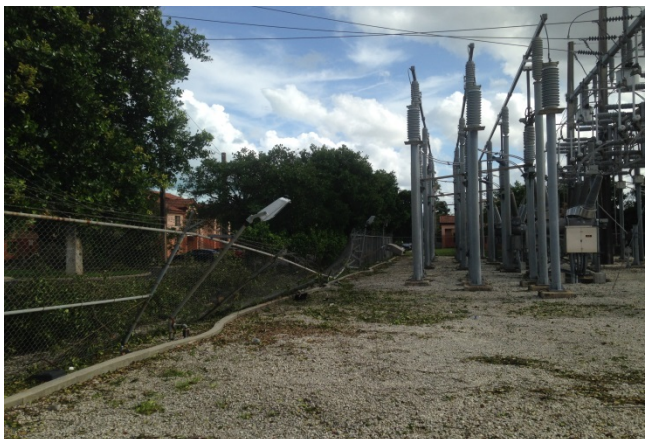
Crystal River Substation – Fence

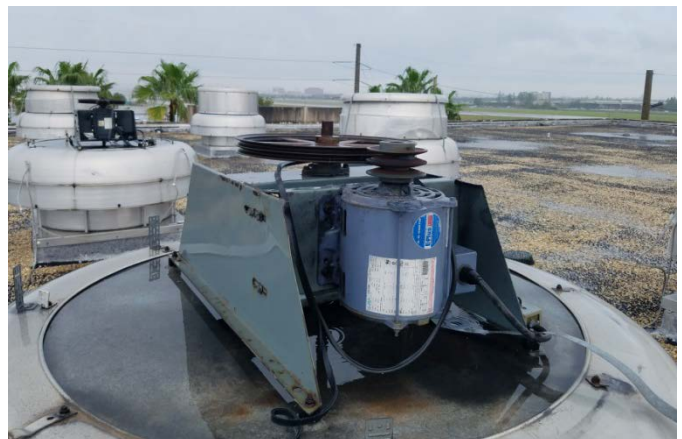
Watkins Substation – Roof Exhaust Fan

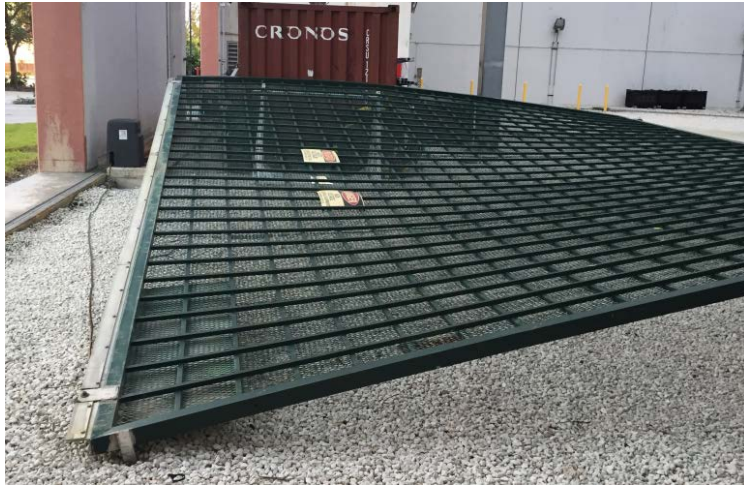
Natural Bridge Substation – Gate

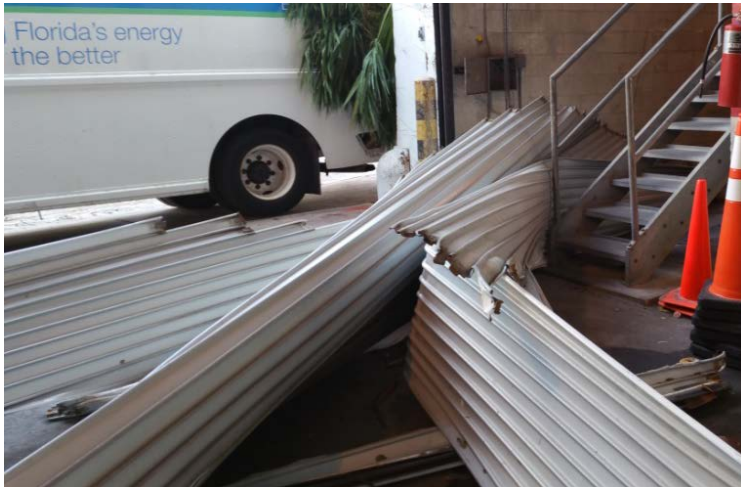
Watkins Substation – Overhead Door

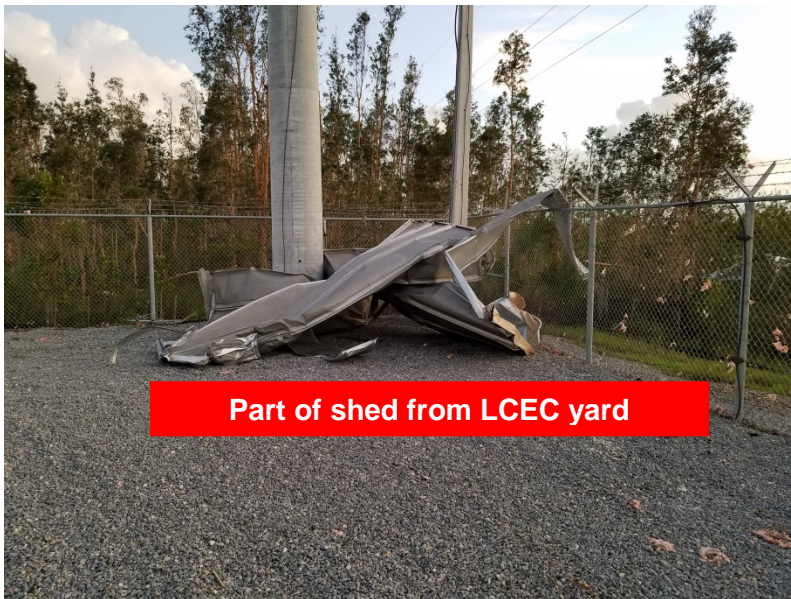
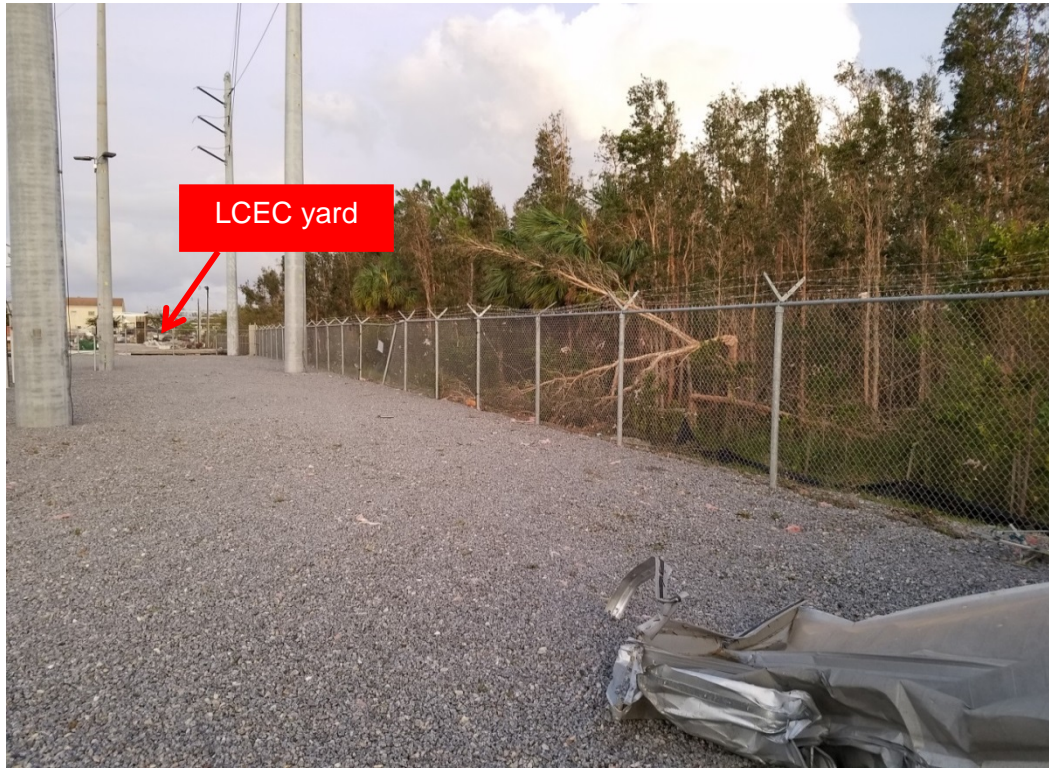
Large debris found in substation (part of shed and wood light pole from LCEC yard).

Current design, 150mph-gust-wind-designed fence partially damaged in areas due to flying debris and failing LCEC wood light pole.

Switch jumper was damaged/disconnected due to debris from LCEC.

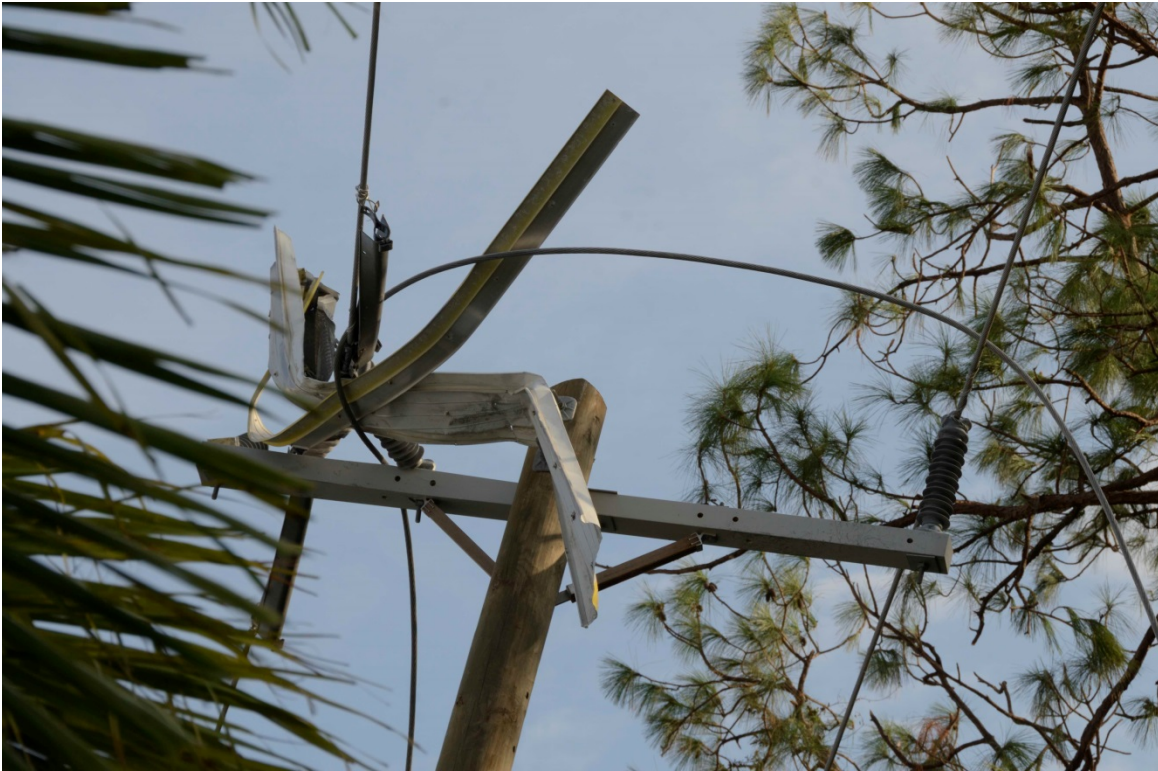
Debris wrapped around pole in line.

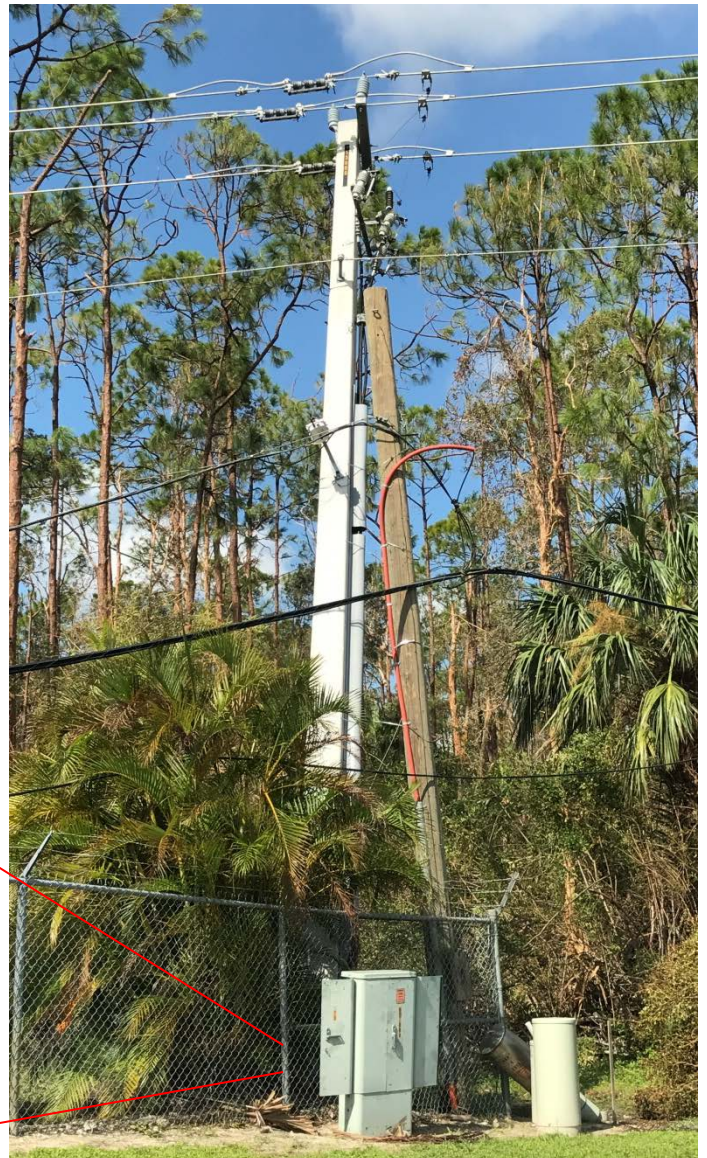
Leaning concrete pole

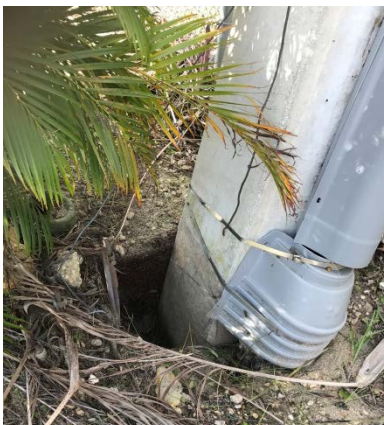
Base of leaning concrete pole

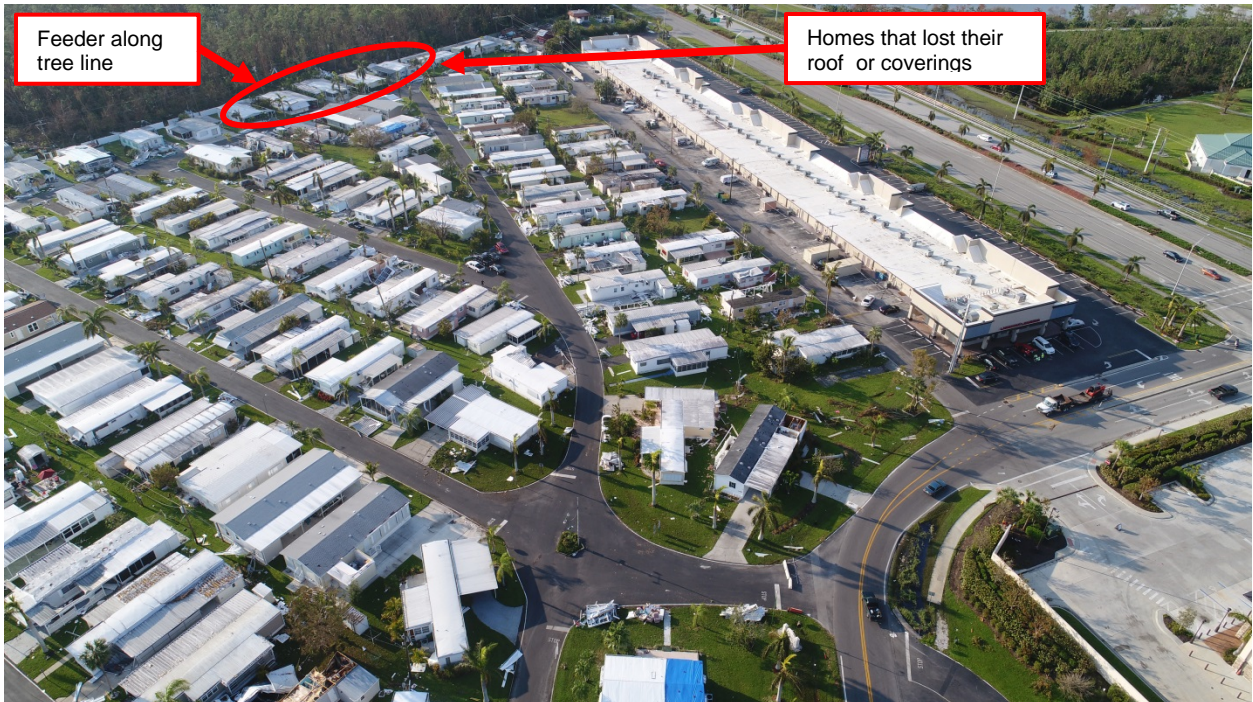
Looking northwest through the trailer park toward the feeder

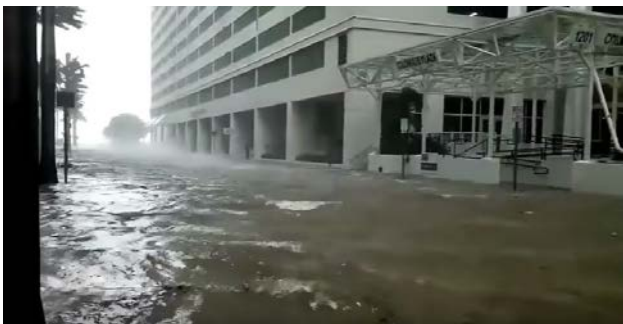
2' deep at SE 12th St & Brickell Ave (Mike Seidel Twitter Feed)
