Re: Docket No. 20220001-EI

Please find enclosed for filing in the above referenced docket the Direct Testimony and Exhibits of Richard Polich, P.E. This filing is being made via the Florida Public Service Commission's Web Based Electronic Filing portal.

**Turkey Point
 Root Cause Evaluation
 Unit 3 Trip During Restoration from RPS Testing
 Event Date: March 1, 2021 CR 2385529
 Revision 1**

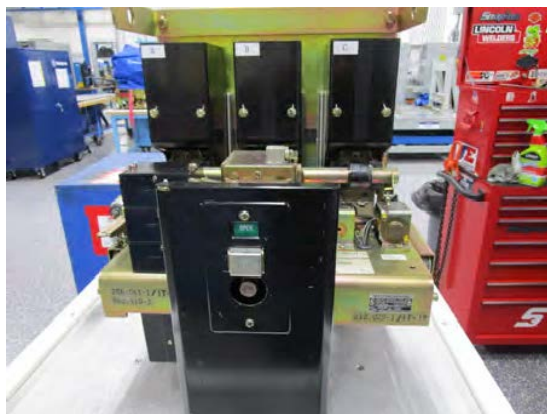
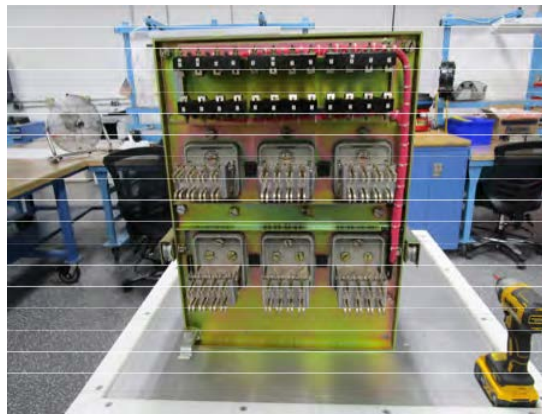
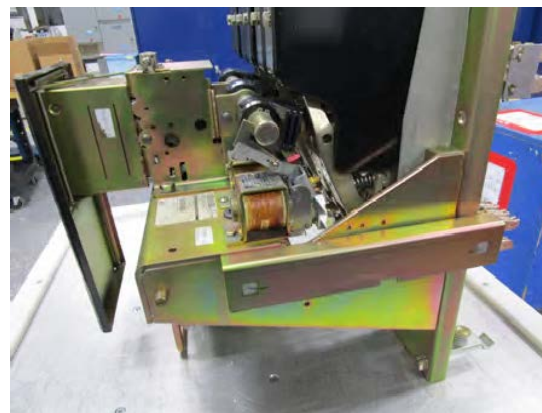
This breaker was received looking as it had just been refurbished, there were no visible areas of concern.

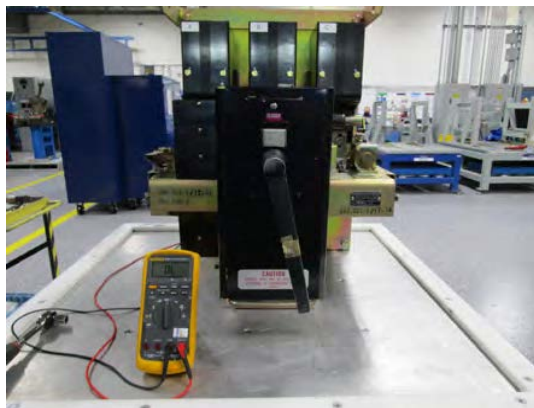
The UVTA reset arm was restrained to allow the breaker to be closed, the breaker was manually closed. These photos show that this NC contact changed state when the breaker was closed. Also verified was that there was no interference from closing the breaker.

Breaker Open, Switch Contact Closed

Breaker Closed, Switch Contact Open

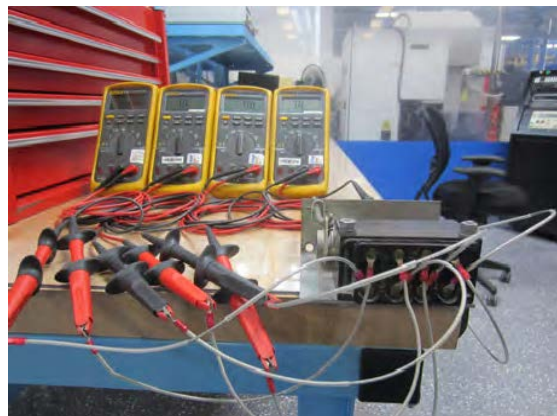
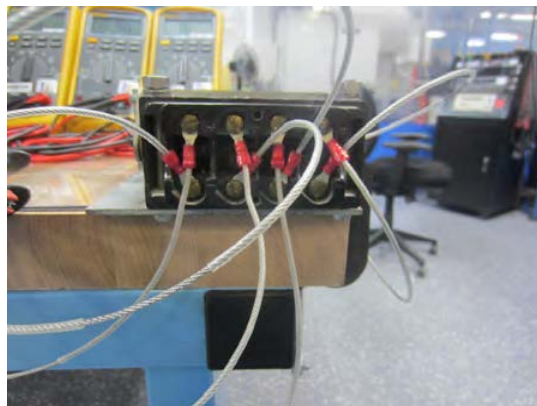
The single contact that was monitored worked 100% of the time. Four multimeters were then connected to each of the 4 switches. The switch was cycled and the switch at the end (switch terminals 3 & 4) remained open in both states of the switch as shown in these photos.

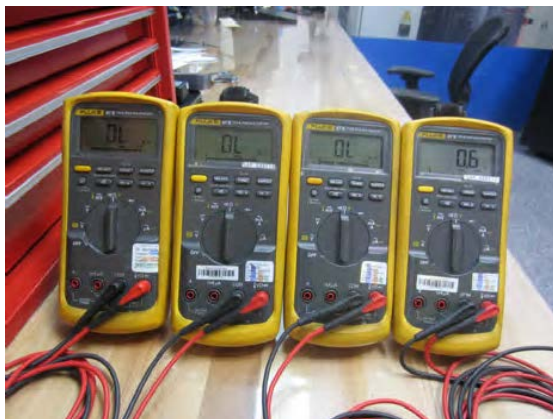
Breaker Closed Switch Position

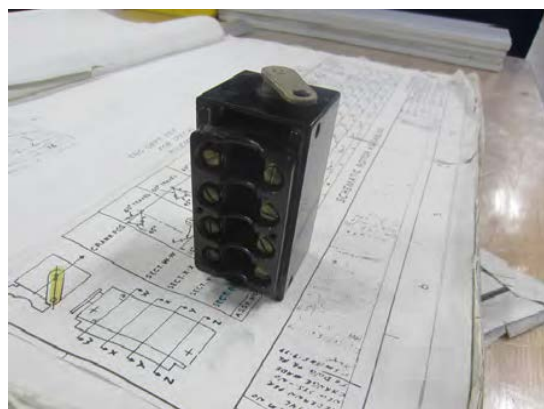
Both the left-side switch and right-side switch were removed from their base plates and were verified per drawing to be assembled correctly.

Switch Contact Verification

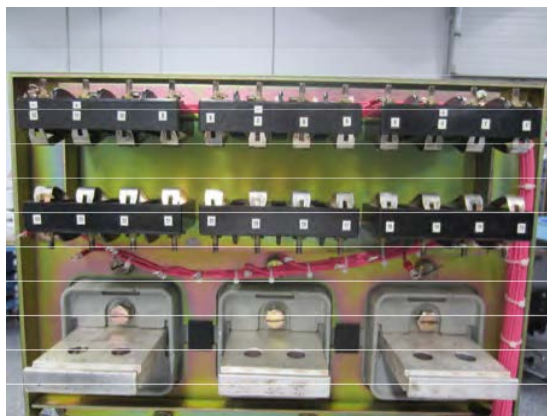
No issues were found with the secondary contact assembly.

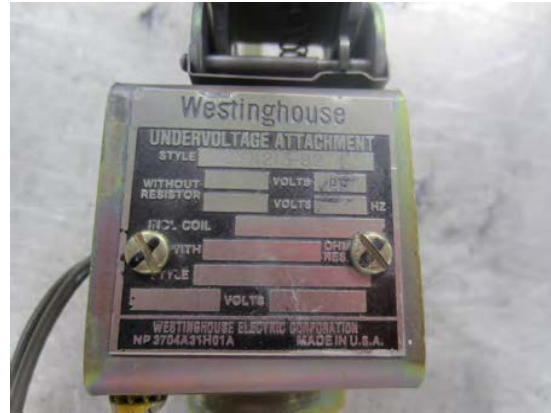
The visual inspection of the UVTA did not provide anything to be concerned about.

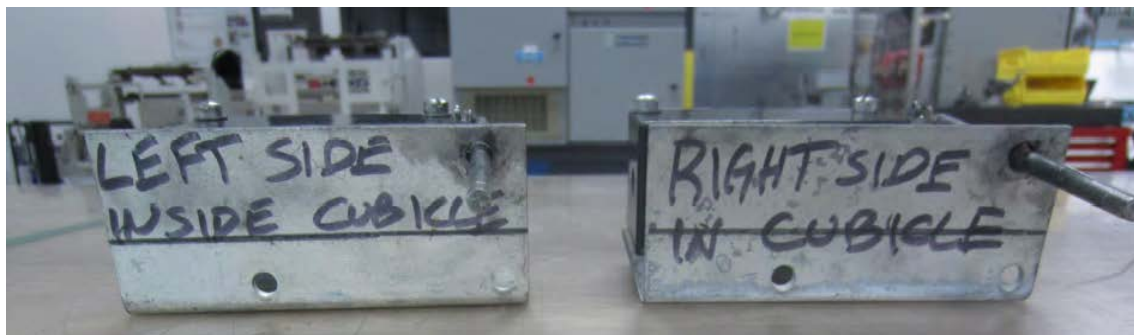
Left-Side and Right-Side Switches

The left-side switch and right-side switch were properly assembled with all of the stationary fingers securely in place. The switch contacts were cleaned and properly lubricated during the assembly and each switch was mounted back onto the base plate and the plunger was attached to complete the assembly. Both the front and rear covers remained off of the switches so that the contacts could be monitored. Photos of the switches are provided:

If these were the original cell switches that were provided with the switchgear, it is recommended that they be replaced with safety related switch assemblies provided by Westinghouse Electric Company.

It is recommended that all original cell switches be replaced and after the cell switches are replaced that they be maintained to the requirements provided in the Maintenance Program Manual for Westinghouse Safety Related Type DB Circuit Breakers and Associated Switchgear, Revision 1, July 2011.

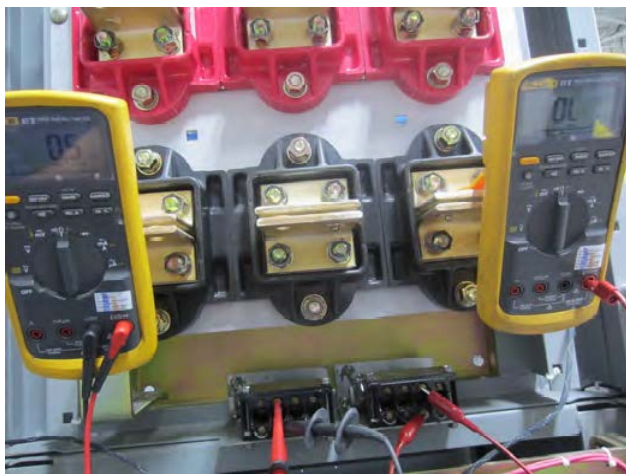
Switch Monitoring Shows a Change of State
