(CONFIDENTIAL) Hearing Exhibit No. 115 from 2/4/20 DOAH Hearing. [CLK Note: See DN 10935-2019 for Exh Nos. 1, 68-75, 80, 82, 100]

DESCRIPTION: RCA Draft Exhibit

OPC RCA EXHIBIT Table of Contents

February 6, 2018

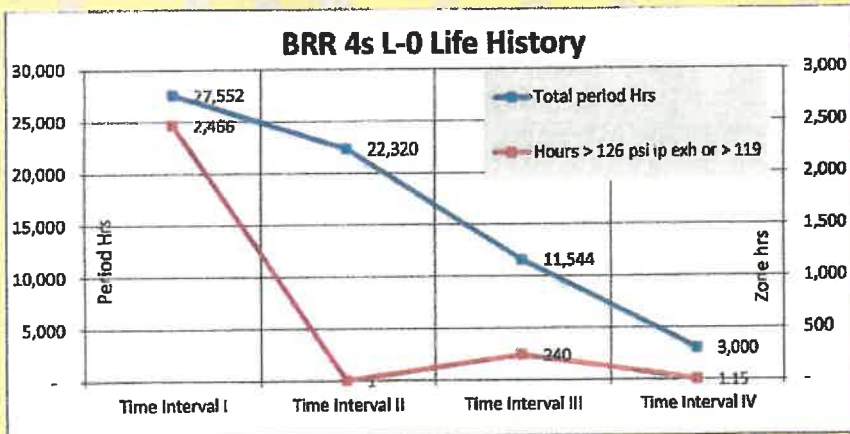
The expected blade life predictions of the latest blade configuration compared to the actual field experience is the driver for the study in attachment A of steam turbine output and operating pressures versus time. There is one particular fact and clear apparent path forward that can be seen in this data. The Table below from the attachment presents the fact that the more we modified the blades, the shorter the time before contact surface failure despite the fact we have continued operate the unit with lower steam flows that fall mostly within the OEM limits for the original design.

Inspection of the data reveal that the original design in time intervals 1 and 2 only had the mid-span snubber failure of the original turbine end (TE) blades - and the 1st time interval nearly 2500 hours of operation was above the OEM limit. In time interval 2, no failures occurred and there was only 1 hours of operation slightly above the limit. This means that the generator end (GE) blades ran nearly 50,000 hours with no failures.

For these reasons the recommended direction on the current repair (fall 2016) is to return to the original blade design (no hard facing) with reasonable operational restrictions on steam flows and pressure limits. These restrictions need to be part of the control logic and not an operator or supervision option to interpret.

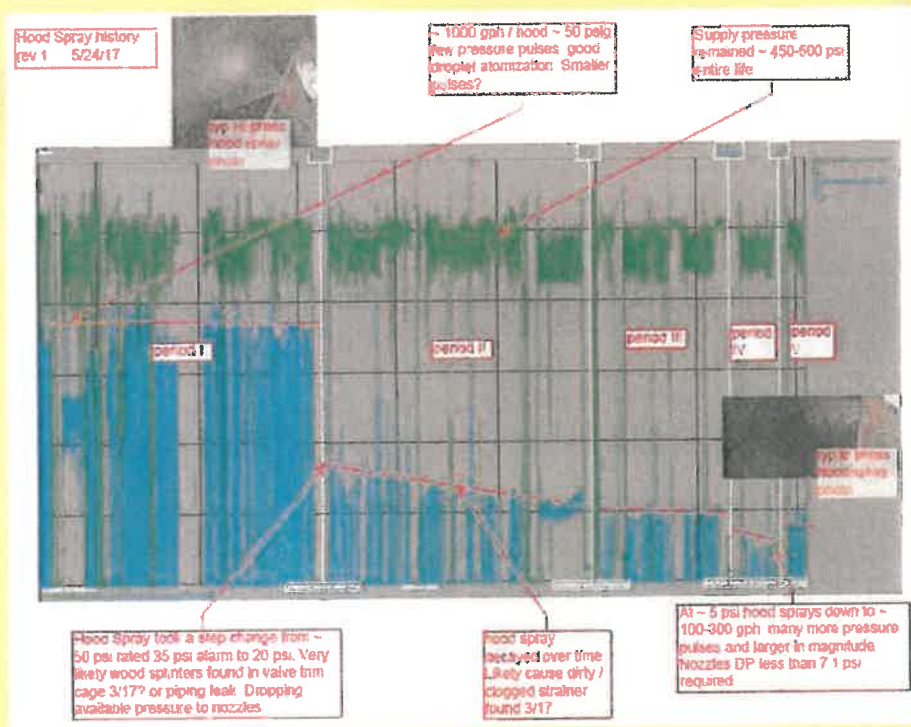
Figure 1 – Hood Spray Pressure Degradation Over Periods 1-5

verified during a test just prior to unit restart in April 2017. A key concern of poor atomization is the effect it might have on generating dynamic pressures which the L-0 blades might see as large water droplets evaporate in the exhaust stream.

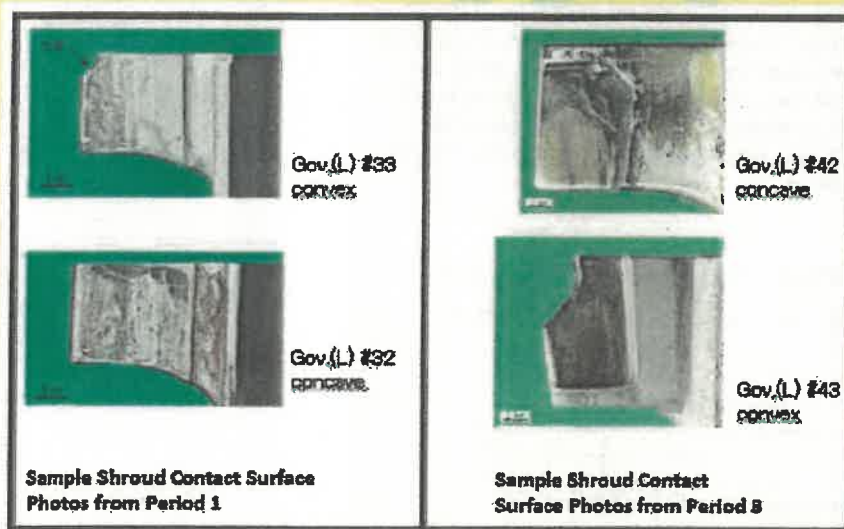
Figure 1 – Comparative Photos of Shroud Contact Surface Wear for Periods 1 and 3

Conversely, during Period 3, there were only 240 hours (out of 10,286 total hours) of operation in the "avoidance zone", approx. 11 hours of which occurred during the instrumented blade telemetry test performed by MHPS in December 2014. Even with a significantly fewer number of "avoidance zone" hours for Period 3 relative to Period 1—a factor of 10 fewer hours for Period 3—there was significantly greater amounts of blade damage and fretting on both ends of the machine. While the amount of Z-Lock wear is not quantified for Periods 1 and 3, photographic evidence suggests that the amount of wear is much greater for Period 3, as shown below in Figure 1. It is therefore difficult to conclude that damage to the L-0 blades in Period 3 is solely due to unit operation above the exhaust flow limit.

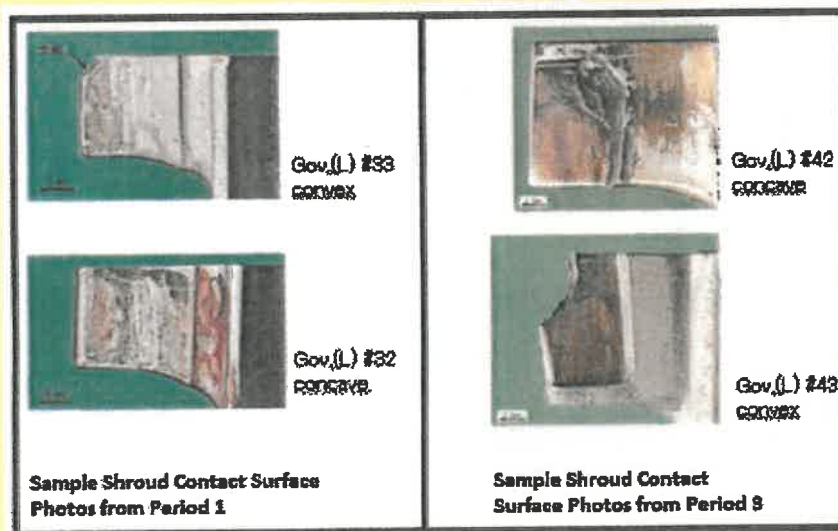
Figure 1 – Comparative Photos of Shroud Contact Surface Wear for Periods 1 and 3

Conversely, during Period 3, there were only 240 hours (out of 10,286 total hours) of operation in the "avoidance zone", approx. 11 hours of which occurred during the instrumented blade telemetry test performed by MHPS in December 2014. Even with a significantly fewer number of "avoidance zone" hours for Period 3 relative to Period 1 – a factor of 10 fewer hours for Period 3 – there was significantly greater amounts of blade damage and fretting on both ends of the machine. While the amount of Z-Lock wear is not quantified for Periods 1 and 3, photographic evidence suggests that the amount of wear is much greater for Period 3, as shown below in Figure 1. It is therefore difficult to conclude that damage to the L-0 blades in Period 3 is solely due to unit operation above the exhaust flow limit.

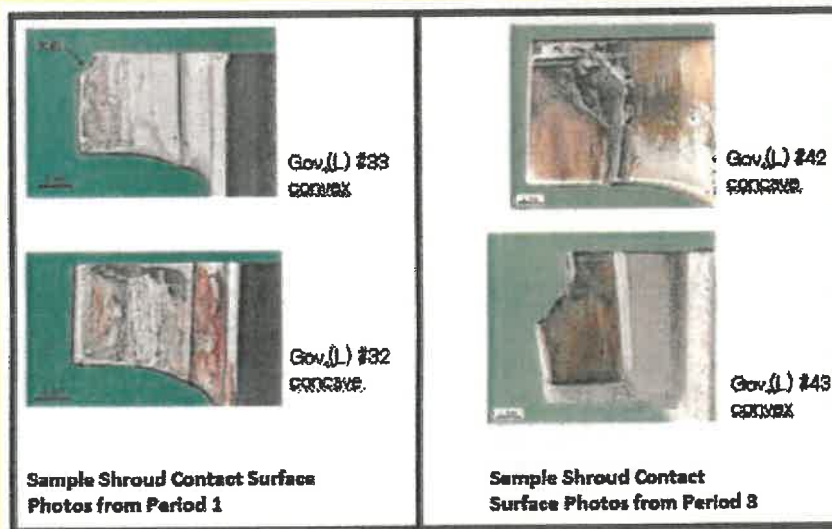
Figure 1 -- Comparative Photos of Shroud Contact Surface Wear for Periods 1 and 3

Conversely, during Period 3, there were only 240 hours (out of 10,286 total hours) of operation in the "avoidance zone", approx. 11 hours of which occurred during the instrumented blade telemetry test performed by MHPS in December 2014. Even with a significantly fewer number of "avoidance zone" hours for Period 3 relative to Period 1 -- a factor of 10 fewer hours for Period 3 -- there was significantly greater amounts of blade damage and fretting on both ends of the machine. While the amount of Z-Lock wear is not quantified for Periods 1 and 3, photographic evidence suggests that the amount of wear is much greater for Period 3, as shown below in Figure 1. It is therefore difficult to conclude that damage to the L-0 blades in Period 3 is solely due to unit operation above the exhaust flow limit.

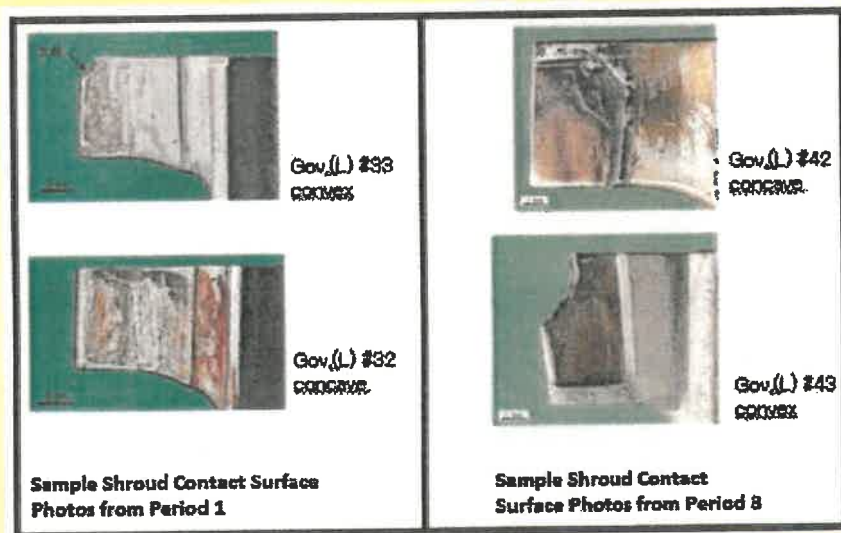
Figure 1 -- Comparative Photos of Shroud Contact Surface Wear for Periods 1 and 3

Conversely, during Period 3, there were only 240 hours (out of 10,286 total hours) of operation in the "avoidance zone", approx. 11 hours of which occurred during the instrumented blade telemetry test performed by MHPS in December 2014. Even with a significantly fewer number of "avoidance zone" hours for Period 3 relative to Period 1 – a factor of 10 fewer hours for Period 3 – there was significantly greater amounts of blade damage and fretting on both ends of the machine. While the amount of Z-Lock wear is not quantified for Periods 1 and 3, photographic evidence suggests that the amount of wear is much greater for Period 3, as shown below in Figure 1. It is therefore difficult to conclude that damage to the L-0 blades in Period 3 is solely due to unit operation above the exhaust flow limit.

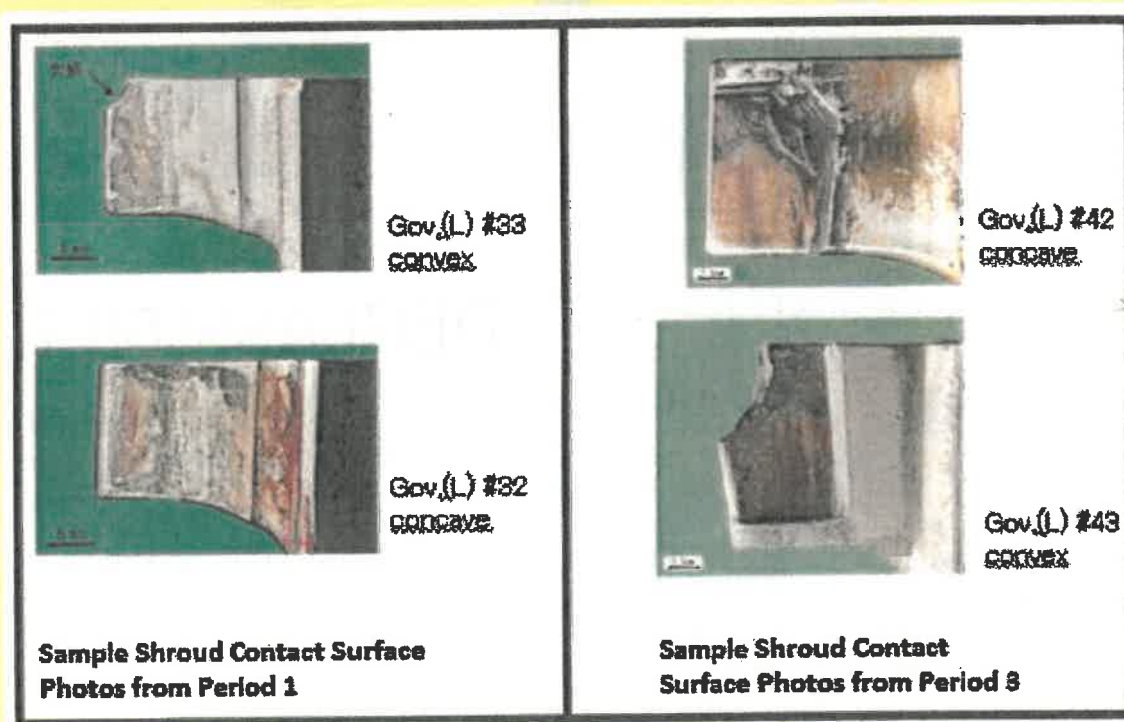
Figure 1 – Comparative Photos of Shroud Contact Surface Wear for Periods 1 and 3

Conversely, during Period 3, there were only 240 hours (out of 10,286 total hours) of operation in the "avoidance zone", approx. 11 hours of which occurred during the instrumented blade telemetry test performed by MHPS in December 2014. Even with a significantly fewer number of "avoidance zone" hours for Period 3 relative to Period 1 – a factor of 10 fewer hours for Period 3 – there was significantly greater amounts of blade damage and fretting on both ends of the machine. While the amount of Z-Lock wear is not quantified for Periods 1 and 3, photographic evidence suggests that the amount of wear is much greater for Period 3, as shown below in Figure 1. It is therefore difficult to conclude that damage to the L-0 blades in Period 3 is solely due to unit operation above the exhaust flow limit.

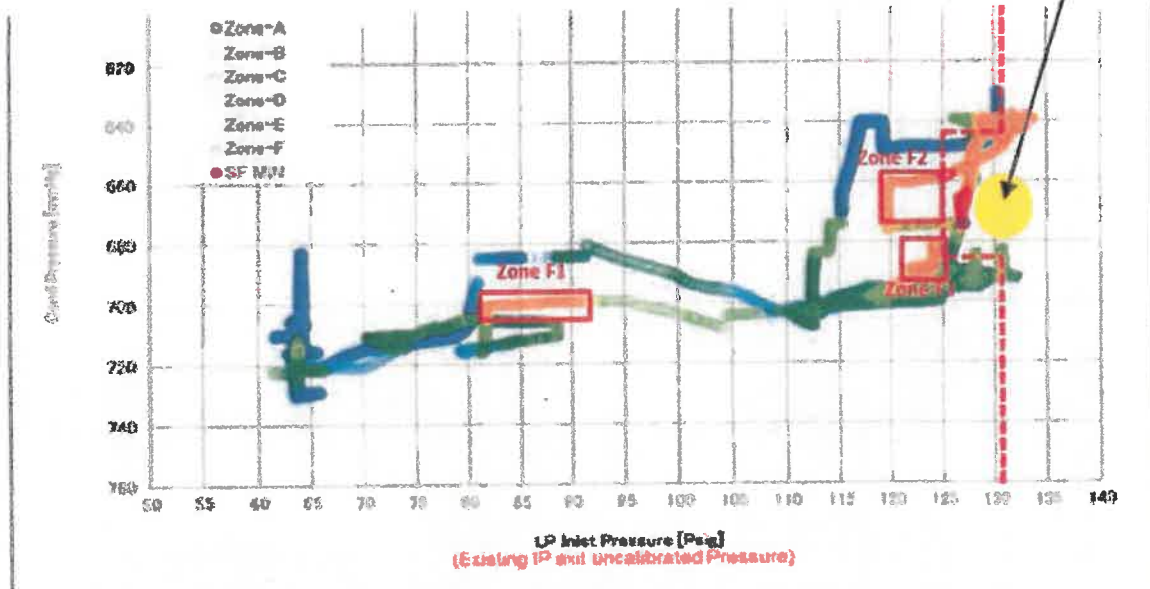
Blade Response – Design Margin
Example : Shroud Fretting Fatigue

Unable to test due to excessive blade response

- Blade response is evaluated through the integration of the stress response all the modes between 180Hz to 120Hz

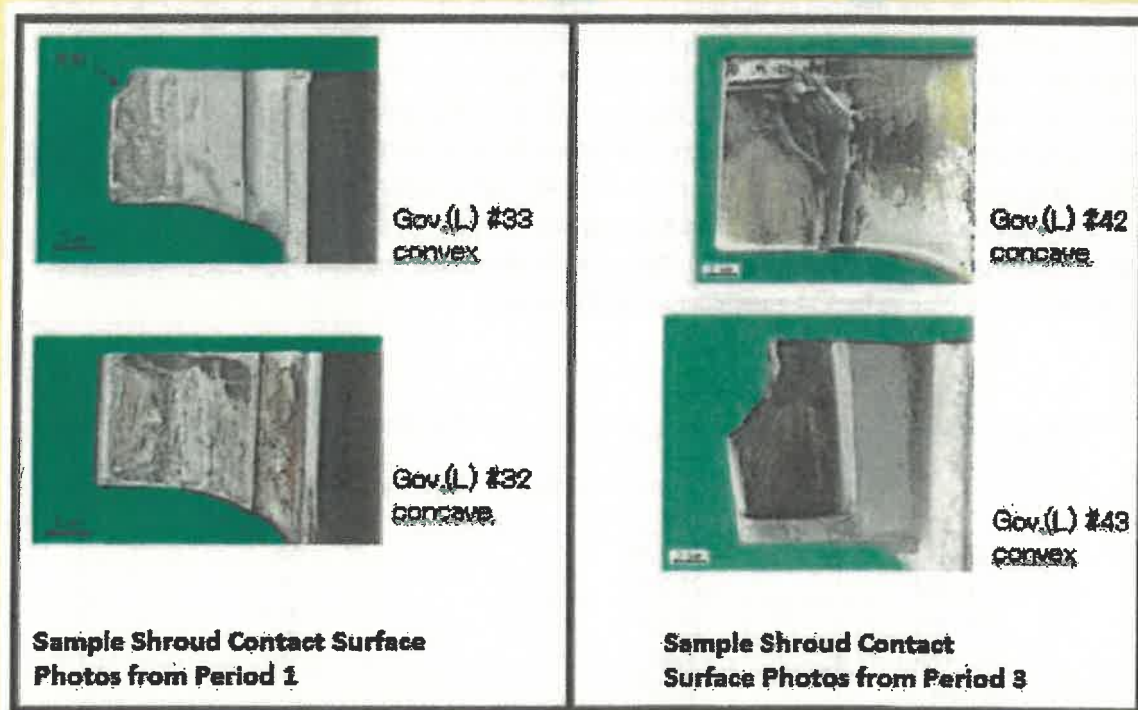
Figure 1 – Comparative Photos of Shroud Contact Surface Wear for Periods 1 and 3

For Period 3, there was hard-facing on the mid-span snubber ONLY. Additional damage seen on the shroud Z-Lock contact surfaces (relative to other Periods) was due to loss of dampening at the snubbers,

Conversely, during Period 3, there were only 240 hours (out of 10,286 total hours) of operation in the "avoidance zone", approx. 11 hours of which occurred during the instrumented blade telemetry test performed by MHPS in December 2014. Even with a significantly fewer number of "avoidance zone" hours for Period 3 relative to Period 1 – a factor of 10 fewer hours for Period 3 – there was significantly greater amounts of blade damage and fretting on both ends of the machine. While the amount of Z-Lock wear is not quantified for Periods 1 and 3, photographic evidence suggests that the amount of wear is much greater for Period 3, as shown below in Figure 1. It is therefore difficult to conclude that damage to the L-0 blades in Period 3 is solely due to unit operation above the exhaust flow limit.

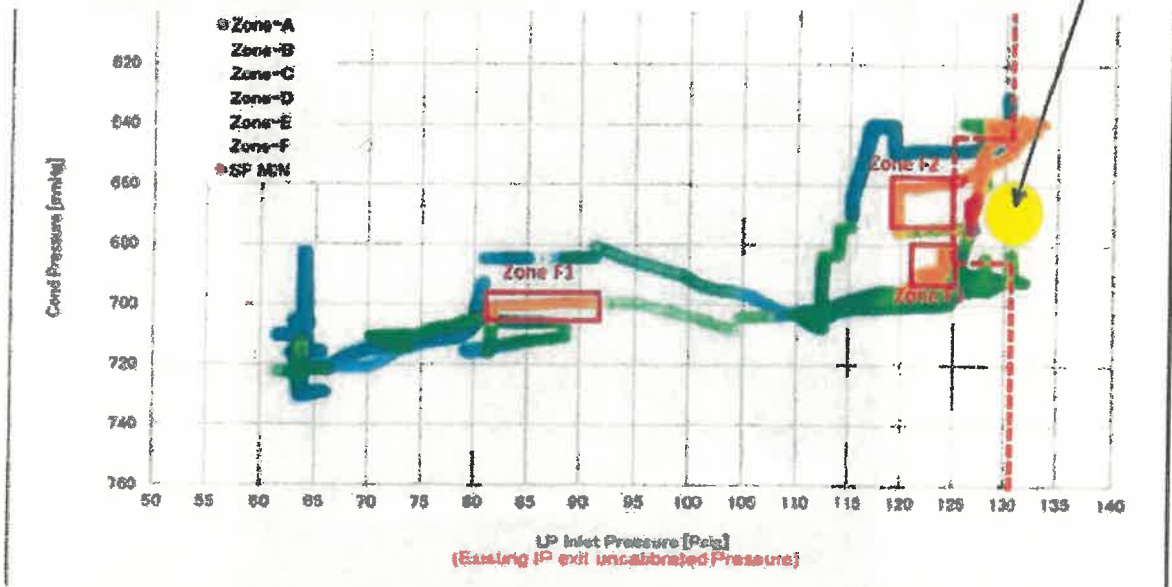
Blade Response – Design Margin
Example : Shroud Fretting Fatigue

Unable to test due to excessive blade response

- Blade response is evaluated through the integration of the stress response all the modes between 180Hz to 120Hz

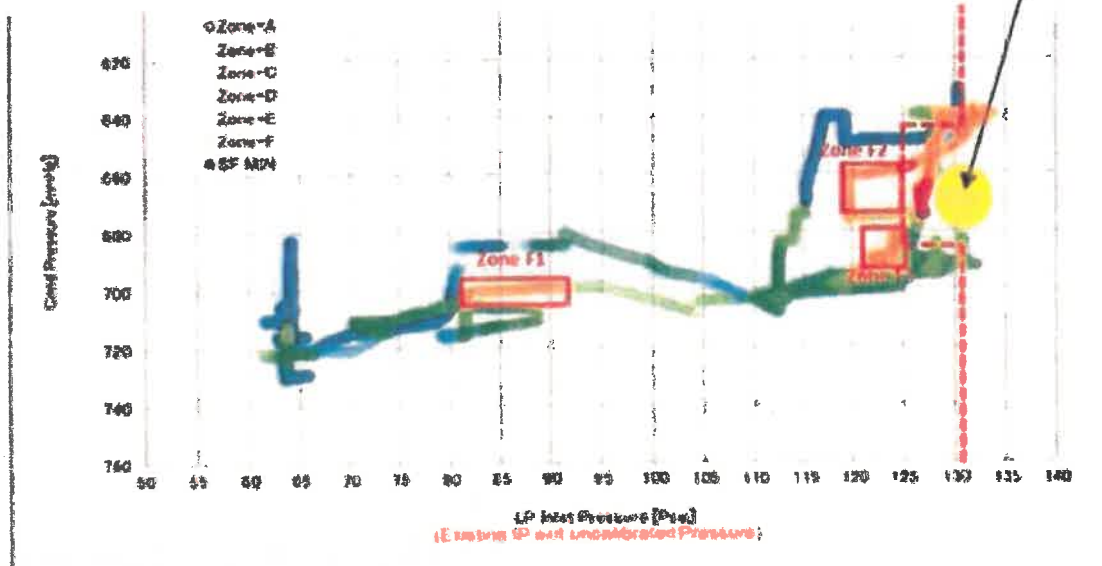
Blade Response – Design Margin Example : Shroud Fretting Fatigue

Unable to test due to excessive blade response

- Blade response is evaluated through the integration of the stress response all the modes between 180Hz to 120Hz
