**Sumter Electric Cooperative, Inc. Report to the Florida Public Service
Commission Pursuant to Rule 25-6.0343, F.A.C.
Calendar Year 2007**

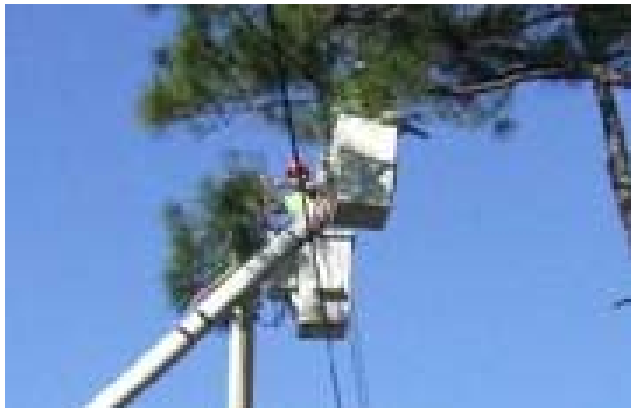
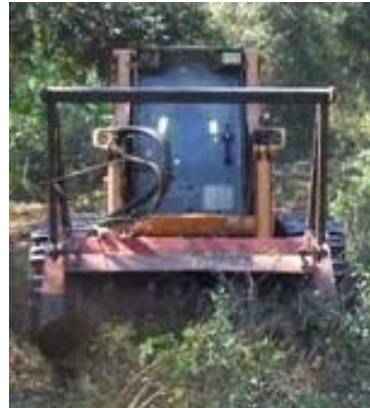
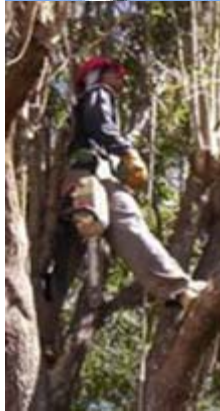
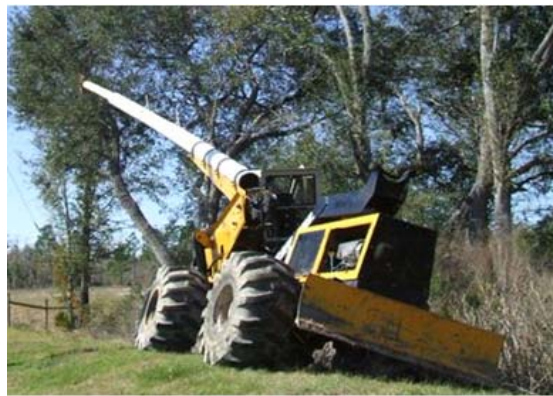
Trimming Activities

All SECO trimming work is performed by Nelson Tree Service, Inc. based on plans developed by ACRT. Nelson utilizes state-of-the-art equipment to ensure maximum effectiveness with minimal impact to our members.

SECO trimming contractors utilize pre-planned manifests generated by ACRT to ensure consistent application of SECO specifications and accuracy of billing. This has led to marked improvements in cost-effectiveness, resource allocation, and record-keeping. Utilizing all available types of equipment has also greatly helped SECO reduce its cost per mile.

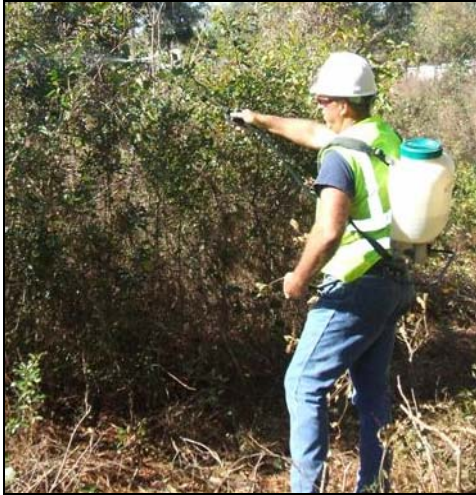
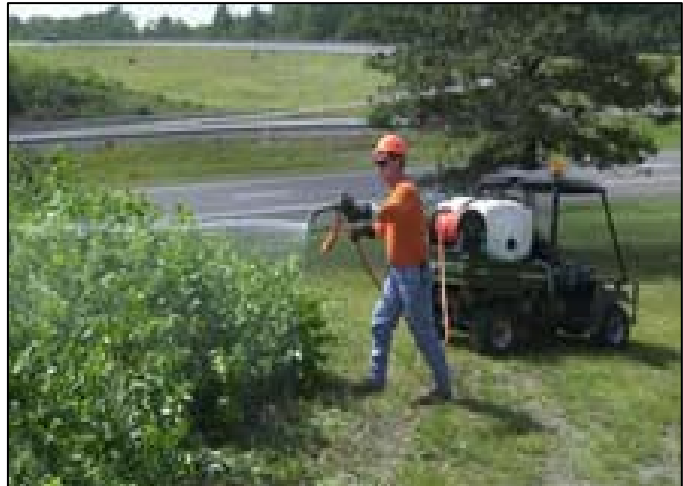
Herbicide Activities

As part of SECO's fully integrated program, a systematic herbicide application program was implemented in 2007.

As shown above, SECO herbicide application contractors utilize both low-volume backpack sprayers and larger scale vehicle-mounted equipment to apply selective herbicides within our easements and rights-of-way.
