*Review of Florida's
Investor-Owned Electric Utilities' Service Reliability
In 2008*

Florida Public Service Commission
Division of Service Quality, Safety and Consumer Assistance

December 17, 2009
(Revised October 7, 2010)

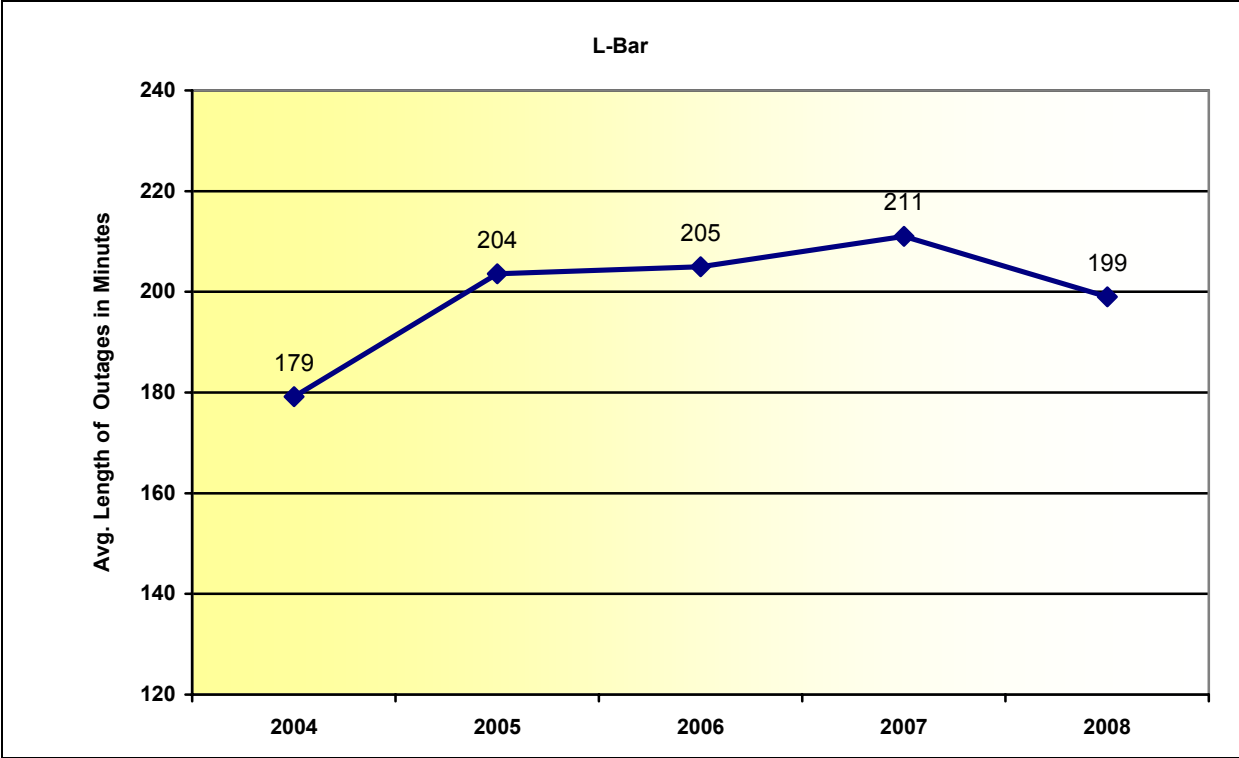
Figure 3-4. FPL's Average Duration of Outages (Adjusted)

The average length of time that FPL spends recovering from outage events, excluding hurricanes and other extreme outage events, is the index known as L-Bar as shown in Figure 3-4. FPL made a 6 percent improvement in L-Bar (the time required to restore service) by decreasing from 211 minutes in 2007 to 199 minutes in 2008.

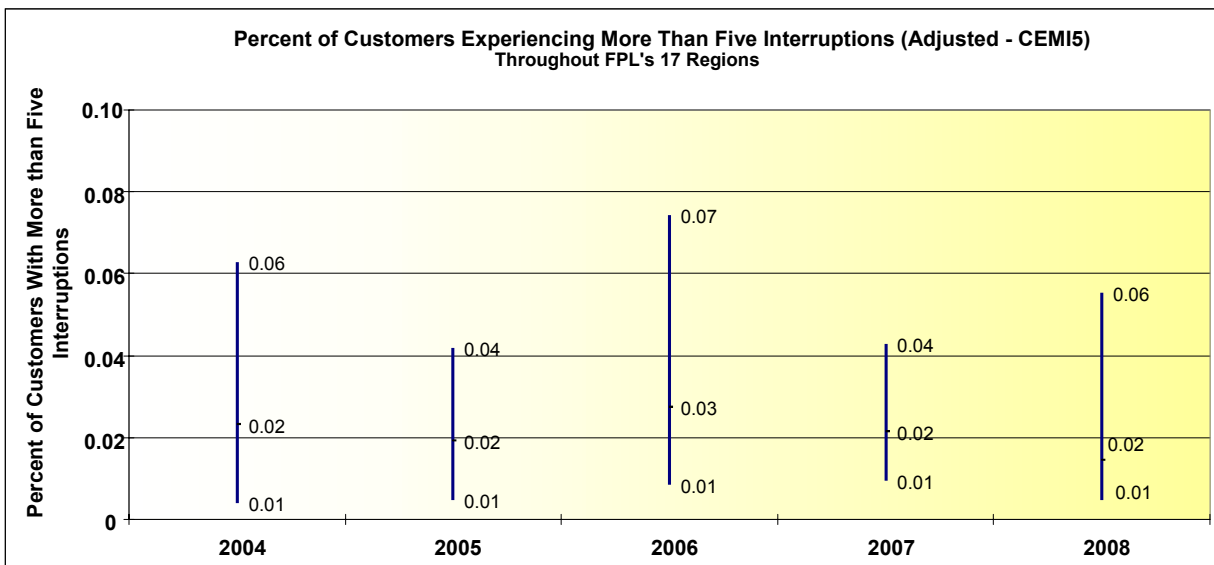
Figure 3-6. CEMI5 Across FPL's 17 Regions (Adjusted)

Figure 3-6 shows the maximum, average, and minimum adjusted CEMI5 (percent of customers experiencing more than five interruptions). FPL reported a declining CEMI5 for FPL's combined 17 service areas which suggest overall improvement for the past five years.

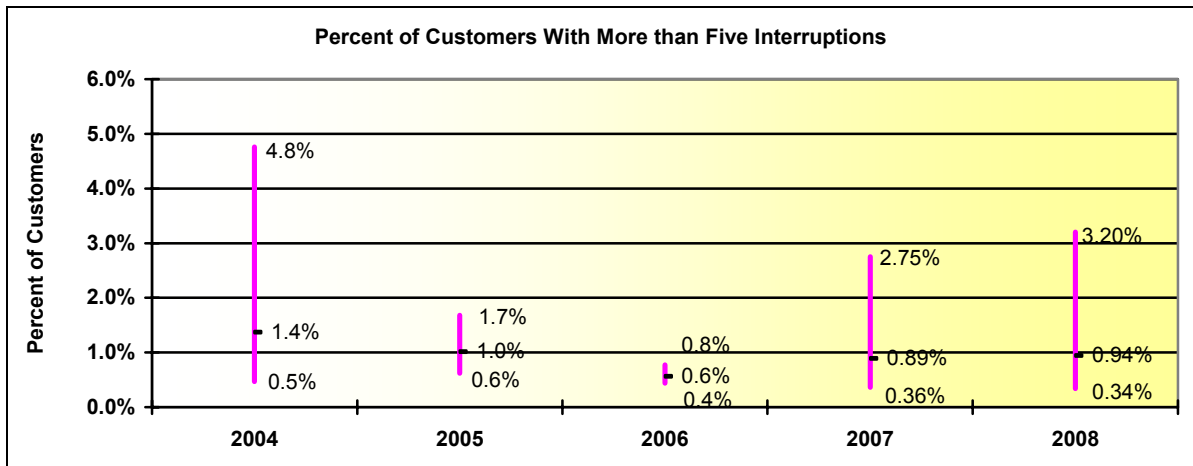
Figure 3-14. CEMI5 Across PEF's Four Regions (Adjusted)

Figure 3-14 charts the maximum, average, and minimum adjusted CEMI5 (percent of customers experiencing more than five interruptions). PEF has experienced little change in the average CEMI5 performance over the past three years. An increasing CEMI5 for the North Coastal and North Central regions indicate a decline in service reliability in these two regions. The North Coastal region has had the highest CEMI5 performance for all four regions over the five-year evaluation period. However, PEF reported declining CEMI5 for its Southern regions, suggesting general improvement in both the South Coastal and South Central Regions.

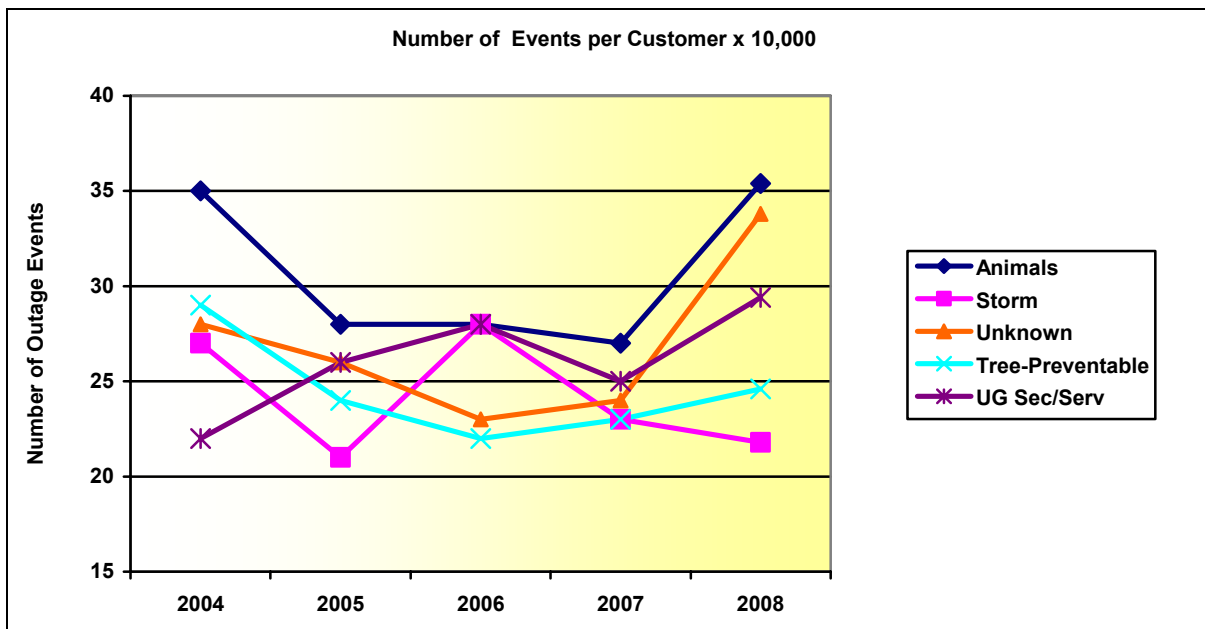
Figure 3-16. PEF's Top Five Outage Causes (Adjusted)

Figure 3-16 shows the top five causes of outage events on PEF’s distribution system normalized to a 10,000 customer base. The figure is based on PEF’s adjusted data of the top ten causes of outage events and represents 58 percent of the outage events that occurred during 2008. For the five-year period, the top five causes of outage events were: animals (13 percent), unknown (11 percent), UG secondary/service (11 percent), tree-preventable (10 percent), and storm (10 percent) on a cumulative basis. The number of outages experienced due to animals and unknown causes rose sharply from 2007 to 2008.
