Re: PSC Storm Hardening Report for the City of Tallahassee Electric Utility pursuant to Rule 25-6.0343, F.A.C for Calendar Year 2012.

**City of Tallahassee Electric Utility
Report to the Florida Public Service Commission Pursuant to
Rule 25-6.0343, F.A.C.
Calendar Year 2012**

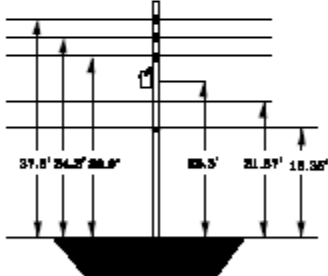
EXAMPLE 2: INSS01-2D FRAMING, #1/0 TPX SECONDARY, SPAN LENGTH OF 230' RIGHT AND 210' LEFT. 50KVA TRANSFORMER. 45' POLE REQUIRED.
