# Florida Public Utilities Company

## Storm Protection Plan 2026 - 2035

Rule 25-6.030, F.A.C.

*Corrected/Modified plan filed August 5, 2025*

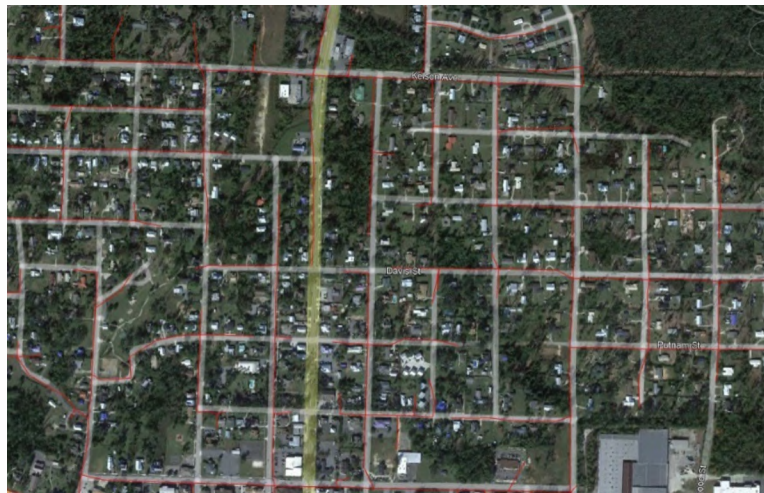
Figure 14 - Accessible Areas - NW Division

FPUC system-specific GIS data was overlaid on top of aerial/satellite imagery as shown in Figures 14 and 15 to determine their accessibility (ability for FPUC to easily access utility assets with standard trucks and tools). Inaccessible areas, such as those shown in Figure 15, take longer to restore due to the inability to leverage truck and tools specially designed to provide efficiencies in the construction and maintenance of electric grids.

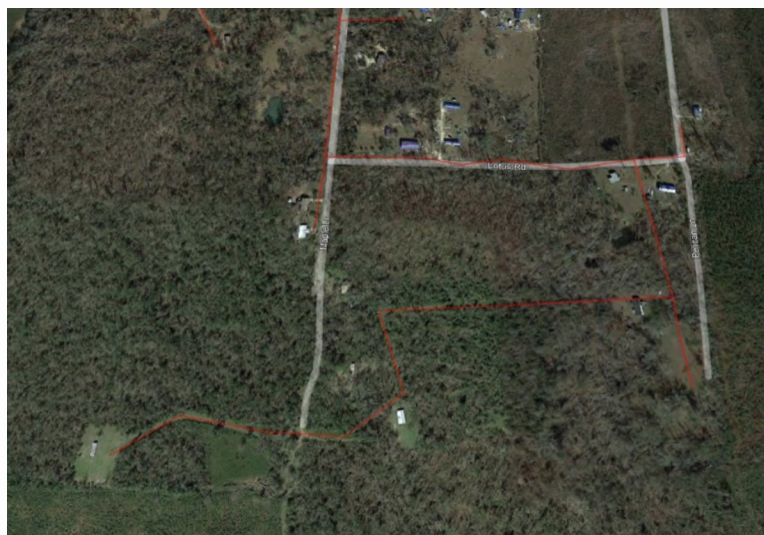
Figure 15 - Inaccessible Area - NW Division

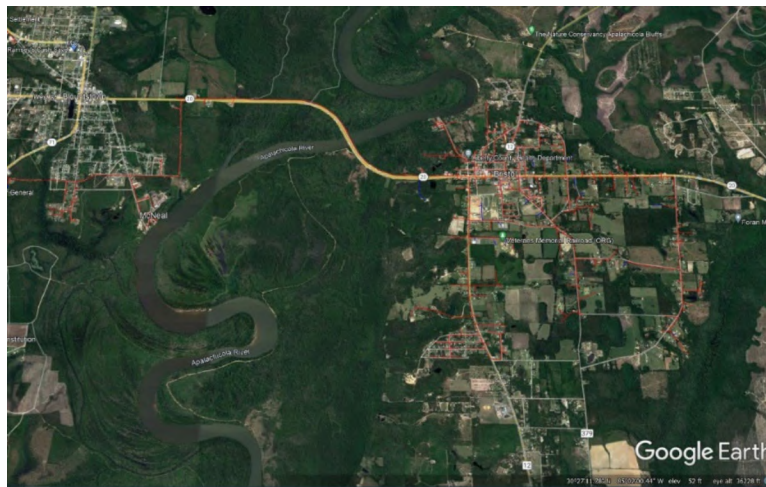
Figure 16 - Radial service to Liberty County customers

As mentioned earlier, it is practically and technically impossible to eliminate all outages associated with extreme weather events. The ability to restore and recover unaffected areas of the distribution grid is essential in minimizing the customer impact associated with these events. This can prove to be problematic in more rural areas of a utility's service territory, particularly at the tail end of a distribution circuit. FPUC's service to customers in Liberty County, Florida is an example of this scenario where customers are served from a single overhead feeder that spans across the Apalachicola River. FPUC GIS data, electrical connectivity models, and discussions with FPUC personnel were leveraged to identify areas of the FPUC territory with this type of risk (Figure 16).
