Re: (New Filing) - Petition of Florida Public Utilities Company for Approval of 2013 Storm Hardening Plan

STORM HARDENING PLAN
OF
FLORIDA PUBLIC UTILITIES COMPANY

Storm Hardening Plan
2013 - 2015

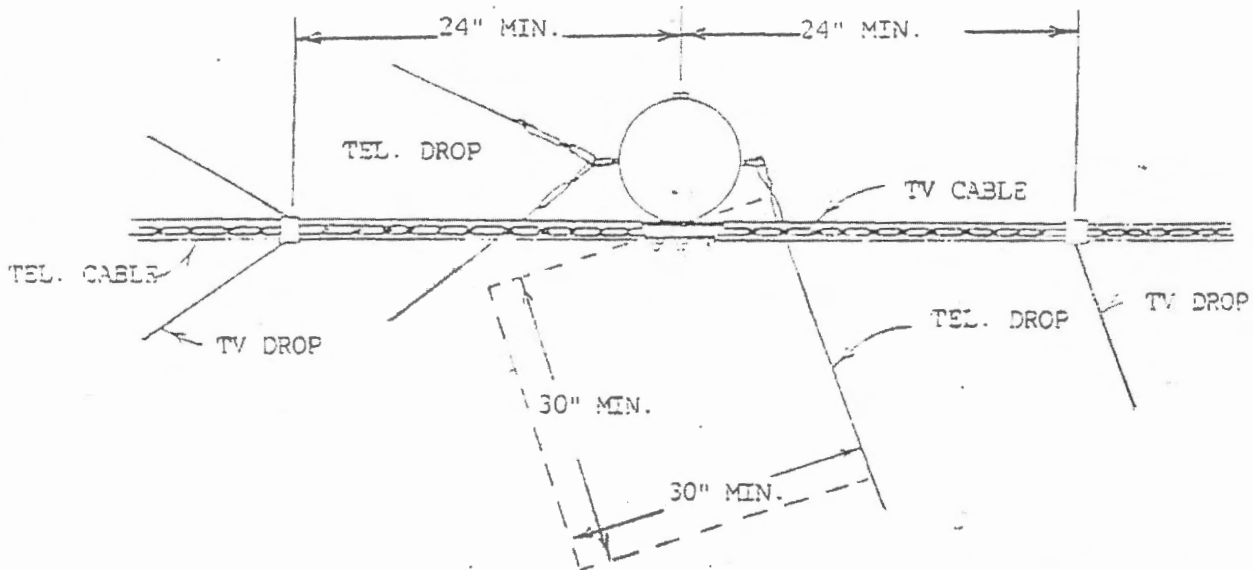
POWER SYSTEM VERTICAL
RUN OR GRND. WIRE

SEPARATION BETWEEN VERTICAL RUN,
INCLUDING STAPLES OR OTHER DEVICES
USED TO FASTEN IT TO POLE & COM-
MUNICATION DRIVE HOOK SHALL BE AT
LEAST 2" IN ANY
DIRECTION.

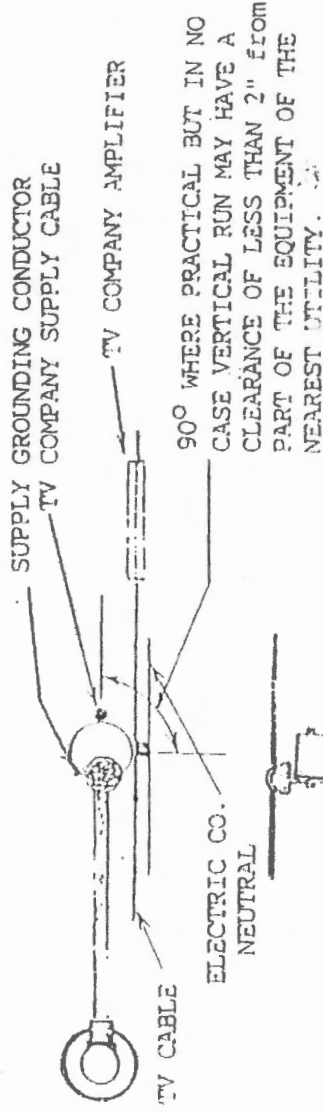
TV POWER SUPPLY INSTALLED IN CONDUIT WITH WEATHERHEAD AND DRIP LOOP

90° WHERE PRACTICAL BUT IN NO CASE VERTICAL RUN MAY HAVE A CLEARANCE OF LESS THAN 2" FROM PART OF THE EQUIPMENT OF THE NEAREST UTILITY.

ELECTRIC CO. NEUTRAL

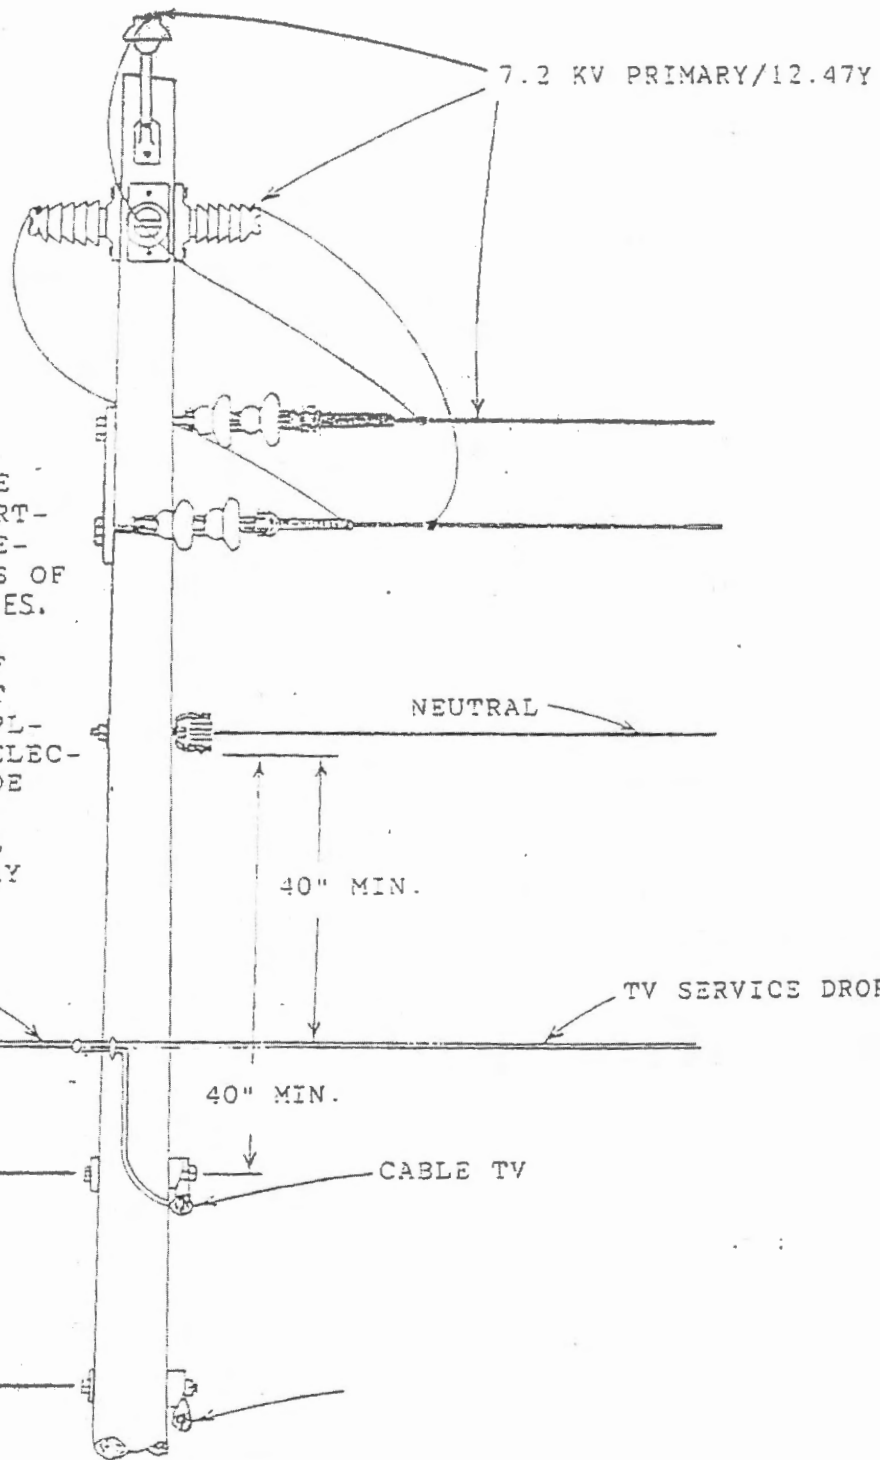
TYI CO. ATTACHMENT TO FPU POLE
SINGLE TRANSFORMER INSTALLATION

7.2 KV CONSTRUCTION

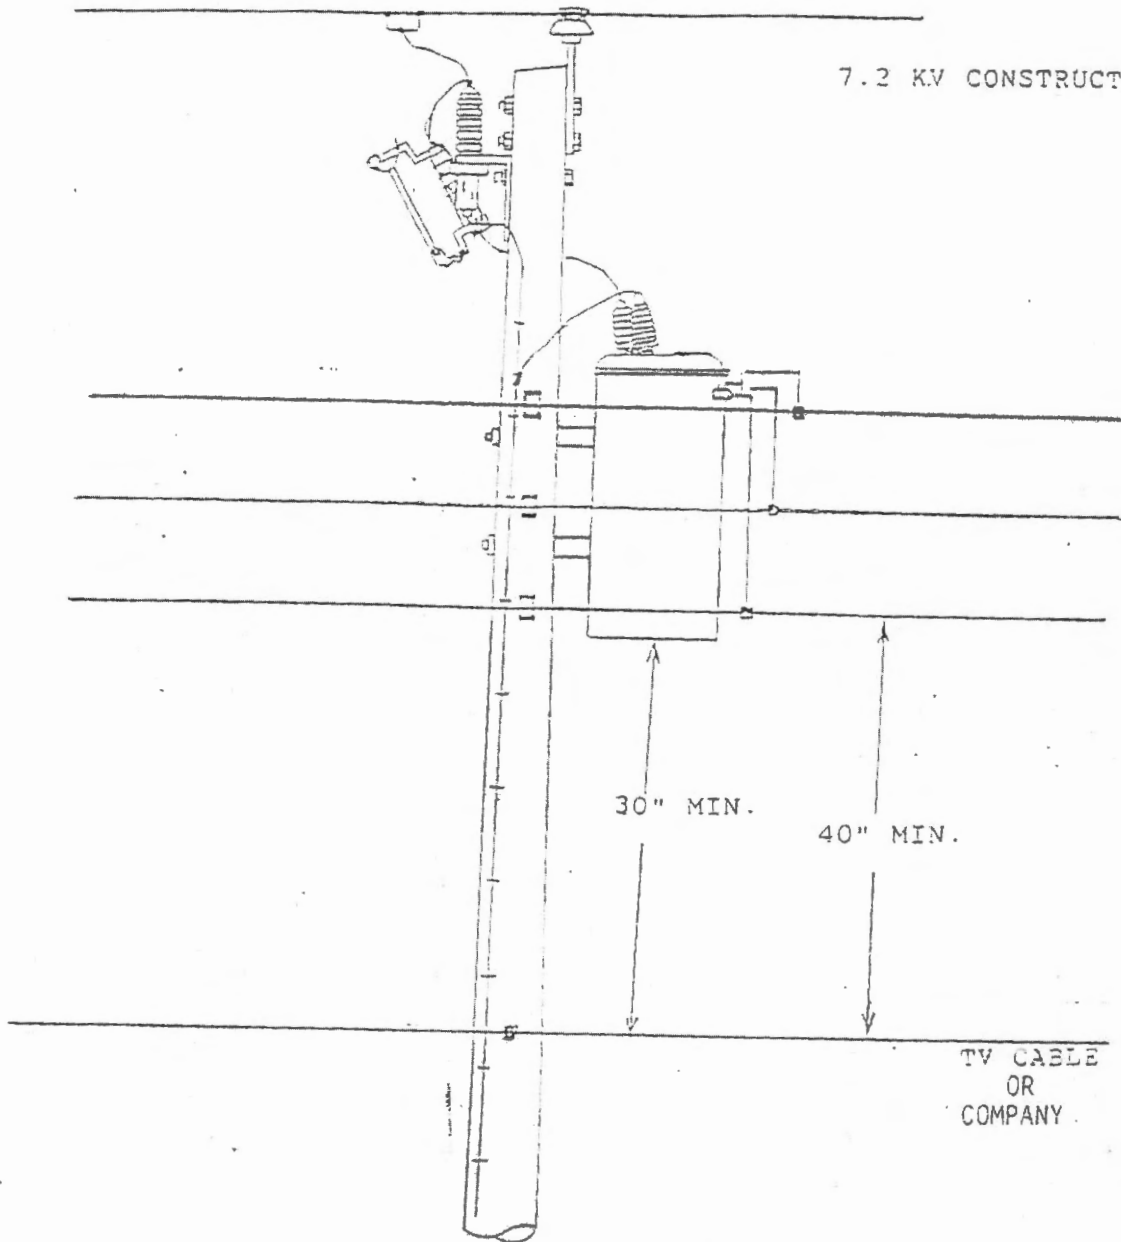
TYPICAL COMPANY ATTACHMENT TO FPU CO POLE

TV CABLE
OR
COMPANY
