Florida Public Utilities Company

Storm Protection Plan 2022 - 2031

Rule 25-6.030, F.A.C.

Modified plan filed November 15, 2022

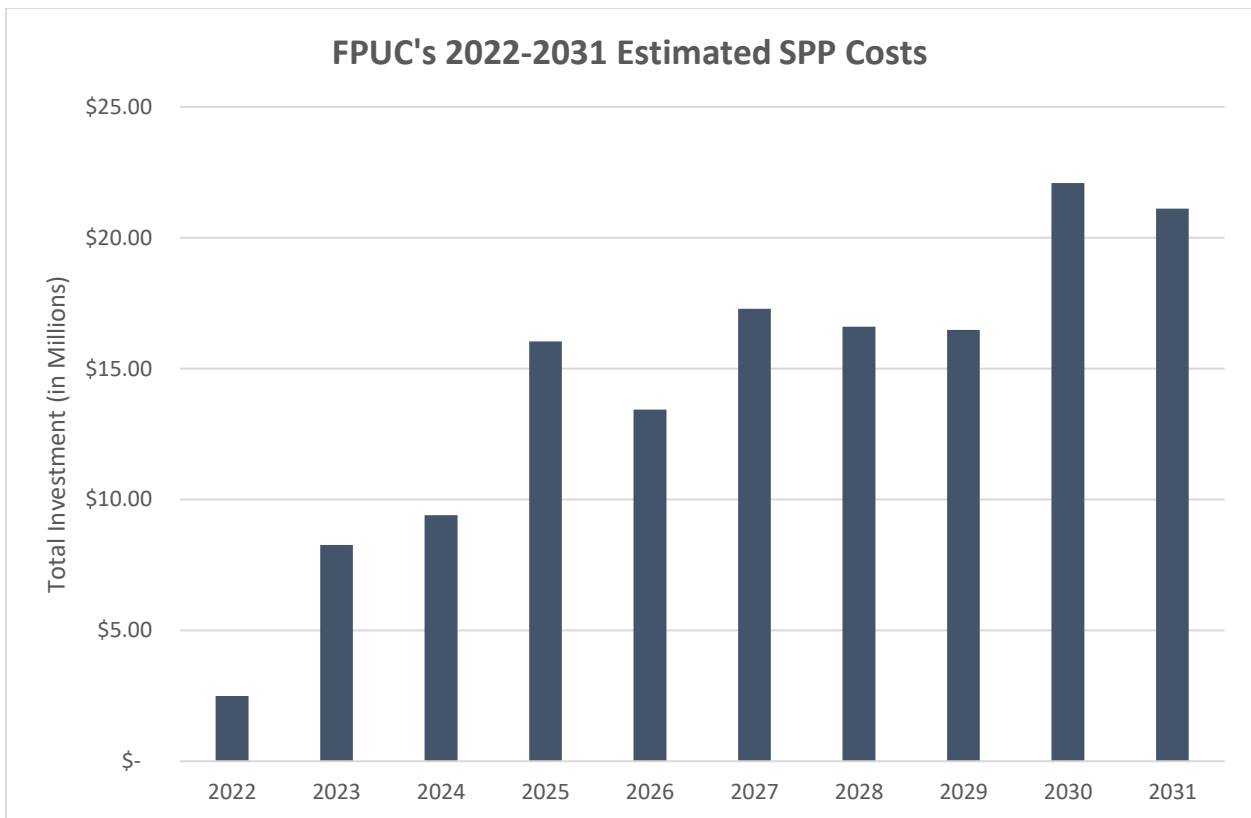
Figure 1 - Ten-year estimated investment profile for SPP Programs⁴

FPUC recognizes the complexities of implementing new programs, the importance of identifying potential pitfalls early, and the validation of initial assumptions. With this in mind, the FPUC SPP ten-year investment plan in the three new Distribution SPP Programs (Overhead Feeder Hardening, Overhead Lateral Hardening, and Overhead Lateral Undergrounding) includes \$110.5M in Capital investments and O&M expenditures. The implementation plan includes a methodical ramp up of investments that allows for the acquisition of resources, initiation of design activities, the refinement of projects, and the Hurricane Michael cost recovery surcharge to expire³. Figure 1 below shows the full SPP 10-year investment plan which includes the \$110.5M in new Distribution SPP programs mentioned above and \$32.7M for T&D Vegetation Management, Distribution Pole Inspections and Replacements, and Transmission System Inspection and Hardening activities. Figure 2 below, details the breakdown by Program type for the \$20.2M in the first three years of the plan within the approximately \$143.2M SPP 10-year investment. As expected with these types of programs and as detailed within Figures 1 and 2, most of these investments are split between the new Overhead Lateral Undergrounding program and the Legacy Programs being carried forward.

⁴ 2024 – 2026 include costs associated with Transmission and Substation Resiliency detailed in Section 3.6

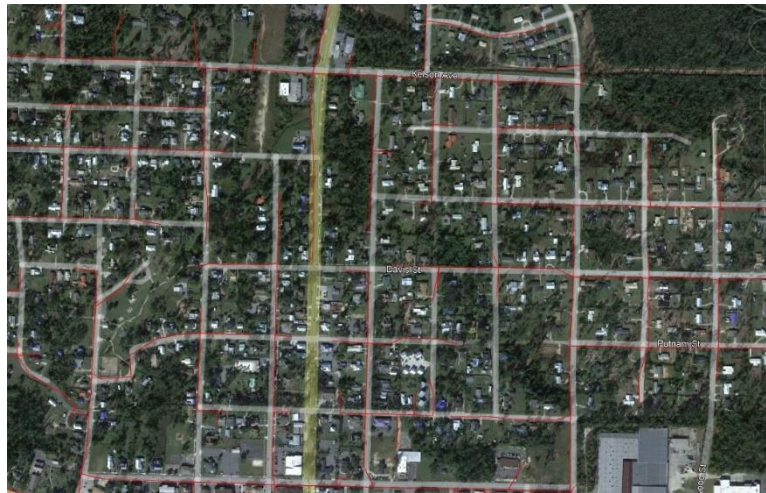
Figure 14 - Accessible Areas - NW Division

FPUC system-specific GIS data was overlaid on top of aerial/satellite imagery as shown in Figures 14 and 15 to determine their accessibility (ability for FPUC to easily access utility assets with standard trucks and tools). Inaccessible areas, such as those shown in Figure 15, take longer to restore due to the inability to leverage truck and tools specially designed to provide efficiencies in the construction and maintenance of electric grids.

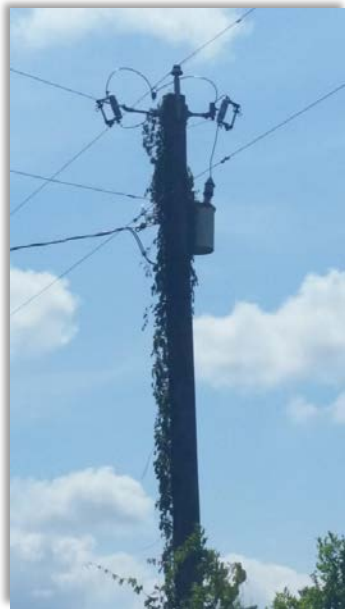
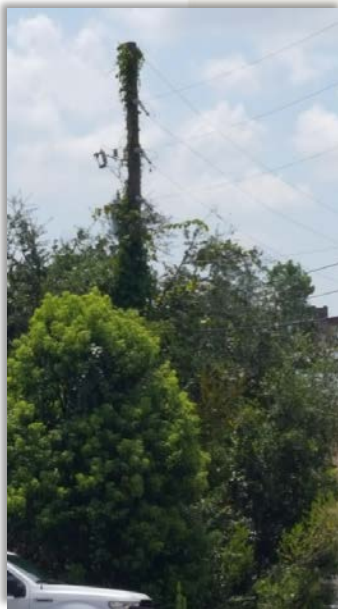
190 vine locations have been identified in the 62 sample areas. Of these locations, 148 are located on single phase and 42 are on three phase. Vine locations are spread evenly across the system. Residential areas account for 91 occurrences (48%), Agriculture account for 84 (44%) and commercial had 15 (8%).

Vines	
1Phase	148
Ag	66
Res	82
Com	0
3 Phase	42
Ag	18
Res	9
Com	15
Total	190

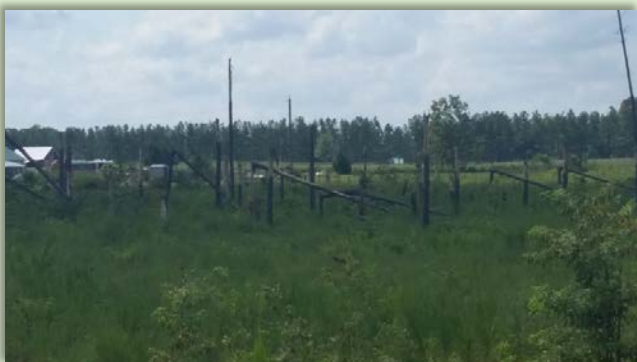
While conducting the Tree/Wire Interface assessment, The DRG GIS dept has identified additional areas with storm damage have been identified from aerial photography. An additional 58.46 miles have been determined to have “storm damage”. Storm Damage areas is defined as areas with trees that have broken tops, leaning or damaged in other ways.

While this mileage is in addition to the TIF miles, It represents the damage caused by Hurricane Michael in 2018. While all of the areas may not have vegetation deemed hazardous to the electrical system, It represents the widespread damage due to Hurricane Michael in 2018.

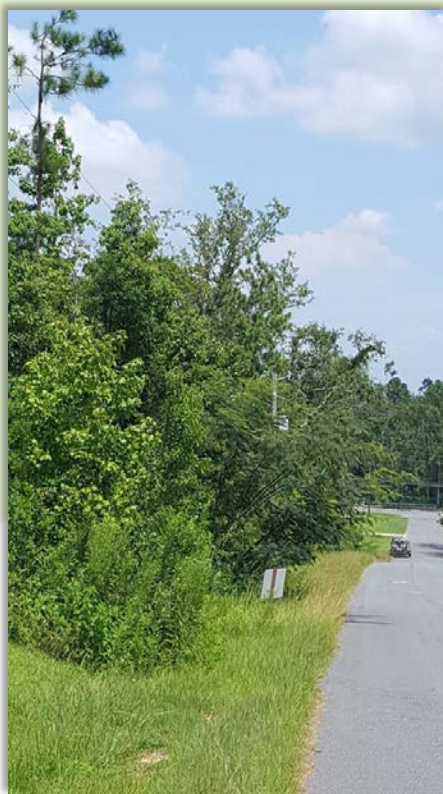
Trapped trees are any small tree or brush that has the potential to contact conductors and has its upward growth pushed toward conductors. Trapped trees are excellent candidates for removal. Removal of trapped trees can reduce future workloads by number of trees to trim and disposal of debris generated for trimming activities. Trapped trees can be addressed by manual removal, mowing operations or herbicide application. If trapped trees are removed manually or by mowing operation, it is recommended to follow up with an herbicide stump treatment to minimize future regrowth and future workloads.

Most occurrences with Trapped Trees are mainly concentrated in Residential (27%) and Agricultural (31%) areas. Most occurrences of trapped trees have not been planted by property owners. They are volunteers that have been naturally seeded. With proper notification of residential customer, most all would be removed. In agricultural areas, many are located along fence lines and edge of right of ways and should be removed during routine maintenance.
