**Re: Docket No. 20220049-EI: Review of Storm Protection Plan pursuant to Rule 25-6.030,
F.A.C., Florida Public Utilities Company**

Florida Public Utilities Company

Storm Protection Plan 2022 - 2031

Rule 25-6.030, F.A.C.

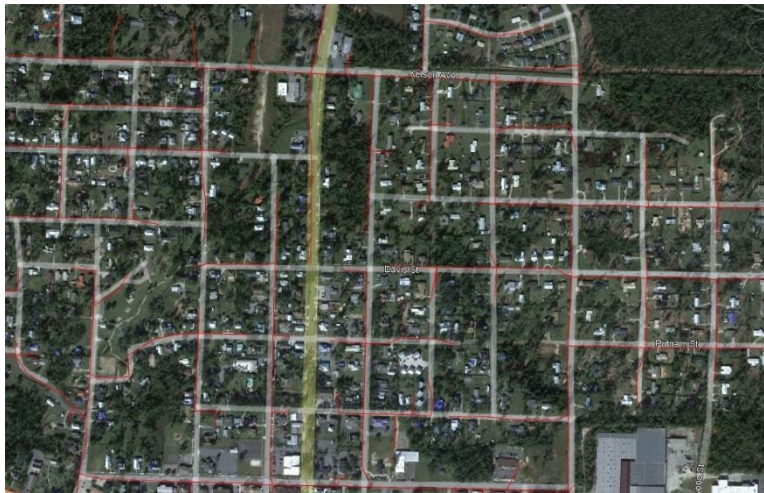
Figure 14 - Accessible Areas - NW Division

FPUC system-specific GIS data was overlaid on top of aerial/satellite imagery as shown in Figures 14 and 15 to determine their accessibility (ability for FPUC to easily access utility assets with standard trucks and tools). Inaccessible areas, such as those shown in Figure 15, take longer to restore due to the inability to leverage truck and tools specially designed to provide efficiencies in the construction and maintenance of electric grids.

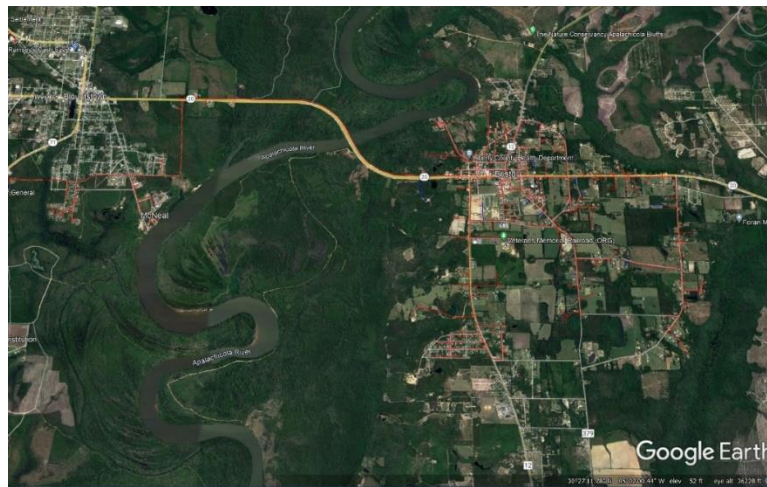
Figure 16 - Radial service to Liberty County customers

As mentioned earlier, it is practically and prudently impossible to eliminate all outages associated with extreme weather events. The ability to restore and recover unaffected areas of the distribution grid is essential in minimizing the customer impact associated with these events. This can prove to be problematic in more rural areas of a utility’s service territory, particularly at the tail end of a distribution circuit. FPUC’s service to customers in Liberty County, Florida is an example of this scenario where customers are served from a single overhead feeder that spans across the Apalachicola River. FPUC GIS data, electrical connectivity models, and discussions with FPUC personnel were leveraged to identify areas of the FPUC territory with this type of risk (Figure 16).

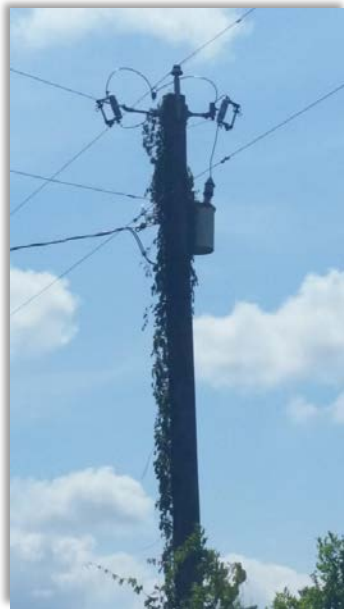
190 vine locations have been identified in the 62 sample areas. Of these locations, 148 are located on single phase and 42 are on three phase. Vine locations are spread evenly across the system. Residential areas account for 91 occurrences (48%), Agriculture account for 84 (44%) and commercial had 15 (8%).

Vines	
1Phase	148
Ag	66
Res	82
Com	0
3 Phase	42
Ag	18
Res	9
Com	15
Total	190

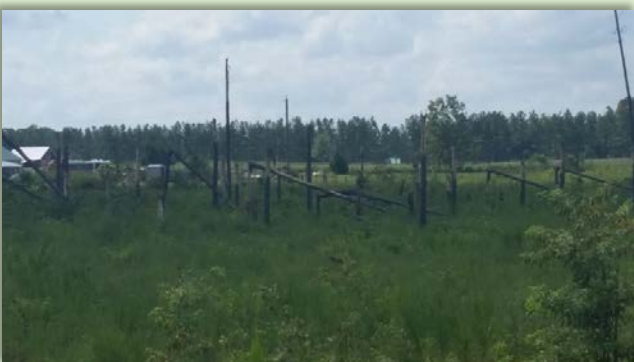
While conducting the Tree/Wire Interface assessment, The DRG GIS dept has identified additional areas with storm damage have been identified from aerial photography. An additional 58.46 miles have been determined to have “storm damage”. Storm Damage areas is defined as areas with trees that have broken tops, leaning or damaged in other ways.

While this mileage is in addition to the TIF miles, It represents the damage caused by Hurricane Michael in 2018. While all of the areas may not have vegetation deemed hazardous to the electrical system, It represents the widespread damage due to Hurricane Michael in 2018.

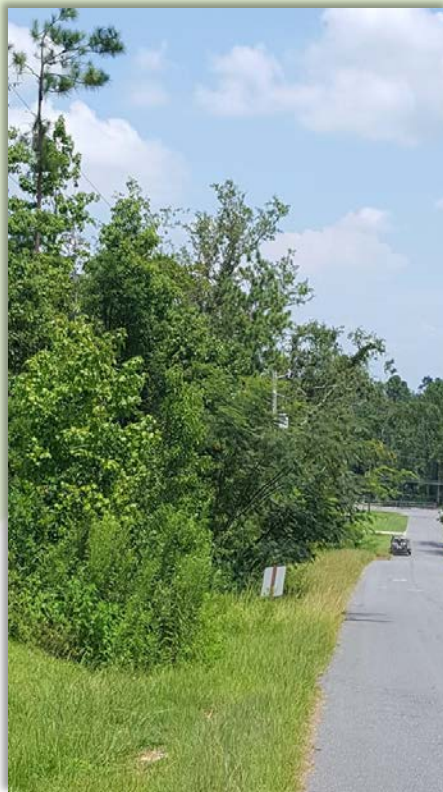
Trapped trees are any small tree or brush that has the potential to contact conductors and has its upward growth pushed toward conductors. Trapped trees are excellent candidates for removal. Removal of trapped trees can reduce future workloads by number of trees to trim and disposal of debris generated for trimming activities. Trapped trees can be addressed by manual removal, mowing operations or herbicide application. If trapped trees are removed manually or by mowing operation, it is recommended to follow up with an herbicide stump treatment to minimize future regrowth and future workloads.

Most occurrences with Trapped Trees are mainly concentrated in Residential (27%) and Agricultural (31%) areas. Most occurrences of trapped trees have not been planted by property owners. They are volunteers that have been naturally seeded. With proper notification of residential customer, most all would be removed. In agricultural areas, many are located along fence lines and edge of right of ways and should be removed during routine maintenance.

Trapped Trees	TOTALS	Res	Com	Ag
Total Locations	40	17	4	19
All Phasing	62	27.42%	6.45%	30.65%
3 Phase	11	3	4	4
1 phase	29	14	0	15

A strong post work audit should be completed to assure all trapped trees have been addressed.
