Florida Public Utilities Company

Storm Protection Plan 2026 - 2035

Rule 25-6.030, F.A.C.

Modified plan filed July 17, 2025

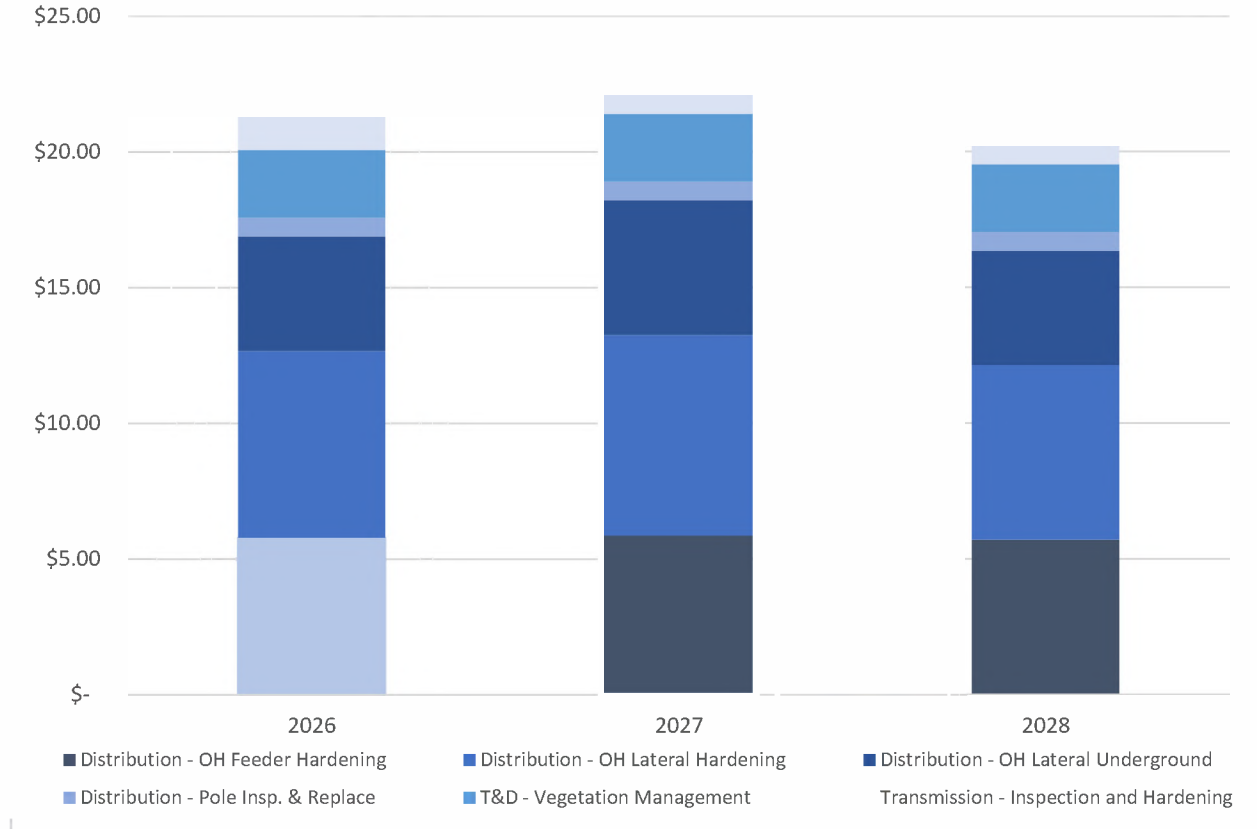
Figure 10 - Three-year estimated investment profile for SPP Programs

FPUC's proposed 10-year estimated investment plan is shown in Figure 9 below and outlines a levelized annual investments over the next ten-year planning horizon. This investment recommendation ensures the continued execution of currently approved SPP Programs at a pace that is commensurate with the cruciality of improvements, the impact to Customer rates, and the Company's execution capacity. A detailed breakdown for the first three years of the plan is subsequently shown in Figure 10 and Table 1.

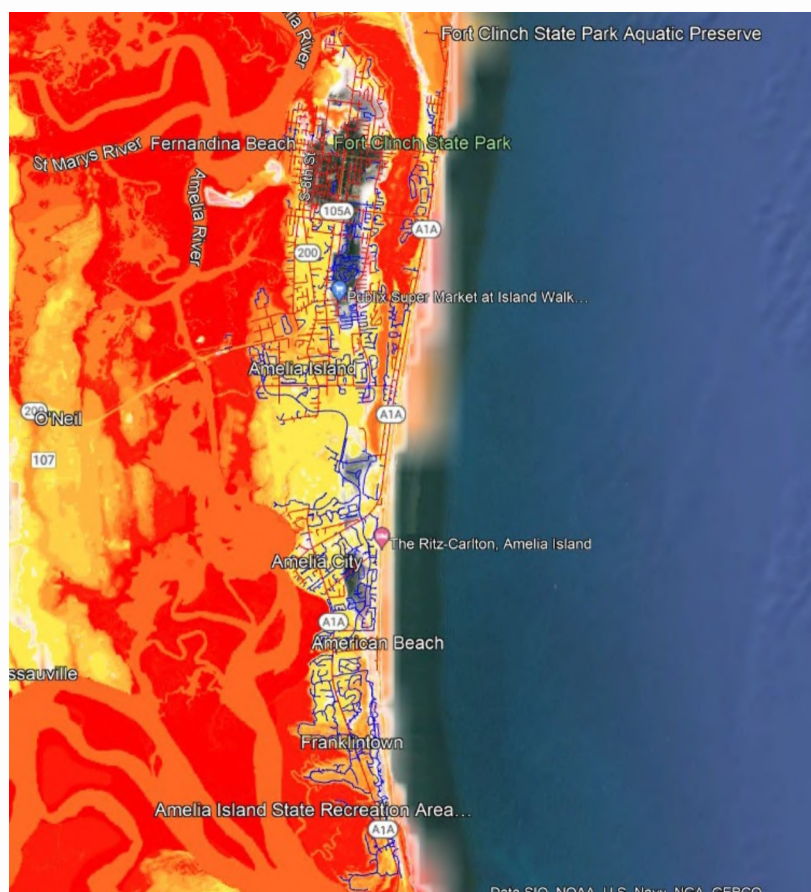
Figure 13 – NOAA Coastal Flood Exposure Map – NE Division

As shown in Figure 12, FPUC's NW Division has minimal flood hazard potential across most of the territory except for facilities serving communities located near the Apalachicola River (Blountstown and Bristol). Storm Surge and Flood Hazard potential varies greatly in the NE Division as shown in Figure 13.

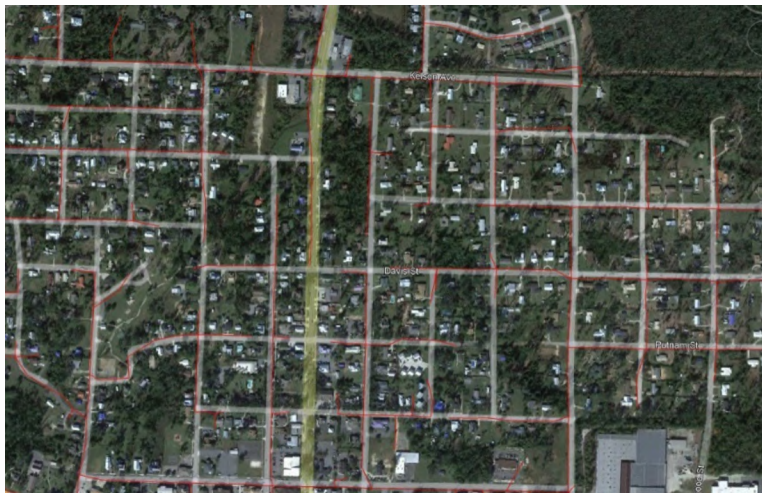
Figure 14 - Accessible Areas - NW Division

FPUC system-specific GIS data was overlaid on top of aerial/satellite imagery as shown in Figures 14 and 15 to determine their accessibility (ability for FPUC to easily access utility assets with standard trucks and tools). Inaccessible areas, such as those shown in Figure 15, take longer to restore due to the inability to leverage truck and tools specially designed to provide efficiencies in the construction and maintenance of electric grids.

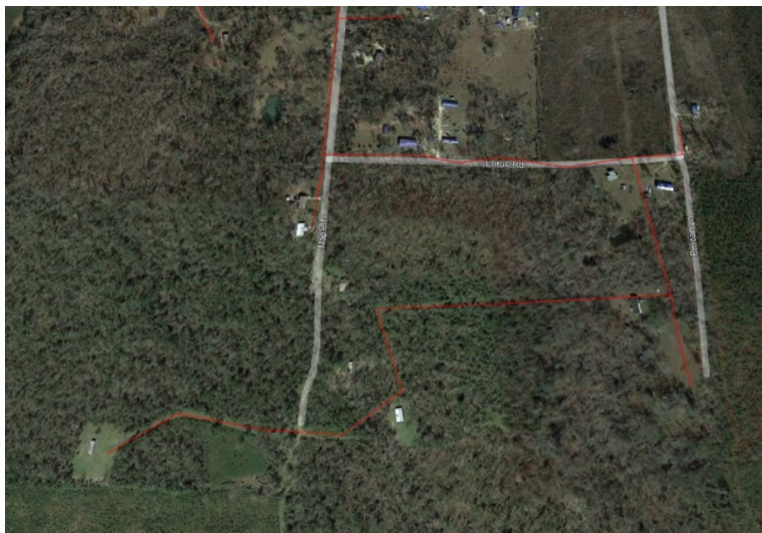
Figure 15 - Inaccessible Area - NW Division

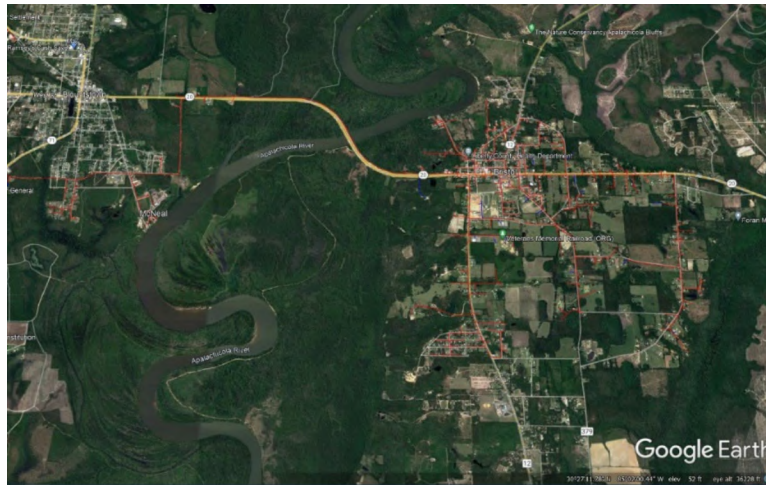
Figure 16 - Radial service to Liberty County customers

As mentioned earlier, it is practically and technically impossible to eliminate all outages associated with extreme weather events. The ability to restore and recover unaffected areas of the distribution grid is essential in minimizing the customer impact associated with these events. This can prove to be problematic in more rural areas of a utility's service territory, particularly at the tail end of a distribution circuit. FPUC's service to customers in Liberty County, Florida is an example of this scenario where customers are served from a single overhead feeder that spans across the Apalachicola River. FPUC GIS data, electrical connectivity models, and discussions with FPUC personnel were leveraged to identify areas of the FPUC territory with this type of risk (Figure 16).

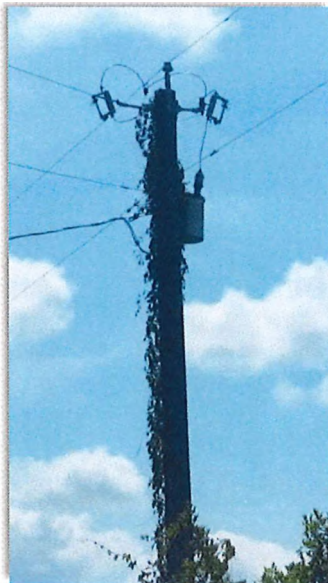
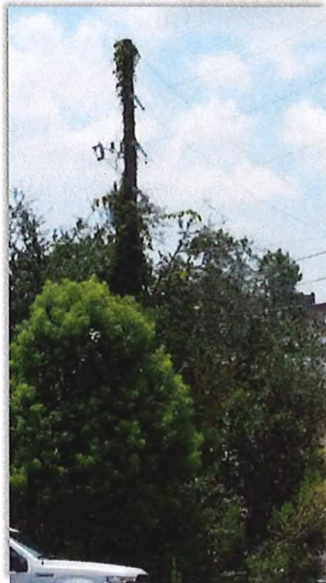
Vines	
1Phase	148
Ag	66
Res	82
Com	0
3 Phase	42
Ag	18
Res	9
Com	15
Total	190

190 vine locations have been identified in the 62 sample areas. Of these locations, 148 are located on single phase and 42 are on three phase. Vine locations are spread evenly across the system. Residential areas account for 91 occurrences (48%), Agriculture account for 84 (44%) and commercial had 15 (8%).

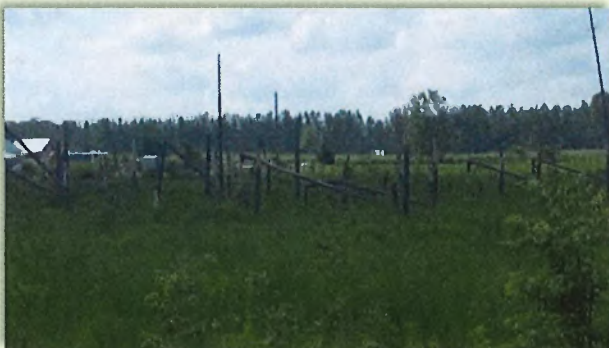
While conducting the Tree/Wire Interface assessment, The DRG GIS dept has identified additional areas with storm damage have been identified from aerial photography. An additional 58.46 miles have been determined to have "storm damage". Storm Damage areas is defined as areas with trees that have broken tops, leaning or damaged in other ways.

While this mileage is in addition to the TIF miles, It represents the damage caused by Hurricane Michael in 2018. While all of the areas may not have vegetation deemed hazardous to the electrical system, It represents the widespread damage due to Hurricane Michael in 2018.

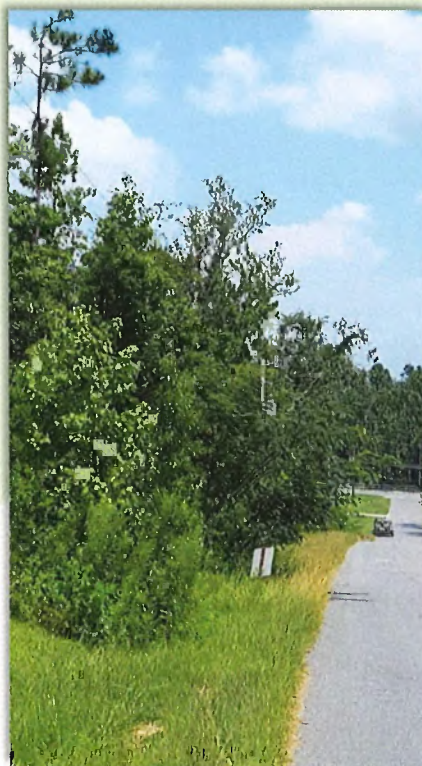
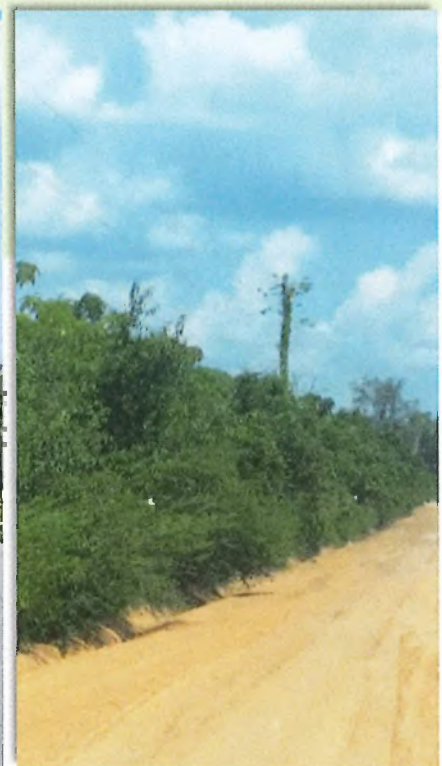
Trapped trees are any small tree or Brush that has the potential to contact conductors and has its upward growth pushed toward conductors. Trapped trees are excellent candidates for removal. Removal of trapped trees can reduce future workloads by number of trees to trim and disposal of debris generated for trimming activities. Trapped trees can be addressed by manual removal, mowing operations or herbicide application. If trapped trees are removed manually or by mowing operation, it is recommended to follow up with an herbicide stump treatment to minimize future regrowth and future workloads.

Most occurrences with Trapped Trees are mainly concentrated in Residential (27%) and Agricultural (31%) areas. Most occurrences of trapped trees have not been planted by property owners. They are volunteers that have been naturally seeded. With proper notification of residential customer, most all would be removed. In agricultural areas, many are located along fence lines and edge of right of ways and should be removed during routine maintenance.

Trapped Trees	TOTALS	Res	Com	Ag
Total Locations	40	17	4	19
All Phasing	62	27.42%	6.45%	30.65%
3 Phase	11	3	4	4
1 phase	29	14	0	15

A strong post work audit should be completed to assure all trapped trees have been addressed.
