BEFORE THE FLORIDA PUBLIC SERVICE COMMISSION

In re: Application for increase in water and)
wastewater rates in Brevard, Citrus, Duval,) DOCKET NO. 20250052-WS
Highlands, Marion, and Volusia Counties by)
CSWR-Florida Utility Operating Company, LLC.)

REBUTTAL TESTIMONY OF

JACOB FREEMAN

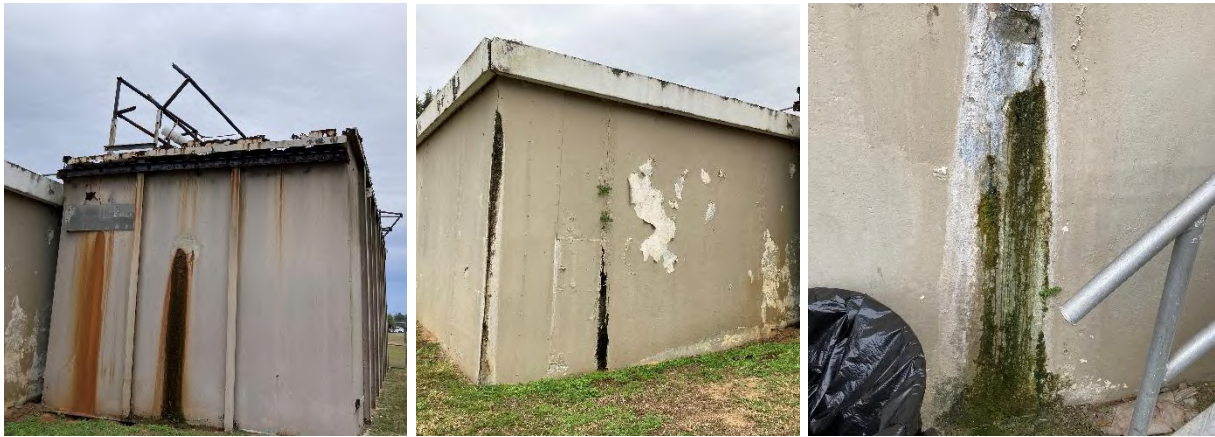
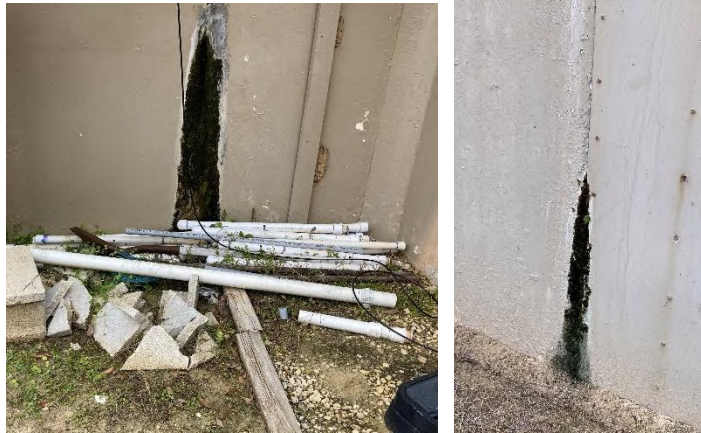
32 A. Yes. The following pictures show the active leaks on the CFAT concrete tanks.
33 Moreover, given the significant algal and bacterial growth on the tanks’ exteriors, it is
34 apparent that the leaks have been present for a significant period.

Examples of leaks on the steel (top left) and concrete (all other photos) tanks with ongoing leaks evident by ineffective patching and significant growth of algae and rust accumulation below leaks.

7 The facility, as it exists today, cannot meet these limits without
8 significant changes. CSWR Florida’s third-party engineering partners
9 evaluated the facility to determine if the existing plant could be
10 upgraded to meet these limits, or if a new treatment plant would be
11 required. In this evaluation the current condition of the treatment plant
12 structures was considered and the work that would be required to ensure
13 the tanks are in good condition for the future. The third-party engineers
14 determined the existing leaking concrete tanks cannot be effectively
15 repaired, and therefore the most cost-effective and responsible approach
16 to achieving compliance will be constructing a new wastewater
17 treatment facility that is designed with total nitrogen limit compliance
18 in mind. The process of designing, permitting, bidding, and
19 constructing a new treatment plant is a long one. Therefore, the existing

20 facility must remain operational throughout the whole process. This
21 means CSWR Florida will make only the minimal necessary repairs to
22 ensure the existing facility can continue to operate until a new facility
23 can be brought online. Improvements to be made will, to the greatest
24 extent possible, ensure any new equipment will be usable at, or will not
25 conflict with, the new facility. Any improvements made to the existing
26 facility will involve the bare minimum investment necessary to ensure
27 the existing facility is operating as required to comply with applicable
28 environmental laws and ensure customers receive safe and reliable
29 service.¹³

1 Since that time, the facility design has progressed with third-party engineers
2 who have proposed an MABR (Membrane Aerated Biofilm Reactor) facility which will
3 effectively meet all permitted limits. Plans are expected to be submitted to FDEP for
4 permitting by June 2026.

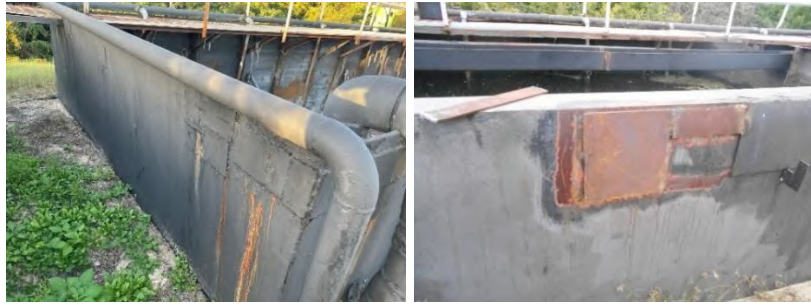
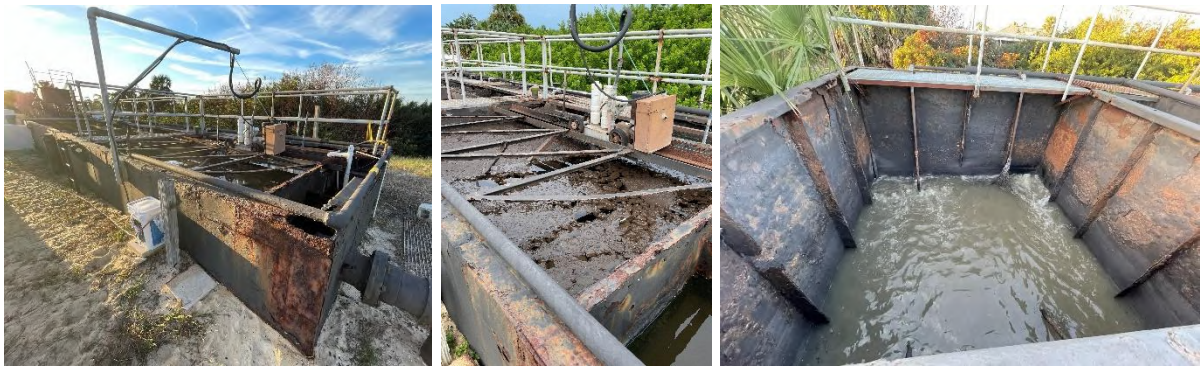
17 A. As described in my Direct Testimony, the wastewater treatment plant was “in
18 extremely poor condition at the time of acquisition.”¹⁸ I noted: (1) “all three package
19 plants [were] in failing condition,” (2) significant leaks and bowing walls in both steel
20 plants, and (3) a wall failure in the concrete plant which resulted in the release of
21 wastewater.¹⁹ As a result, I concluded that “each of the package plants [had] reached
22 the end of its useful life and further repairs [would] not significantly extend the life or
23 meaningfully remedy each plant’s problems.”²⁰ Moreover, I posited that “the overall

5 A. Yes. The following pictures exemplify the problems at North Peninsula.

Examples of steel tanks and equipment deterioration at closing and examples of the numerous poorly installed welded patches on the tanks.

1 A. As discussed in the response to Data Request #2 filed on March 24, 2026, in Docket
2 20250038-WS, the approach for the North Peninsula site was originally to shut the
3 facility down and connect to the City of Ormond Beach treatment facility. However
4 various obstacles have caused the project approach to be reevaluated. The following is
5 an excerpt from the data request response:

19 project complex, they can be overcome. Therefore, CSWR-Florida now
20 believes plant replacement is the most viable alternative. Furthermore,
21 in the reexamination of the plant replacement option, our third-party
22 engineers now believe the estimated cost of the plant replacement
23 project could be significantly lower than their initial evaluation. As a
24 result, the plant replacement option is now estimated at a total of
25 \$4.25M compared to \$5.93M for the consolidation with City of Ormond
26 Beach. While these are still preliminary estimates and not bids or
27 proposals, it further justifies the decision to switch to plant replacement
28 as the selected alternative.

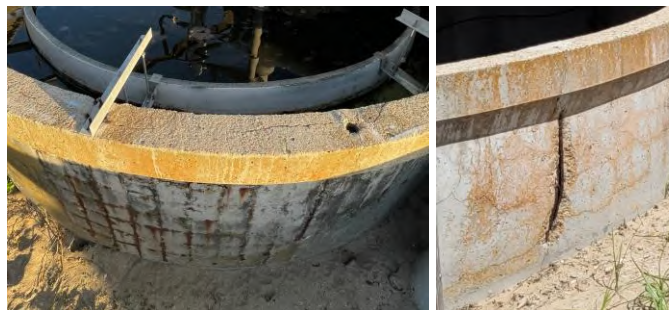
Examples of cracking and exposed rebar in concrete tanks.
