**Re: Petitioner's Submission of Priority Additional Evidence Supporting Formal Complaint; Docket No. 20260045-EI**

### PETITIONER'S PRIORITY SUBMISSION OF ADDITIONAL EVIDENCE SUPPORTING FORMAL COMPLAINT

## FORMAL WRITTEN QUESTIONS AND EVIDENCE SUBMISSION

RE: Duke Energy High Voltage Equipment Noncompliance

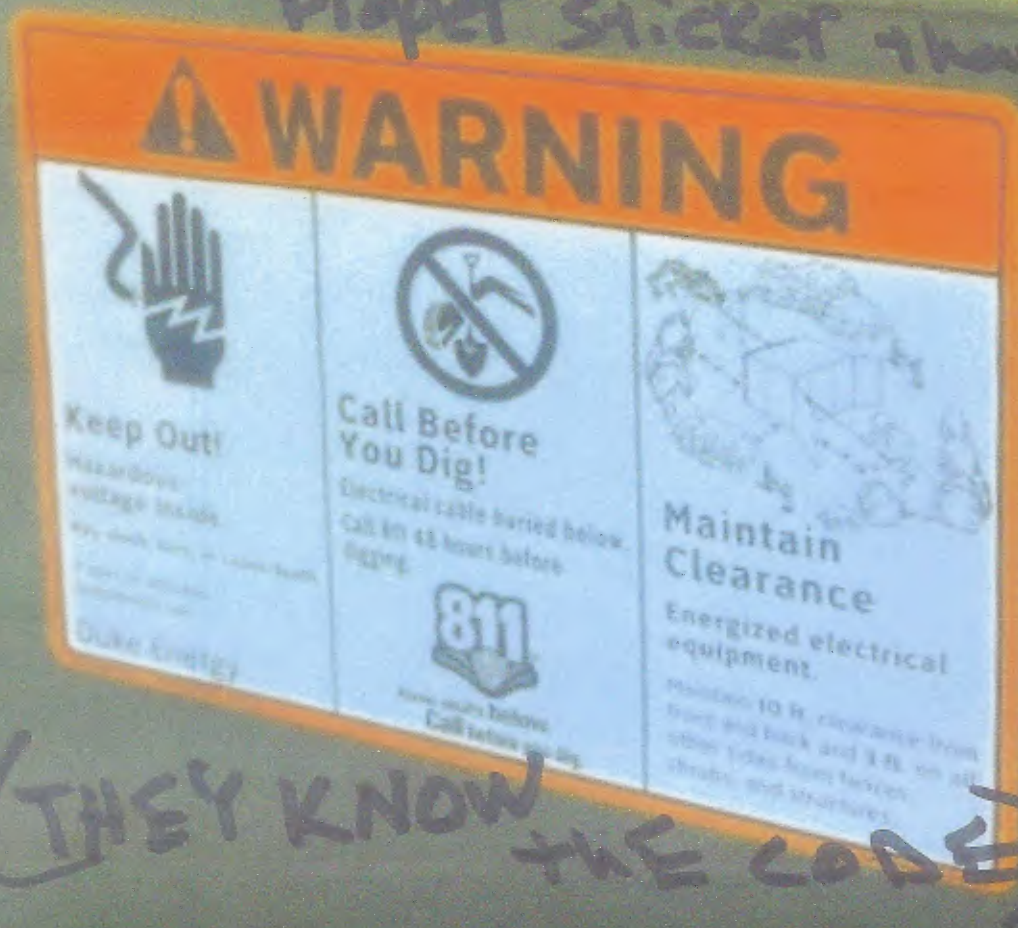
K112656

Here is a pic of a DUKE  
Energy Box which is walking  
Distance from the Box in violation

Proper sticker that should be  
used

\* NOTE  
the 10'  
clearance  
Requirement

(THEY KNOW  
THE CODE)

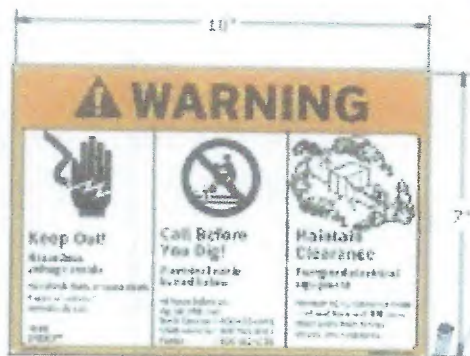
Duke Standard  
for  
PME-4 Box

PME SWITCHGEAR  
FRONT VIEW  
DOORS CLOSED

PME SWITCHGEAR  
SIDE VIEW  
DOORS CLOSED

WARNING LABEL  
EXTERIOR MOUNTING ONLY  
CN 9220111314

DANGER LABEL  
INTERIOR MOUNTING ONLY  
CN 21129884

PME SWITCHGEAR (48.5)  
FRONT VIEW  
DOOR CLOSED

"WARNING" LABEL SHALL BE LOCATED ON THE OUTSIDE OF PAD-MOUNTED SWITCHGEAR, LOOP COVER BOXES, AND PRIMARY METERING CABINETS ON CENTER LINE OF DOOR HANDLE AS SHOWN.

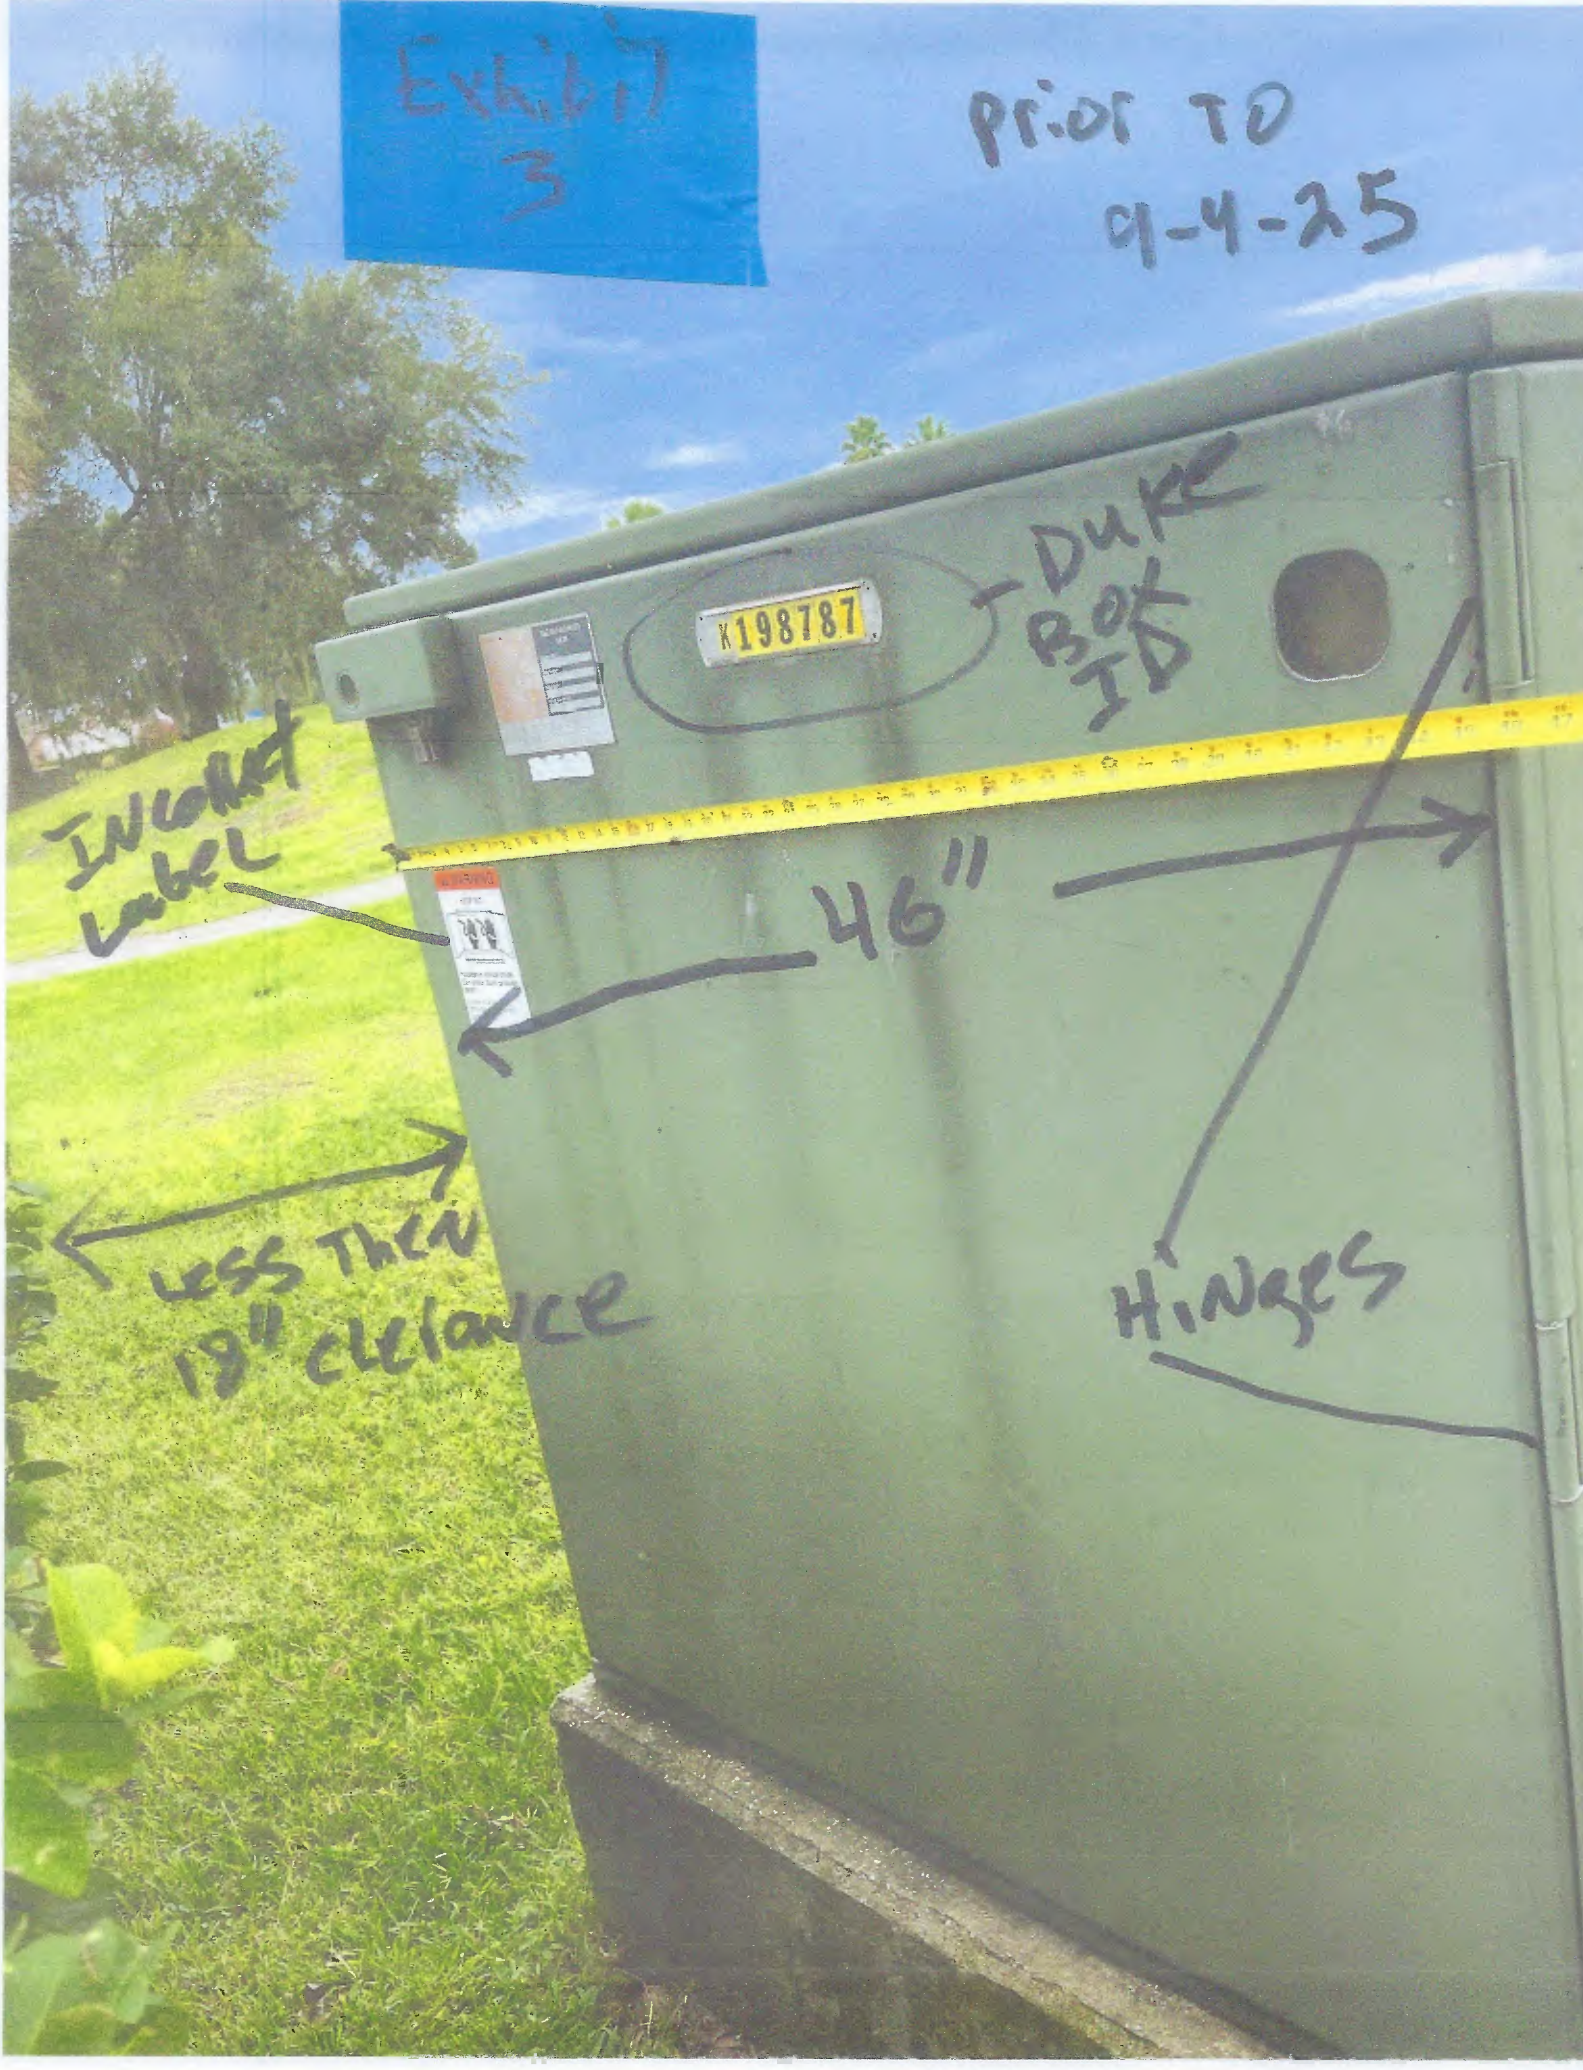
- **Exhibit 2, 3:** Photo evidence showing improper clearance and incorrect label prior to the Duke Energy visit on 9-4-25 (tape measured in photo reflecting the door would not be able to fully open) (less than 18" clearance on a 46" door)

LESS THAN  
18" clearance

Hinges

As shown in the photos, the bushes prohibit the door from opening fully so the PME-4 is not in compliance with NESC requirements.
