REBUTTAL TESTIMONY & EXHIBITS OF:

IN RE: APPLICATION FOR INCREASE IN WATER RATES IN FRANKLIN COUNTY BY WATER MANAGEMENT SERVICES, INC.

DOCKET NO. 100104-WU

BEFORE THE FLORIDA PUBLIC SERVICE COMMISSION

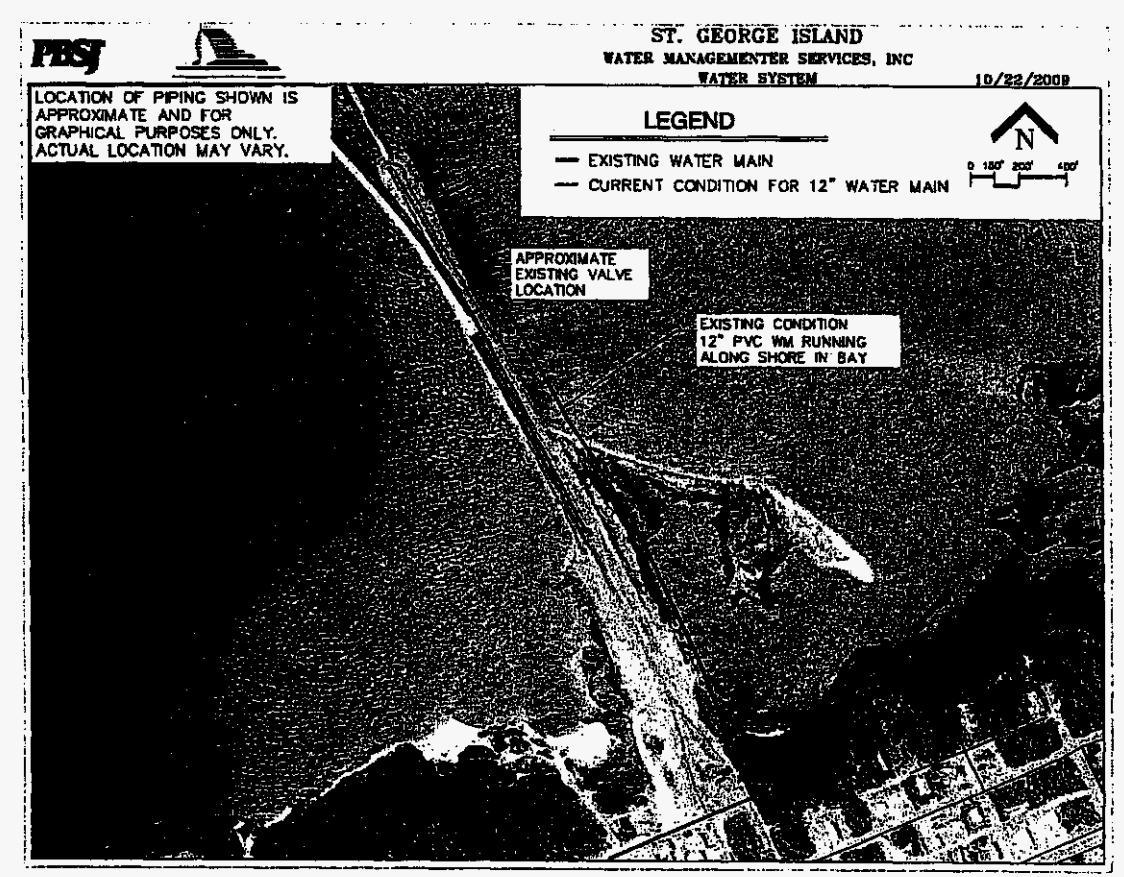
Figure 2.3 – Current Configuration

Page 3 of 14
Figure 2.3 illustrates the current routing of the raw water transmission main as it enters onto St. George Island.

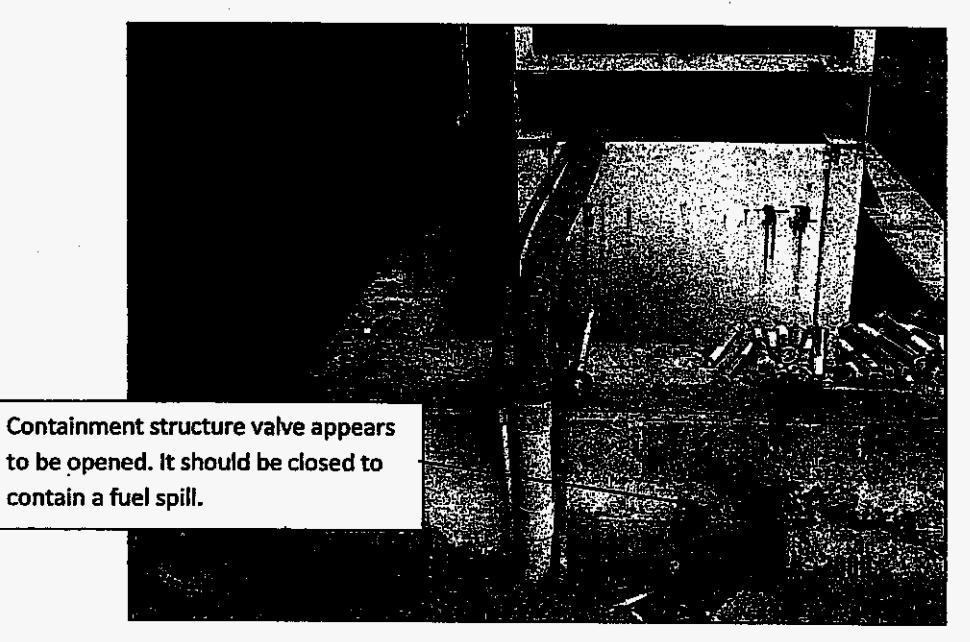
Figure 9-Containment structure

Generator corrosion is apparent. Containment structure does not appear to be large enough to contain a spill.

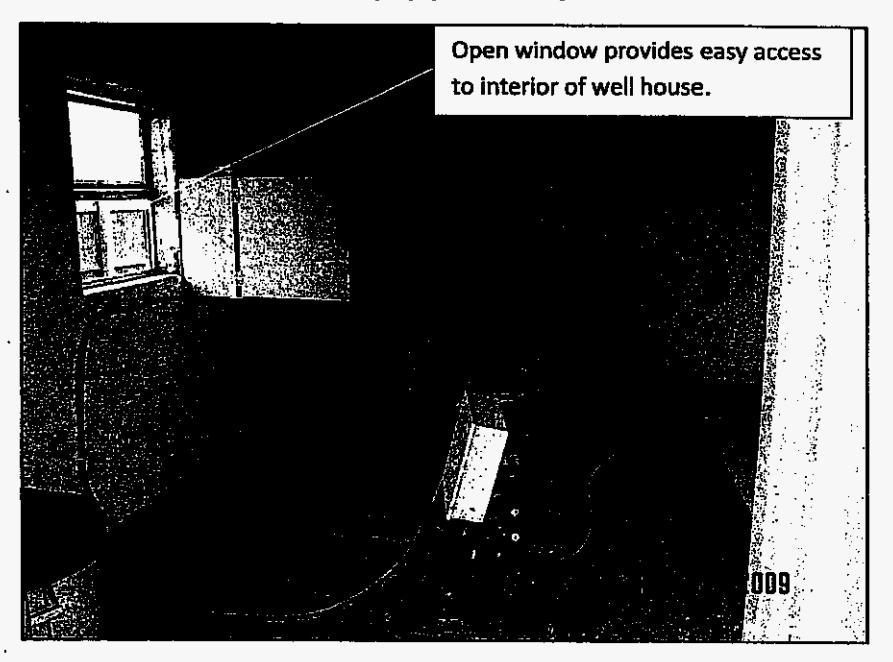
Figure 19-Well house interior

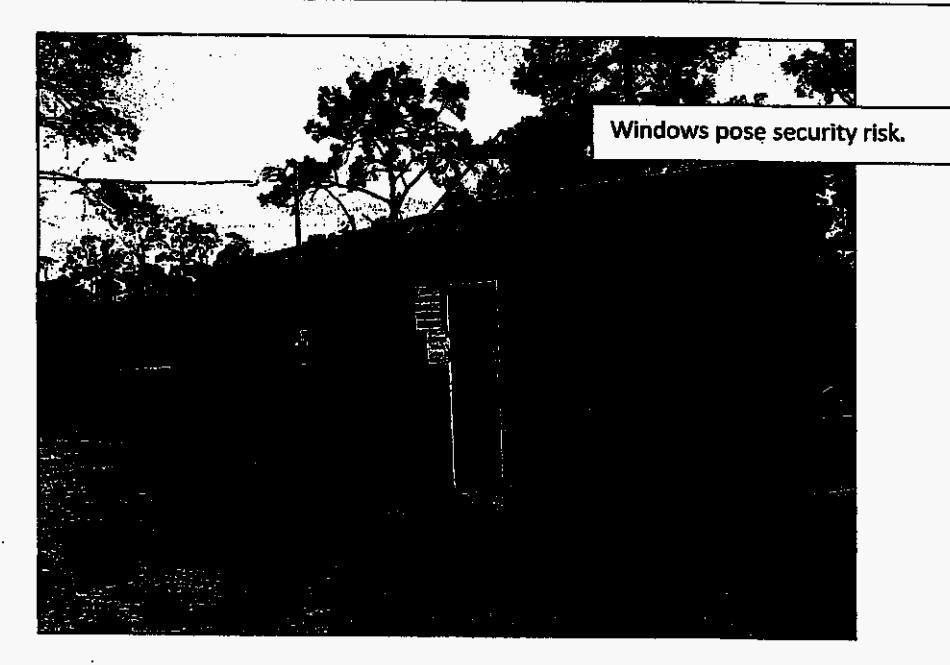
Figure 20-Well house exterior

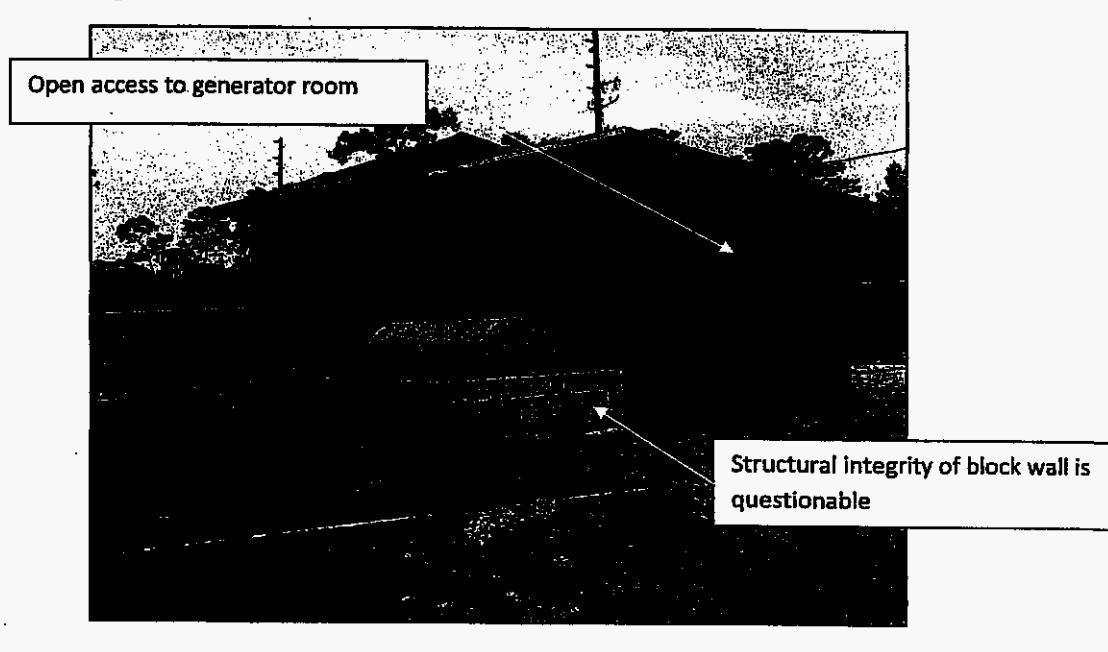
Figure 21-Well house exterior (backside)

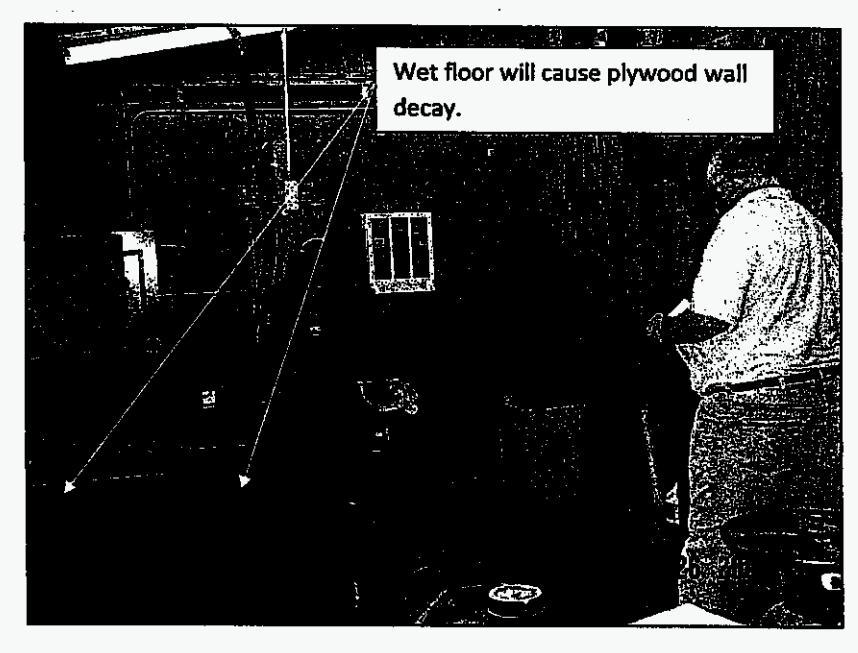
Figure 22-Well pump & piping

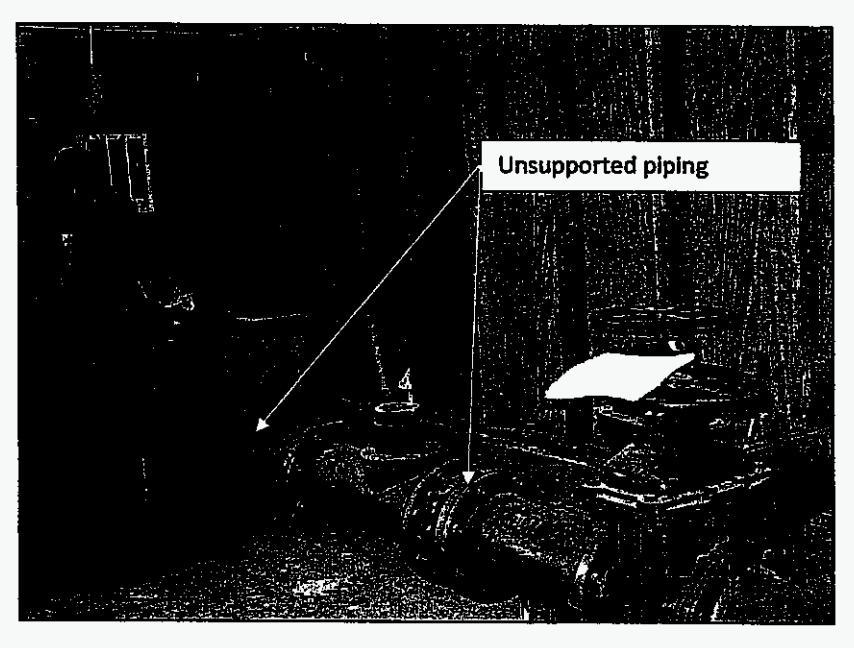
Figure 23-Discharge piping

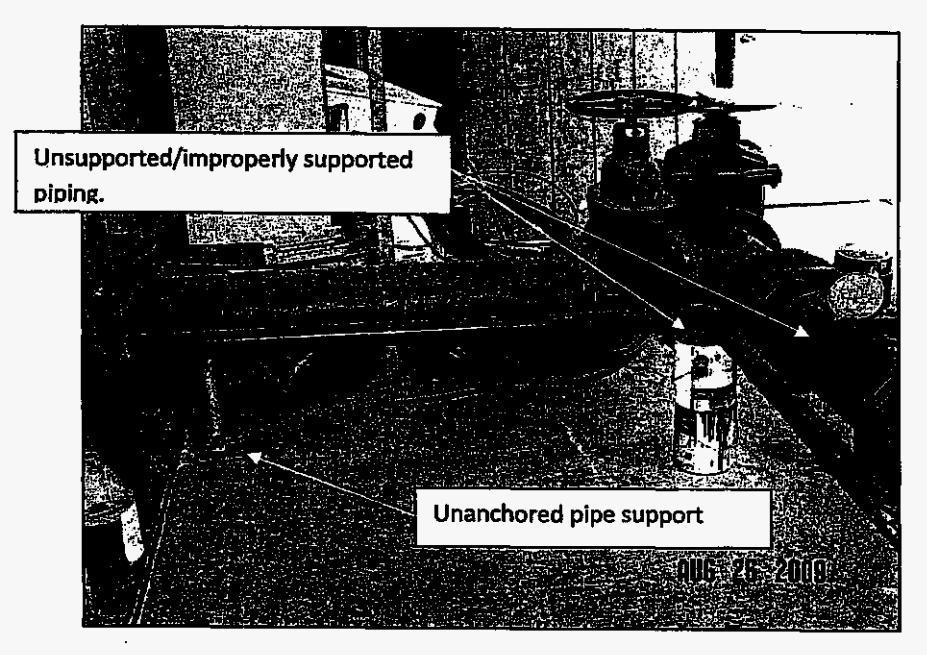
Figure 24-Blowoff piping

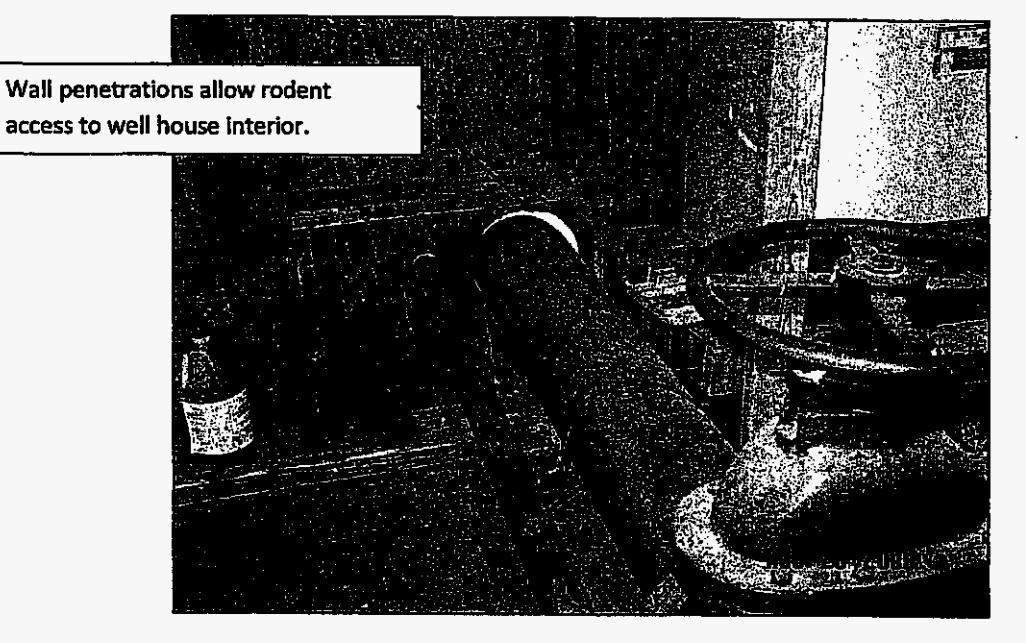
Figure 25-Blowoff piping

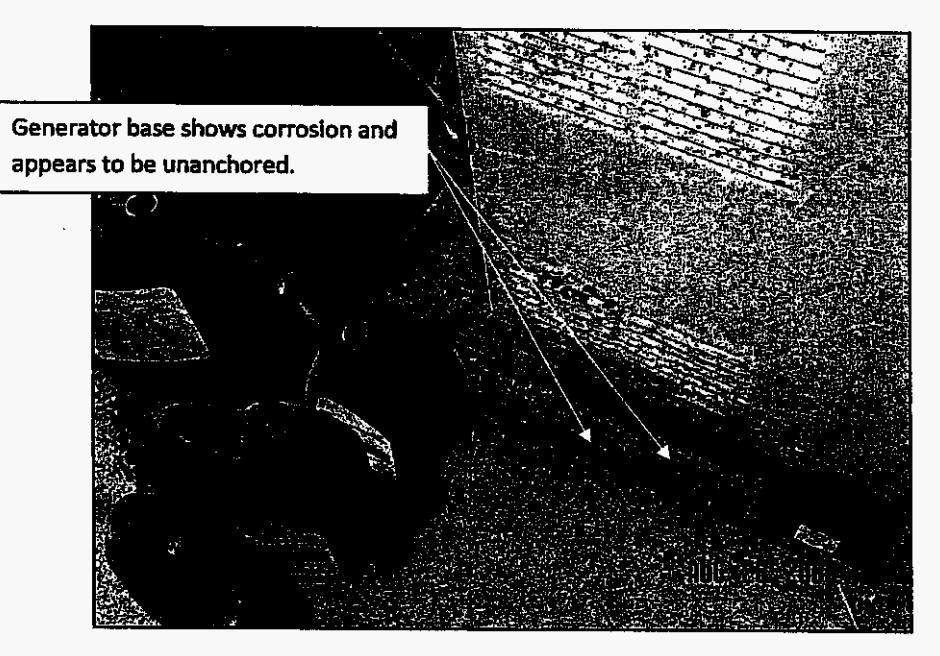
Figure 26-Generator base

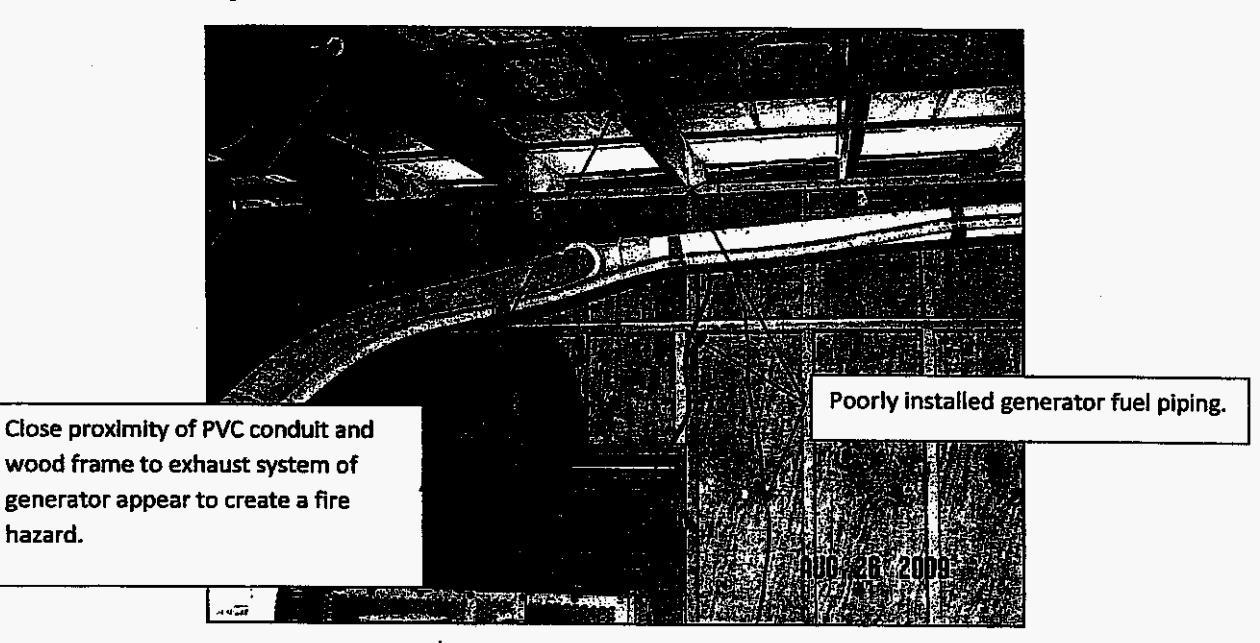
Figure 27-Generator room

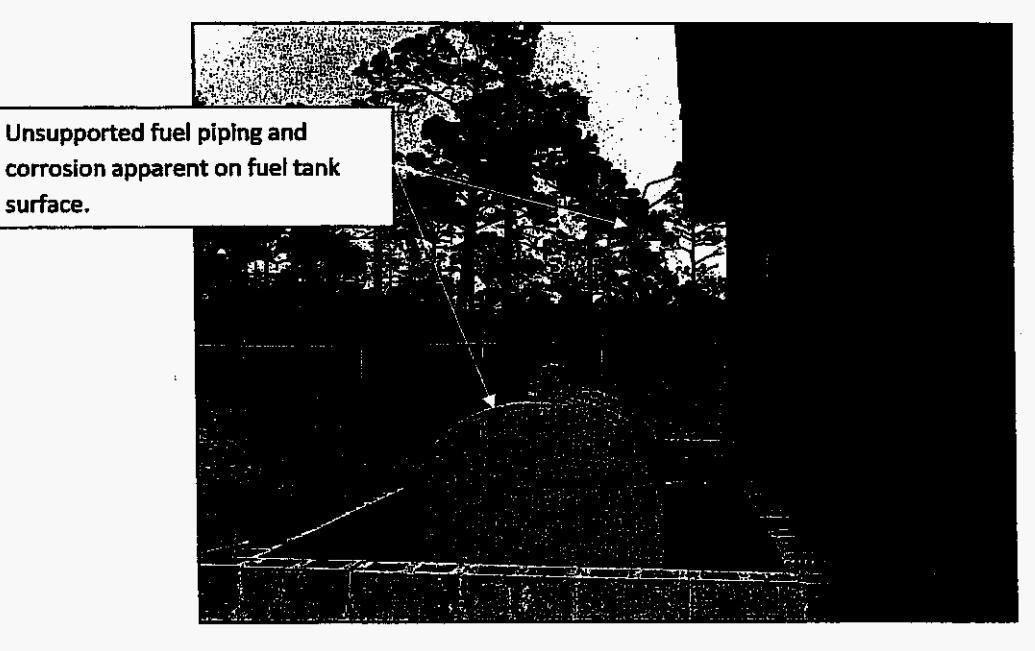
Figure 28-Diesel fuel tank

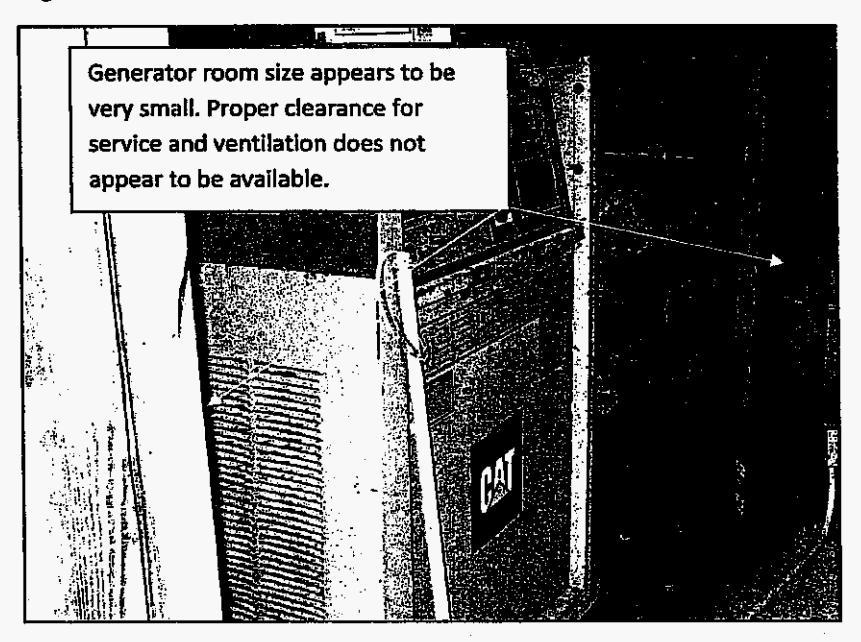
Figure 29-Standby generator

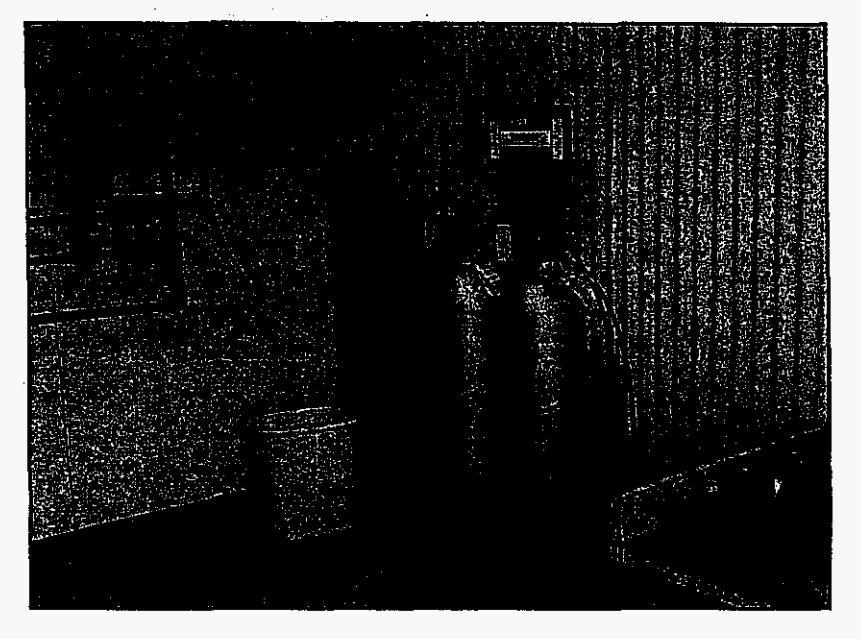
Figure 3- dual chlorine scale, vacuum regulators and ejector for the main disinfection system

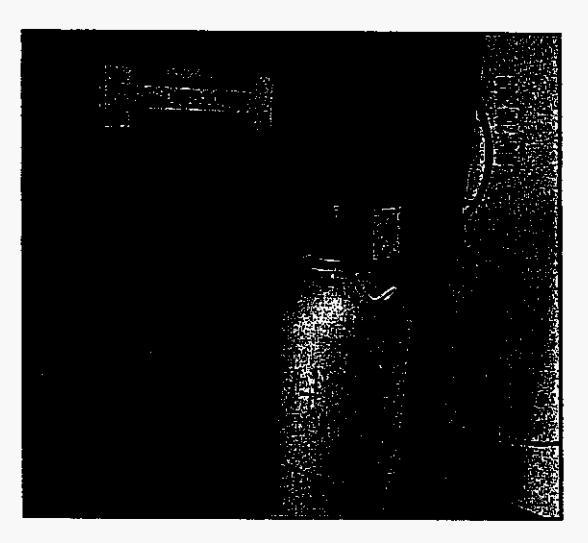
Photo 4- dual chlorine scale, vacuum regulators for the chlorine feed to the tray aerators

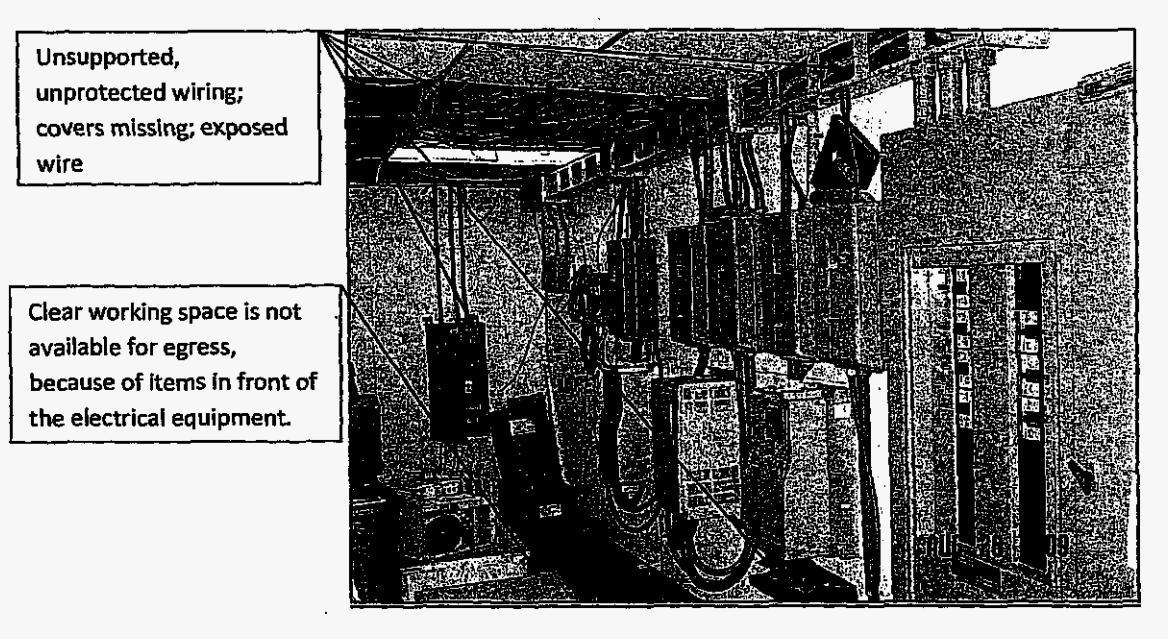
Figure 4.2 - WTF Electrical Room

- The electrical room's condition is very poor and multiple code violations are present inside the electrical room. Safety is a major concern. All issues relate to personal safety, fire hazards and code violations. The following is a short list of visible problems (refer to **Figure 4.2**):

- Live wires appear to be wrapped around ceiling grids to support the wire.
 - Old abandoned equipment and enclosures were not removed prior to new equipment being installed. These old enclosures appear now to be used for wireways.

- Multiple taps and connections are visible in the ceiling. These connections have been made in free space; no enclosure or protection for the wire and the tap.

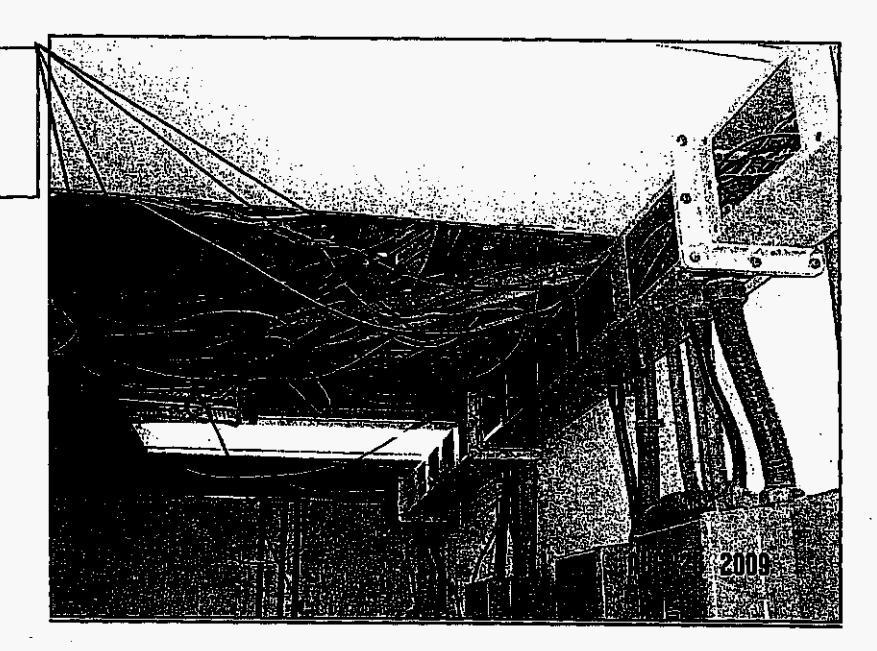
Figure 4.3-Electrical Room Conduits at ceiling

Multiple cable splices and multiple cables hanging, unsupported and unprotected.

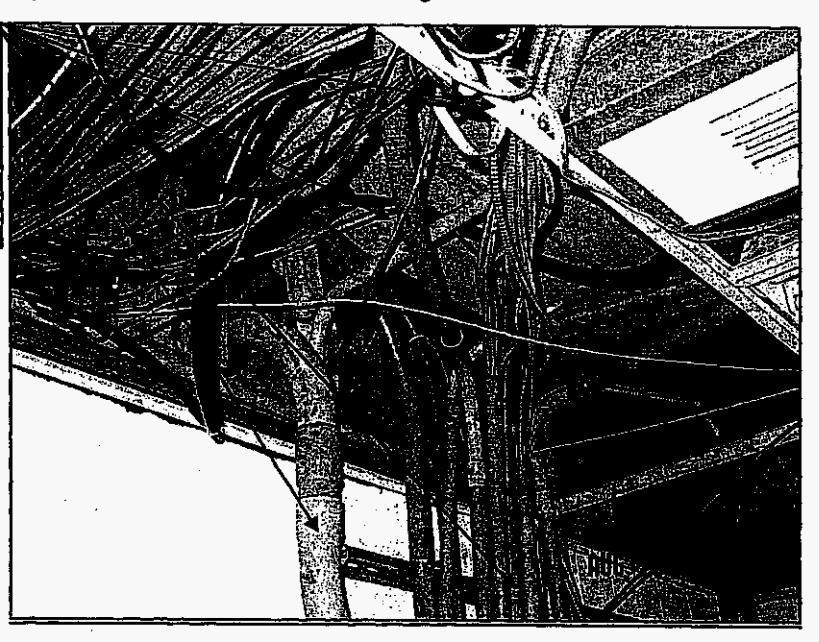
Figure 4.4-Wiring in electrical room above panel board

NM type-residential cable is being used to feed many circuits in the facility; wire is wrapped around ceiling tile grid; PVC conduit partially run and unsupported

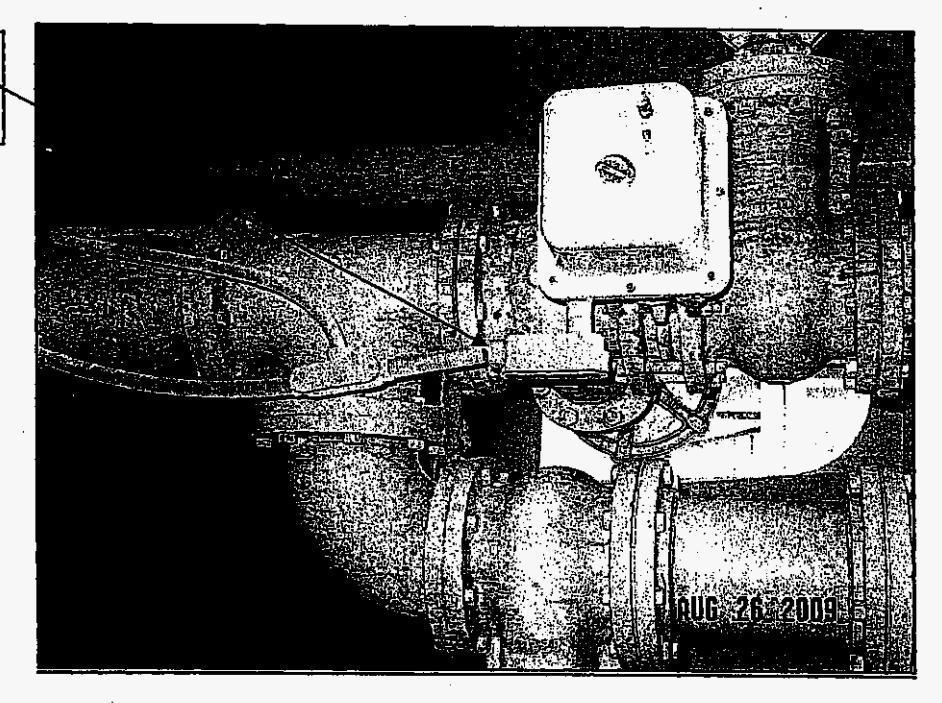
Figure 4.6-Elevated tank control valve

Bad conduit connection, exposed wire and exposed terminations.

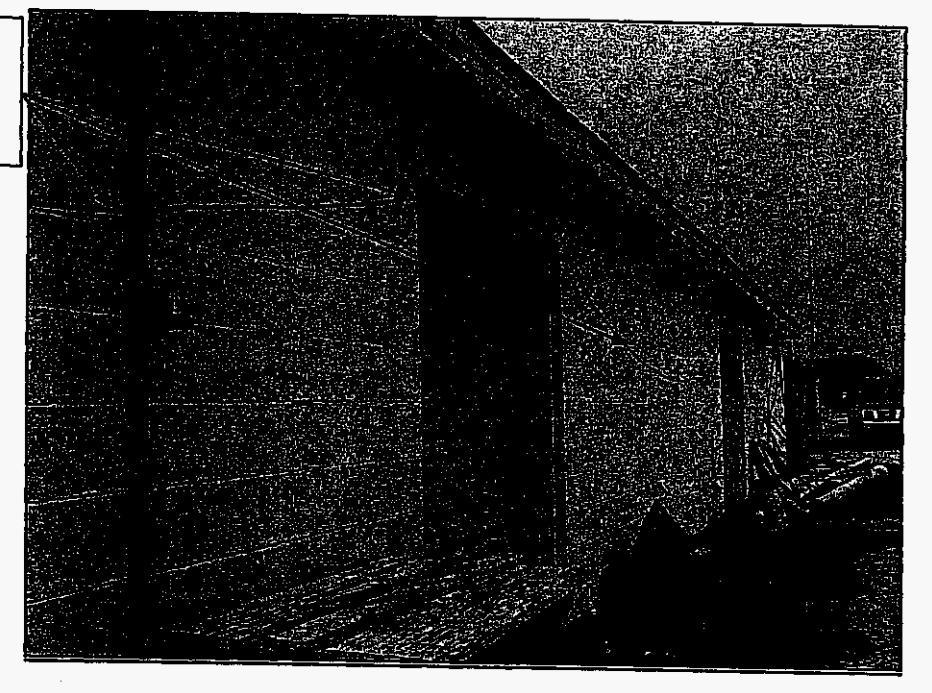
Figure 4.8-Northside of WTF

dential NM wire being used exterior circuit; not listed for this use and not protected

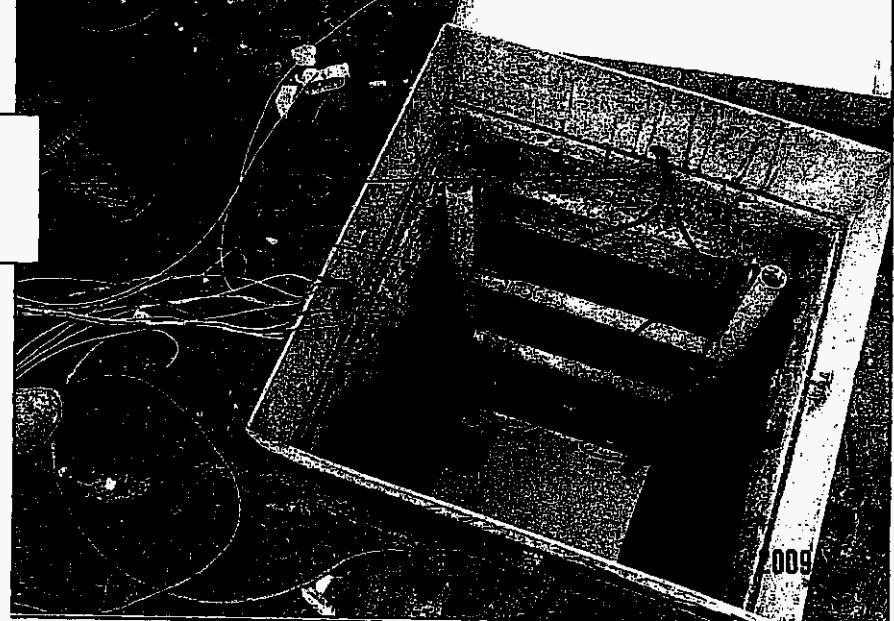
Exposed, abandoned wire; float switches do not have

proper supports

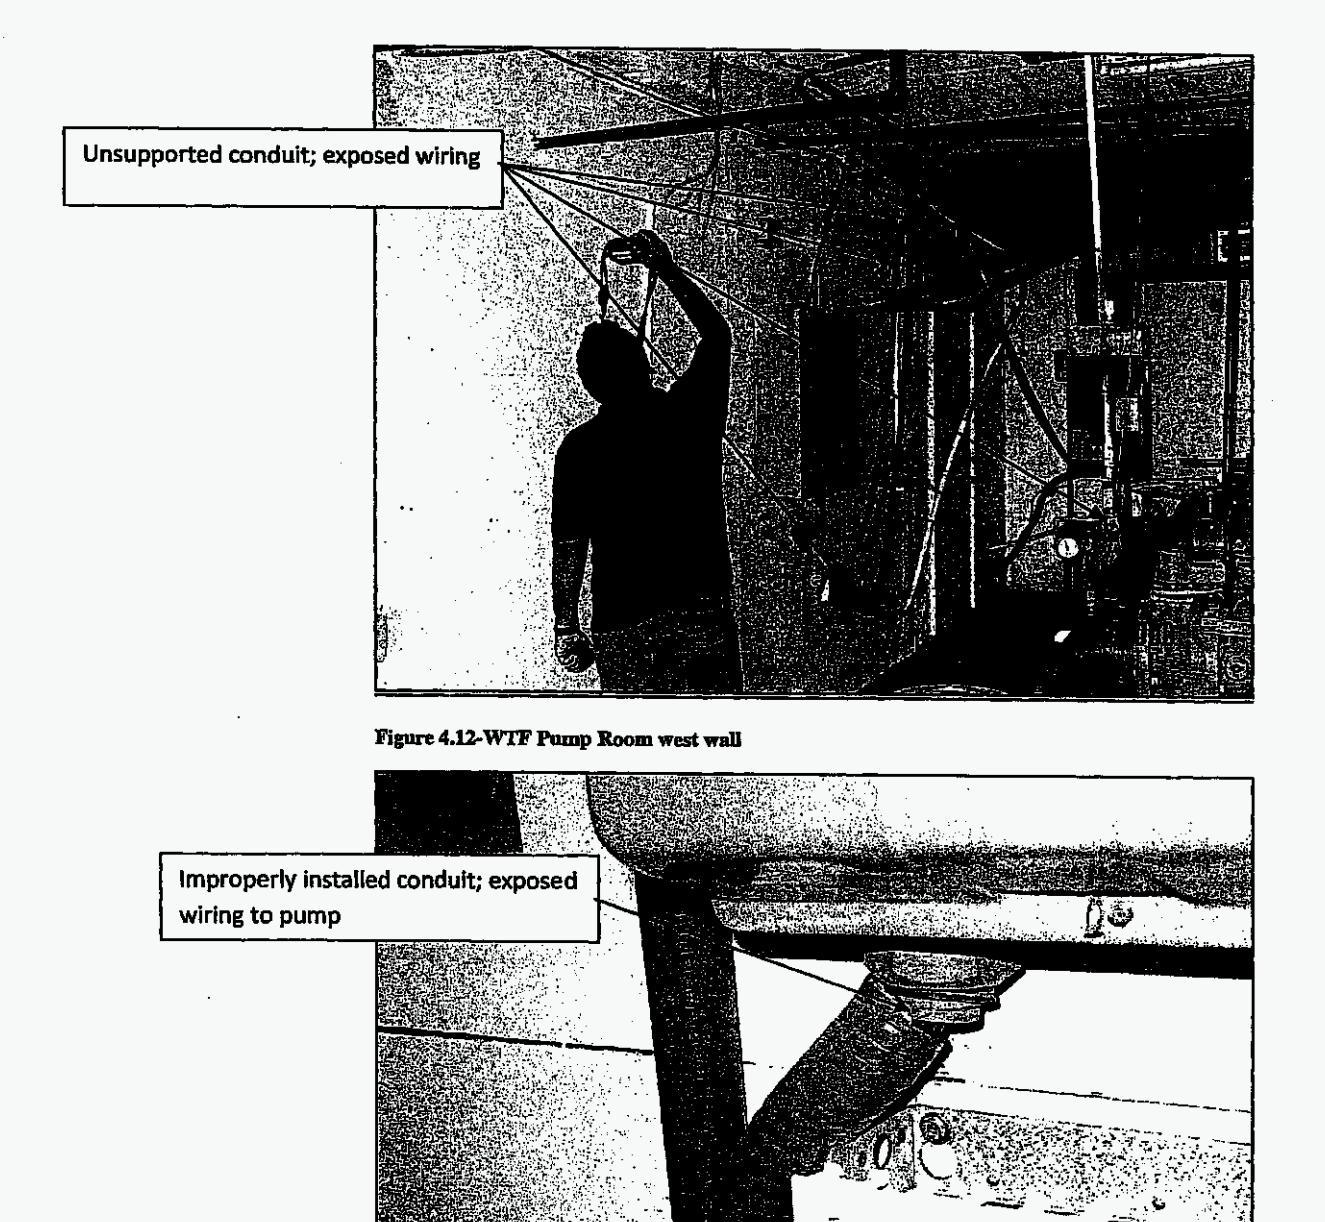
Figure 4.13-WTF Electrical Room high service pump starter

hanging in mid air.

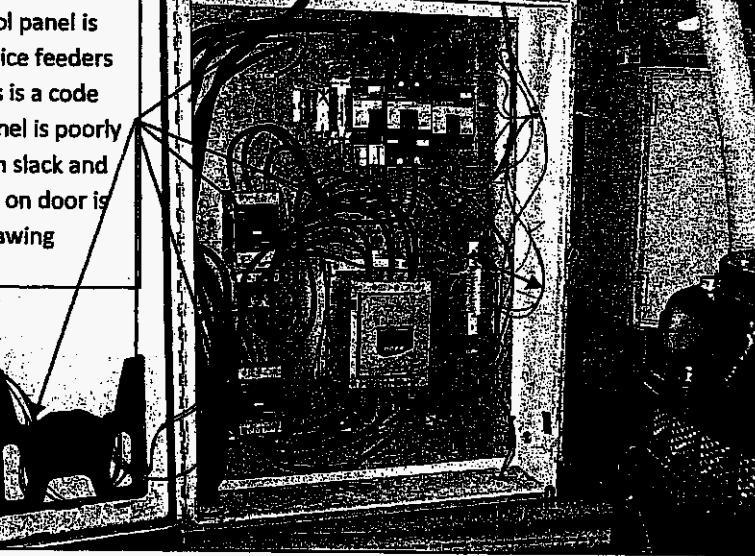
Figure 4.33-Well pump motor starter

Pump motor starter control panel is used as a wireway for service feeders to the transfer switch. This is a code violation. Wiring inside panel is poorly constructed with too much slack and no support. Control wiring on door is supported by using the drawing oncket.

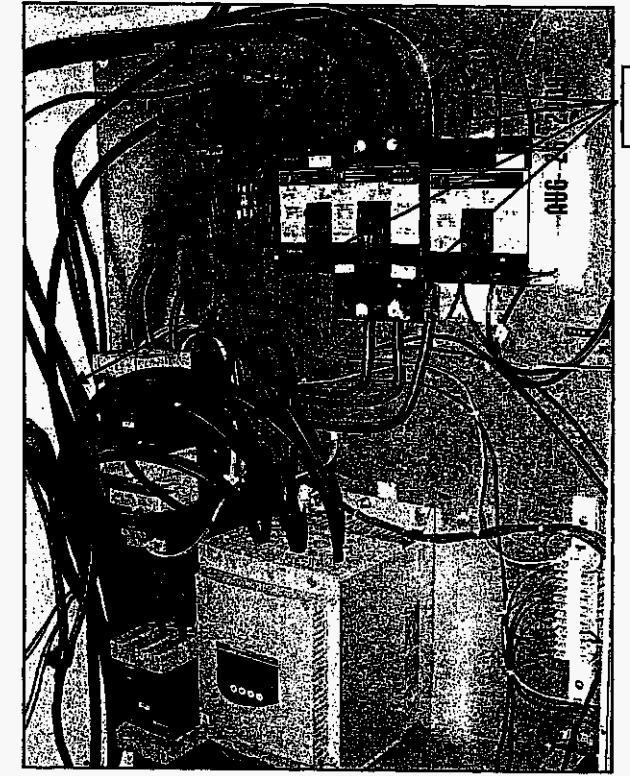
too small

Unsecured wire; ground lug appears

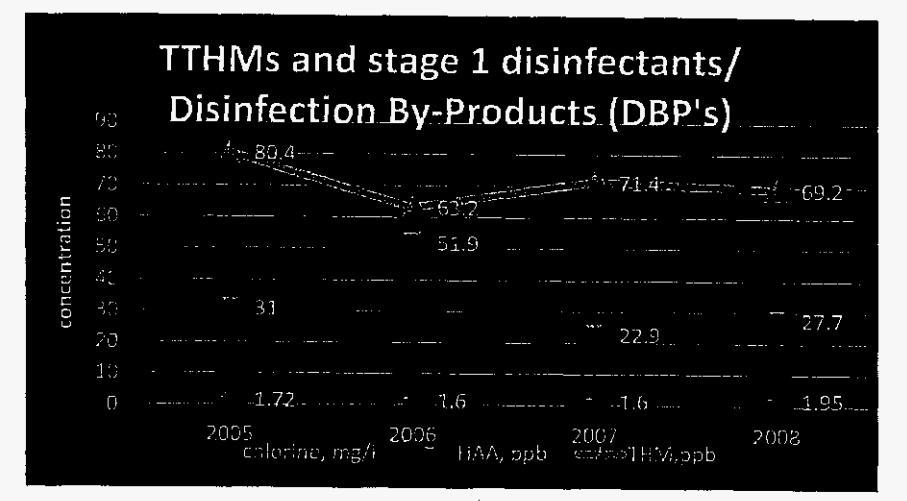
Figure 1 illustrates the concentrations TTHM's and chlorine residual in the distribution system over the past four years. The chlorine residual and HAA concentration have increased approximately 20% from year 2007 to 2008. All values, except the 2005 THM concentration <u>are below the maximum</u> containment levels allowed.
