Power Delivery Performance

Hurricane Irma

Storm Date: September 9, 2017

Report Date: April 19, 2018

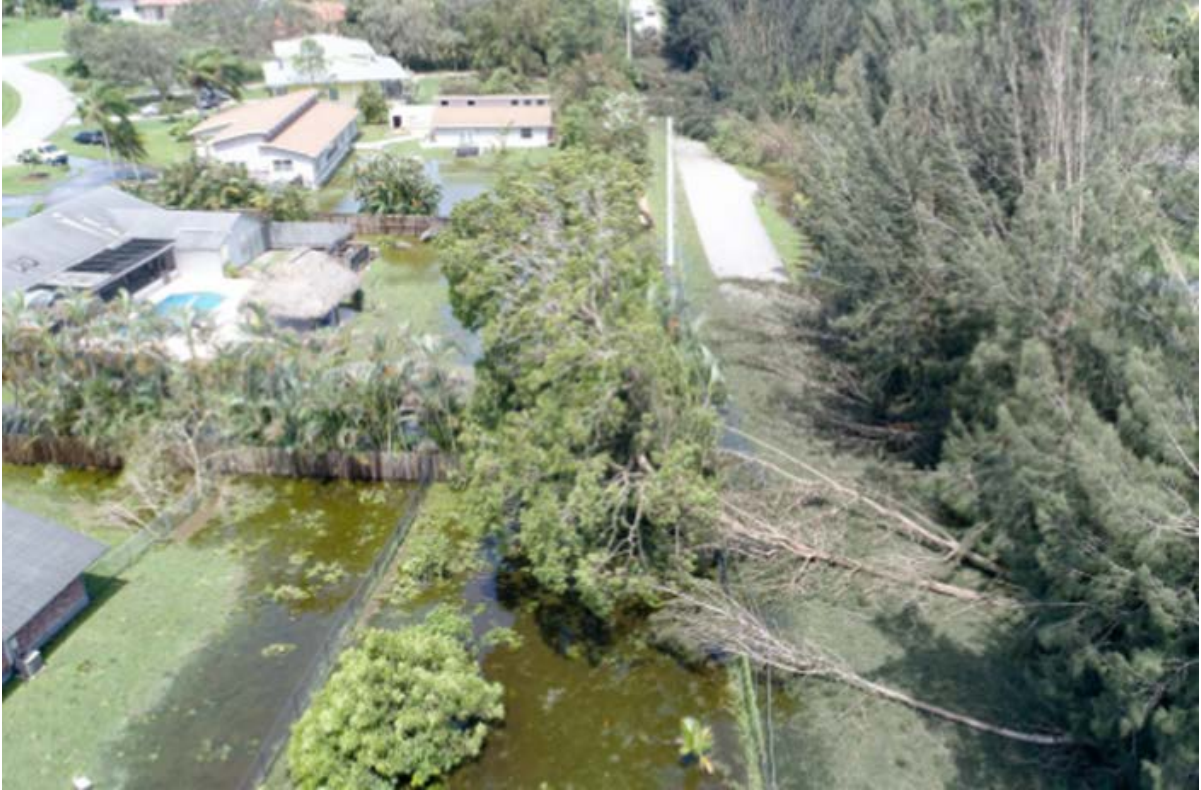
Vegetation outside of ROW toppling into Overhead Circuits was common.

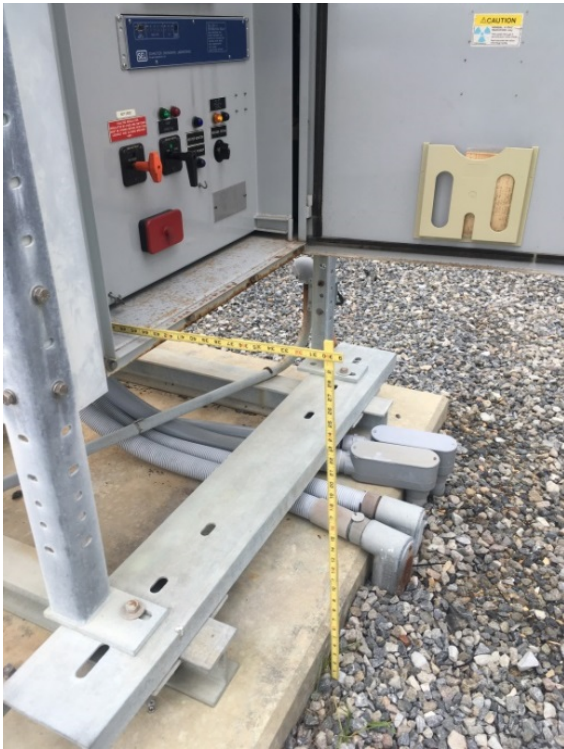
Equipment failures were dominated by feeder breaker failures during the storm and surge arrester failure post event. Most of the failures of the feeder breakers were a result of the High Voltage (HV) compartments flashing from water intrusion due to wind-blown rain. The surge arrester failures appear to be a latent failure mode with water intrusion and/or contamination due to the storm the most likely root cause of the failures occurring post storm after energization.

Feeder Breakers with water intrusion

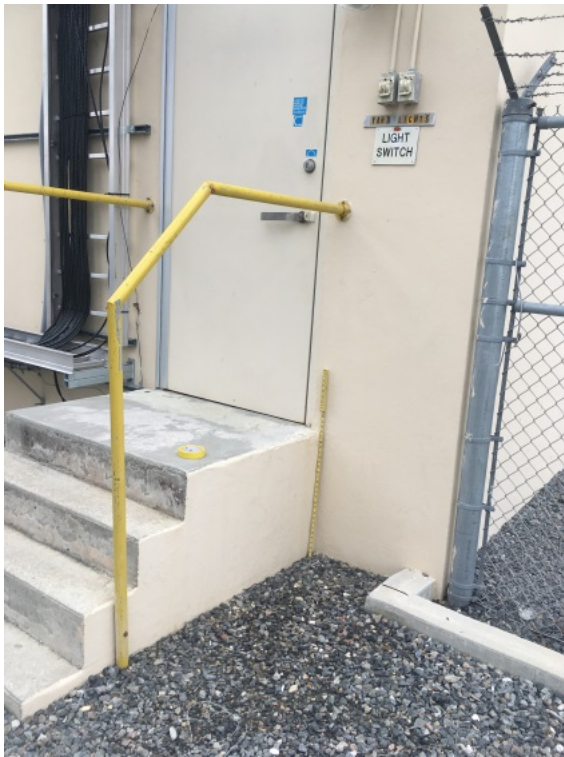
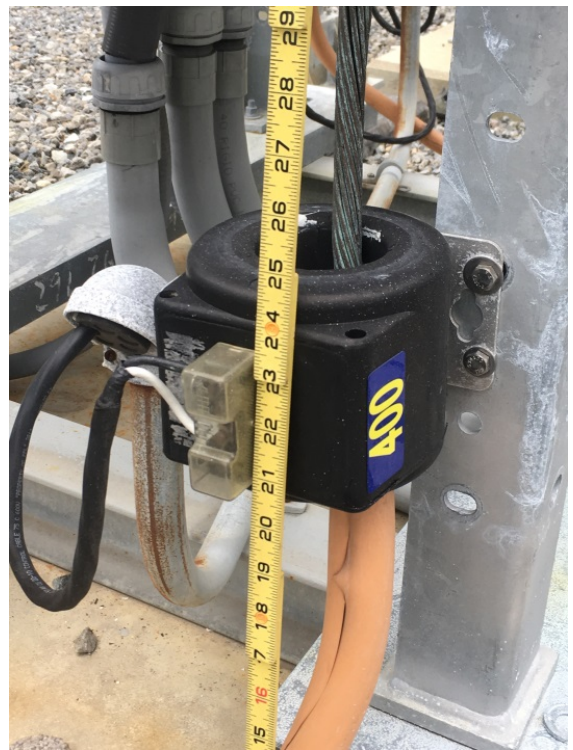
Fault bus CT's were submerged throughout entire substation

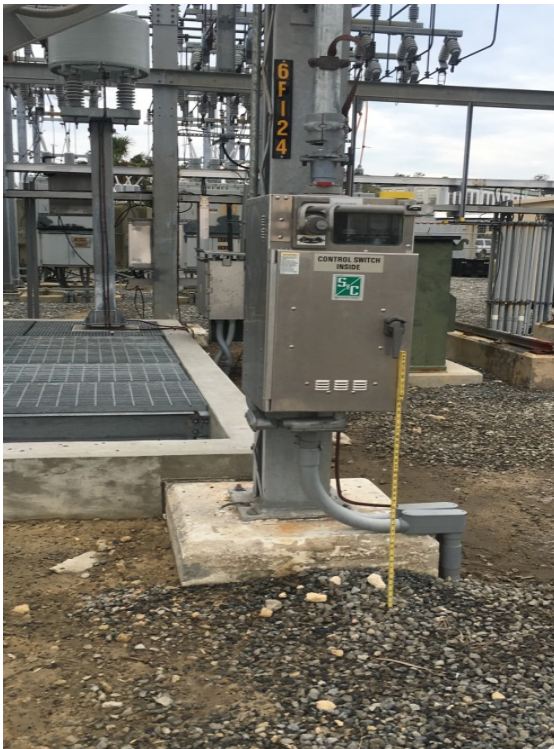
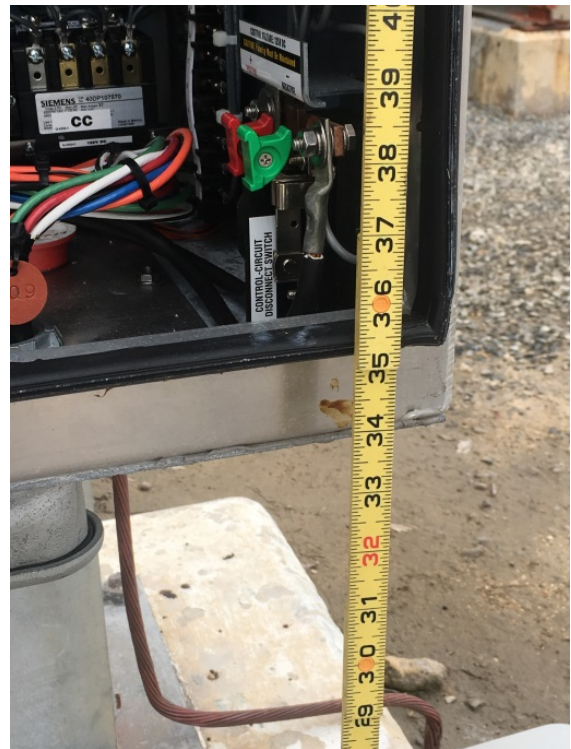
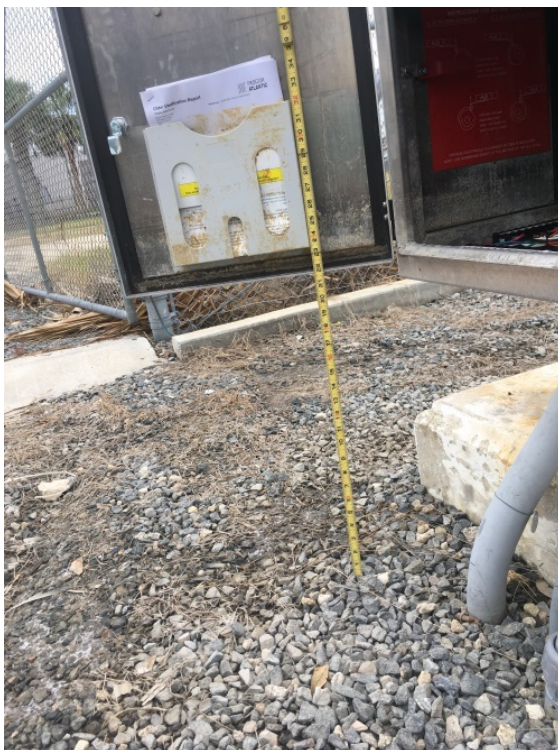
Examples of St. Augustine Substation motor operator impacted by storm surge

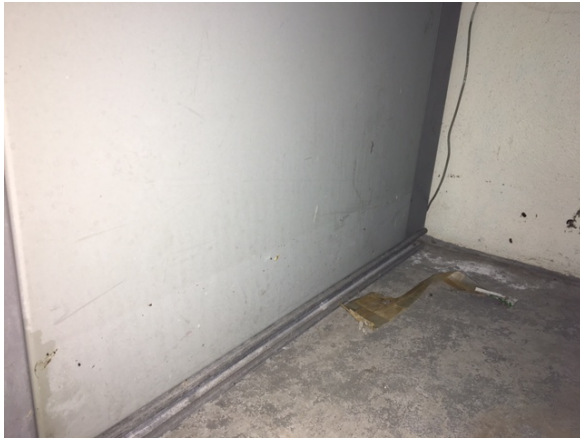
Examples of South Daytona Substation Damage inside the vault

Flood waters reached 5 1/2" on the inside of the relay vault and affected ground bus and some connections

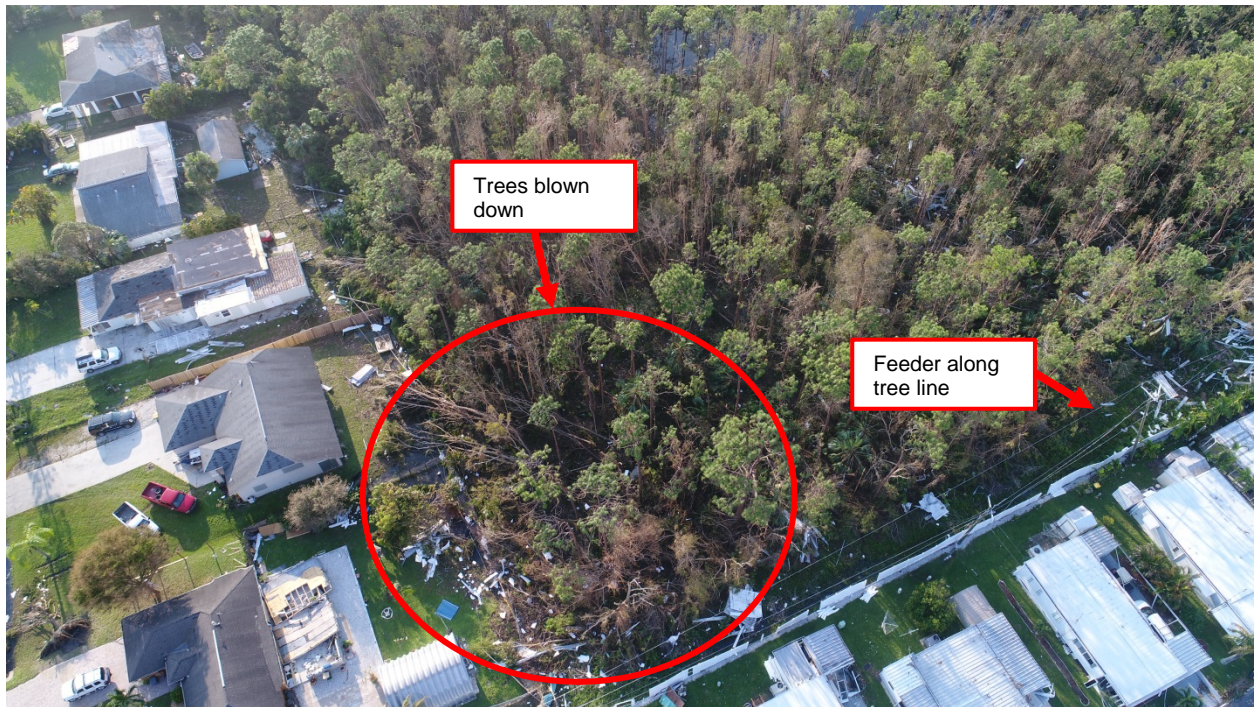
Indications of enhanced wind activity

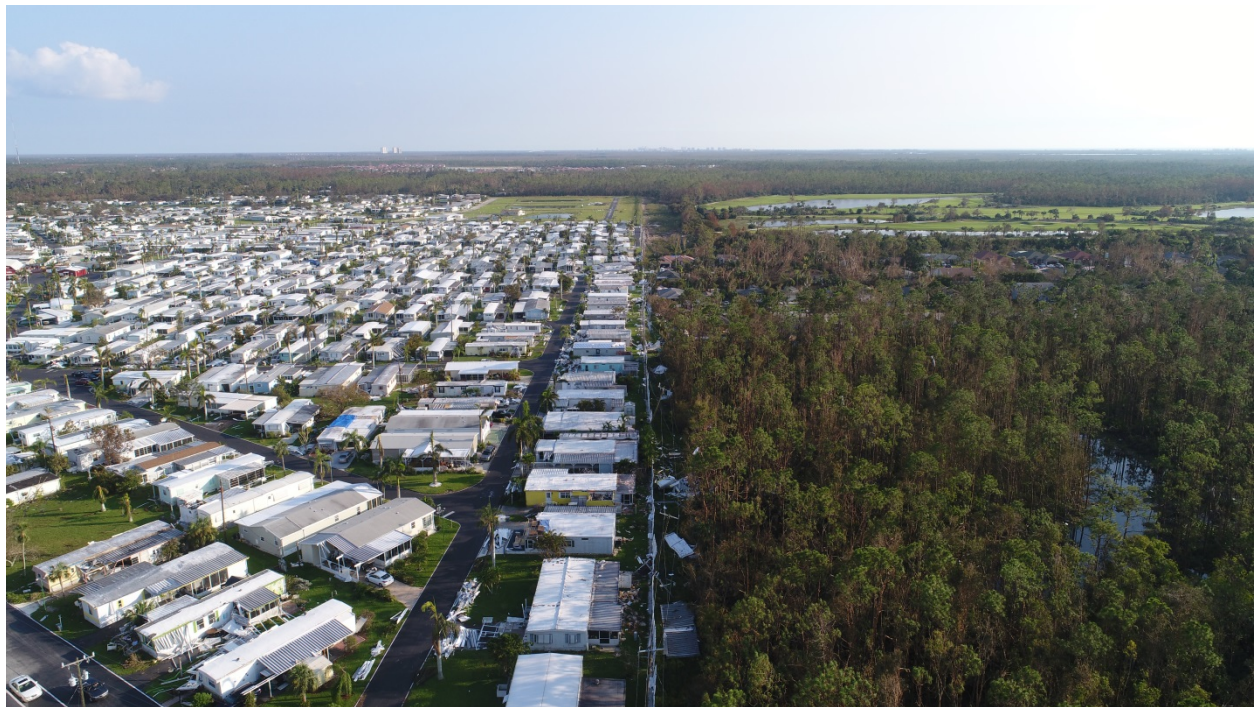
Looking south along feeder.

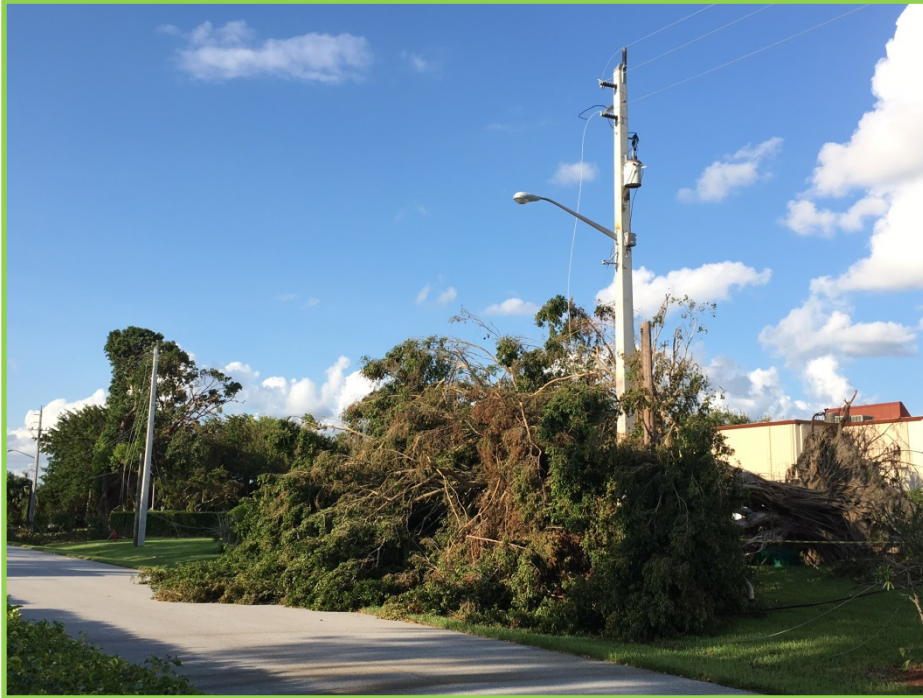
Hardened Feeder

- Wires down, but not the poles will result in quicker restoration.
- Boca Raton Area

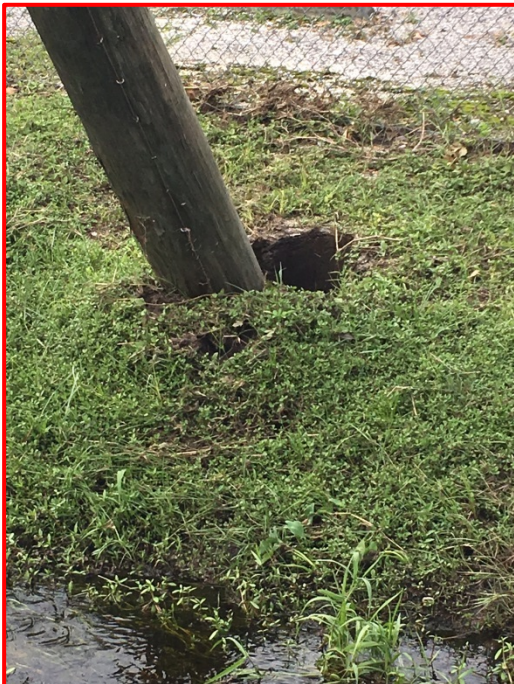
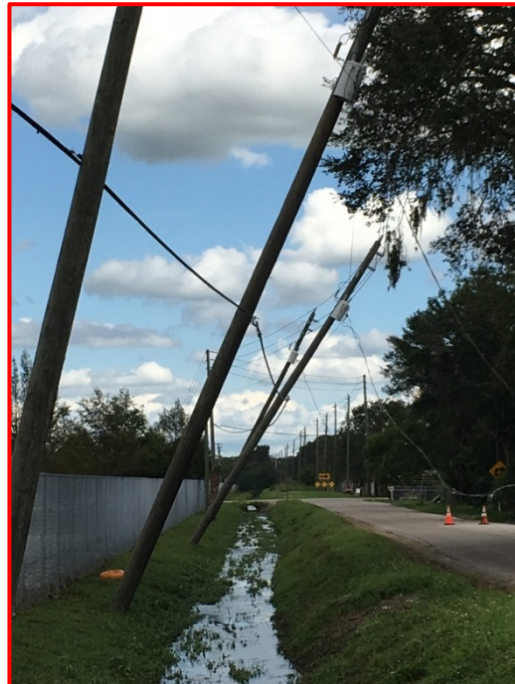
Non-Hardened Feeder (independent of the above Hardened Feeder)

- Leaning poles due to soft / saturated ground
- Carlstrom 5961 (Ft. Myers / Arcadia Area)

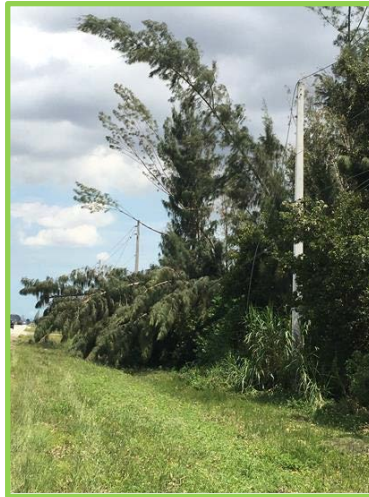
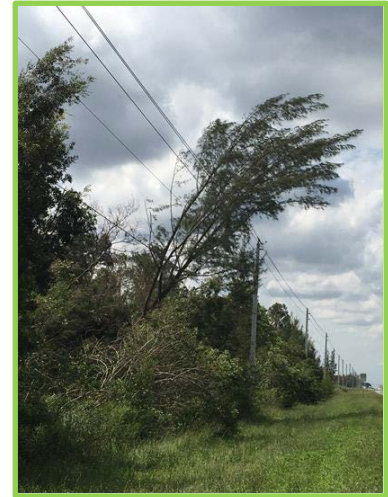
Hardened:

- No poles down.
- The only wires down were due to a massive tree
- However, this leaning tree did not bring down poles

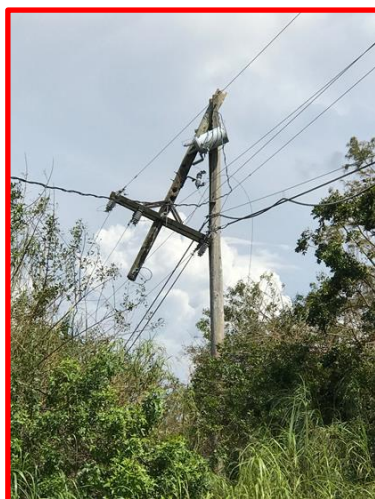
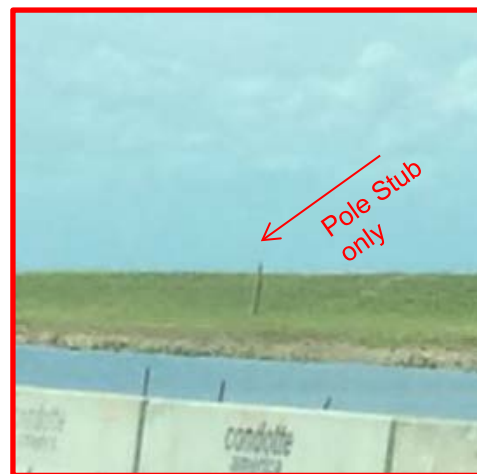
Non-Hardened:

- Feeder behind the OCR had three broken poles shown below due to wind
- Two stub poles are all that remain and the rest of the poles and wires were behind the berm across the canal

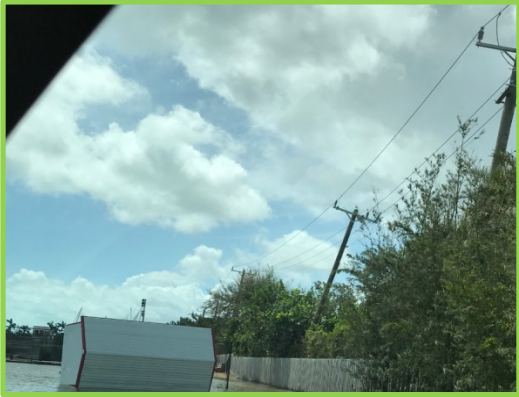
Hardened (Holy Cross 701937):

- Slightly leaning in rear of due to wind

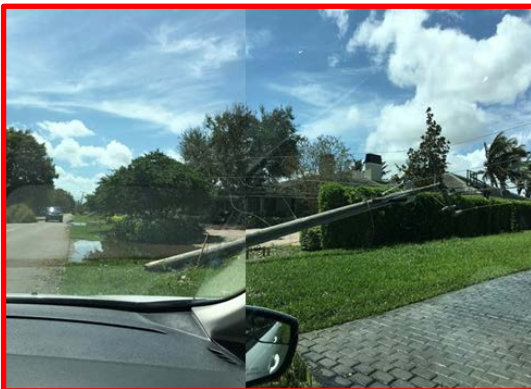
Non-Hardened (Sample 701932):

- Broken pole

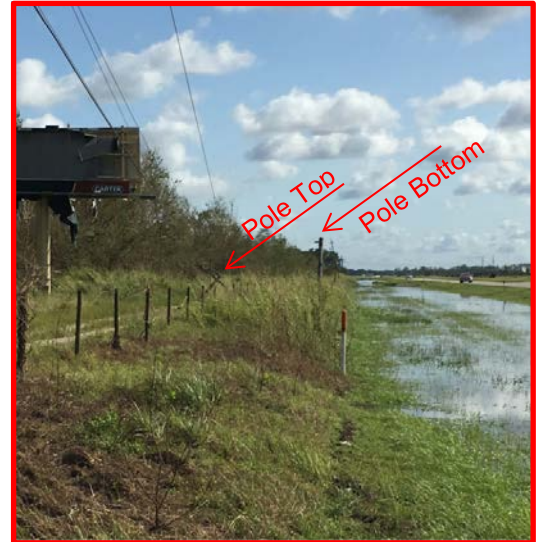
Broken →

- Pole line leaning significantly as well as another section that had 2 broken poles. This section of Feeder was not Hardened
- Poles appeared to be 45'5 or 45'4 poles, but could not identify pole brand

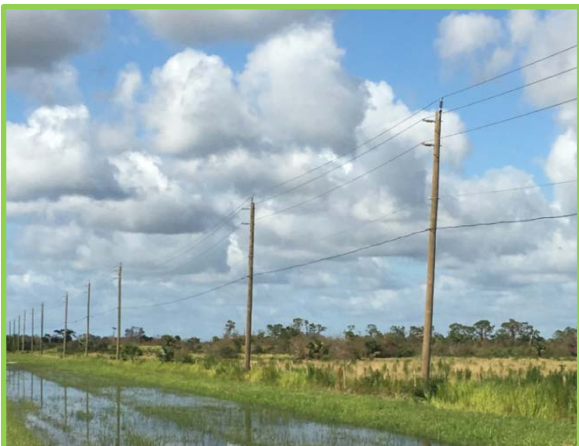
Hardened (Alva Feeder 504761 – West of switch number 20714)

- Section of wood hardened poles that were unaffected by the storm. These poles were not leaning and showed no signs of any damage.

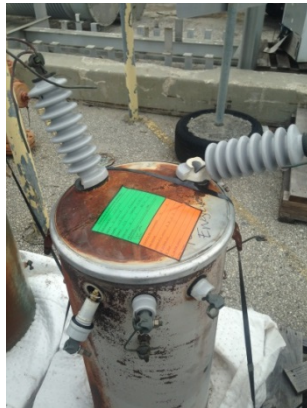
- The observed aerial transformers mainly fall in two categories:
 - Broken insulator/bushings due to trees and flying objects
 - Extensive physical deformation due to impact or fall due to broken pole

Broken bushings

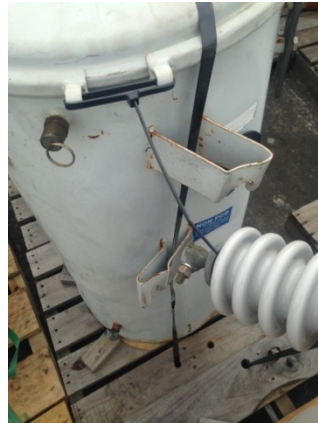
Bent frames

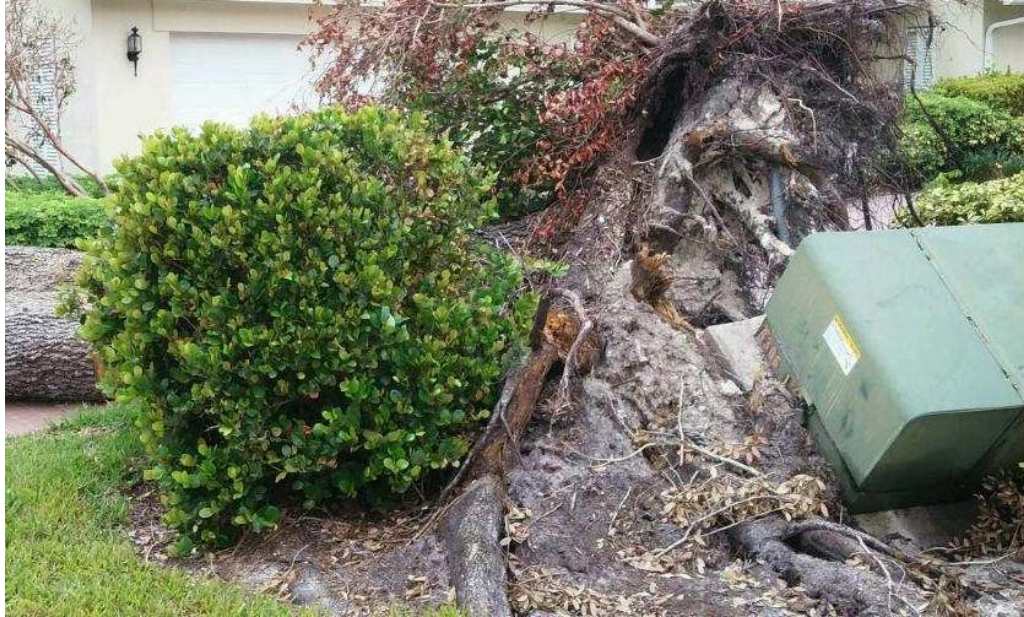
Before Restoration

Underground facilities were also impacted by vegetation

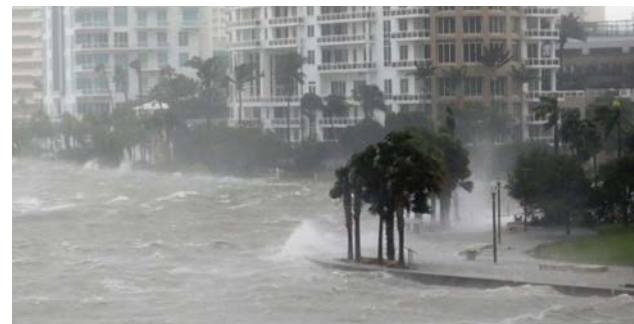
Waves crash at mouth of Miami River at Biscayne Bay (AP)

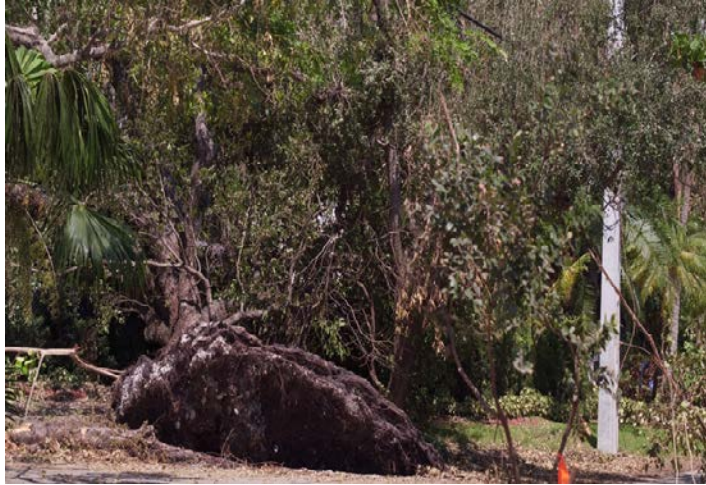
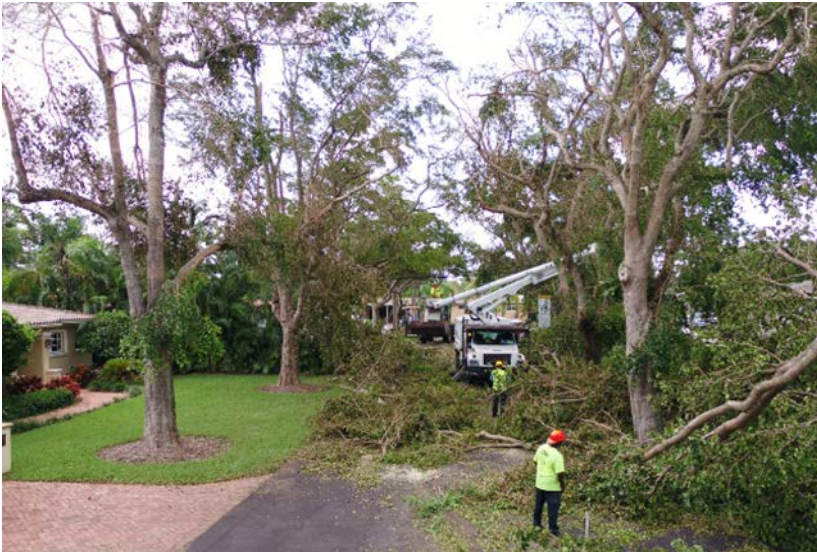
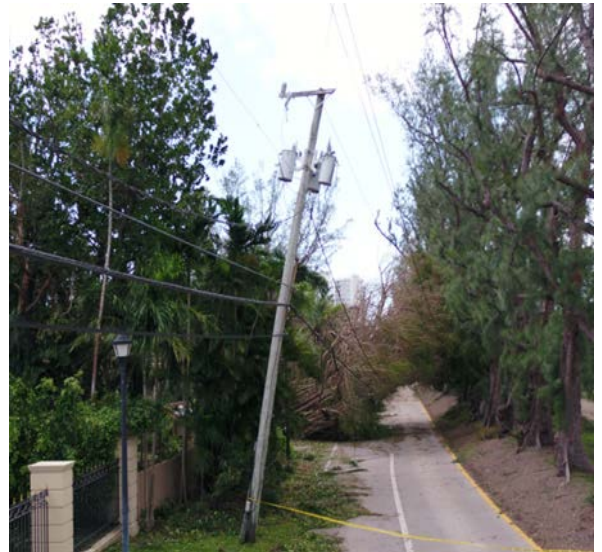
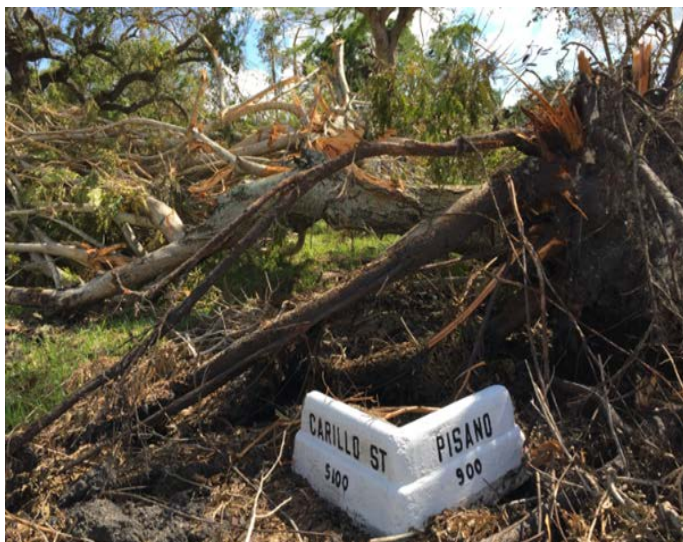
Examples of Vegetation Damage in Dade Area

Observation	Dade	East	North	West
% of tree damage For Native and non-Native trees	Native 20% Non-Native 80%	Native 30% Non-Native 70%	Native 70% Non-Native 30%	Native 55% Non-Native 45%
% of tree damage by tree type	Ficus 23% Palm 10% Aust. Pine 9% Black Olive 7% Oak 6% Avocado 5% Mango 5% Bischofia 4% Royal Poin. 3% Bean Tree 3% H.K. Orchid 3% Vine 3% Other 20%	Ficus 24% Aust. Pine 13% Oak 11% Palm 7% Melaleuca 6% Pine 6% Back Olive 4% Brazi.Pepper 4% Acacia 2% Java Plum 2% Vine 2% Other 18%	Oak 43% Pine 21% Palm 8% Hardwood 5% Aust. Pine 5% Other 19%	Pine 30% Oak 16% Ficus 9% Palm 7% Melalueca 6% Acacia 5% Aust. Pine 5% Carrotwood 4% Other 19%
Primary damage	Up-rooted trees and broken trunks	Broken Limbs	Broken Limbs	Up-rooted trees and broken trunks
% of primary damage	59%	57%	56%	70%
Secondary damage	Broken Limbs	Up-rooted trees and broken trunks	Up-rooted trees and broken trunks	Broken Limbs

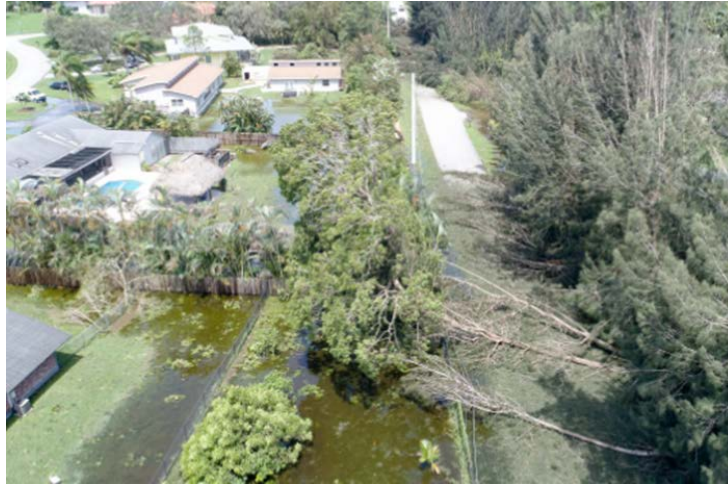
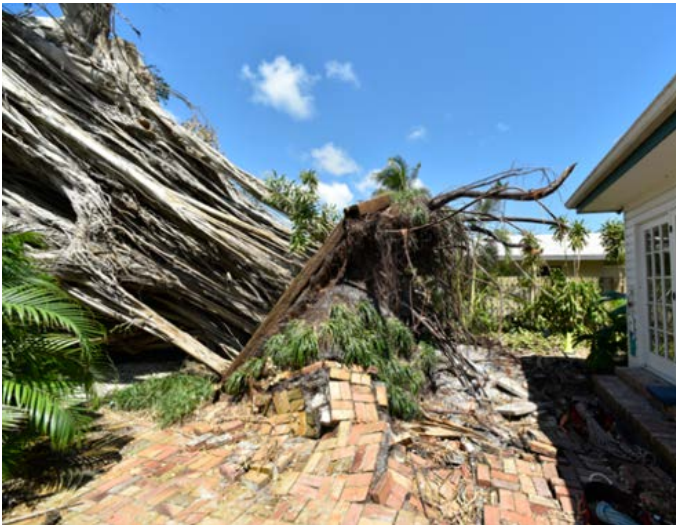
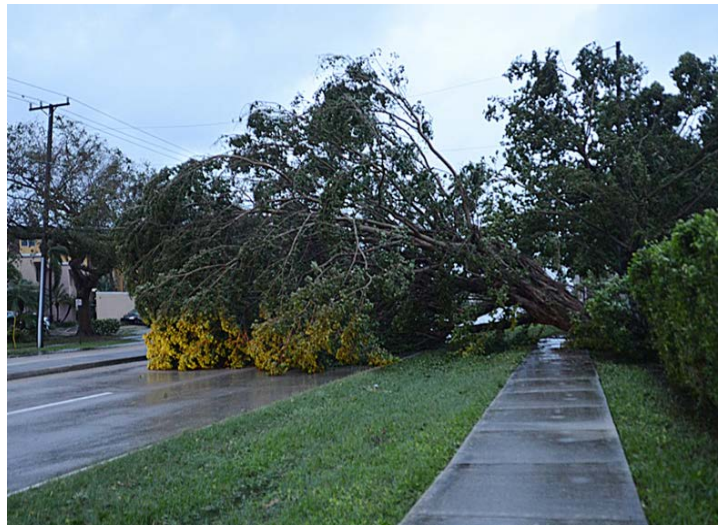
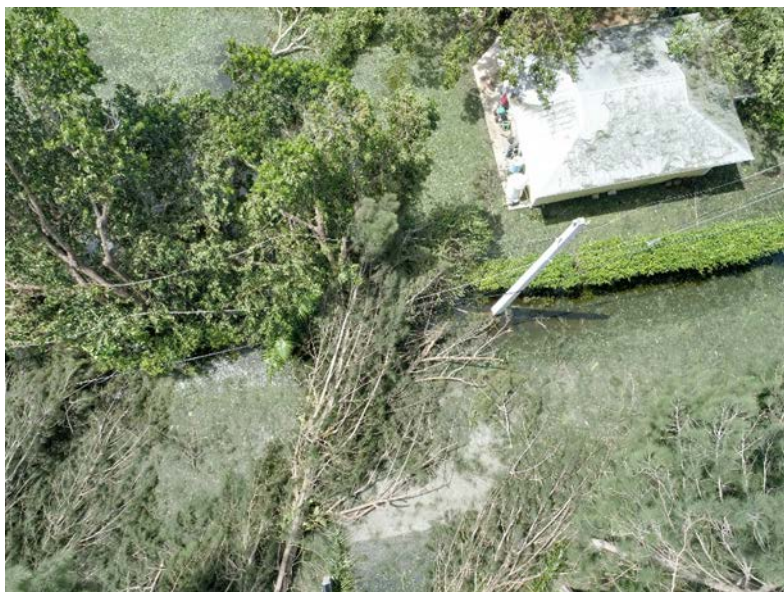
Examples of Vegetation Damage in East Area

% of secondary damage	41%	43%	44%	30%
Ground Condition	Saturated			Saturated
General Comments	Access was an issue due to large number of exotics which are less storm resilient	Higher percentage of non-native and exotics are less storm resilient	Larger and older trees which are typically less storm resilient	Larger and older trees which are typically less storm resilient, High winds and saturated soil caused storm resilient trees to fail such as palms

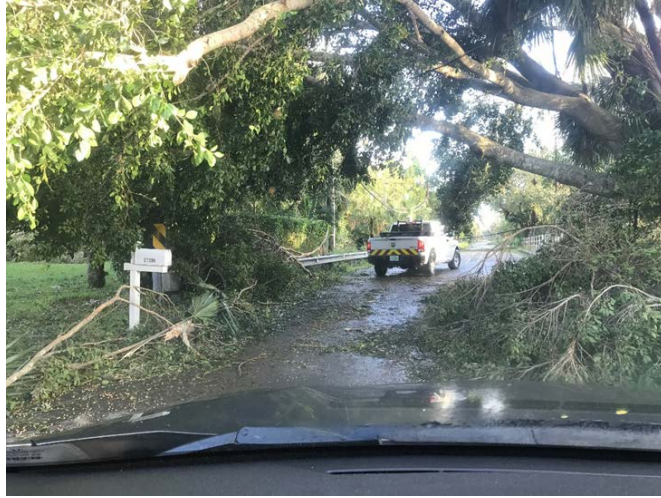
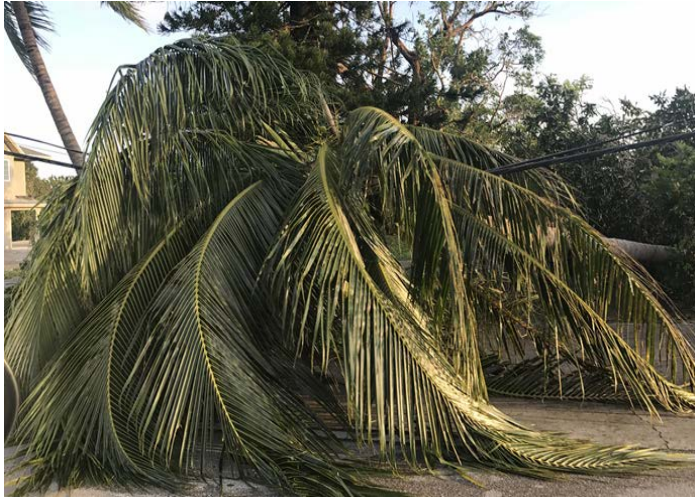
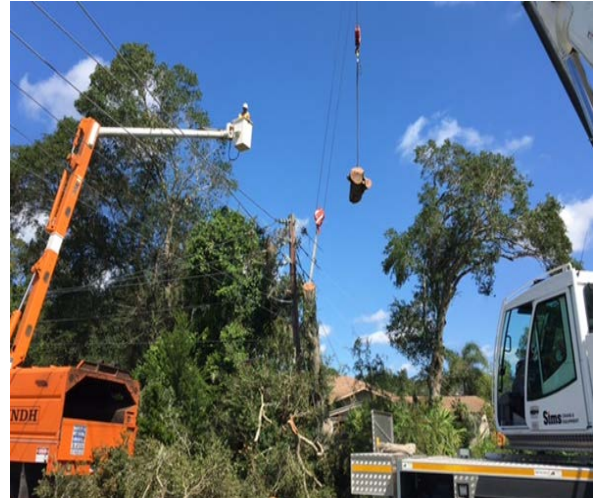
Examples of Vegetation Damage in West Area

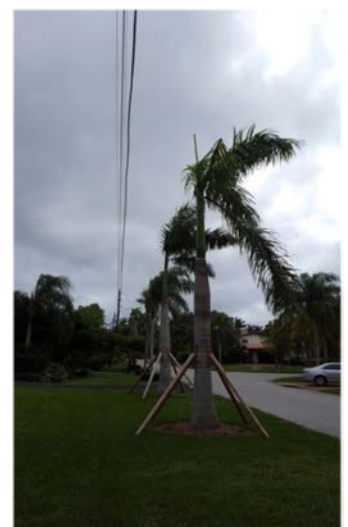
Pictures to the right:
Young canopy trees (i.e. oak) and palms planted in the wrong place and will impact facilities in the future

- Prior Lessons Learned from the 2004 and 2005 storm seasons, older trees are more likely to fail in hurricanes and over-mature trees should be removed and replaced by new trees. Source: "Wind and Trees: Lessons Learned from Hurricanes" published by UF Institute of Food and Agriculture Sciences (IFSA).
- Follow Right Tree Right place guidelines and stop actively planting large canopy trees adjacent to power lines.
- Adopt ordinances that support keeping vegetation away from utilities

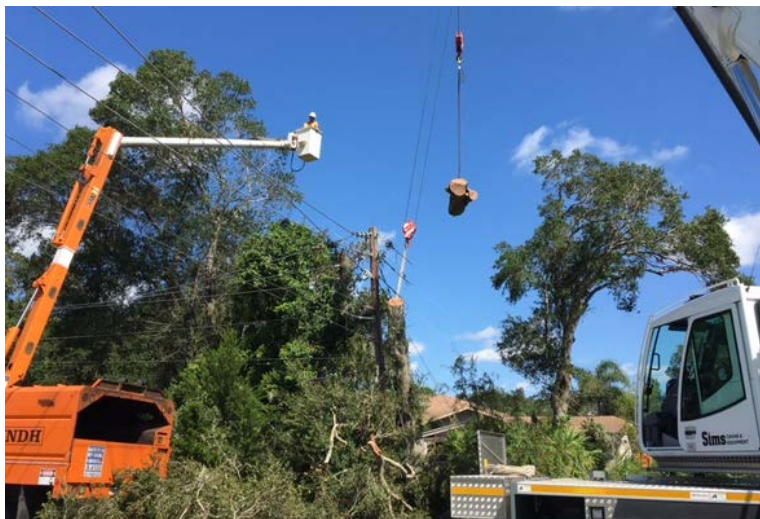
Tree failure in West Florida included many large older trees, which studies have shown are less storm resilient. Large trees may require specialized equipment to remove, slowing restoration. High wind and saturated soil may have contributed to high rate of tree failure, as even more wind resistant trees such as palms were more likely to fail.

Trimming crews use a crane to remove large tree from utility lines

- Prior Lessons Learned from the 2004 and 2005 storm seasons, older trees are more likely to fail in hurricanes and over-mature trees should be removed and replaced by new trees. Source: “Wind and Trees: Lessons Learned from Hurricanes” published by UF Institute of Food and Agriculture Sciences (IFSA).
- Follow Right Tree Right place guidelines and stop actively planting large canopy trees adjacent to power lines.
- Adopt ordinances that support keeping vegetation away from utilities
