Re: Docket No. 20220001-EI

Please find enclosed for filing in the above referenced docket the Direct Testimony and Exhibits of Richard Polich, P.E. This filing is being made via the Florida Public Service Commission's Web Based Electronic Filing portal.

**Turkey Point
 Root Cause Evaluation
 Unit 3 Trip During Restoration from RPS Testing
 Event Date: March 1, 2021 CR 2385529
 Revision 1**

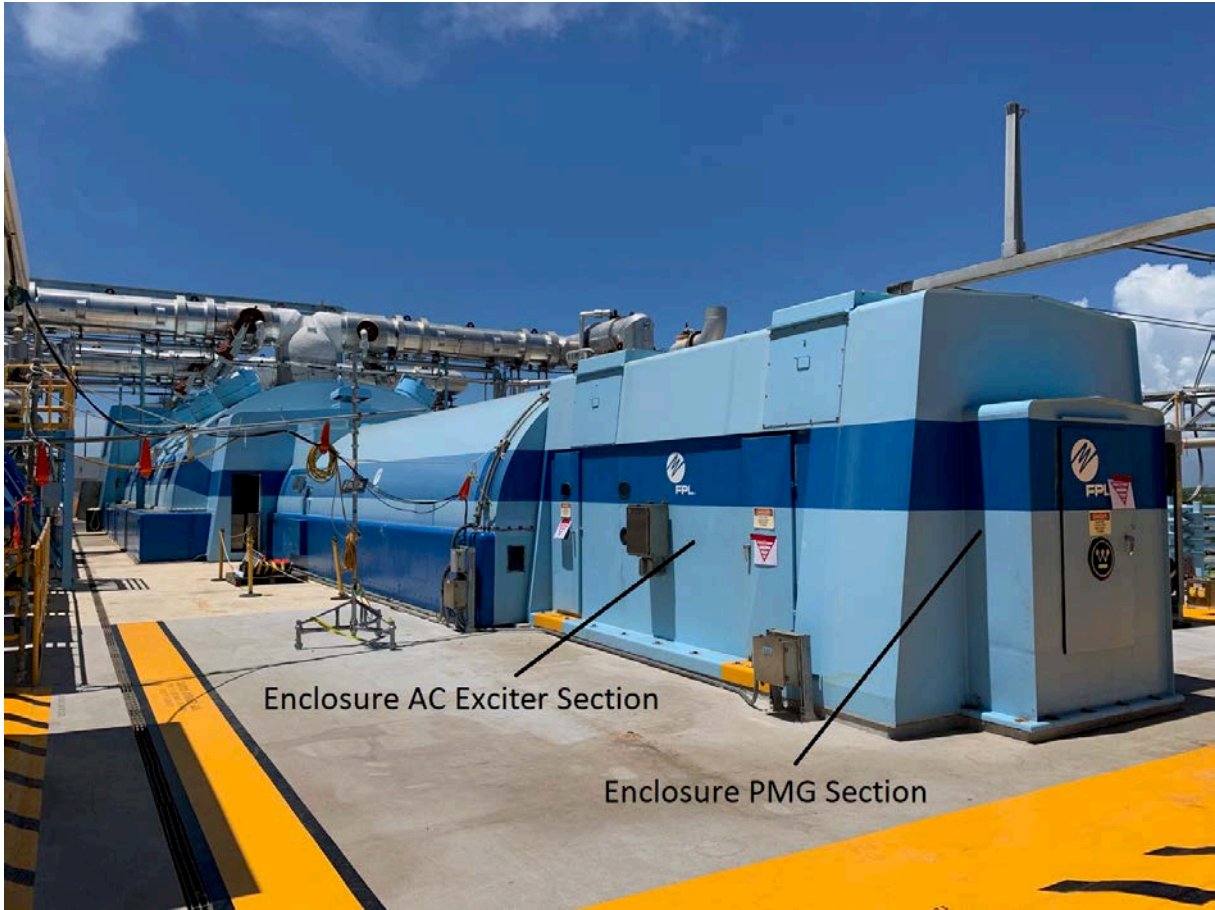
Fig. 1 U4 Exciter Housing

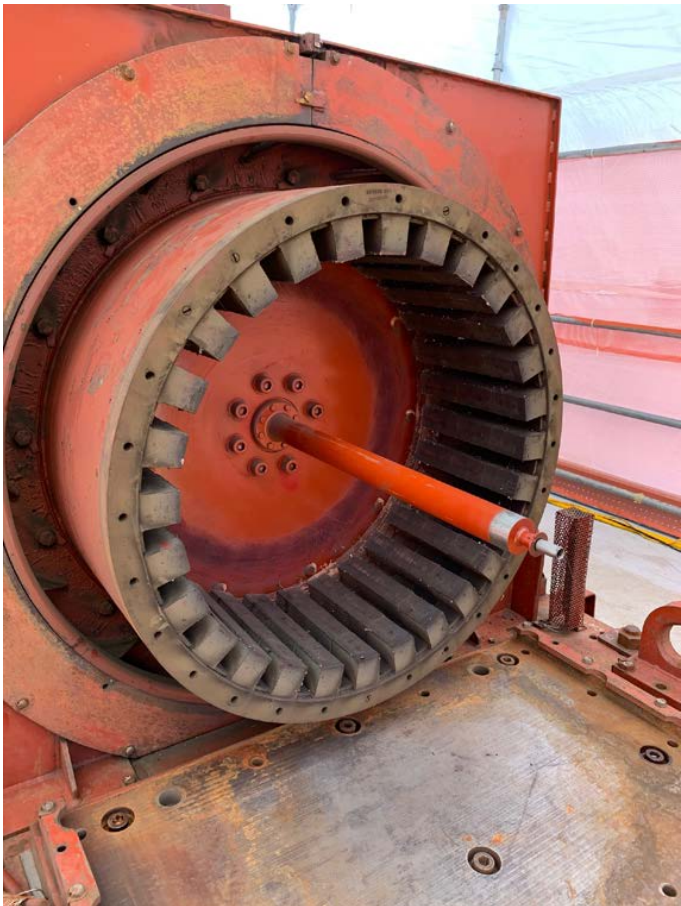
Fig. 8 PMG Pole Support w/ Magnets

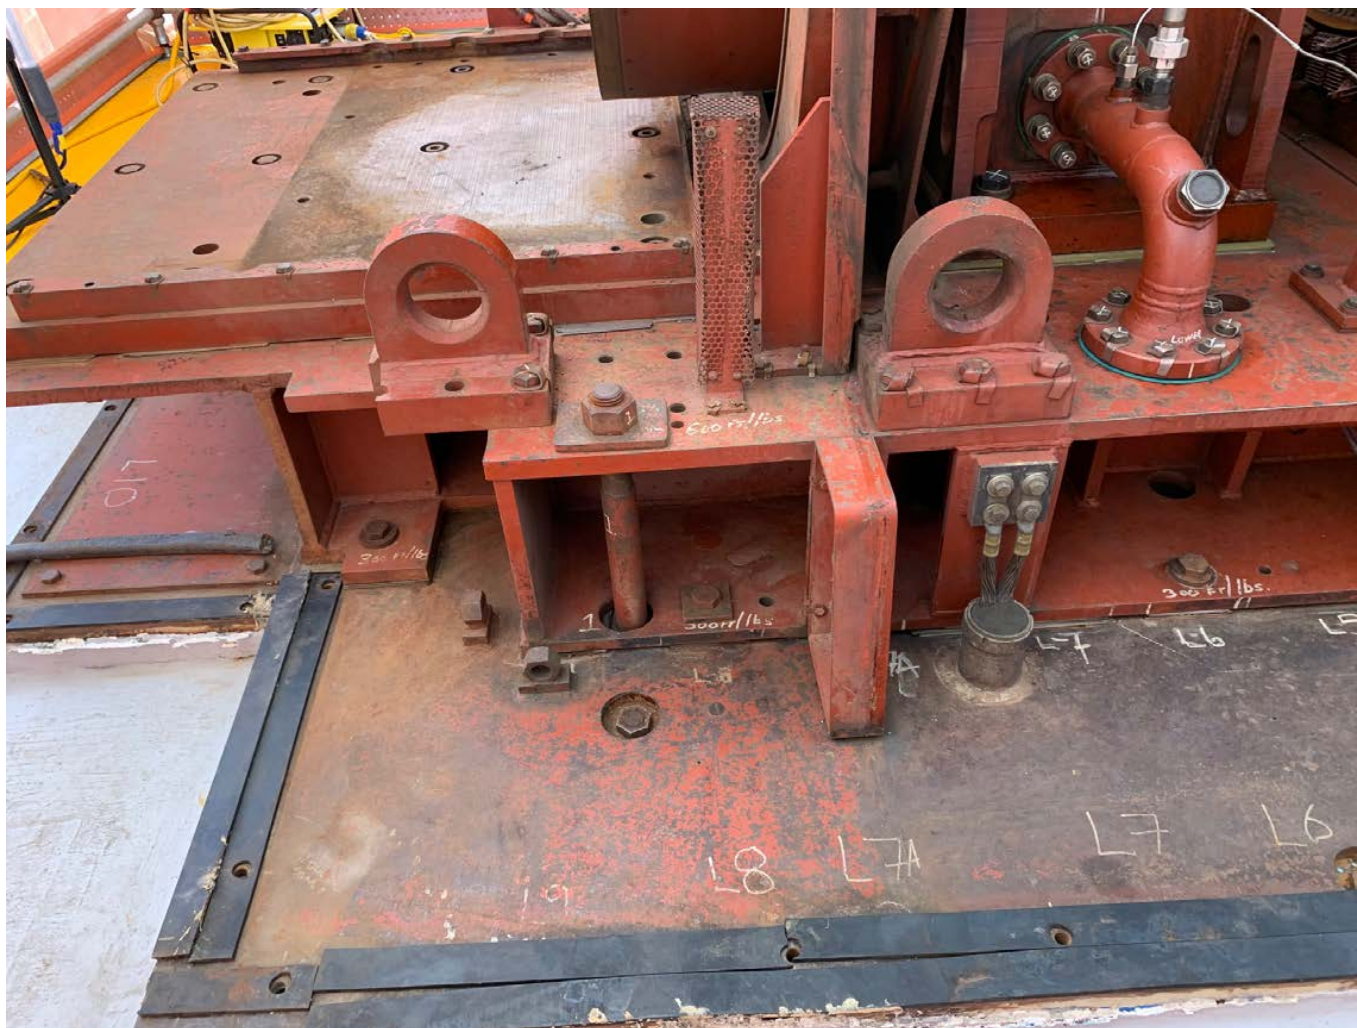
Fig. 13 Exciter Base to Housing Seal / Gasket Arrangement

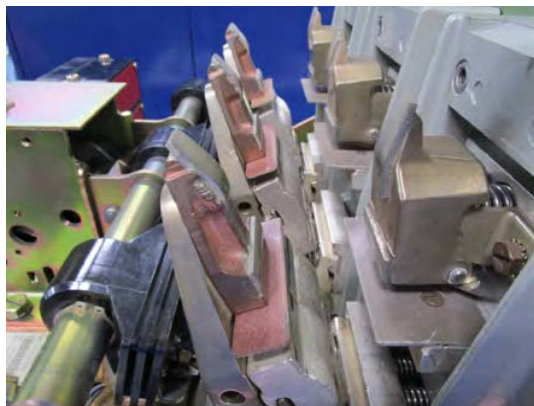
The arc chute assemblies were removed, and no concerns were found. The assemblies were not disassembled at this time.

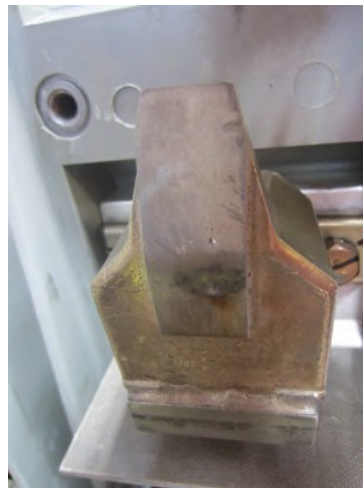
Stationary Arcing Contacts

These values were greater than expected. Photos were taken of these contacts and then the contacts were cleaned with Scotchbrite and isopropyl alcohol. Additional photos were taken to show the cleaned contacts.

After receiving values greater than expected the pole bases will need to be disassembled and cleaned as a standard part of a DB breaker refurbishment. These values are not a concern for the tripping of the breaker, simply that the contacts were slightly oxidized. After applying operating current to the pole bases the oxidation would burn off and the breaker would operate fine.

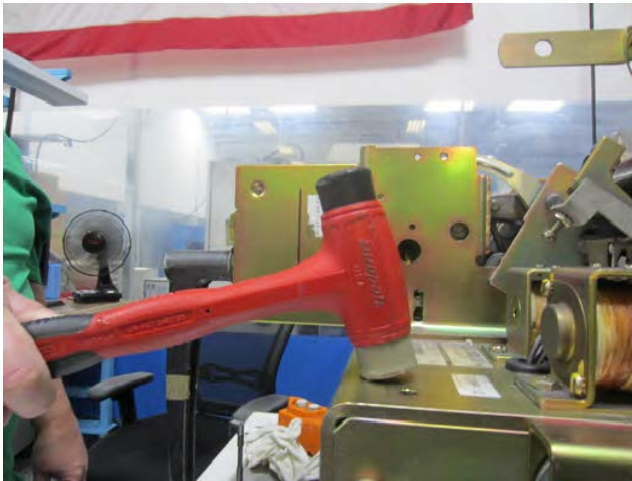
Breaker Platform Shock Test Timing tests were performed on this breaker:

The UVTA was again energized with 125 V DC and the breaker was closed with 125 V DC. A plastic head hammer was used to shock the breaker platform in an attempt to shock out the UVTA or cause the breaker to trip open. A photo of this is provided below. The UVTA did not release and the breaker did not open.

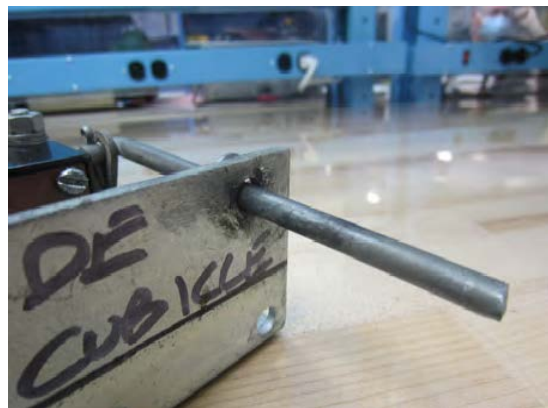
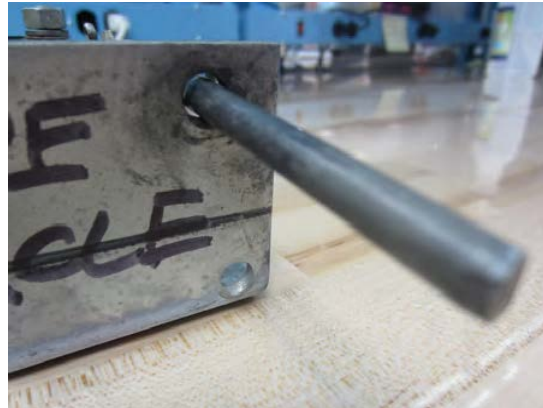
These cell switches were received and looked like they were the original switches provided with the switchgear. The switch plungers were improperly lubricated, and the plunger return spring was not lubricated.

The push rod of the cell switches were lubricated with a foreign lubrication and the return springs were not lubricated with anything. These two locations are to be lubricated with Molybdenum Disulfide in Isopropyl Alcohol (53701GW) lubricant during maintenance intervals.

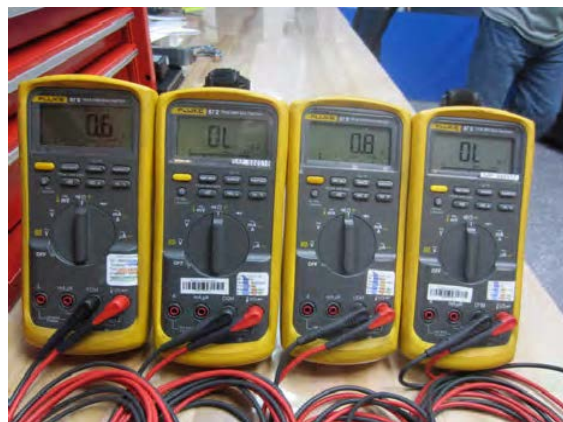
The single contact that was monitored worked 100% of the time. Four multimeters were then connected to each of the 4 switches. The switch was cycled and the switch at the end (switch terminals 3 & 4) remained open in both states of the switch as shown in these photos.

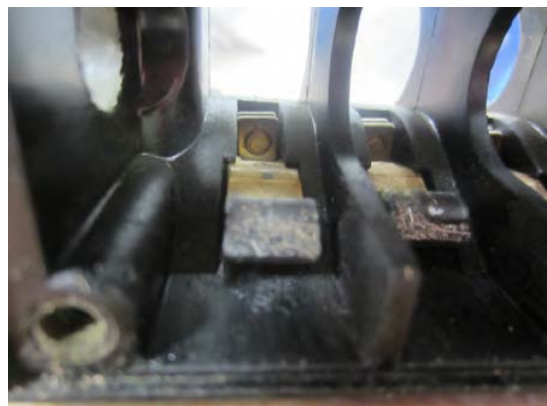
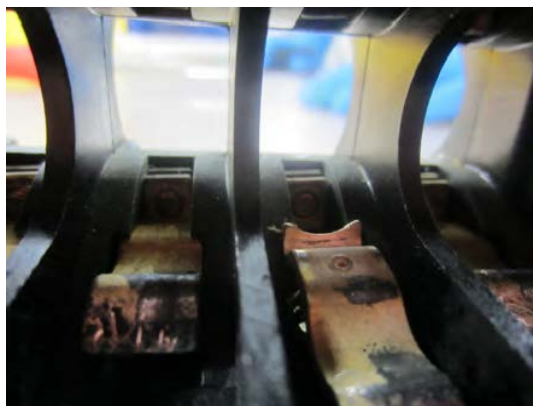
The switch rotors were removed from each of the switches and the bottom stationary contact finger in each case had come loose from the terminal point as shown here (left-hand switch and right)

The cell switches appeared to be original supplied equipment. They were not properly maintained, and the hardened lubrication could cause the stationary contacts to become dislodged, as documented above. In addition, to contributing to the dislodging the stationary contacts, excess or dry grease can cause improper indications from the switch contacts. This could be considered a possible cause of failure.

If these were the original cell switches that were provided with the switchgear, it is recommended that they be replaced with safety related switch assemblies provided by Westinghouse Electric Company.

It is recommended that all original cell switches be replaced and after the cell switches are replaced that they be maintained to the requirements provided in the Maintenance Program Manual for Westinghouse Safety Related Type DB Circuit Breakers and Associated Switchgear, Revision 1, July 2011.

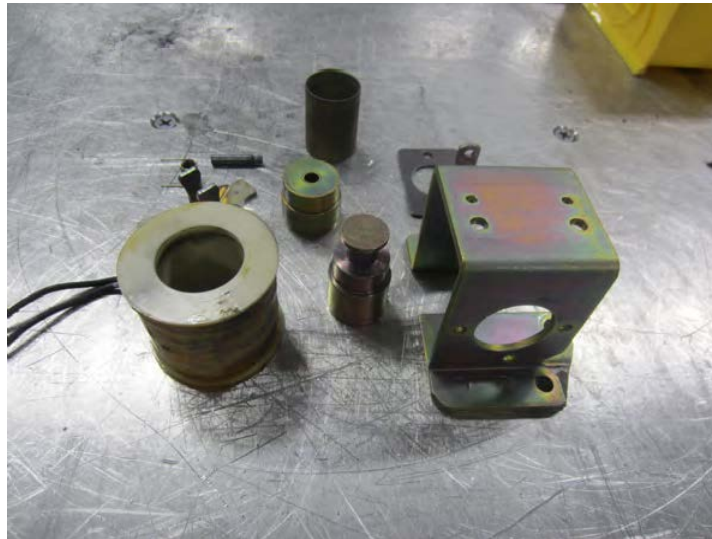
The STA was visually inspected and disassembled, no issues were found.

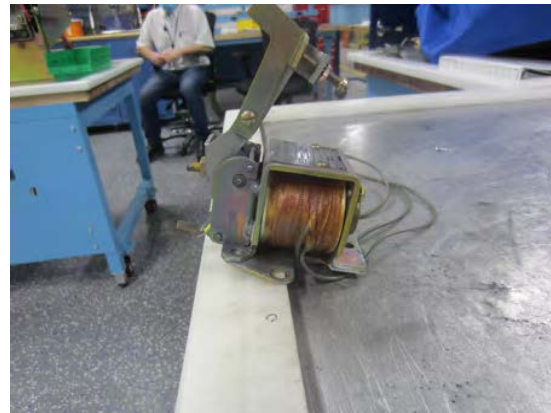
The visual inspection of the UVTA did not provide anything to be concerned about.
